## Item #13811347 - 2016 JLG 600AJ 4WD Diesel Articulating Boom Lift

# Inspection Report

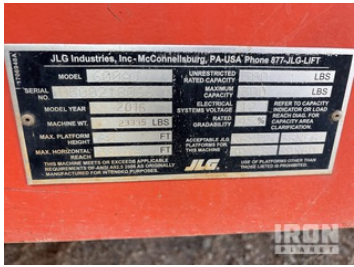
| Serial Number / VIN | 0300218066 | |

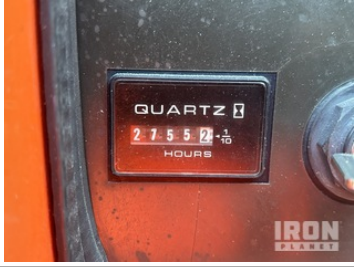
| Hour Meter / Odometer | 2755 hrs | |

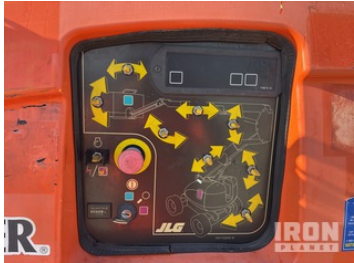
| Control Station Ground | | |
|---|---|---|
| Function Controls | ★★★★☆ | |

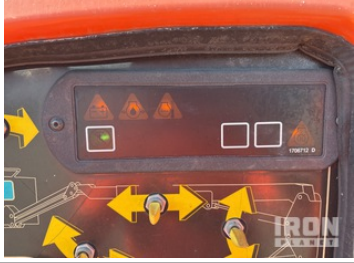
| Control Station Ground | | |
|---|---|---|
| Warning Lights | Operational | |

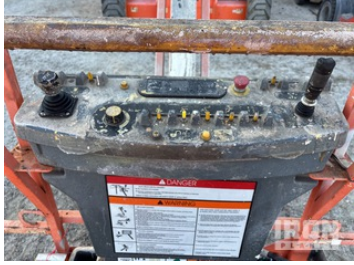
| Item | Assessment | Photo |
|---|---|---|
| Control Console | No visible damage or missing components | |

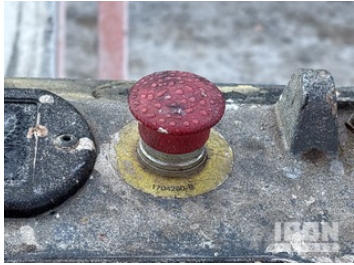
| Item | Assessment | Photo |
|---|---|---|
| Emergency Shut Off Switch | Operational | |

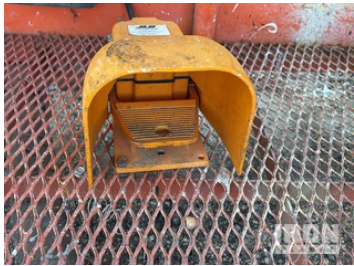
| Item | Assessment | Photo |
|---|---|---|
| Safety Control Hand/Foot Switch | ★★★★☆<br>Operational | |

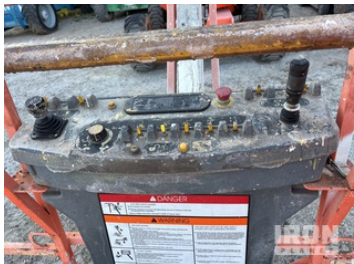
| Item | Assessment | Photo |
|---|---|---|
| Function Controls | ★★★★☆ | |

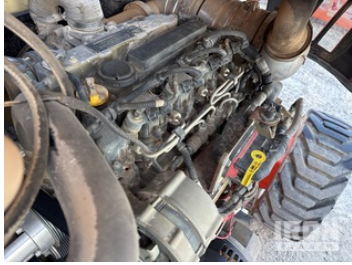
| Engine | | |
|---|---|---|
| Fuel System | Operational | |

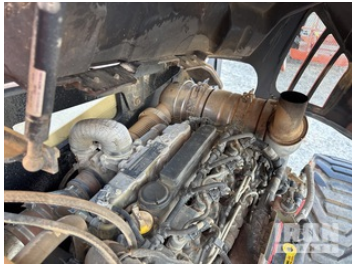
| Engine | | |
|---|---|---|
| Exhaust System | No visible damage or missing components | |

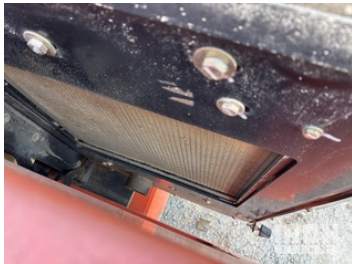
| Engine | | |
|---|---|---|
| Radiator | ★★★★☆ | |

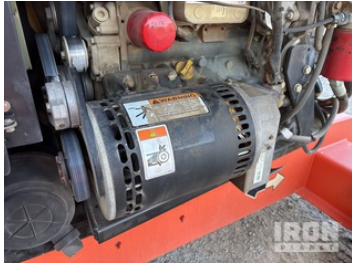
| Engine | | |
|---|---|---|
| Onboard Generator | Not operationally checked | |

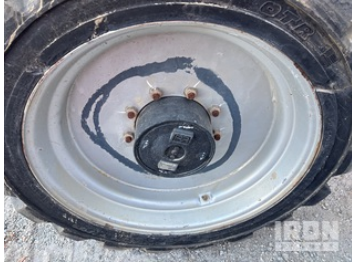
| Item | Assessment | Photo |
|---|---|---|
| Left Front Final Drive | ★★★★☆ | A close-up photograph of the left front final drive assembly, showing a black metal housing with a central hub and several bolts. |

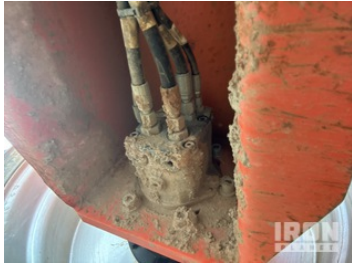
| Item | Assessment | Photo |
|---|---|---|
| Left Front Drive Motor | ★★★★☆ | A close-up photograph of the left front drive motor, showing a red metal housing and hydraulic lines. |

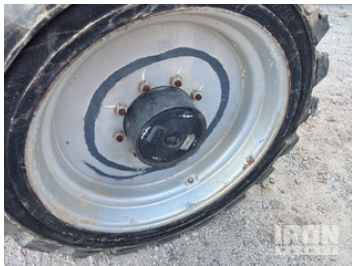
| Item | Assessment | Photo |
|---|---|---|
| Left Rear Final Drive | ★★★★☆ | A close-up photograph of the left rear final drive assembly, showing a black metal housing with a central hub and several bolts. |

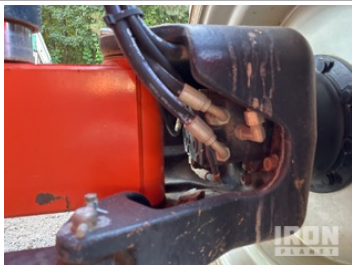
| Item | Assessment | Photo |
|---|---|---|
| Left Rear Drive Motor | ★★★★☆ | A close-up photograph of the left rear drive motor, showing a red metal housing and hydraulic lines. |

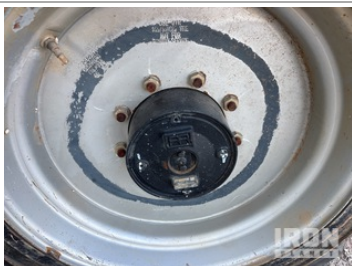
| Item | Assessment | Photo |
|---|---|---|
| Right Rear Final Drive | ★★★★☆ | A close-up photograph of the right rear final drive assembly, showing a black metal housing with a central hub and several bolts. |

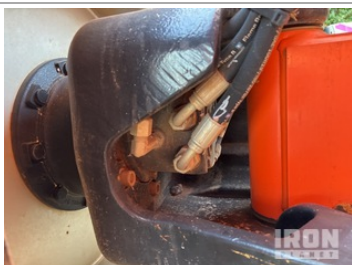
| Item | Assessment | Photo |
|---|---|---|
| Right Rear Drive Motor | ★★★★☆ | A close-up photograph of the right rear drive motor, showing a red metal housing and hydraulic lines. |

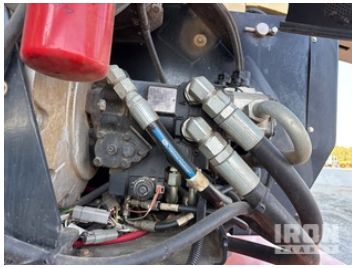
| Hydraulics | | |
|---|---|---|
| Pumps (Hydraulics) | ★★★★☆ | |

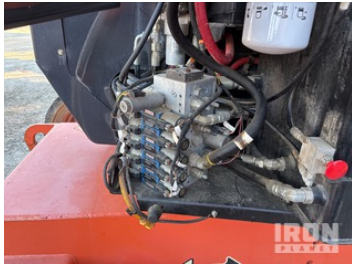
| Hydraulics | | |
|---|---|---|
| Valves | ★★★★☆ | |

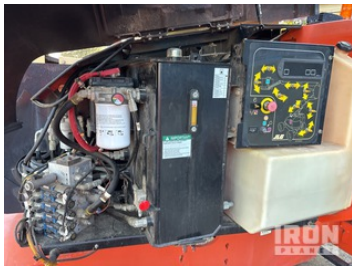
| Hydraulics | | |
|---|---|---|
| Hydraulic Tank | ★★★★☆ | |

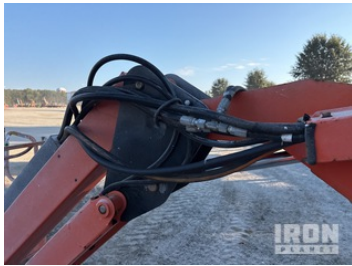
| Hydraulics | | |
|---|---|---|
| Hoses (Hydraulic) | ★★★★☆ | |

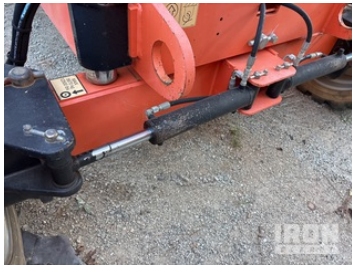
| Hydraulics | | |
|---|---|---|
| Steering Cylinders | ★★★★☆ | |

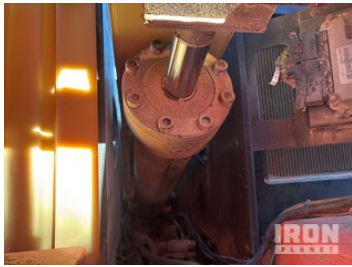
| Hydraulics | | |
|---|---|---|
| Boom Lift Cylinder | ★★★★☆ | |

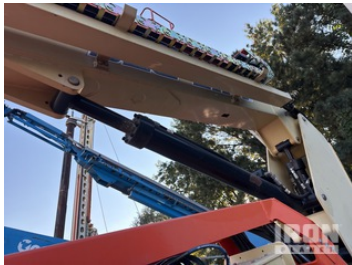
| Secondary Boom Cylinder | ★★★★☆ | |

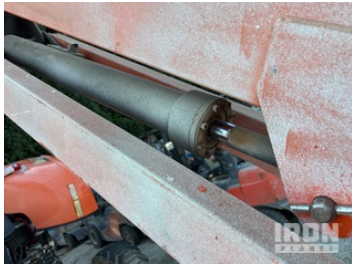
| Jib Cylinder | ★★★★☆ | |

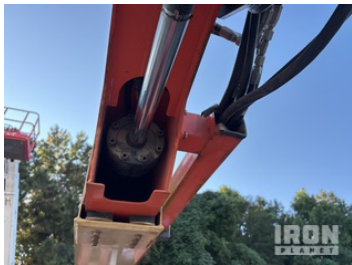
| Basket Tilt Cylinder | ★★★★☆ | |

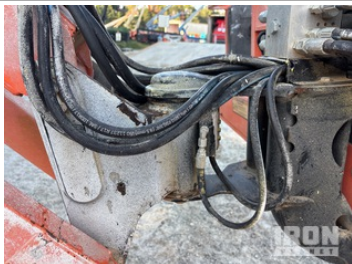
| Basket Rotator Motor | ★★★★☆ | |

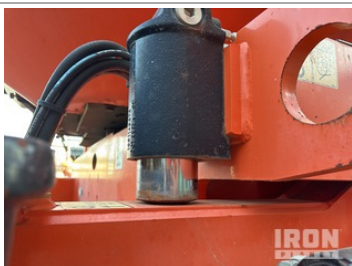
| Frame Leveling Cylinders | ★★★★☆ | |

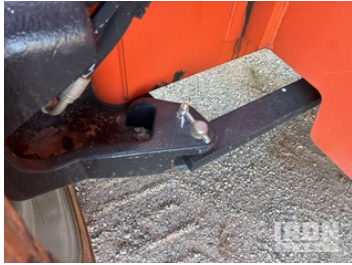
| Chassis | | |
|---|---|---|
| Steering Linkage | ★★★★☆ | |

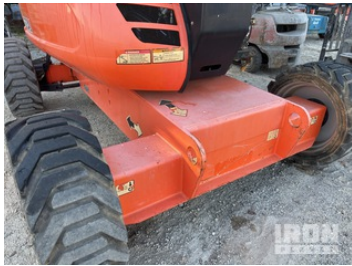
| Chassis | | |
|---|---|---|
| Frame Condition | ★★★★☆ | |

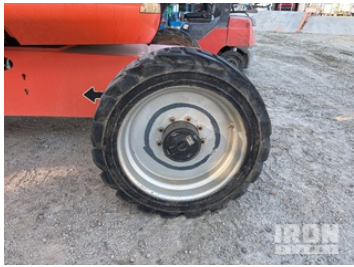
| Wheel Condition | No visible damage or missing components | |

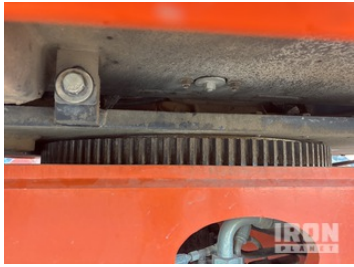
| Turntable Bearing | ★★★★☆ | |

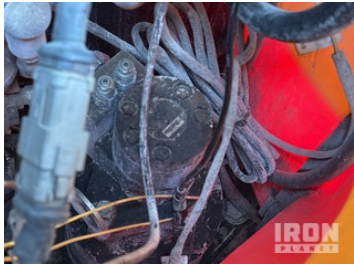
| Swing Motor | ★★★★☆ | |

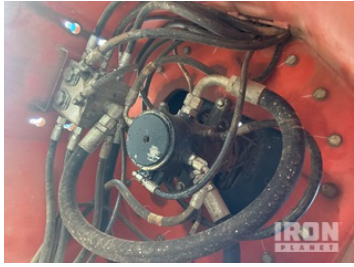
| Hydraulic Center Swivel | ★★★★☆ | |

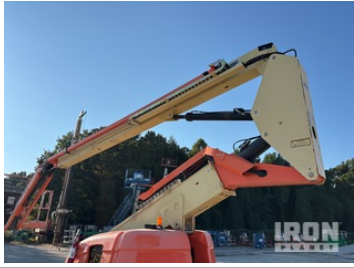
| Boom Condition | ★★★★☆ | |
