## Item #13810611 - 2017 Skyjack SJ63AJ 4WD Dual Fuel Articulating Boom Lift

# Inspection Report

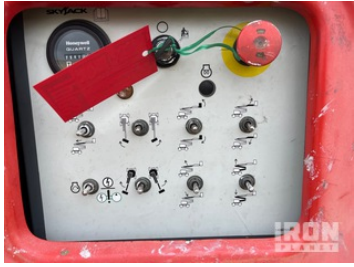
| Control Station Ground | | |
|---|---|---|
| Function Controls | ☆☆☆☆ | |

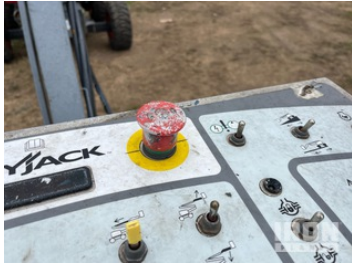
| Item | Assessment | Photo |
|---|---|---|
| Emergency Shut Off Switch | Operational | |

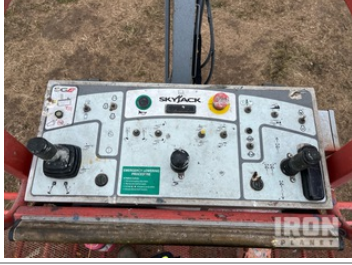
| Item | Assessment | Photo |
|---|---|---|
| Function Controls | ☆☆☆☆ | |

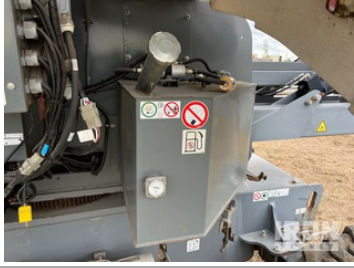
| Engine | | |
|---|---|---|
| Fuel System | Operational | |

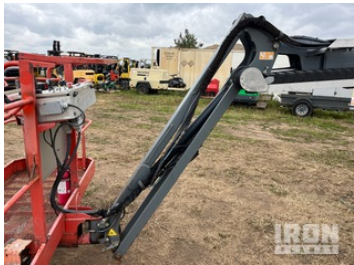
| Jib Condition | ☆☆☆☆ | |
