## Item #14339885 - 2016 JLG 600AJ 4WD Dual Fuel Articulating Boom Lift

- Features: 60 ft Max Platform Height, 500 lb Max Weight Capacity, Jib, Power to Platform, PSI 4 Cylinder 3 L Dual Fuel Engine, 355/55D625 Foam-Filled Tires
- Meter Reading: 3,021 Hours
- Serial # : 0300213470
- Inspection Completed: 11/6/25

# Inspection Report

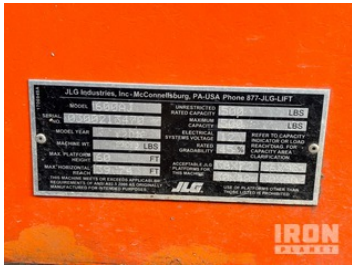
| Serial Number / VIN | 0300213470 | |

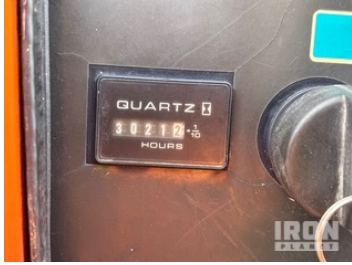
| Hour Meter / Odometer | 3021 hrs | |

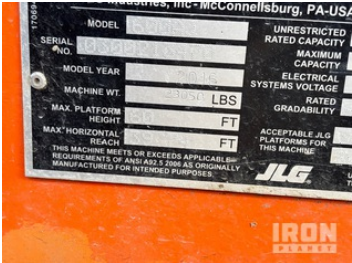
| Safety | | |
|---|---|---|
| ANSI Guidelines | Yes | |
