## Item #14340564 - 2017 Genie Z-30/20N RJ 2WD Electric Articulating Boom Lift

- Features: 29 ft 2 in Max Platform Height, 500 lb Max Weight Capacity, Jib, Power to Platform, 22x7x17 3/4 Non-Marking Tires
- Meter Reading: 381 Hours
- Serial # : Z30NF-19645
- Inspection Completed: 11/24/25

# Inspection Report

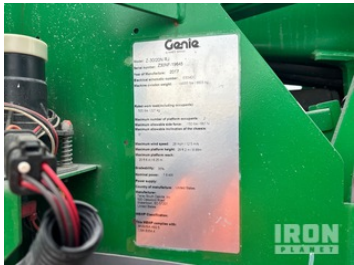
| Serial Number / VIN | Z30NF-19645 | |

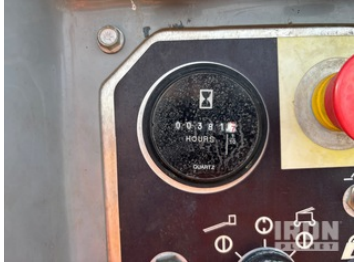
| Hour Meter / Odometer | 381 hrs | |

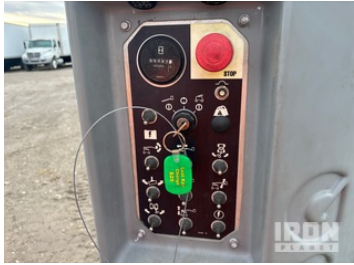
| Control Station Ground | | |
|---|---|---|
| Function Controls | ☆☆☆☆ | |

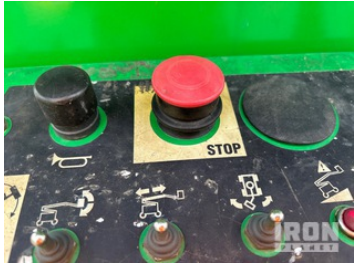
| Item | Assessment | Photo |
|---|---|---|
| Emergency Shut Off Switch | Operational | |

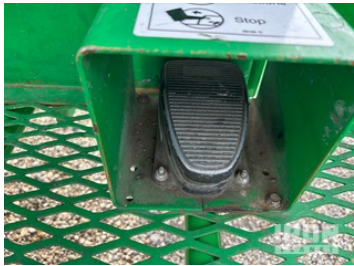
| Item | Assessment | Photo |
|---|---|---|
| Safety Control Hand/Foot Switch | ☆☆☆☆<br>Operational | |

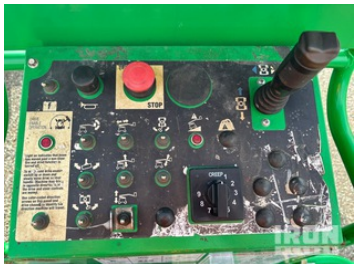
| Item | Assessment | Photo |
|---|---|---|
| Function Controls | ☆☆☆☆ | |
