## Item #13810845 - 2016 JLG 600AJ 4WD Diesel Articulating Boom Lift

## Inspection Report

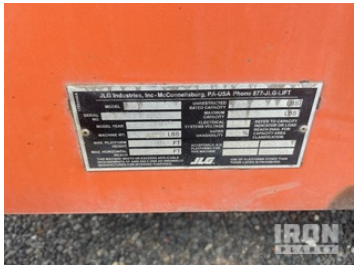
| Serial Number / VIN | 0300217838 | |

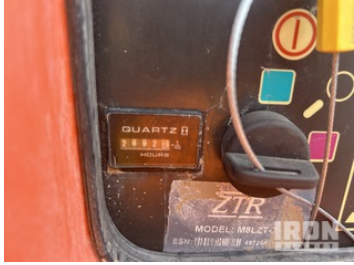
| Hour Meter / Odometer | 2892 hrs | |

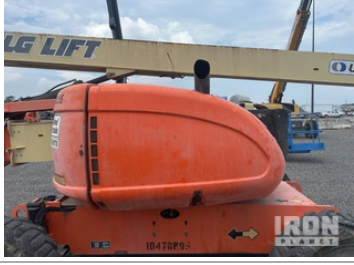
| Body Panels | No visible damage or missing components | |

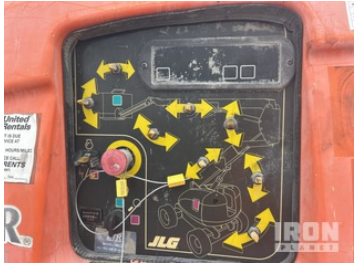
| Control Station Ground | | |
|---|---|---|
| Gauges | Operational | |

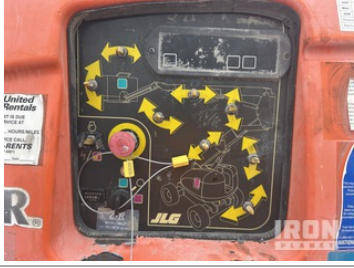
| Control Station Ground | | |
|---|---|---|
| Function Controls | ★★★★☆ | |

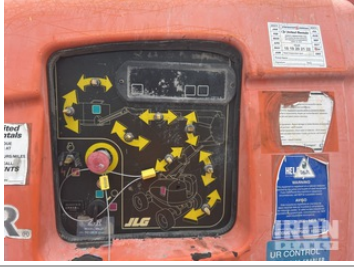
| Control Station Ground | | |
|---|---|---|
| Warning Lights | Operational | |

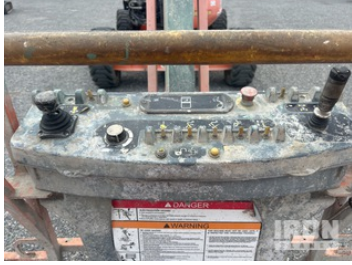
| Item | Assessment | Photo |
|---|---|---|
| Control Console | No visible damage or missing components | |

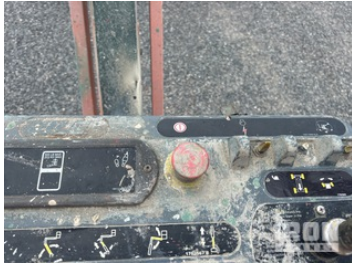
| Item | Assessment | Photo |
|---|---|---|
| Emergency Shut Off Switch | Operational | |

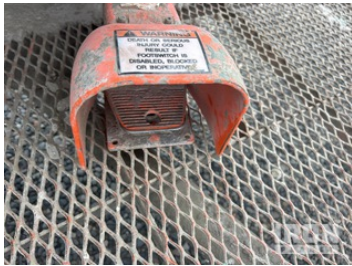
| Item | Assessment | Photo |
|---|---|---|
| Safety Control Hand/Foot Switch | ★★★★☆<br>Operational | |

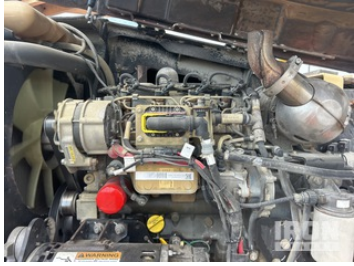
| Engine | | |
|---|---|---|
| Fuel System | Operational | |

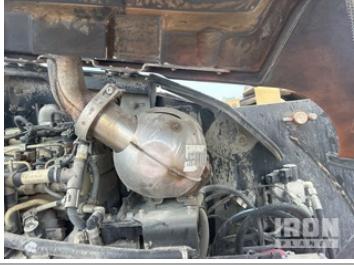
| Engine | | |
|---|---|---|
| Exhaust System | No visible damage or missing components | |

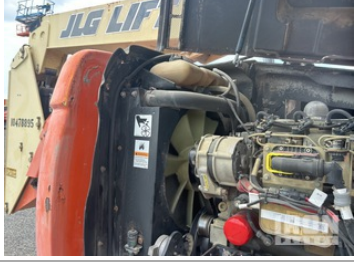
| Engine | | |
|---|---|---|
| Radiator | ★★★★☆ | |

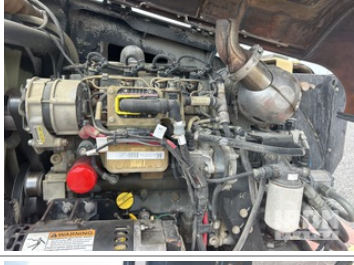
| Engine | | |
|---|---|---|
| Fuel Leaks | No dripping leaks | |

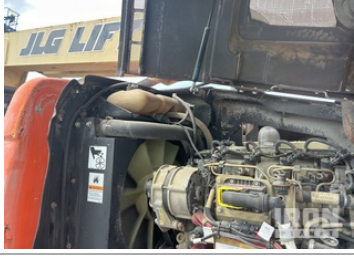
| Engine | | |
|---|---|---|
| Cooling System Leaks | No dripping leaks | |

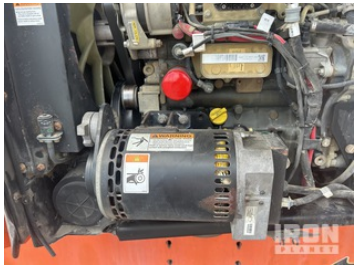
| Onboard Generator | Not operationally checked | |
