## Item #13810858 - 2016 JLG 600S 4WD Diesel Telescopic Boom Lift

# Inspection Report

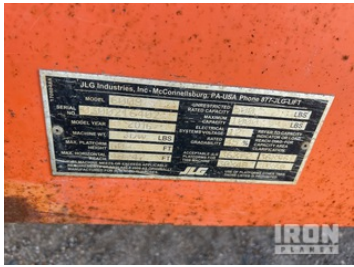
| Serial Number / VIN | 0300216402 | |

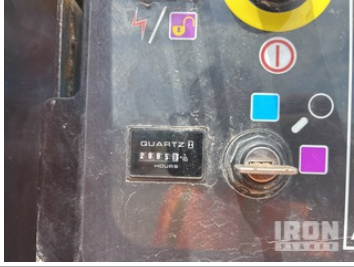
| Hour Meter / Odometer | 2995 hrs | |

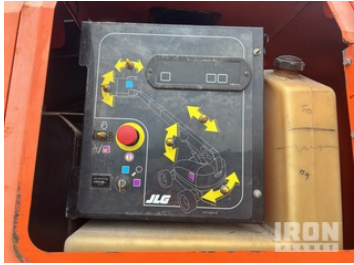
| Control Station Ground | | |
|---|---|---|
| Gauges | Operational | |

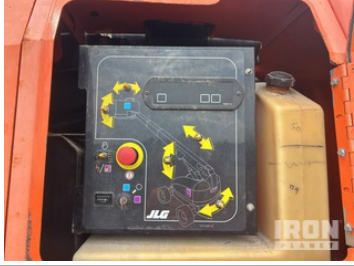
| Control Station Ground | | |
|---|---|---|
| Function Controls | ★★★★☆ | |

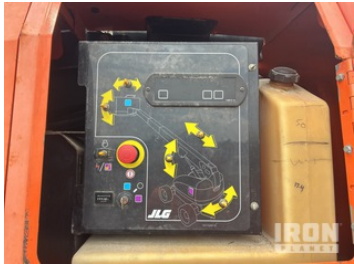
| Control Station Ground | | |
|---|---|---|
| Warning Lights | Operational | |

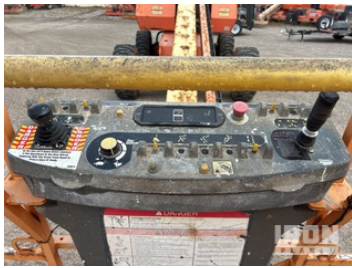
| Item | Assessment | Photo |
|---|---|---|
| Control Console | No visible damage or missing components | |

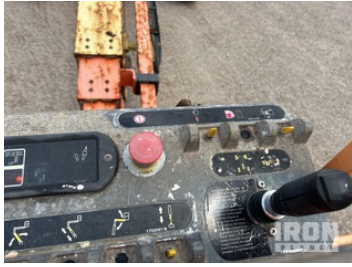
| Item | Assessment | Photo |
|---|---|---|
| Emergency Shut Off Switch | Operational | |

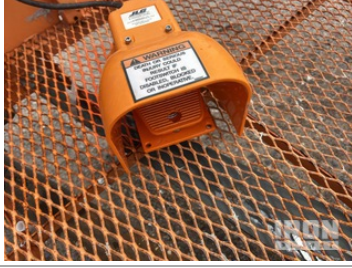
| Item | Assessment | Photo |
|---|---|---|
| Safety Control Foot Switch | ☆☆☆☆ | |

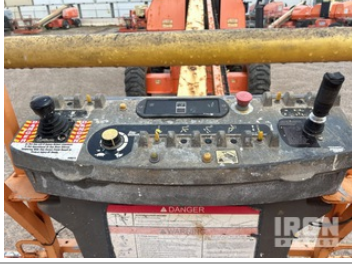
| Item | Assessment | Photo |
|---|---|---|
| Function Controls | ☆☆☆☆ | |

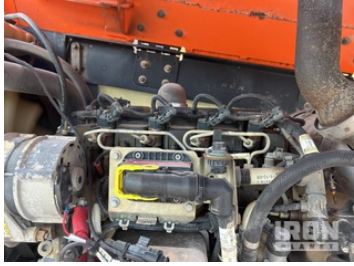
| <b>Engine</b> | | |
|---|---|---|
| Fuel System | Operational | |

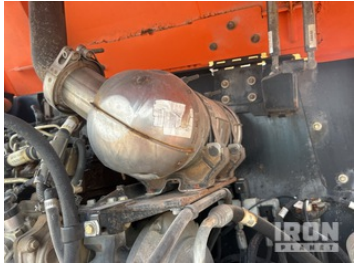
| <b>Engine</b> | | |
|---|---|---|
| Exhaust System | No visible damage or missing components | |

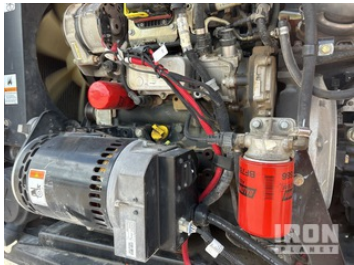
| <b>Engine</b> | | |
|---|---|---|
| Oil Leaks | No dripping leaks | |

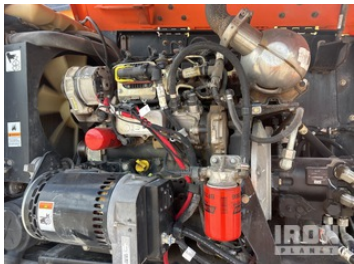
| <b>Engine</b> | | |
|---|---|---|
| Fuel Leaks | No dripping leaks | |

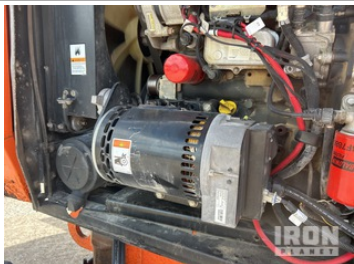
| <b>Engine</b> | | |
|---|---|---|
| Onboard Generator | Not operationally checked | |

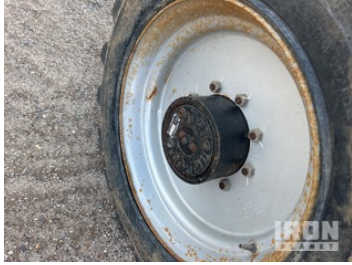
| Item | Assessment | Photo |
|---|---|---|
| Left Front Final Drive | ★★★★☆ | |

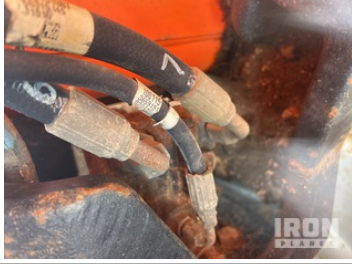
| Item | Assessment | Photo |
|---|---|---|
| Left Front Drive Motor | ★★★★☆ | |

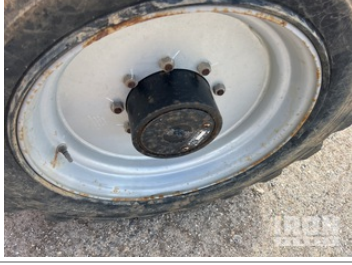
| Item | Assessment | Photo |
|---|---|---|
| Left Rear Final Drive | ★★★★☆ | |

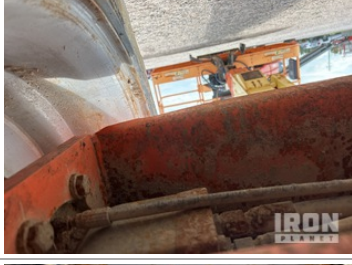
| Item | Assessment | Photo |
|---|---|---|
| Left Rear Drive Motor | ★★★★☆ | |

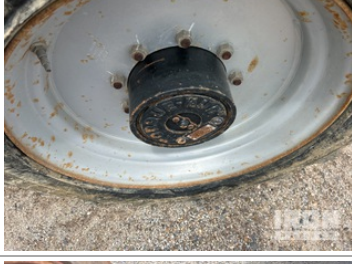
| Item | Assessment | Photo |
|---|---|---|
| Right Rear Final Drive | ★★★★☆ | |

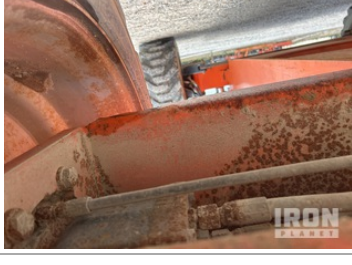
| Item | Assessment | Photo |
|---|---|---|
| Right Rear Drive Motor | ★★★★☆ | |

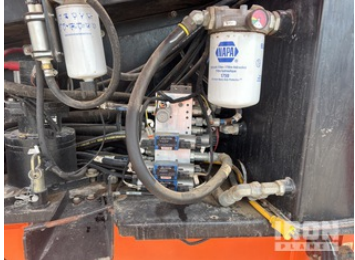
| Hydraulics | | |
|---|---|---|
| Valves | ★★★☆ | |

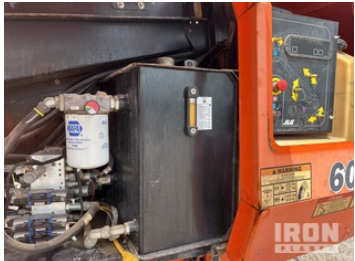
| Hydraulics | | |
|---|---|---|
| Hydraulic Tank | ★★★☆ | |

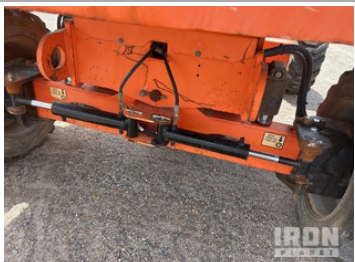
| Hydraulics | | |
|---|---|---|
| Steering Cylinders | ★★★☆ | |

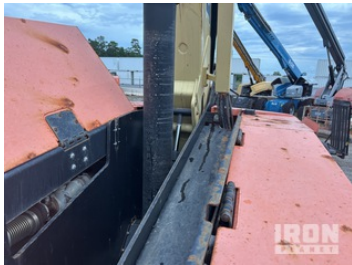
| Secondary Boom Cylinder | ★★★★☆ | |

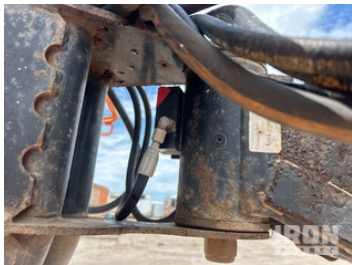
| Basket Rotator Motor | ★★★★☆ | |

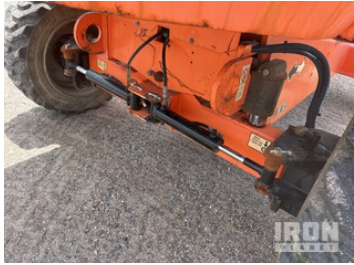
| Chassis | | |
|---|---|---|
| Steering Linkage | ★★★★☆ | |

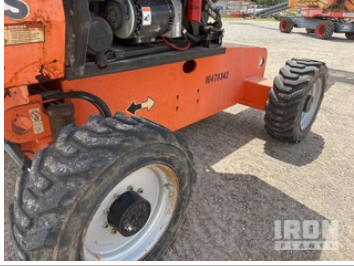
| Chassis | | |
|---|---|---|
| Frame Condition | ★★★★☆ | |

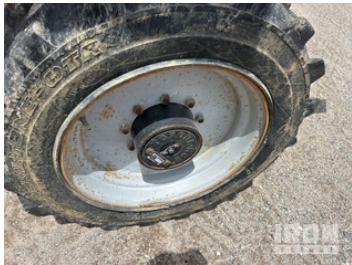
| Wheel Condition | No visible damage or missing components | |

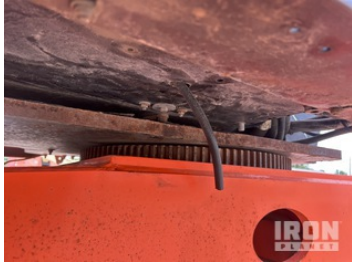
| Turntable Bearing | ★★★★☆ | |

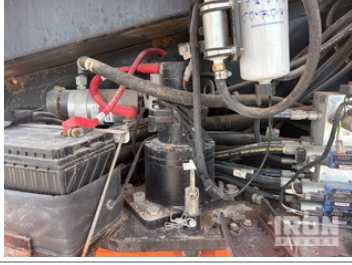
| Swing Motor | ★★★★☆ | |

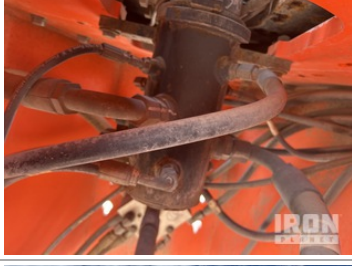
| Hydraulic Center Swivel | ★★★★☆ | |

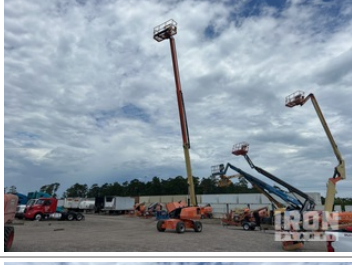
| Boom Condition | ★★★★☆ | |

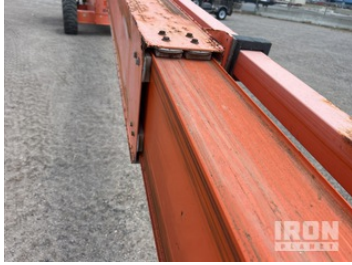
| Boom Wear Guides | ★★★★☆ | |
