## Item #13810892 - 2016 Skyjack SJ45T Dual Fuel Telescopic Boom Lift

- Features: 45 ft Max Platform Height, 500 lb Max Weight Capacity, Power to Platform, 4 Cylinder Dual Fuel Engine, 12-16.5 Tires
- Meter Reading: 4,539 Hours
- Serial # : 98001768
- Inspection Completed: 9/29/25

# Inspection Report

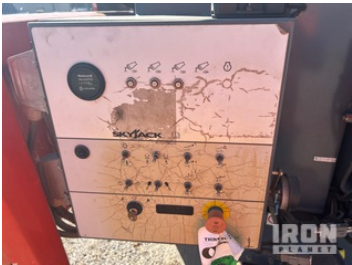
| Control Station Ground | | |
|---|---|---|
| Function Controls | ☆☆☆☆ | |

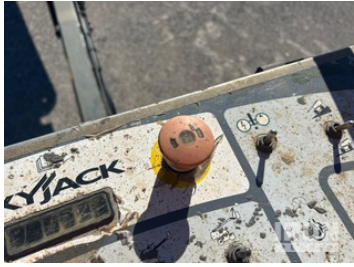
| Item | Assessment | Photo |
|---|---|---|
| Emergency Shut Off Switch | Operational | |

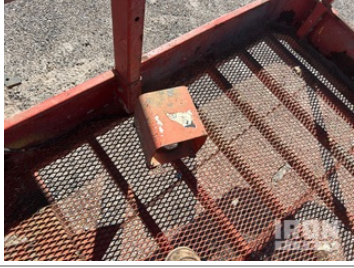
| Item | Assessment | Photo |
|---|---|---|
| Safety Control Hand/Foot Switch | ★★★★☆<br>Operational | |

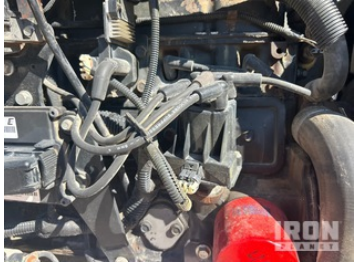
| Engine | | |
|---|---|---|
| Fuel System | Operational | |

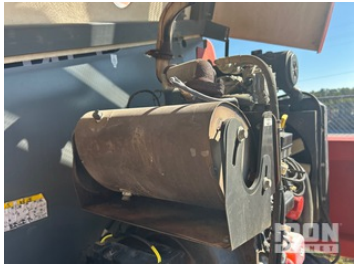
| Engine | | |
|---|---|---|
| Exhaust System | No visible damage or missing components | |

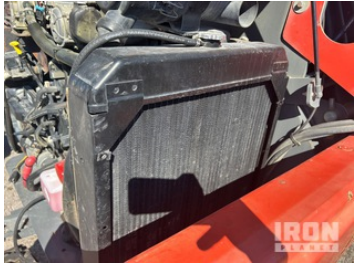
| Engine | | |
|---|---|---|
| Radiator | ★★★★☆ | |

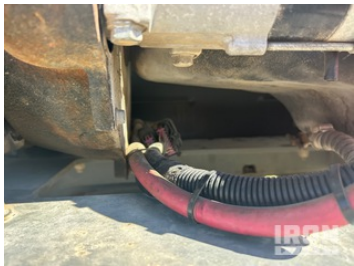
| Engine | | |
|---|---|---|
| Oil Leaks | No dripping leaks | |

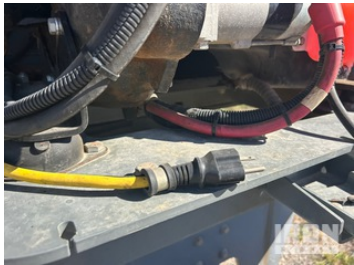
| Engine | | |
|---|---|---|
| Fuel Leaks | No dripping leaks | |

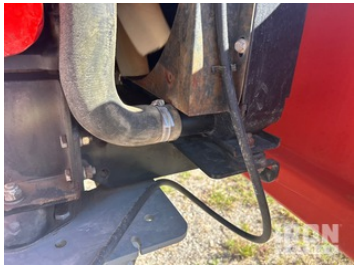
| Cooling System Leaks | No dripping leaks | |

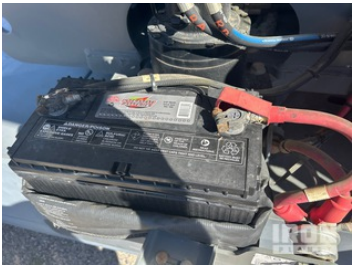
| Electrical Operating System | | |
|---|---|---|
| Cables and Connections | No visible damage or missing components | |

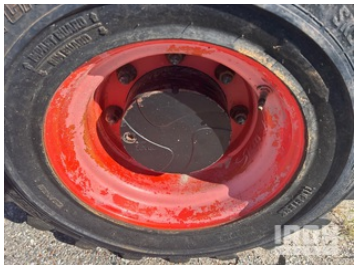
| Item | Assessment | Photo |
|---|---|---|
| Left Front Final Drive | ★★★★☆ | |

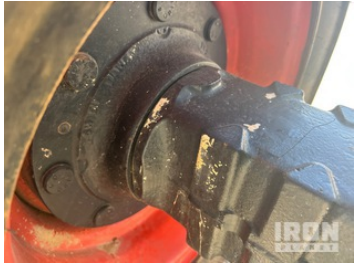
| Item | Assessment | Photo |
|---|---|---|
| Left Front Drive Motor | ★★★★☆ | |

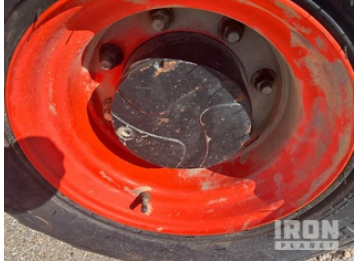
| Item | Assessment | Photo |
|---|---|---|
| Left Rear Final Drive | ★★★★☆ | |

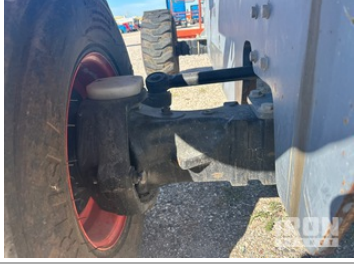
| Item | Assessment | Photo |
|---|---|---|
| Left Rear Drive Motor | ★★★★☆ | |

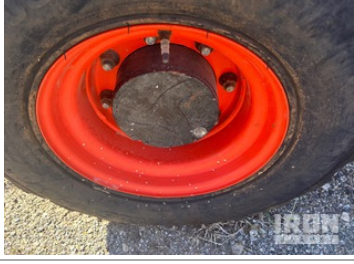
| Item | Assessment | Photo |
|---|---|---|
| Right Rear Final Drive | ★★★★☆ | |

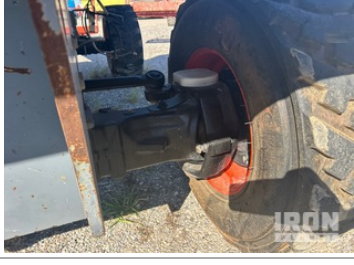
| Item | Assessment | Photo |
|---|---|---|
| Right Rear Drive Motor | ★★★★☆ | |

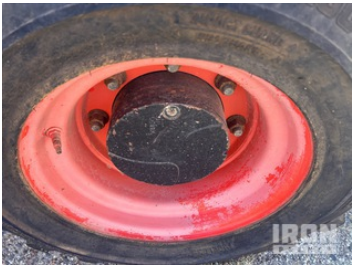
| Right Front Final Drive | ☆☆☆☆ | |

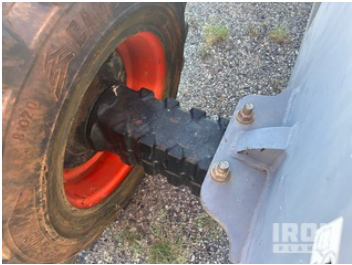
| Right Front Drive Motor | ☆☆☆☆ | |

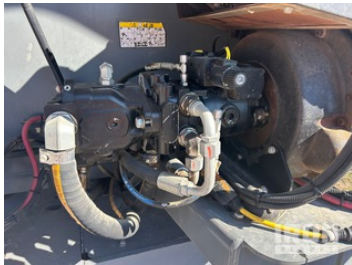
| Hydraulics | | |
|---|---|---|
| Pumps (Hydraulics) | ★★★★☆ | |

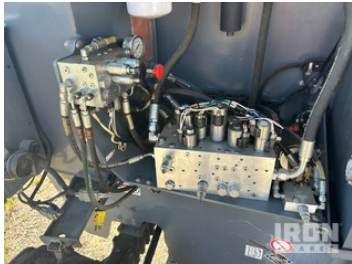
| Hydraulics | | |
|---|---|---|
| Valves | ★★★★☆ | |

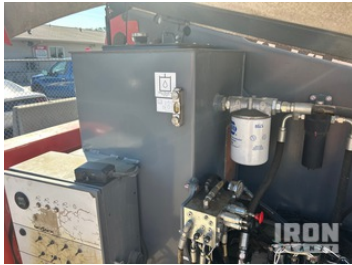
| Hydraulics | | |
|---|---|---|
| Hydraulic Tank | ★★★★☆ | |

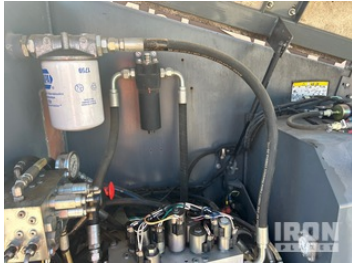
| Hydraulics | | |
|---|---|---|
| Hoses (Hydraulic) | ★★★★☆ | |

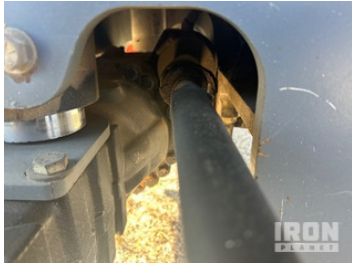
| Hydraulics | | |
|---|---|---|
| Steering Cylinders | ★★★★☆ | |

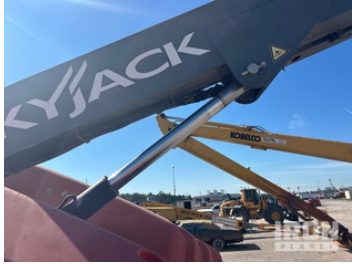
| Hydraulics | | |
|---|---|---|
| Boom Lift Cylinder | ★★★★☆ | |

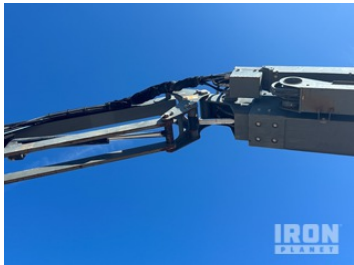
| Jib Cylinder | ★★★★☆ | |

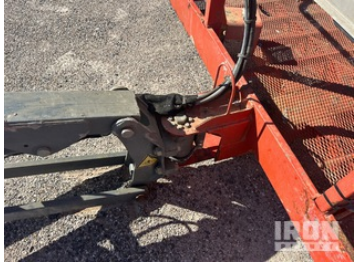
| Basket Tilt Cylinder | ★★★★☆ | |

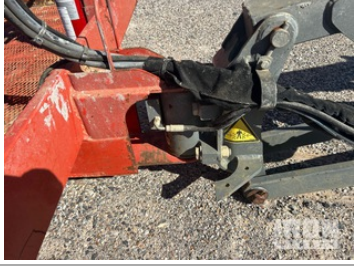
| Basket Rotator Motor | ★★★★☆ | |

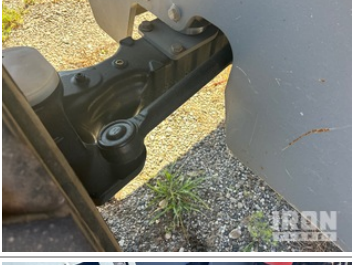
| Steering Linkage | ★★★★☆ | |

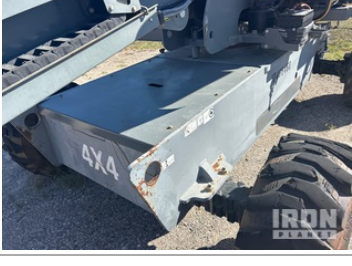
| Frame Condition | ★★★★☆ | |

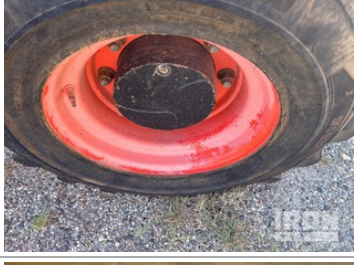
| Wheel Condition | No visible damage or missing components | |

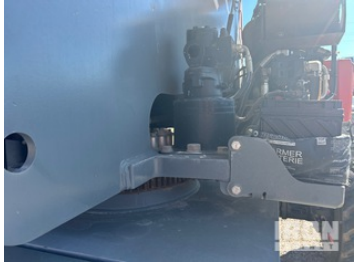
| Swing Motor | ★★★★☆ | |

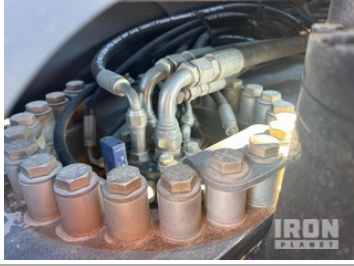
| Hydraulic Center Swivel | ★★★★☆ | |

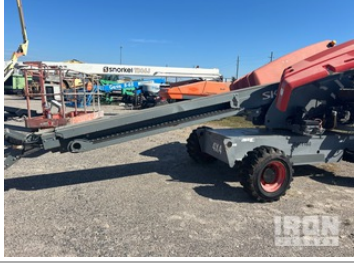
| Boom Condition | ★★★★☆ | |

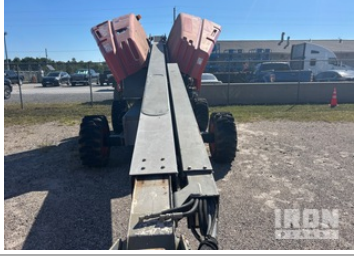
| Boom Wear Guides | ★★★★☆ | |

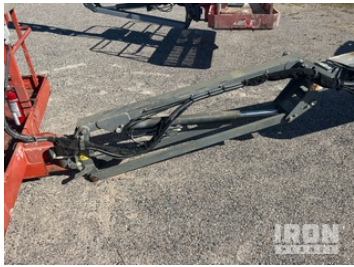
| Jib Condition | ☆☆☆☆ | |
