Item #14095044 - 2017 Skyjack SJ61T 4WD Diesel Telescopic Boom Lift

Inspection Report

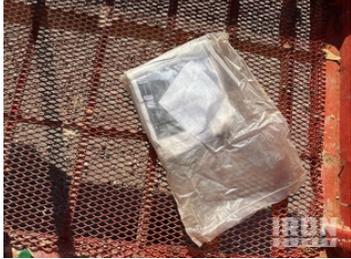
Safety		
Item	Assessment	Photo
Horn	Inoperable	
Swing Brake	Operational	
Current Safety Manual	No	
Current Operator/Maintenance Manual	Yes	
ANSI Guidelines	Yes

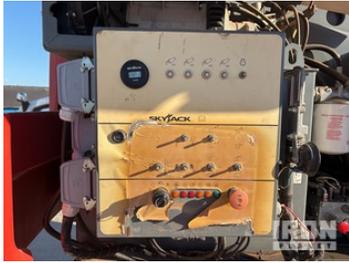
Control Station Ground		
Item	Assessment	Photo
Function Controls	★★★☆☆

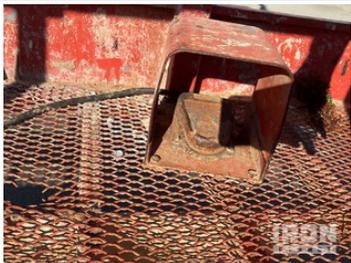
Safety Control Hand/Foot Switch	★★★★☆ Operational

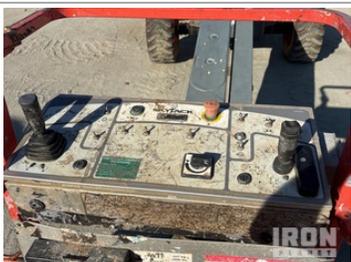
Function Controls	★★★★☆

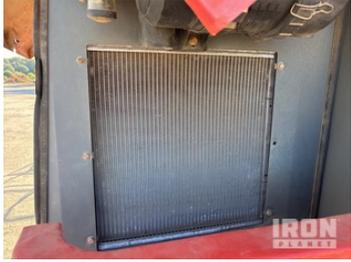
Radiator	★★★★☆

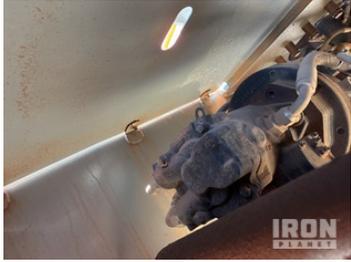
Drivetrain		
Operational test is limited to low speed in a confined flat area without load. Differential interlocks, full transmission shifting and functionality of all drive axles cannot be fully verified. Inspector listens for abnormal noises, observes leaks and notes physical damage.		
Item	Assessment	Photo
Front Center Drive Motor	★★★★☆

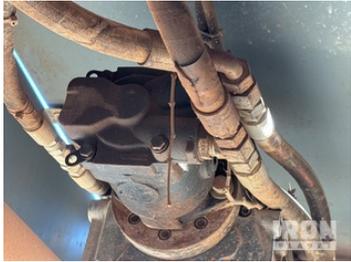
Rear Center Drive Motor	★★★★☆

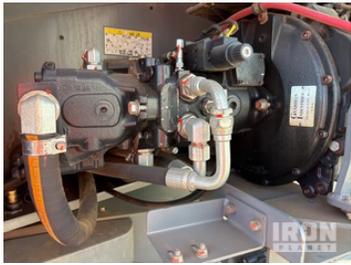
<h2>Hydraulics</h2>		
See photos for condition		
Item	Assessment	Photo
Pumps (Hydraulics)	★ ★ ★ ☆

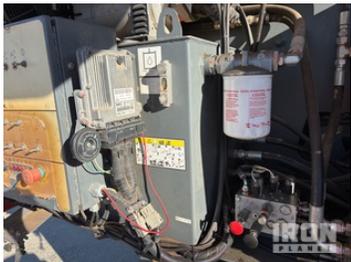
Hydraulic Tank	★ ★ ★ ☆

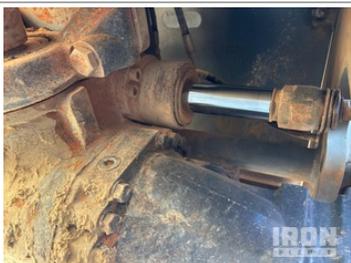
Steering Cylinders	★ ★ ★ ☆

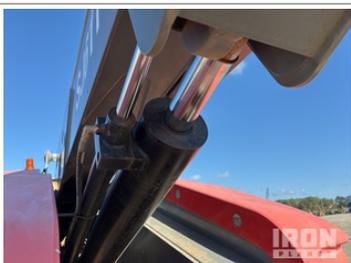
Boom Lift Cylinder	★ ★ ★ ☆

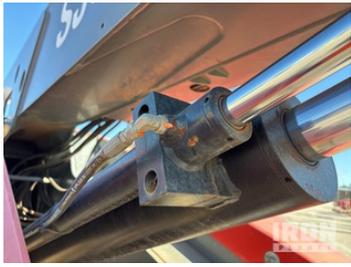
<p>Secondary Boom Cylinder</p>	<p>★★★★☆</p>

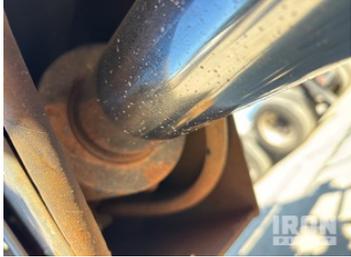
<p>Boom Extension Cylinder</p>	<p>★★★★☆</p>	
<p>Basket Tilt Cylinder</p>	<p>★★★★☆</p>

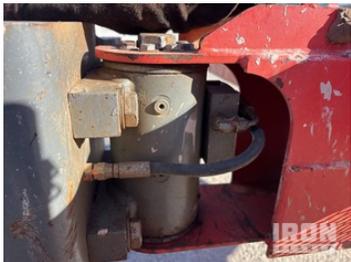
<p>Basket Rotator Motor</p>	<p>★★★★☆</p>

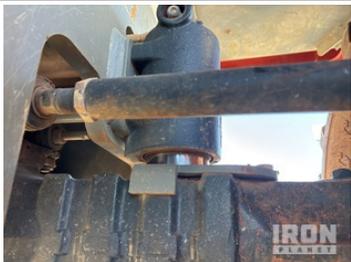
<p>Limited Function Check</p>	<p>The hydraulic system was operational.</p>	
<p>Hydraulics #1</p>

<p>Frame Leveling Cylinders</p>	<p>★★★★☆</p>

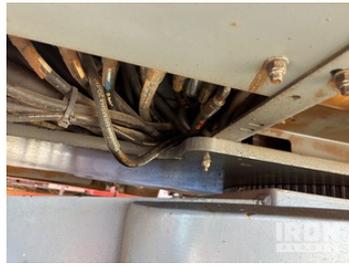
Chassis		
Item	Assessment	Photo
Steering Linkage	★★☆☆☆ Damaged boots
