## Item #14251163 - 2006 JLG 600S 4WD Diesel Telescopic Boom Lift

# Inspection Report

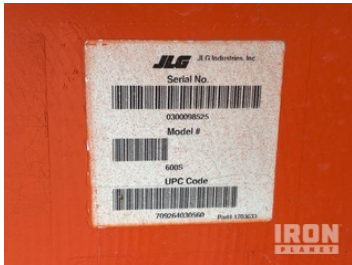
| Serial Number / VIN | 0300098525 | |

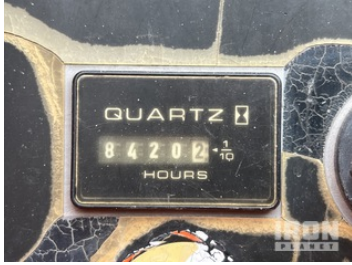
| Hour Meter / Odometer | 8420 hrs | |

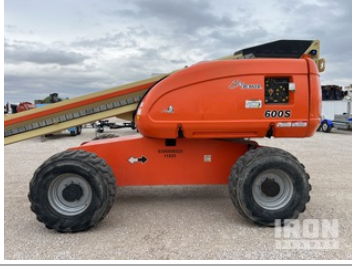
| Paint | No visible damage | |

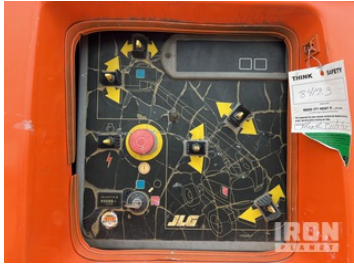
| Control Station Ground | | |
|---|---|---|
| Function Controls | ★★★★☆ | |

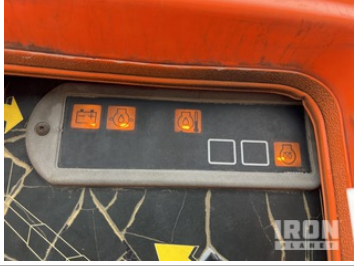
| Control Station Ground | | |
|---|---|---|
| Oil Pressure | The fault indicator shuts off after the engine oil pressure rises. | |

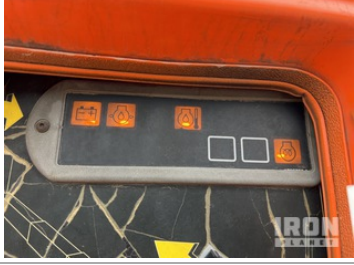
| Control Station Ground | | |
|---|---|---|
| Warning Lights | Operational | |

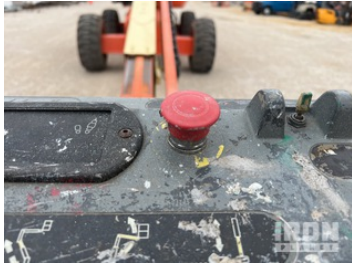
| Item | Assessment | Photo |
|---|---|---|
| Emergency Shut Off Switch | Operational | |

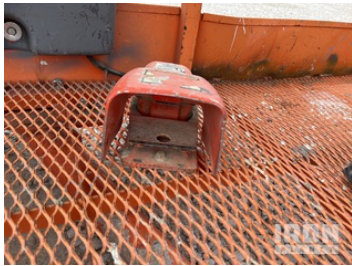
| Item | Assessment | Photo |
|---|---|---|
| Safety Control Hand/Foot Switch | ★★★★☆<br>Operational | |

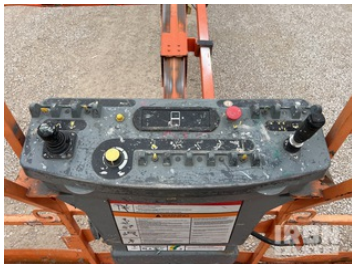
| Item | Assessment | Photo |
|---|---|---|
| Function Controls | ★★★★☆ | |

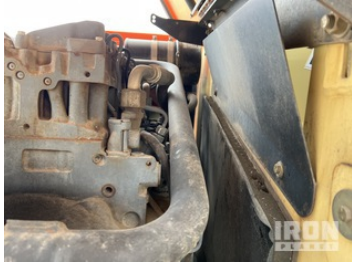
| Engine | | |
|---|---|---|
| Fuel System | Operational | |

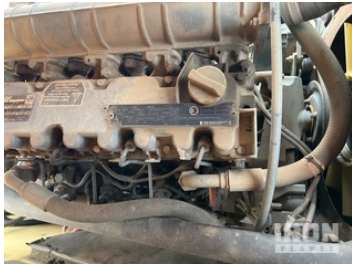
| Engine | | |
|---|---|---|
| Exhaust System | No visible damage or missing components | |

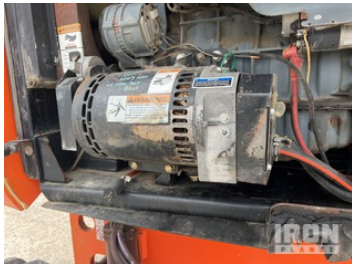
| Engine | | |
|---|---|---|
| Onboard Generator | Not operationally checked | |

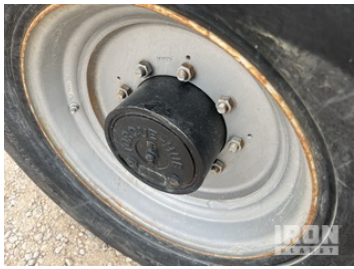
| Item | Assessment | Photo |
|---|---|---|
| Left Front Final Drive | ★★★★☆ | |

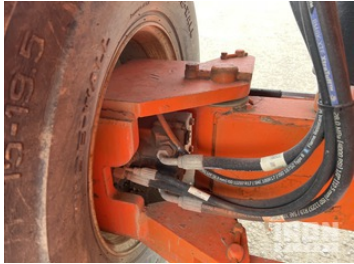
| Item | Assessment | Photo |
|---|---|---|
| Left Front Drive Motor | ★★★★☆ | |

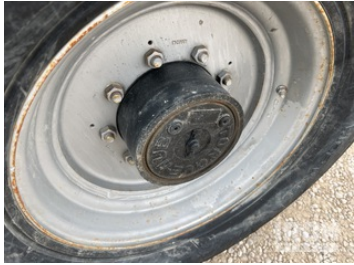
| Item | Assessment | Photo |
|---|---|---|
| Left Rear Final Drive | ★★★★☆ | |

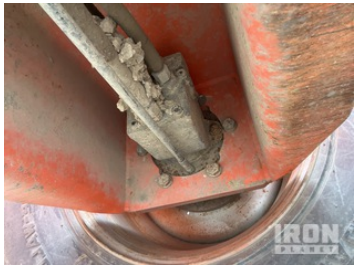
| Item | Assessment | Photo |
|---|---|---|
| Left Rear Drive Motor | ★★★★☆ | |

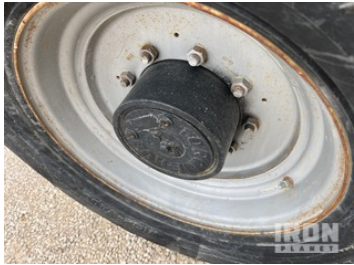
| Item | Assessment | Photo |
|---|---|---|
| Right Rear Final Drive | ★★★★☆ | |

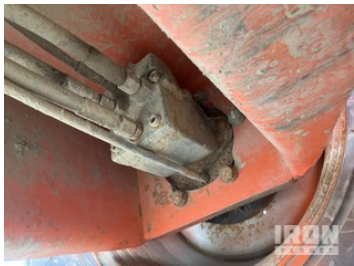
| Item | Assessment | Photo |
|---|---|---|
| Right Rear Drive Motor | ★★★★☆ | |

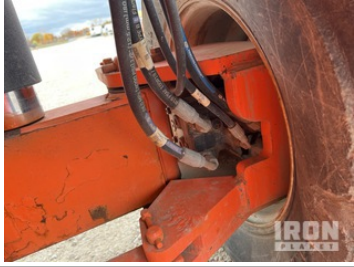
| Right Front Drive Motor | ☆☆☆☆ | |

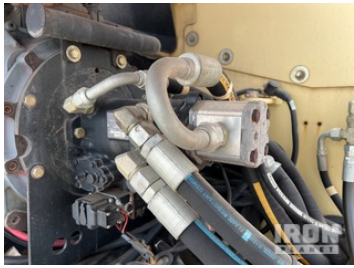
| Hydraulics | | |
|---|---|---|
| Pumps (Hydraulics) | ★★★★☆ | |

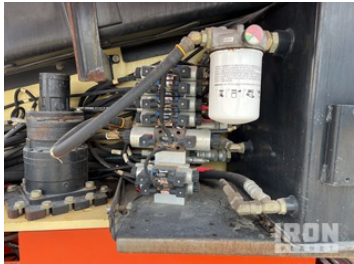
| Hydraulics | | |
|---|---|---|
| Valves | ★★★★☆ | |

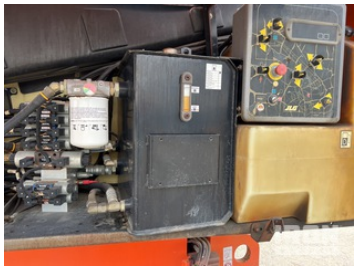
| Hydraulics | | |
|---|---|---|
| Hydraulic Tank | ★★★★☆ | |

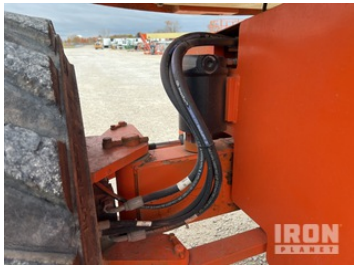
| Hydraulics | | |
|---|---|---|
| Hoses (Hydraulic) | ★★★★☆ | |

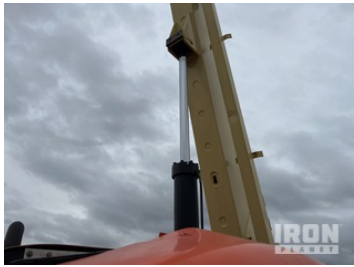
| Hydraulics | | |
|---|---|---|
| Boom Lift Cylinder | ★★★★☆ | |

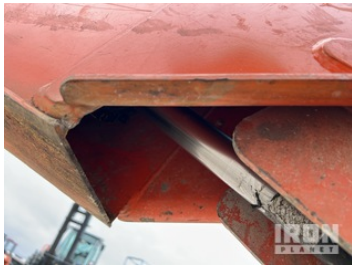
| Basket Tilt Cylinder | ★★★★☆ | |

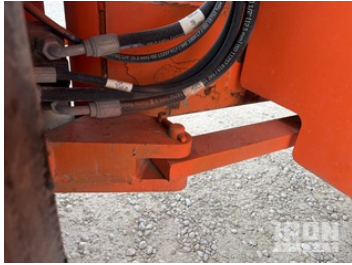
| Chassis | | |
|---|---|---|
| Steering Linkage | ☆☆☆☆ | |

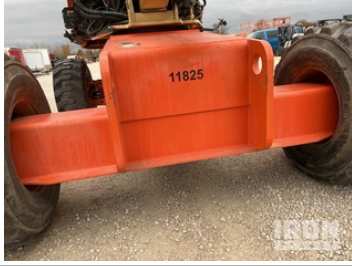
| Chassis | | |
|---|---|---|
| Frame Condition | ☆☆☆☆ | |

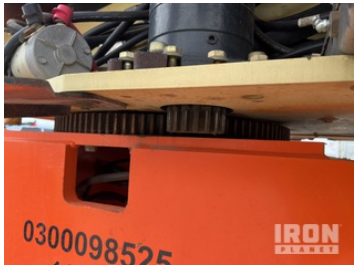
| Turntable Bearing | ★★★★☆ | |

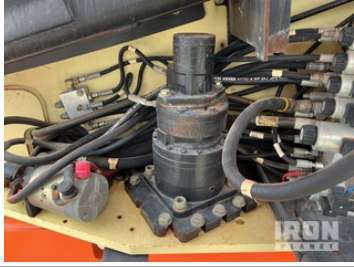
| Swing Motor | ★★★★☆ | |

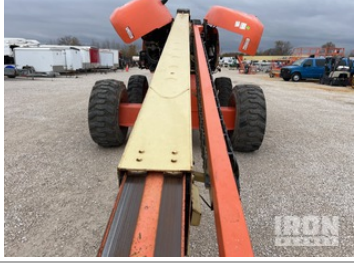
| Boom Condition | ★★★★☆ | |

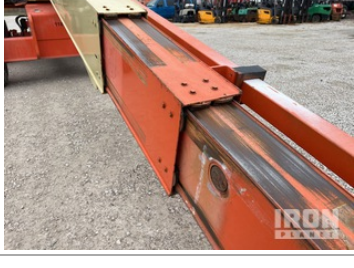
| Boom Wear Guides | ★★★★☆ | |
