## Item #13810610 - 2017 Skyjack SJ45T 4WD Diesel Telescopic Boom Lift

# Inspection Report

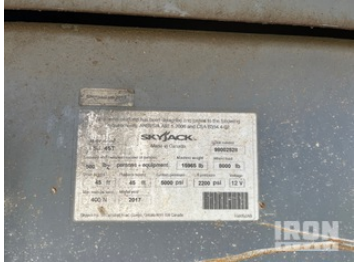
| Safety | | |
|---|---|---|
| ANSI Guidelines | Yes | |

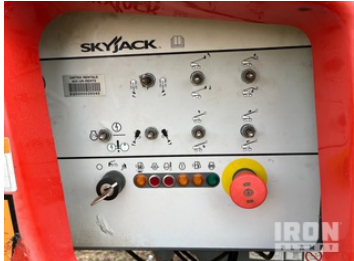
| Control Station Ground | | |
|---|---|---|
| Function Controls | ★★★★☆ | |

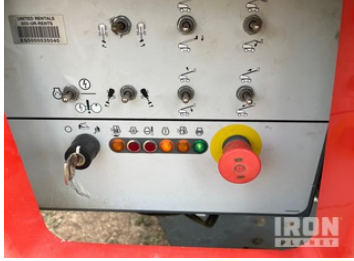
| Control Station Ground | | |
|---|---|---|
| Warning Lights | Operational | |

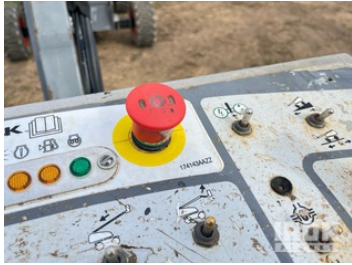
| Item | Assessment | Photo |
|---|---|---|
| Emergency Shut Off Switch | Operational | |

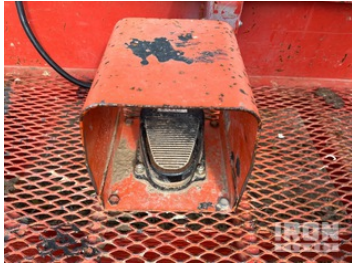
| Item | Assessment | Photo |
|---|---|---|
| Safety Control Foot Switch | ☆☆☆☆<br>Operational | |

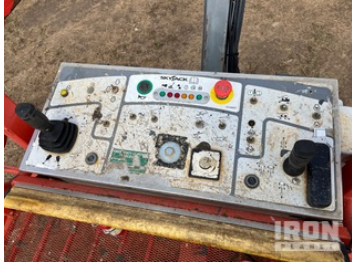
| Item | Assessment | Photo |
|---|---|---|
| Function Controls | ☆☆☆☆ | |

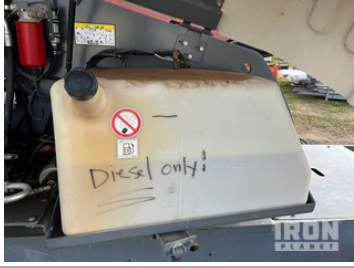
| Engine | | |
|---|---|---|
| Fuel System | Operational | |

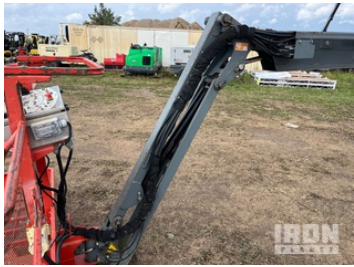
| Jib Condition | ☆☆☆☆ | |
