## Item #13811326 - 2017 Skyjack SJ45T 4WD Diesel Telescopic Boom Lift

# Inspection Report

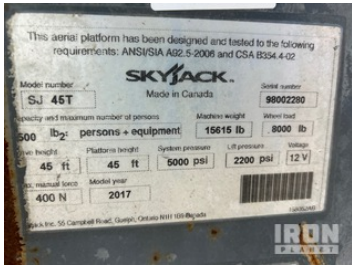
| Serial Number / VIN | 98002280 | |

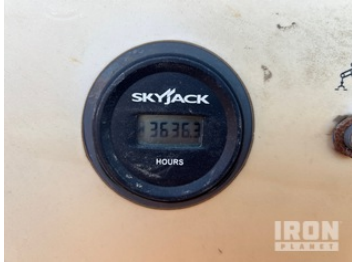
| Hour Meter / Odometer | 3636 hrs | |

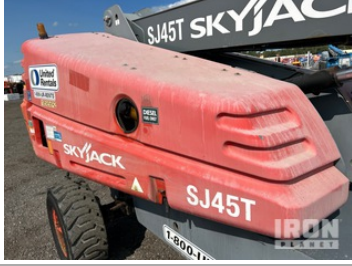
| Paint | No visible damage | |

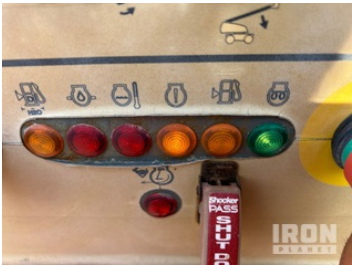
| Control Station Ground | | |
|---|---|---|
| Warning Lights | Operational | |

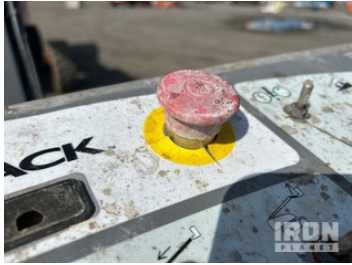
| Control Station | | |
|---|---|---|
| Emergency Shut Off Switch | Operational | |

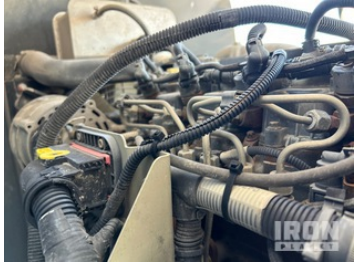
| Engine | | |
|---|---|---|
| Fuel System | Operational | |

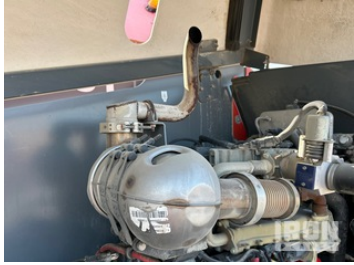
| Engine | | |
|---|---|---|
| Exhaust System | No visible damage or missing components | |

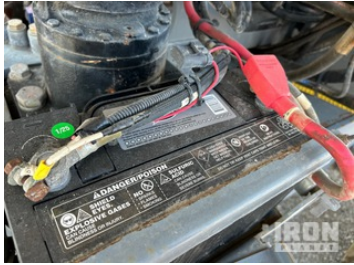
| Electrical Operating System | | |
|---|---|---|
| Cables and Connections | No visible damage or missing components | |

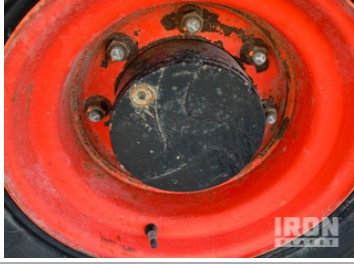
| Item | Assessment | Photo |
|---|---|---|
| Right Front Final Drive | ★★★★☆ | |

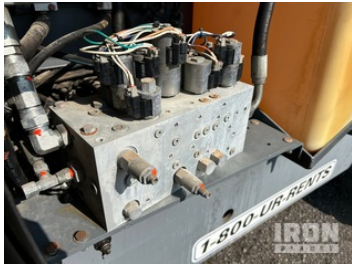
| Hydraulics | | |
|---|---|---|
| Valves | ★★★★☆ | |

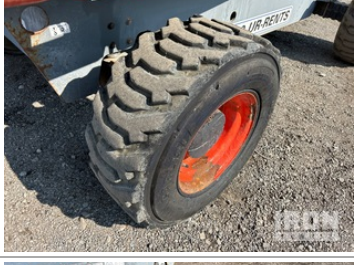
| Left Front Tire | No visible defects | |

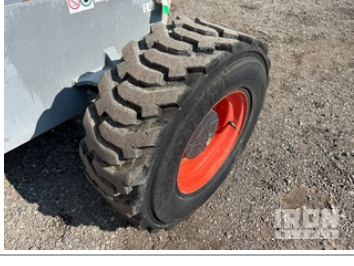
| Left Rear Tire | No visible defects | |

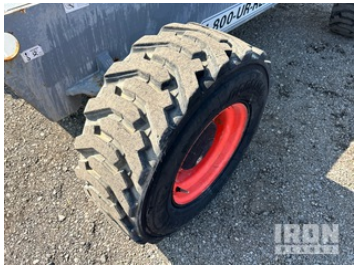
| Right Rear Tire | No visible defects | |

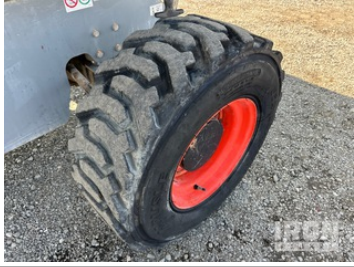
| Right Front Tire | No visible defects | |

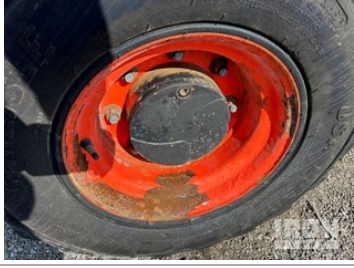
| Wheel Condition | No visible damage or missing components | |
