## Item #13890476 - 2016 Skyjack SJ61T 4WD Diesel Telescopic Boom Lift

- Features: 61 ft Max Platform Height, 500 lb Max Weight Capacity, Power to Platform, Onboard Generator, 2016 US EPA Label, Deutz TD 2.9 L4 4 Cylinder 74 hp 2.92 L Diesel Engine, 385/65D19.5 Foam-Filled Tires
- Meter Reading: 2,409 Hours
- Serial # : 97001957
- Inspection Completed: 9/4/25

# Inspection Report

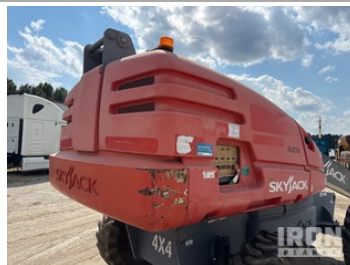
| Paint | No visible damage | |

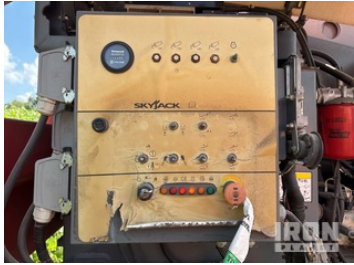
| Control Station Ground | | |
|---|---|---|
| Function Controls | ★★★★☆ | |

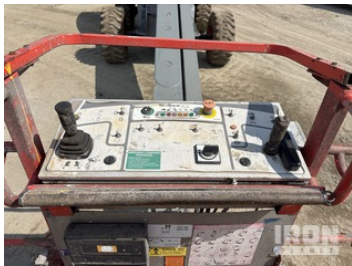
| Item | Assessment | Photo |
|---|---|---|
| Control Console | No visible damage or missing components | |

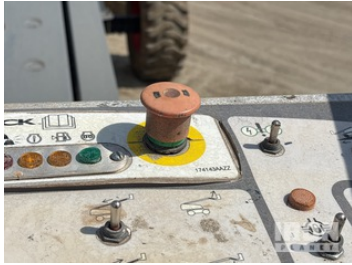
| Item | Assessment | Photo |
|---|---|---|
| Emergency Shut Off Switch | Operational | |

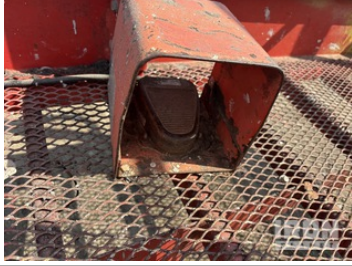
| Item | Assessment | Photo |
|---|---|---|
| Safety Control Foot Switch | ☆☆☆☆<br>Operational | |

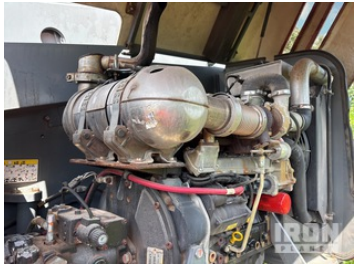
| Engine | | |
|---|---|---|
| Exhaust System | No visible damage or missing components | |

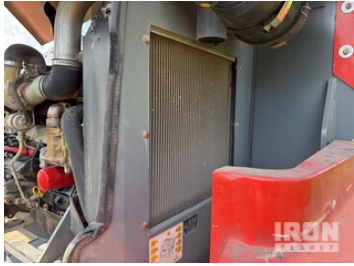
| Engine | | |
|---|---|---|
| Radiator | ★★★★☆ | |

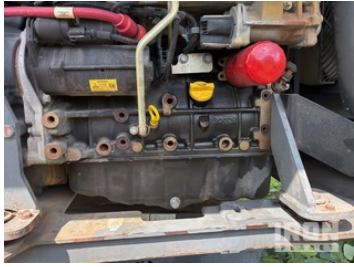
| Engine | | |
|---|---|---|
| Oil Leaks | No dripping leaks | |

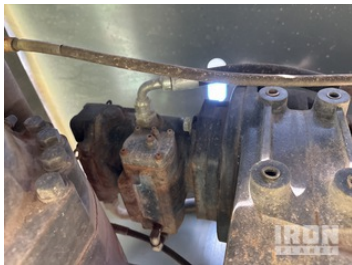
| Item | Assessment | Photo |
|---|---|---|
| Front Center Drive Motor | ★★★★☆ | |

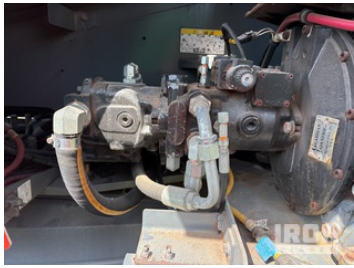
| Hydraulics | | |
|---|---|---|
| Pumps (Hydraulics) | ★★★★☆ | |

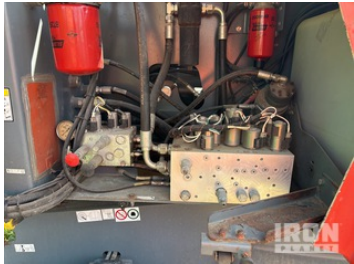
| Hydraulics | | |
|---|---|---|
| Valves | ★★★★☆ | |

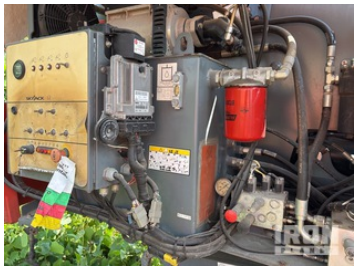
| Hydraulics | | |
|---|---|---|
| Hydraulic Tank | ★★★★☆ | |

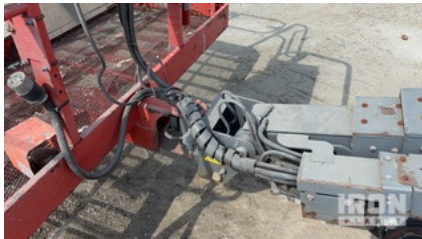
| Hydraulics | | |
|---|---|---|
| Hoses (Hydraulic) | ★★★★☆ | |

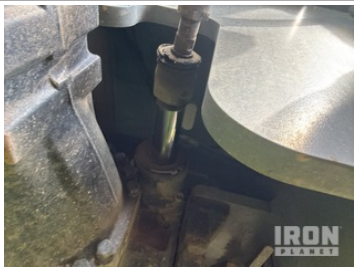
| Hydraulics | | |
|---|---|---|
| Steering Cylinders | ★★★★☆ | |

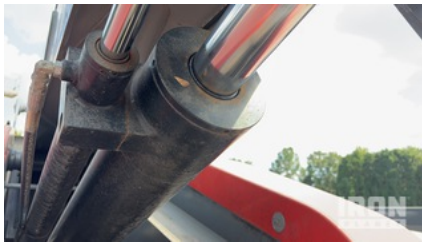
| Hydraulics | | |
|---|---|---|
| Boom Lift Cylinder | ★★★★☆ | |

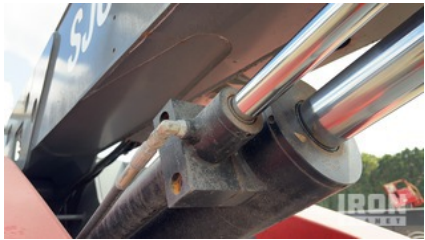
| Secondary Boom Cylinder | ★★★★☆ | |

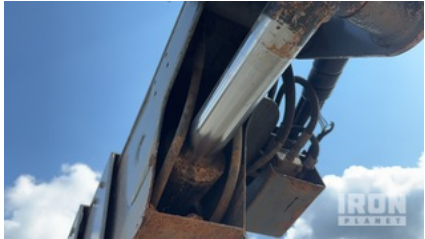
| Boom Extension Cylinder | ★★★★☆ | |

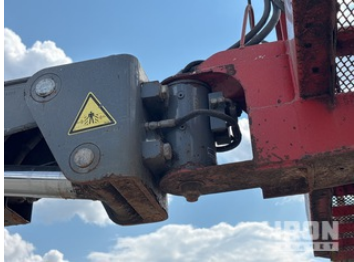
| Basket Rotator Motor | ★★★★☆ | |

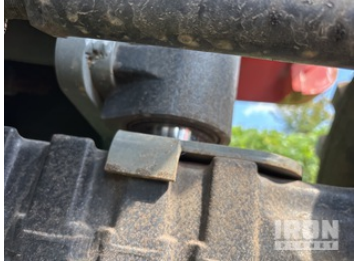
| Frame Leveling Cylinders | ★★★★☆ | |

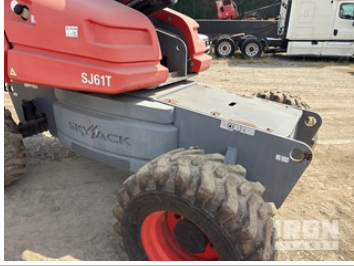
| Chassis | | |
|---|---|---|
| Frame Condition | ★★★★★ | |

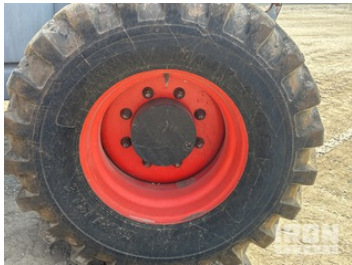
| Wheel Condition | No visible damage or missing components | |

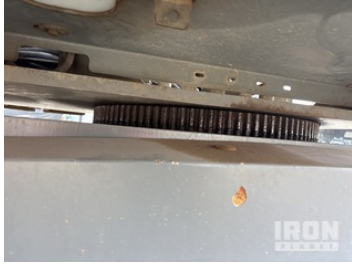
| Turntable Bearing | ★★★★☆ | |

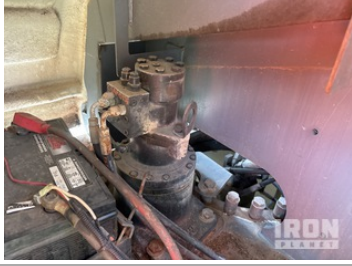
| Swing Motor | ★★★★☆ | |

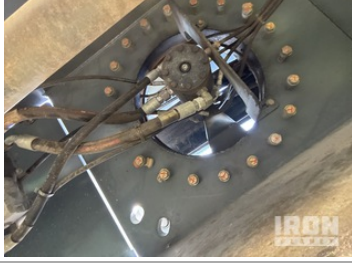
| Hydraulic Center Swivel | ★★★★☆ | |

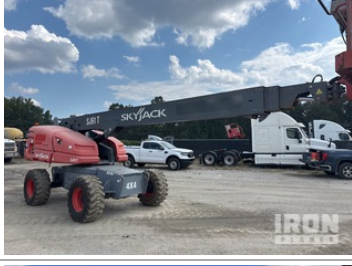
| Boom Condition | ★★★★☆ | |

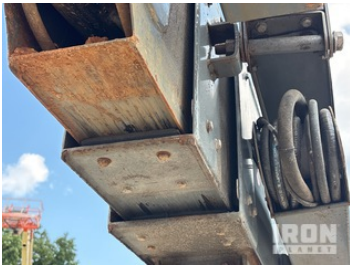
| Boom Wear Guides | ★★★★☆ | |
