## Item #14096207 - 2016 Skyjack SJ61T 4WD Diesel Telescopic Boom Lift

# Inspection Report

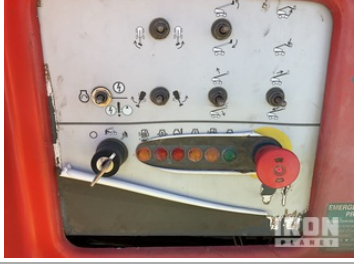
| Control Station Ground | | |
|---|---|---|
| Warning Lights | Operational | |

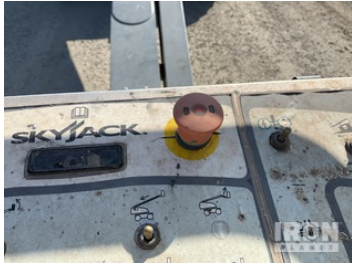
| Item | Assessment | Photo |
|---|---|---|
| Emergency Shut Off Switch | Operational | |

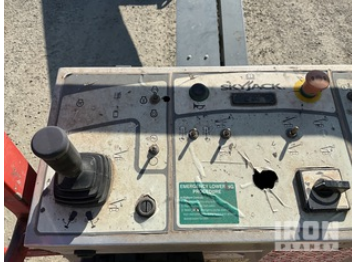
| Item | Assessment | Photo |
|---|---|---|
| Function Controls | ★★★★☆ | |

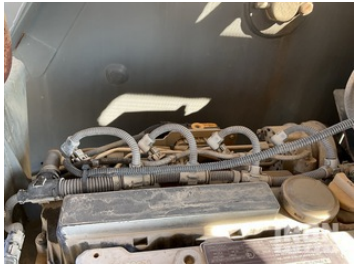
| Engine | | |
|---|---|---|
| Fuel System | Operational | |

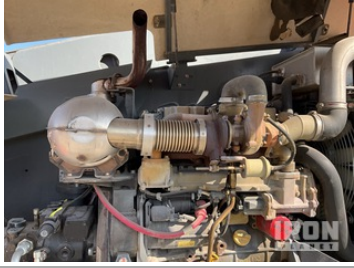
| Engine | | |
|---|---|---|
| Exhaust System | No visible damage or missing components | |

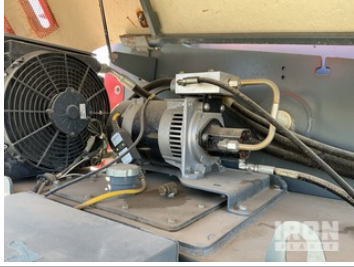
| Onboard Generator | Not operationally checked | |

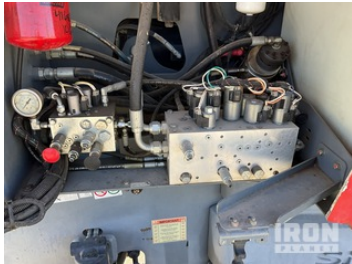
| Hydraulics | | |
|---|---|---|
| Valves | ★★★★☆ | |

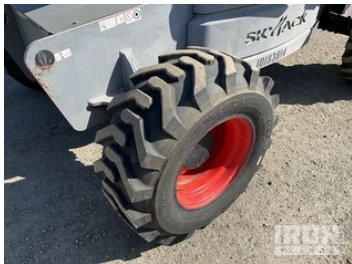
| Chassis | | |
|---|---|---|
| Left Front Tire | No visible defects | |

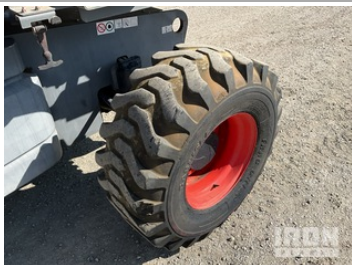
| Chassis | | |
|---|---|---|
| Left Rear Tire | No visible defects | |

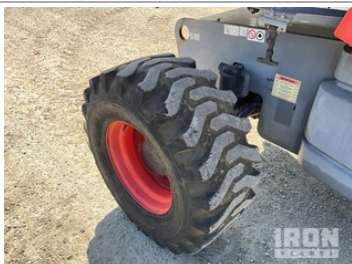
| Chassis | | |
|---|---|---|
| Right Rear Tire | No visible defects | |

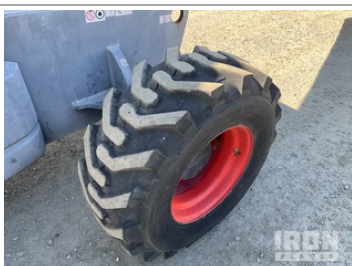
| Chassis | | |
|---|---|---|
| Right Front Tire | No visible defects | |

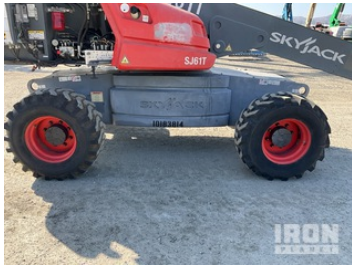
| Wheel Condition | No visible damage or missing components | |
