## Item #13810725 - 2016 JLG 600S 4WD Diesel Telescopic Boom Lift

# Inspection Report

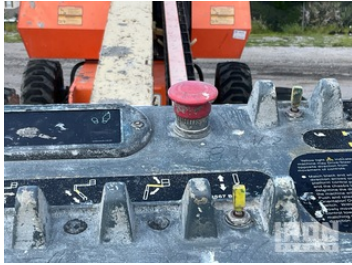
| Item | Assessment | Photo |
|---|---|---|
| Emergency Shut Off Switch | Operational | |

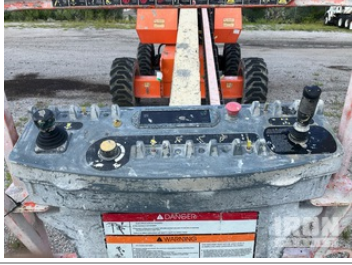
| Item | Assessment | Photo |
|---|---|---|
| Function Controls | ★★★★☆ | |

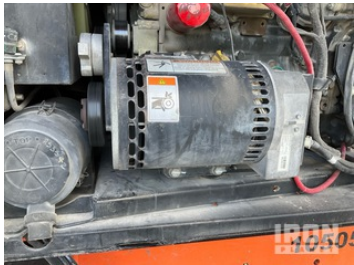
| Onboard Generator | Operational | |

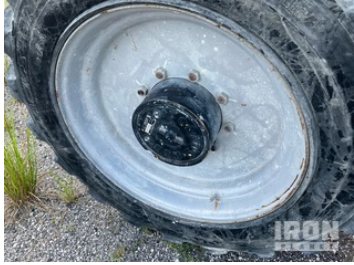
| Item | Assessment | Photo |
|---|---|---|
| Left Front Final Drive | ★★★★☆ | |

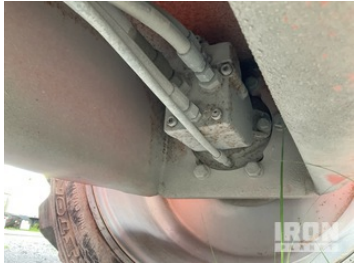
| Item | Assessment | Photo |
|---|---|---|
| Left Front Drive Motor | ★★★★☆ | |

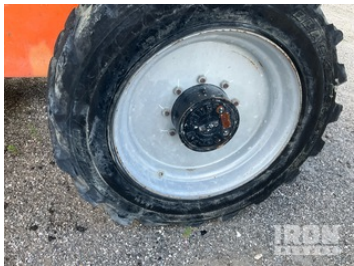
| Item | Assessment | Photo |
|---|---|---|
| Left Rear Final Drive | ★★★★☆ | |

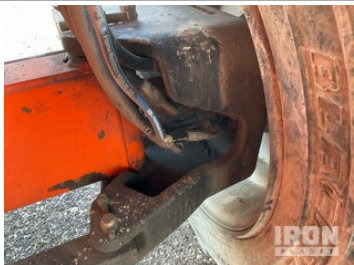
| Item | Assessment | Photo |
|---|---|---|
| Left Rear Drive Motor | ★★★★☆ | |

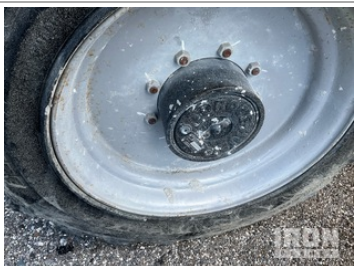
| Item | Assessment | Photo |
|---|---|---|
| Right Rear Final Drive | ★★★★☆ | |

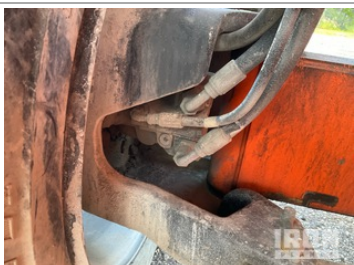
| Item | Assessment | Photo |
|---|---|---|
| Right Rear Drive Motor | ★★★★☆ | |

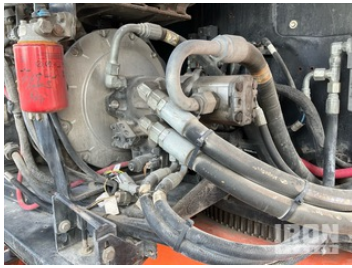
| Hydraulics | | |
|---|---|---|
| Pumps (Hydraulics) | ★★★★☆ | |

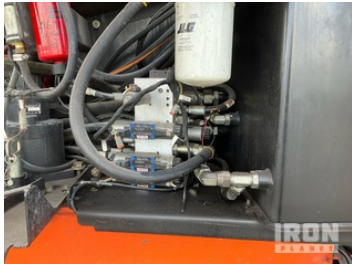
| Hydraulics | | |
|---|---|---|
| Valves | ★★★★☆ | |

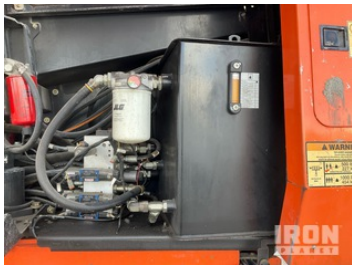
| Hydraulics | | |
|---|---|---|
| Hydraulic Tank | ★★★★☆ | |

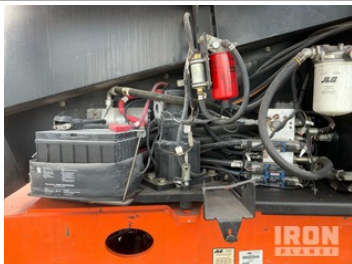
| Hydraulics | | |
|---|---|---|
| Hoses (Hydraulic) | ★★★★☆ | |

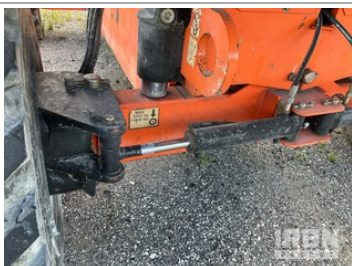
| Hydraulics | | |
|---|---|---|
| Steering Cylinders | ★★★★☆ | |

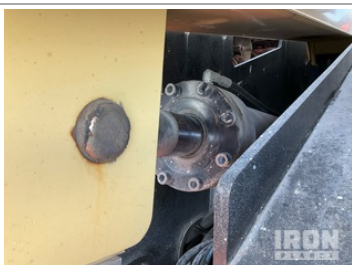
| Hydraulics | | |
|---|---|---|
| Boom Lift Cylinder | ★★★★☆ | |

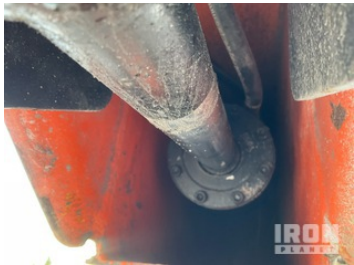
| Basket Tilt Cylinder | ★★★★☆ | |

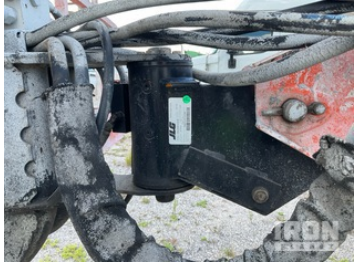
| Basket Rotator Motor | ★★★★☆ | |

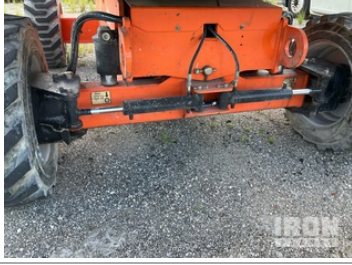
| Chassis | | |
|---|---|---|
| Steering Linkage | ★★★★☆ | |

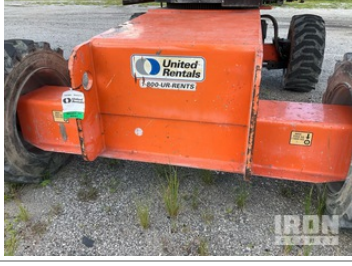
| Chassis | | |
|---|---|---|
| Frame Condition | ★★★★☆ | |

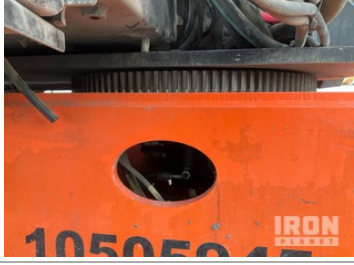
| Turntable Bearing | ★★★★☆ | |

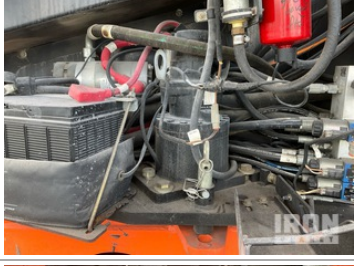
| Swing Motor | ★★★★☆ | |

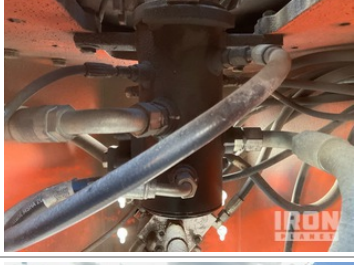
| Hydraulic Center Swivel | ★★★★☆ | |

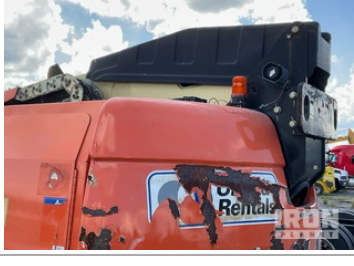
| Boom Condition | ★★★★☆ | |
