## Item #14340450 - 2018 Skyjack SJ1044TH Telehandler

# Inspection Report

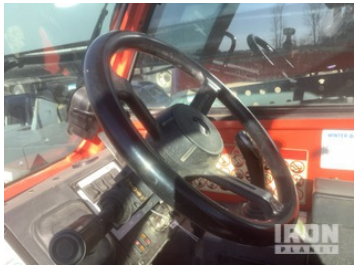
| Steering Control | ★★★★☆ | |

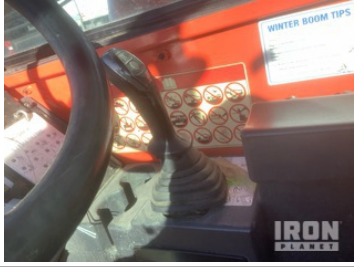
| Hydraulic Controls | ★★★★☆ | |

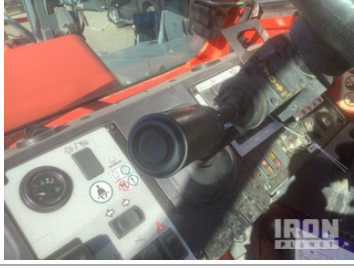
| Drivetrain Controls | ★★★★☆ | |

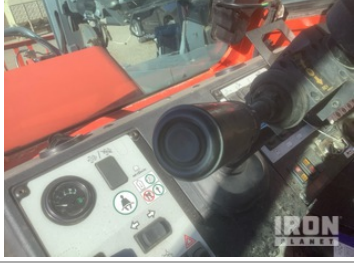
| Transmission Disconnect Control | ★★★★☆ | |

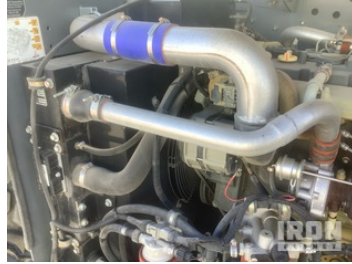
| Engine | | |
|---|---|---|
| Radiator | ★★★★☆ | |

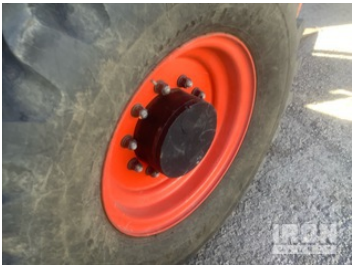
| Final Drives | ☆☆☆☆ | |

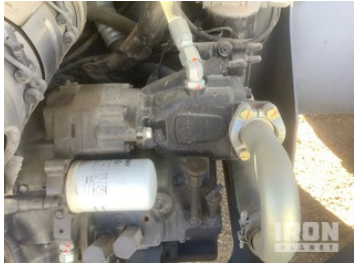
| Hydraulics | | |
|---|---|---|
| Pumps (Hydraulics) | ★★★★☆ | |

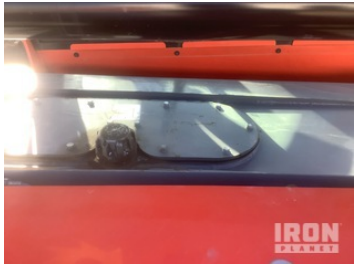
| Hydraulics | | |
|---|---|---|
| Hydraulic Tank | ★★★★☆ | |

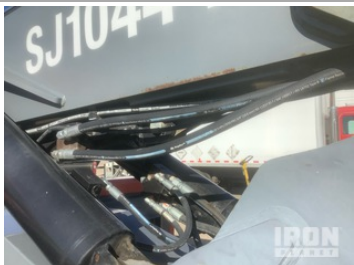
| Hydraulics | | |
|---|---|---|
| Hoses (Hydraulics) | ★★★★☆ | |

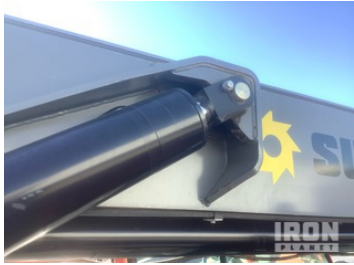
| Hydraulics | | |
|---|---|---|
| Boom Lift Cylinder(s) | ★★★★☆ | |

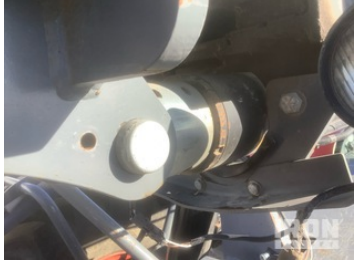
| Hydraulics | | |
|---|---|---|
| Telescopic Boom Cylinders | ★★★★☆ | |

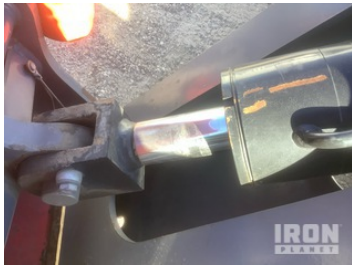
| Carriage Tilt Cylinder | ★★★★☆ | |

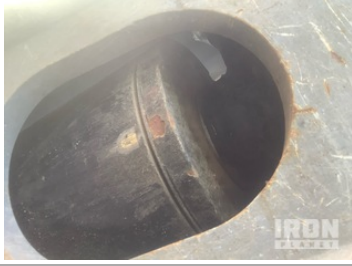
| Outrigger Cylinders | ★★★★☆ | |

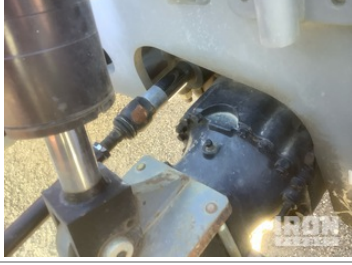
| Steering Cylinders | ★★★★☆ | |

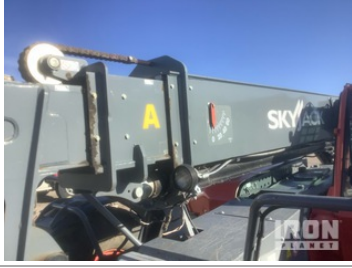
| Item | Assessment | Photo |
|---|---|---|
| Boom Condition | ★★★★☆ | |

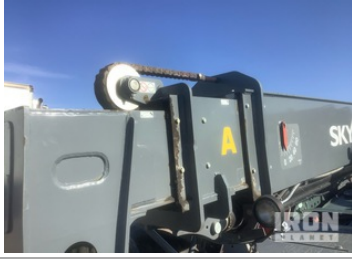
| Item | Assessment | Photo |
|---|---|---|
| Chain / Tensioners | ★★★★☆ | |

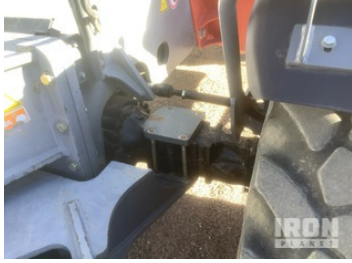
| Item | Assessment | Photo |
|---|---|---|
| Steering Linkage | ★★★★☆ | |

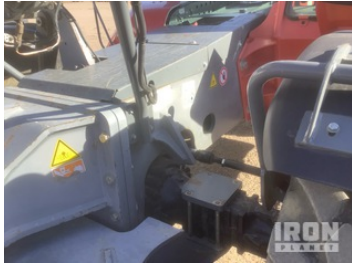
| Item | Assessment | Photo |
|---|---|---|
| Frame Condition | ★★★★☆ | |

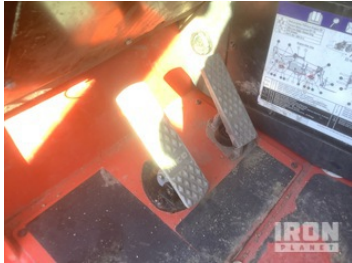
| Item | Assessment | Photo |
|---|---|---|
| Brake Control | ★★★★☆ | |

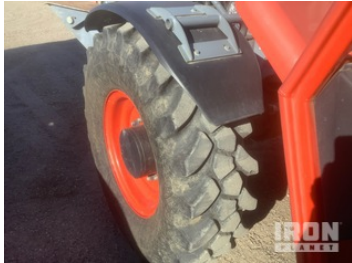
| Item | Assessment | Photo |
|---|---|---|
| Left Front Tire | Size: 14.00-24 Brand: Galaxy Model: Giraffe Tread Depth: 25/32 | |

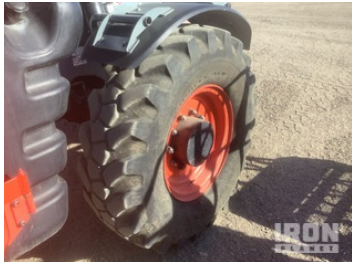
| Item | Assessment | Photo |
|---|---|---|
| Left Rear Tire | Size: 14.00-24 Brand: Galaxy Model: Giraffe Tread Depth: 27/32 | |

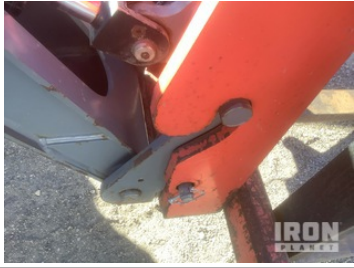
| Loader Quick Coupler | Not operationally checked | |

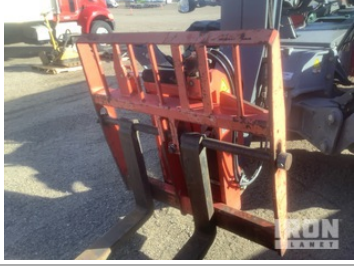
| Load Back Rest | ★★★★☆ | |

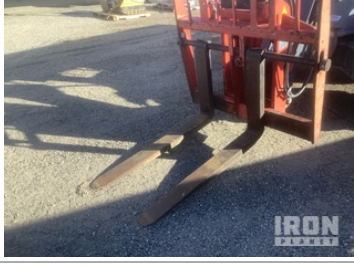
| Forks | ★★★★☆ | |
