## Item #14096209 - 2018 Skyjack SJ843TH Telehandler

# Inspection Report

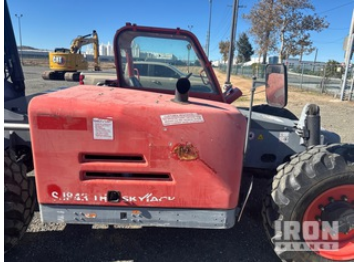
| Paint | No visible damage | |

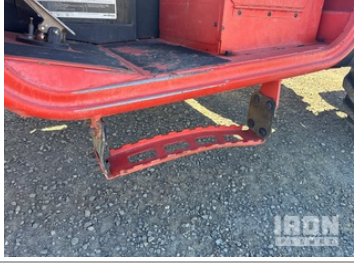
| Steps | No visible damage or missing components | |

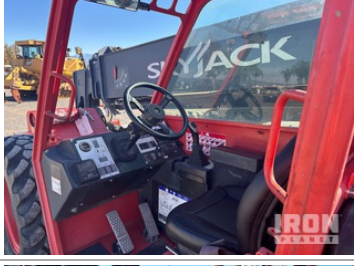
| Hand Rails | No visible damage or missing components | |

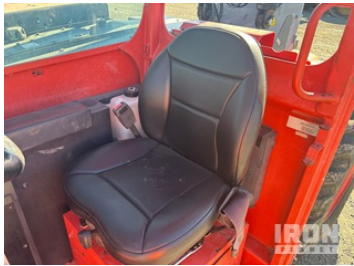
| Control Station | | |
|---|---|---|
| Seat/Armrests | No visible damage or missing components | |

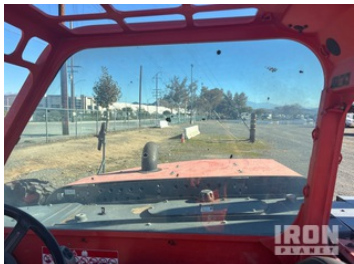
| Control Station | | |
|---|---|---|
| Glass | No visible damage or missing components | |

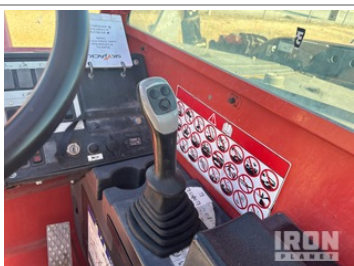
| Control Station | | |
|---|---|---|
| Hydraulic Controls | ★★★★☆ | |

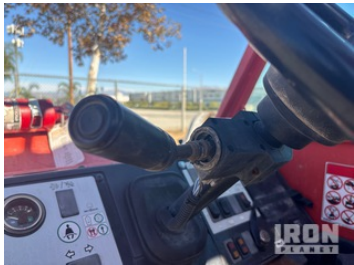
| Drivetrain Controls | ★★★★☆ | |

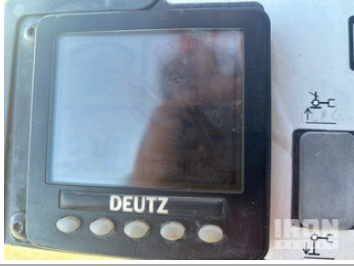
| Engine Oil Pressure | The gauge registers in the operating range. | |

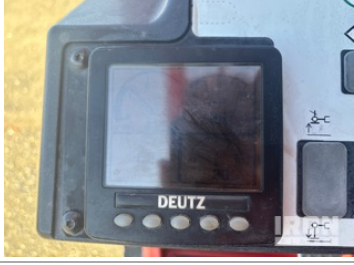
| Warning Lights | Operational | |

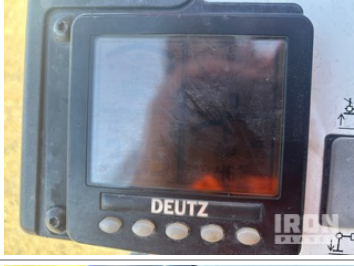
| Gauges | Operational | |

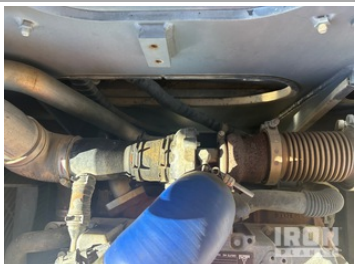
| Engine | | |
|---|---|---|
| Exhaust System | No visible damage or missing components | |

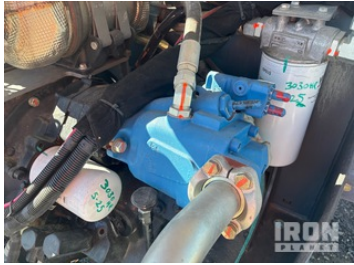
| Hydraulics | | |
|---|---|---|
| Pumps (Hydraulics) | ★★★★☆ | |

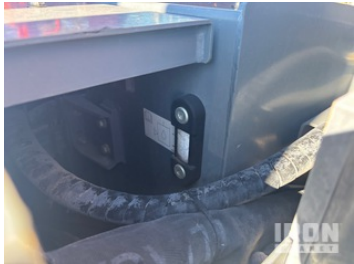
| Hydraulics | | |
|---|---|---|
| Hydraulic Tank | ★★★★☆ | |

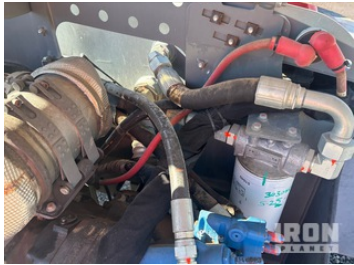
| Hydraulics | | |
|---|---|---|
| Hoses (Hydraulics) | ★★★★☆ | |

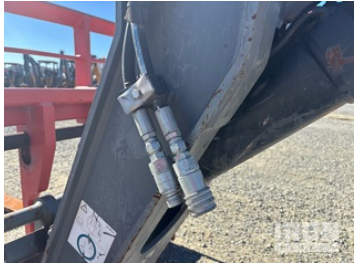
| Hydraulics | | |
|---|---|---|
| Auxiliary Hydraulic Plumbing | Not operationally checked, Front | |

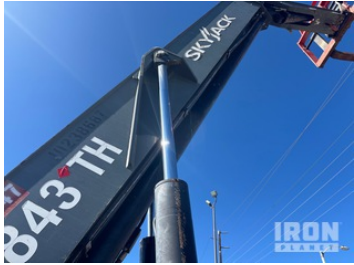
| Hydraulics | | |
|---|---|---|
| Boom Lift Cylinder(s) | ★★★★☆ | |

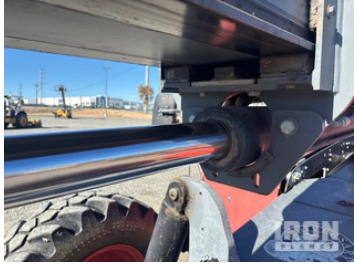
| Hydraulics | | |
|---|---|---|
| Telescopic Boom Cylinders | ★★★★☆ | |

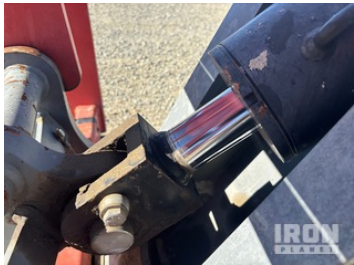
| Carriage Tilt Cylinder | ★★★★☆ | |

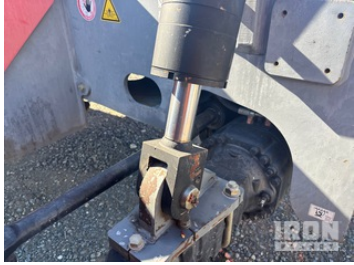
| Frame Leveling Cylinders | ★★★★☆ | |

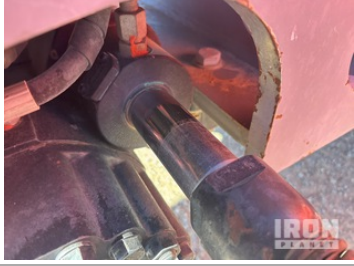
| Steering Cylinders | ★★★★☆ | |

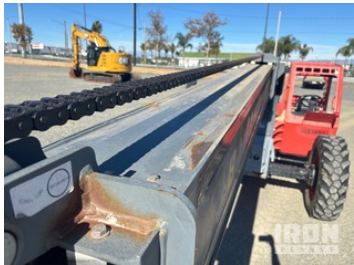
| Boom Condition | ★★★★☆ | |

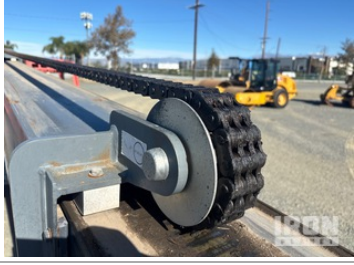
| Chain / Tensioners | ★★★★☆ | |

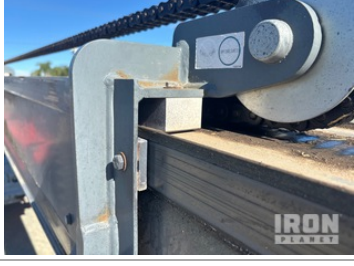
| Boom Wear Guides | ★★★★☆ | |

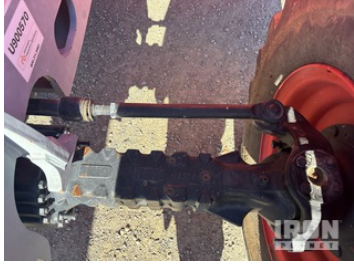
| Item | Assessment | Photo |
|---|---|---|
| Steering Linkage | ★★★★☆ | |

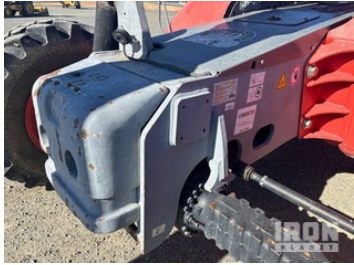
| Item | Assessment | Photo |
|---|---|---|
| Frame Condition | ★★★★☆ | |

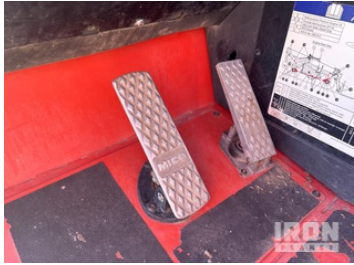
| Item | Assessment | Photo |
|---|---|---|
| Brake Control | ★★★★☆ | |

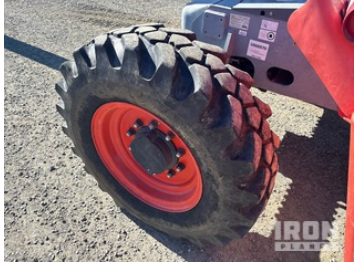
| Item | Assessment | Photo |
|---|---|---|
| Left Front Tire | Size: 13.00-24 Brand: Galaxy Model: Giraffe xlw Tread Depth: 17/32 | |

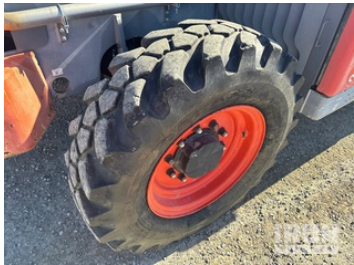
| Right Rear Tire | Size: 13.00-24 Brand: Galaxy Model: Giraffe xlw Tread Depth: 17/32 | |

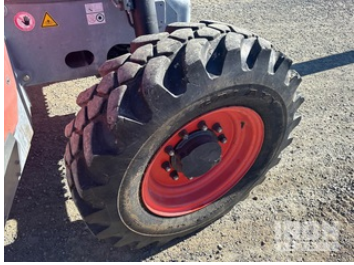
| Right Front Tire | Size: 13.00-24 Brand: Galaxy Model: Giraffe xlw Tread Depth: 17/32 | |

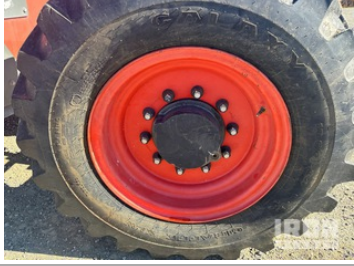
| Wheel Condition | No visible damage or missing components | |

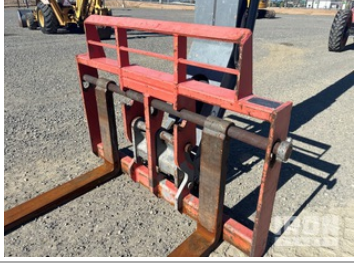
| Load Back Rest | ★★★★☆ | |

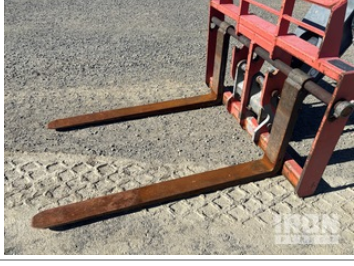
| Forks | ★★★★☆ | |
