## Item #14005021 - 2016 JLG 1255 Telehandler

# Inspection Report

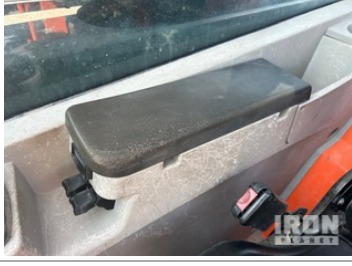
| Control Station | | |
|---|---|---|
| Seat/Armrests | No visible damage or missing components | |

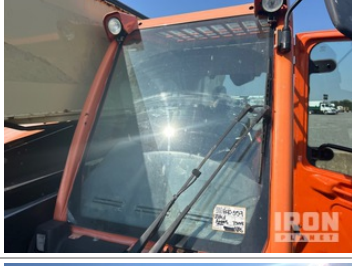
| Control Station | | |
|---|---|---|
| Glass | No visible damage or missing components | |

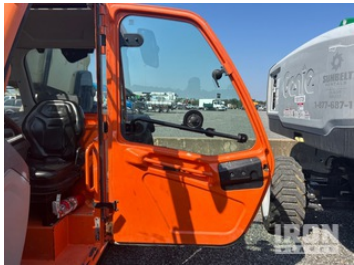
| Cab Door | No visible damage or missing components | |

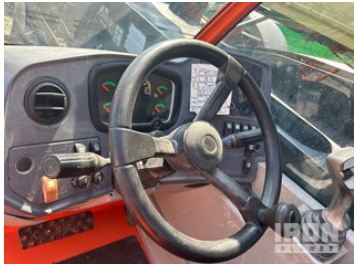
| Steering Control | ★★★★☆ | |

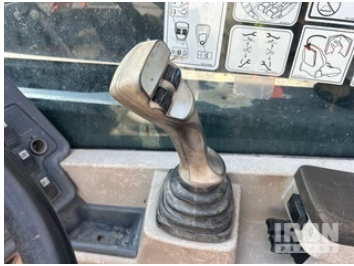
| Hydraulic Controls | ★★★★☆ | |

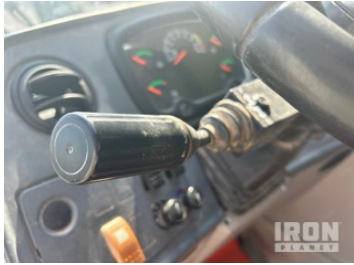
| Drivetrain Controls | ★★★★☆ | |

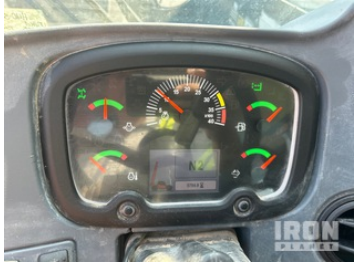
| Engine Oil Pressure | The fault indicator shuts off after the engine oil pressure rises. | |

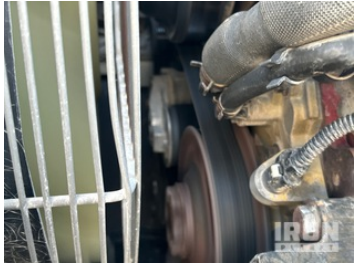
| Engine | | |
|---|---|---|
| A/C Compressor | Operational | |

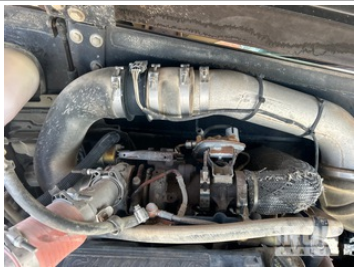
| Engine | | |
|---|---|---|
| Exhaust System | No visible damage or missing components | |

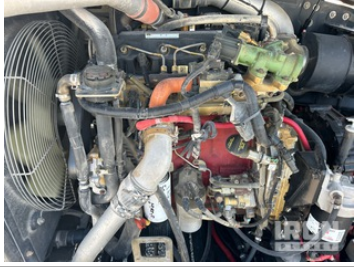
| Engine | | |
|---|---|---|
| Oil Leaks | No dripping leaks | |

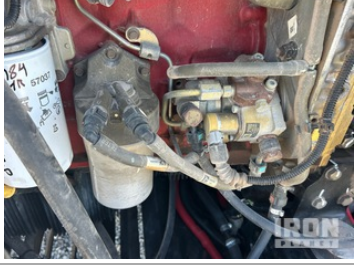
| Engine | | |
|---|---|---|
| Fuel Leaks | No dripping leaks | |

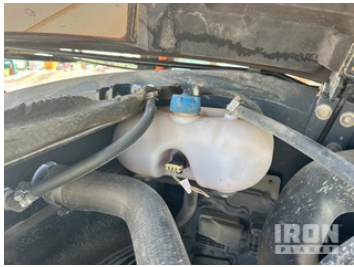
| Cooling System Leaks | No dripping leaks | |

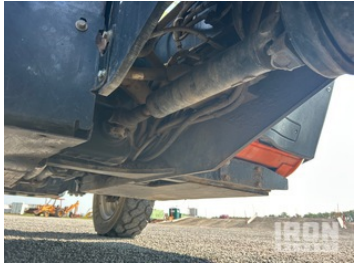
| Item | Assessment | Photo |
|---|---|---|
| Transfer Case / Drop Box | ★★☆☆<br>Operational | |

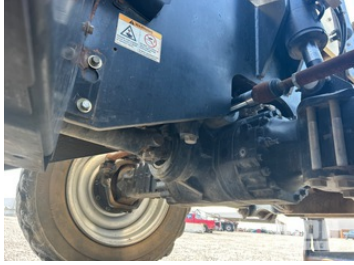
| Item | Assessment | Photo |
|---|---|---|
| Front Drive Axle | ★★☆☆ | |

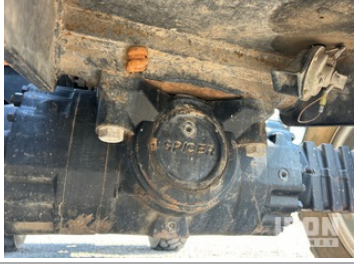
| Item | Assessment | Photo |
|---|---|---|
| Front Axle Oscillating Pin | ★★☆☆ | |

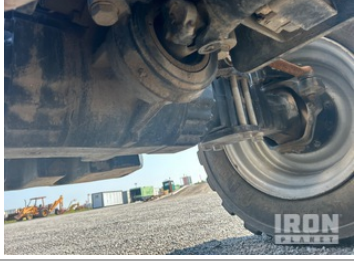
| Item | Assessment | Photo |
|---|---|---|
| Rear Drive Axle | ★★☆☆ | |

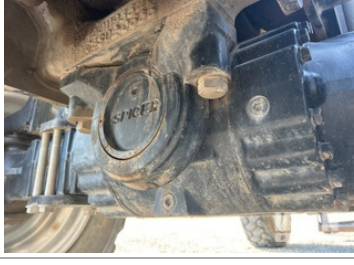
| Item | Assessment | Photo |
|---|---|---|
| Rear Axle Oscillating Pin | ★★☆☆ | |

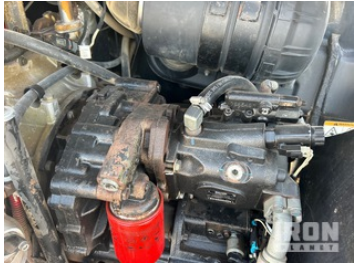
| Hydraulics | | |
|---|---|---|
| Pumps (Hydraulics) | ★★★★☆ | |

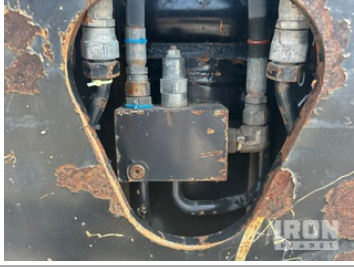
| Hydraulics | | |
|---|---|---|
| Valves | ★★★★☆ | |

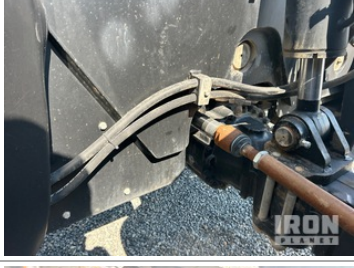
| Hydraulics | | |
|---|---|---|
| Hoses (Hydraulics) | ★★★★☆ | |

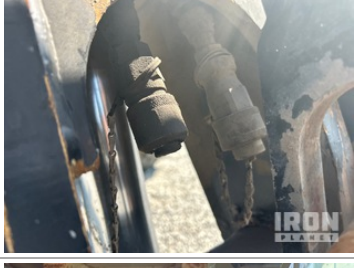
| Hydraulics | | |
|---|---|---|
| Auxiliary Hydraulic Plumbing | Not operationally checked | |

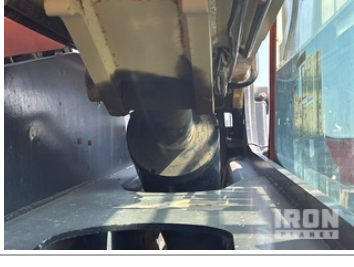
| Hydraulics | | |
|---|---|---|
| Boom Lift Cylinder(s) | ★★★★☆ | |

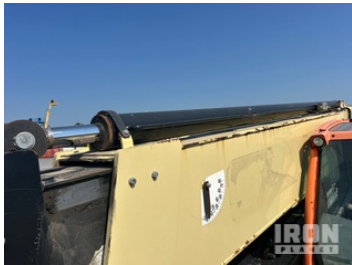
| Telescopic Boom Cylinders | ★★★★☆ | |

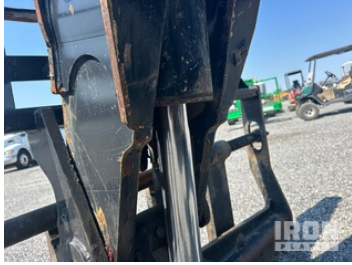
| Carriage Tilt Cylinder | ★★★★☆ | |

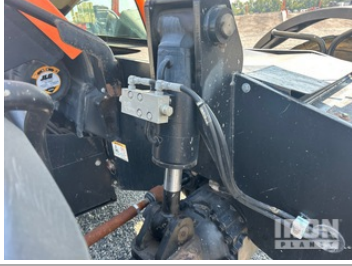
| Frame Leveling Cylinders | ★★★★☆ | |

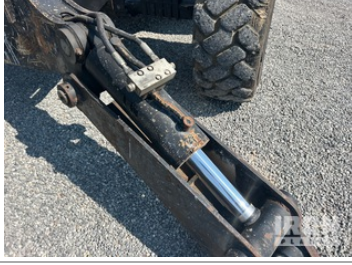
| Outrigger Cylinders | ★★★★☆ | |

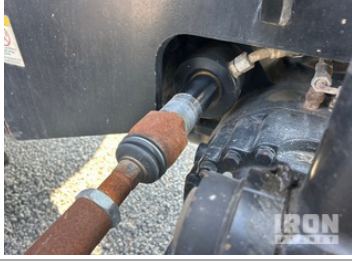
| Steering Cylinders | ★★★★☆ | |

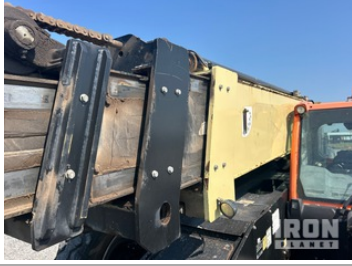
| Boom Condition | ★★★★☆ | |

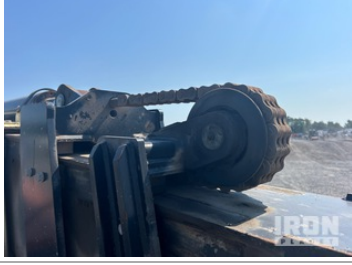
| Chain / Tensioners | ★★★★☆ | |

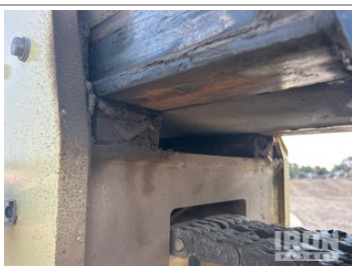
| Boom Wear Guides | ★★★★☆ | |

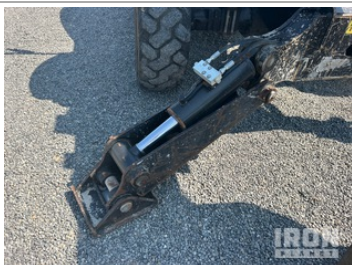
| Outriggers | ★★★★☆ | |

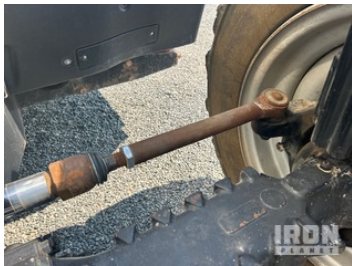
| Item | Assessment | Photo |
|---|---|---|
| Steering Linkage | ★★★★☆ | |

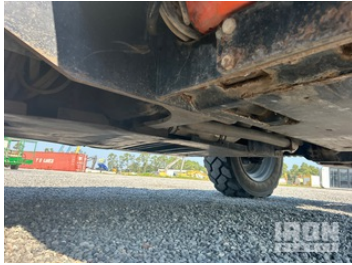
| Item | Assessment | Photo |
|---|---|---|
| Frame Condition | ★★★★☆ | |

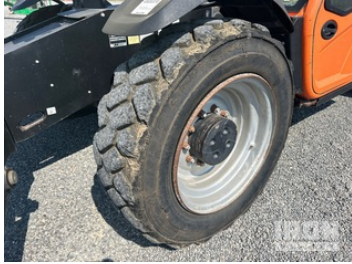
| Item | Assessment | Photo |
|---|---|---|
| Left Front Tire | Size: 400/75-28 Brand: Lightning Tread Depth: 23/32 | |

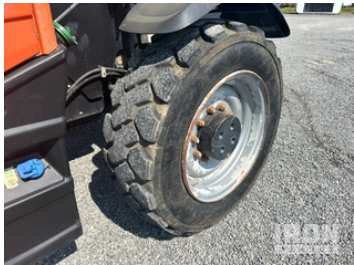
| Left Rear Tire | Size: 400/75-28 Brand: Firestone<br>Model: Duraforce Tread Depth: 26/32 | |

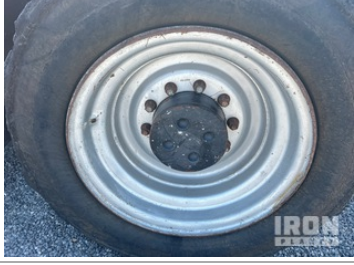
| Wheel Condition | No visible damage or missing components | |

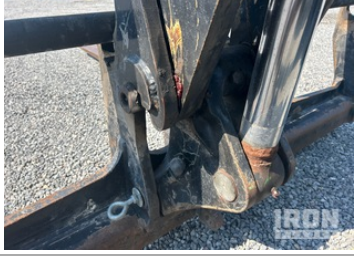
| Loader Quick Coupler | <p>★★★★☆</p> <p>Not operationally checked</p> | |

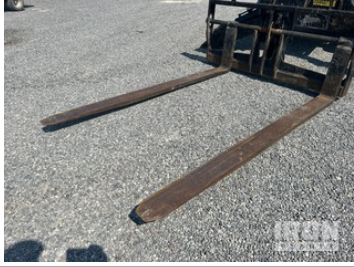
| Forks | ☆☆☆☆ | |
