## Item #14097039 - 2018 JCB 509.42 Telehandler

# Inspection Report

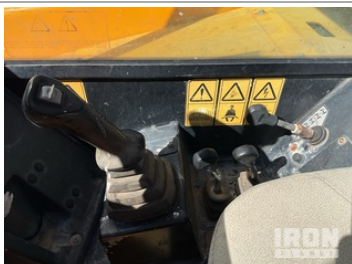
| Control Station | | |
|---|---|---|
| Hydraulic Controls | ★★★★☆ | |

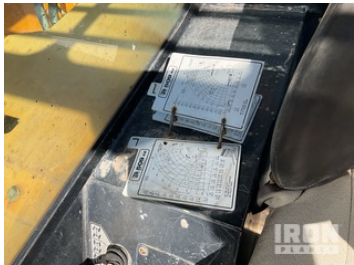
| Load Charts | Chart book in cab | |

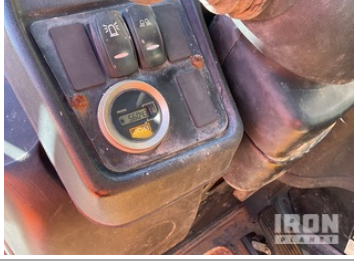
| Hour Meter / Odometer | 5604 hrs | |

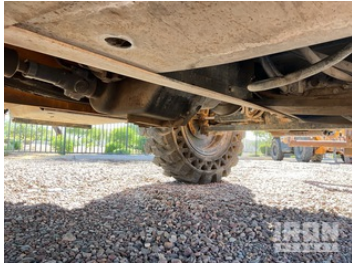
| Item | Assessment | Photo |
|---|---|---|
| Transfer Case / Drop Box | ★★★★☆ | |

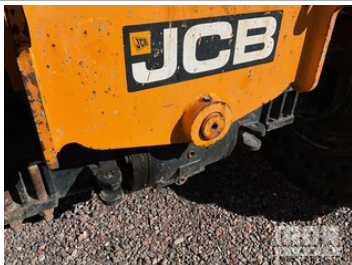
| Item | Assessment | Photo |
|---|---|---|
| Front Axle Oscillating Pin | ★★★★☆ | |

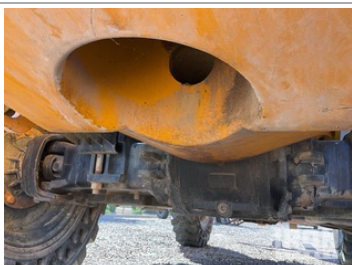
| Item | Assessment | Photo |
|---|---|---|
| Rear Axle Oscillating Pin | ★★★★☆ | |

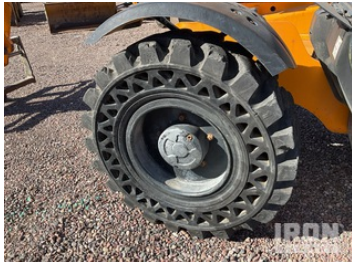
| Item | Assessment | Photo |
|---|---|---|
| Left Front Tire | Size: 14.00R24 Brand: solid air Tread Depth: 65/32 | |

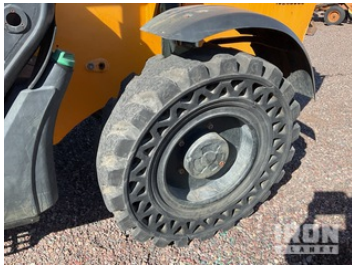
| Left Rear Tire | Size: 14.00R24 Brand: solid air Tread Depth: 60/32 | |
