## Item #13869133 - 2017 Genie GTH-844 Telehandler

- Features: Open Operator Station, 6000 lb Max Lift Capacity, 2017 US EPA Label, 48 in Forks, Frame Leveling, Auxiliary Hydraulic Plumbing
- Meter Reading: 1,762 Hours
- Serial # : GTH08E-11226
- Inspection Completed: 8/23/25

# Inspection Report

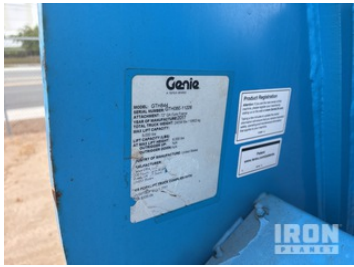
| Serial Number / VIN | GTH08E-11226 | |

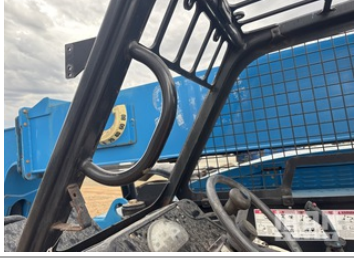
| Hand Rails | No visible damage or missing components | |

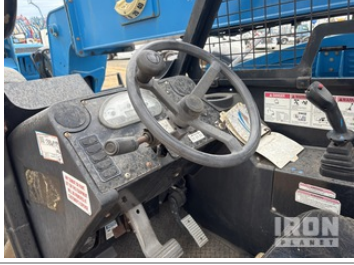
| Control Station | | |
|---|---|---|
| Steering Control | ★★★★☆ | |

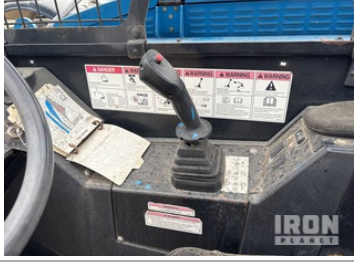
| Control Station | | |
|---|---|---|
| Hydraulic Controls | ★★★★☆ | |

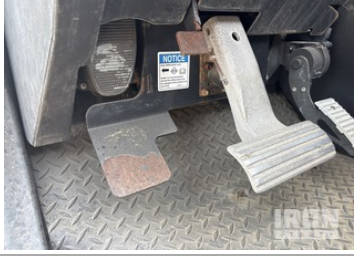
| Control Station | | |
|---|---|---|
| Transmission Disconnect Control | ★★★★☆ | |

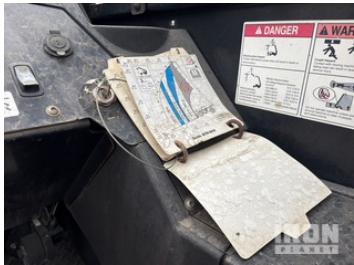
| Load Charts | Chart book in cab | |

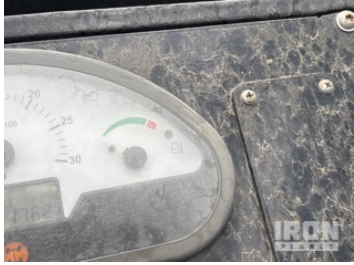
| Engine Oil Pressure | The gauge registers in the operating range. | |

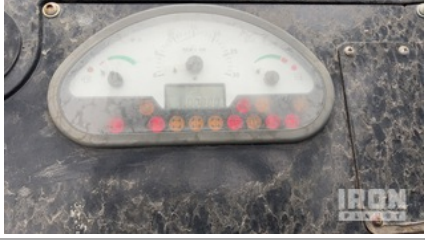
| Warning Lights | Operational | |

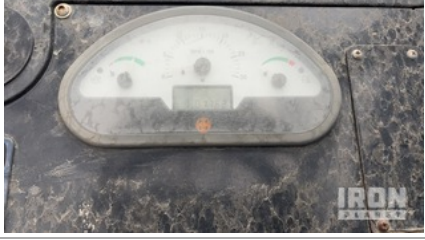
| Gauges | Operational | |

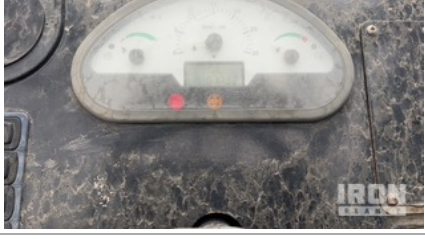
| Hour Meter / Odometer | 1762 hrs | |

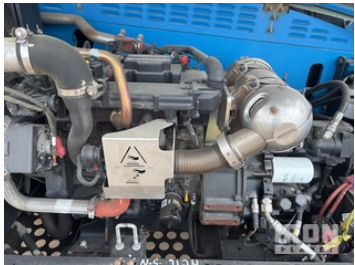
| Engine | | |
|---|---|---|
| Exhaust System | No visible damage or missing components | |

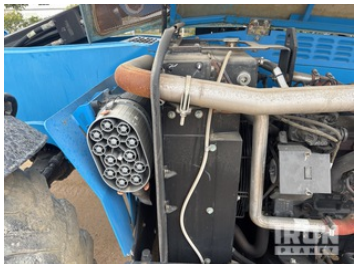
| Engine | | |
|---|---|---|
| Radiator | ★★★★☆ | |

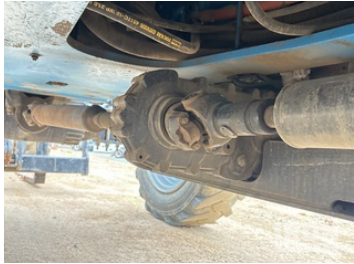
| Item | Assessment | Photo |
|---|---|---|
| Transfer Case / Drop Box | ★★☆☆<br>Operational | |

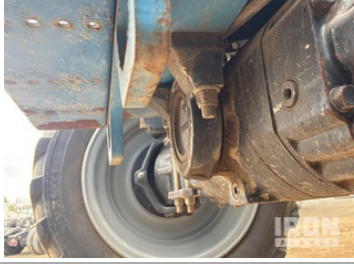
| Item | Assessment | Photo |
|---|---|---|
| Front Axle Oscillating Pin | Seep | |

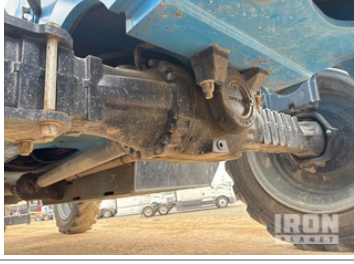
| Item | Assessment | Photo |
|---|---|---|
| Rear Drive Axle | ★★☆☆ | |

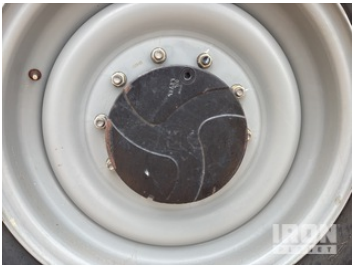
| Final Drives | ☆☆☆☆ | |

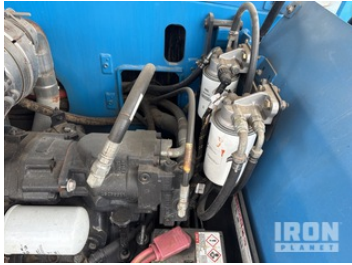
| Hydraulics | | |
|---|---|---|
| Pumps (Hydraulics) | ★★★★☆ | |

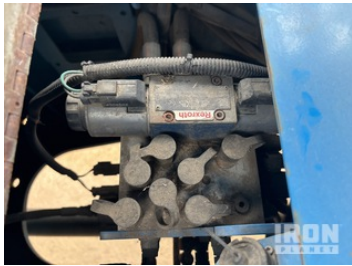
| Hydraulics | | |
|---|---|---|
| Valves | ★★★★☆ | |

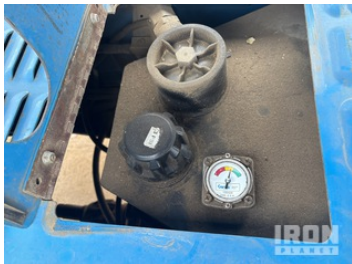
| Hydraulics | | |
|---|---|---|
| Hydraulic Tank | ★★★★☆ | |

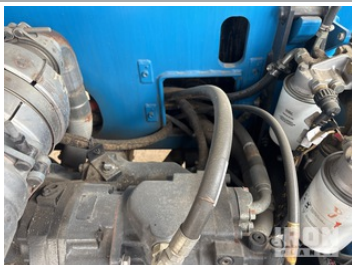
| Hydraulics | | |
|---|---|---|
| Hoses (Hydraulics) | ★★★★☆ | |

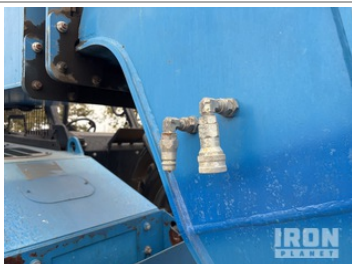
| Hydraulics | | |
|---|---|---|
| Auxiliary Hydraulic Plumbing | Capped off, Front | |

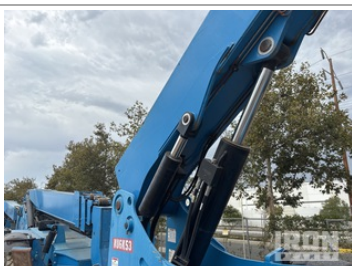
| Hydraulics | | |
|---|---|---|
| Boom Lift Cylinder(s) | ★★★★☆ | |

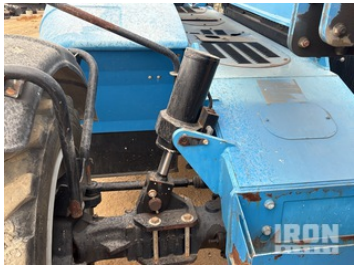
| Carriage Tilt Cylinder | ★★★★☆ | |

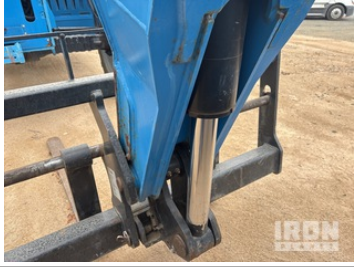
| Fork Positioning Cylinder (on fork carriage) | ★★★★☆ | |

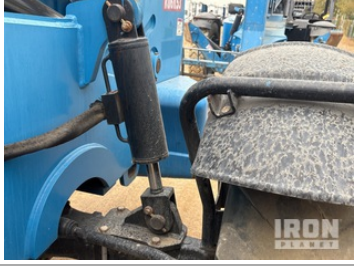
| Frame Leveling Cylinders | ★★★★☆ | |

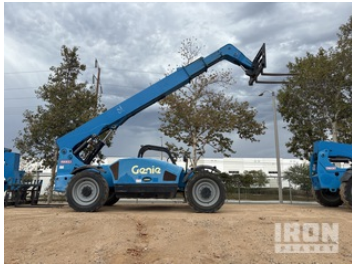
| Item | Assessment | Photo |
|---|---|---|
| Boom Condition | ★★★★☆ | |

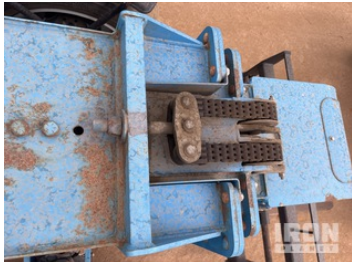
| Item | Assessment | Photo |
|---|---|---|
| Chain / Tensioners | ★★★★☆ | |

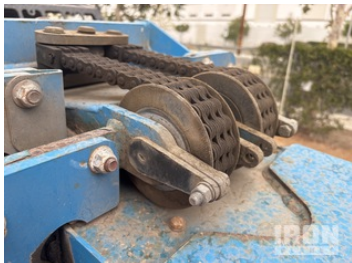
| Item | Assessment | Photo |
|---|---|---|
| Rollers and Guides | ★★★★☆ | |

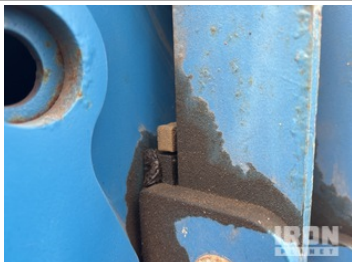
| Item | Assessment | Photo |
|---|---|---|
| Boom Wear Guides | ★★★★☆ | |

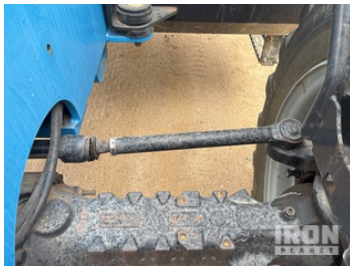
| Item | Assessment | Photo |
|---|---|---|
| Steering Linkage | ★★★★☆ | |

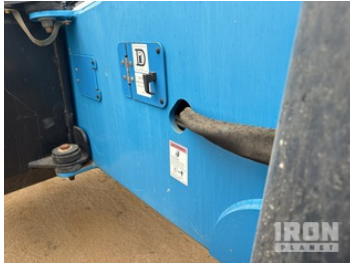
| Item | Assessment | Photo |
|---|---|---|
| Frame Condition | ★★★★☆ | |

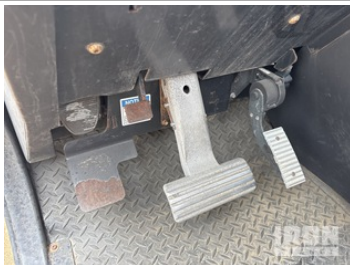
| Item | Assessment | Photo |
|---|---|---|
| Master Cylinder | ★★★★☆ | |

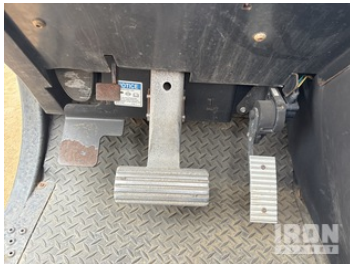
| Item | Assessment | Photo |
|---|---|---|
| Brake Control | ★★★★☆ | |

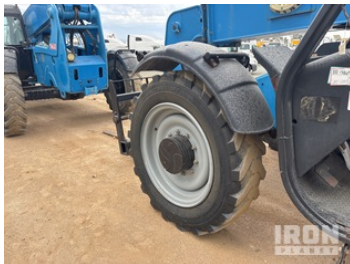
| Item | Assessment | Photo |
|---|---|---|
| Left Front Tire | Size: 330/85-25 Brand: ETREMELIFT Model: EXL-T1 Tread Depth: 8/32 | |

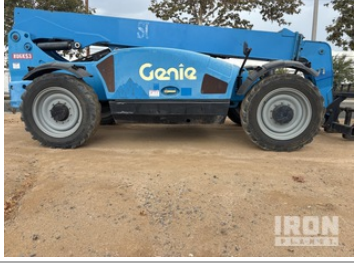
| Wheel Condition | No visible damage or missing components | |

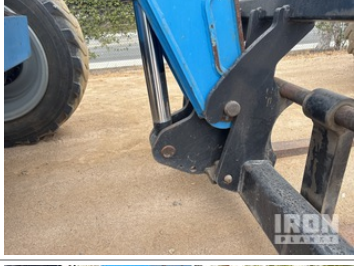
| Loader Quick Coupler | ★★★★☆ | |

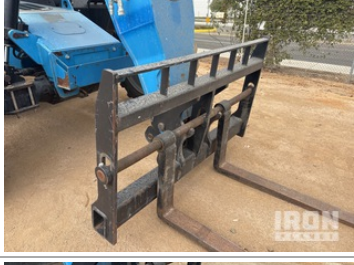
| Load Back Rest | ★★★★☆ | |

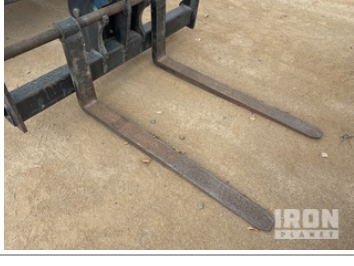
| Forks | ★★★★☆ | |
