## Item #13811325 - 2016 JLG 1055 Telehandler

# Inspection Report

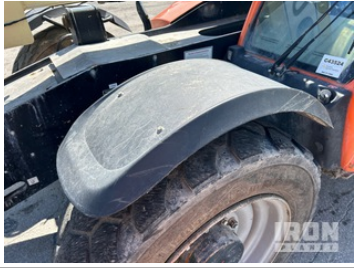
| Fenders | No visible damage or missing components. | |

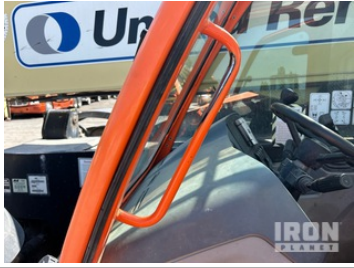
| Hand Rails | No visible damage or missing components | |

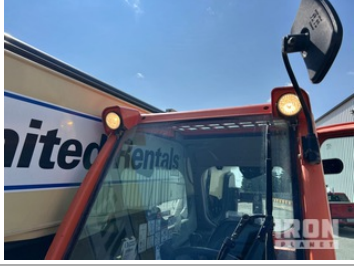
| Exterior Lights | All lights operational | |

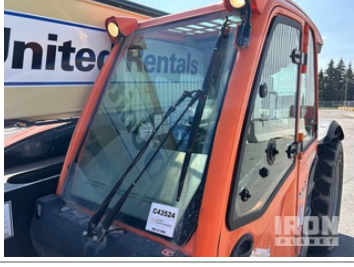
| Glass | No visible damage or missing components | |

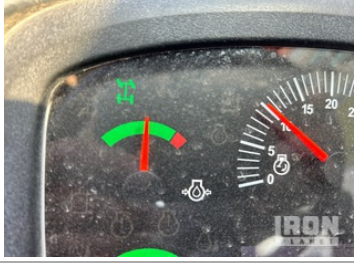
| Engine Oil Pressure | The gauge registers in the operating range. | |

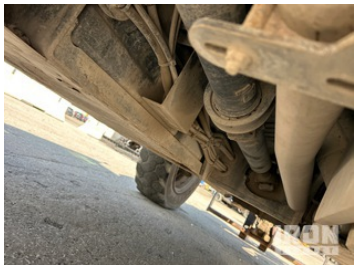
| Engine | | |
|---|---|---|
| Exhaust System | No visible damage or missing components | |

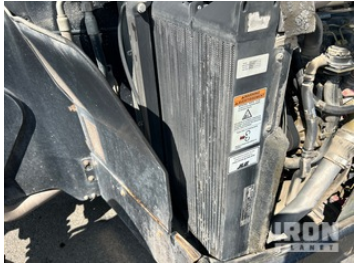
| Engine | | |
|---|---|---|
| Radiator | ★★★★☆ | |

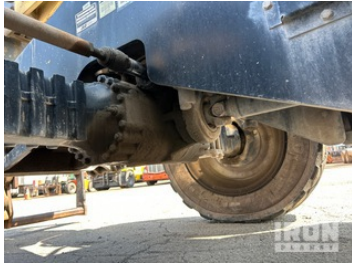
| Item | Assessment | Photo |
|---|---|---|
| Front Drive Axle | ★★★☆ | |

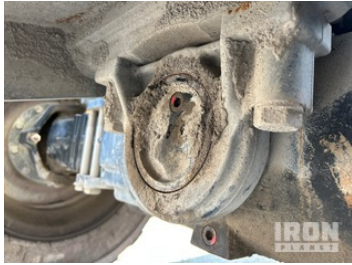
| Item | Assessment | Photo |
|---|---|---|
| Front Axle Oscillating Pin | ★★★☆ | |

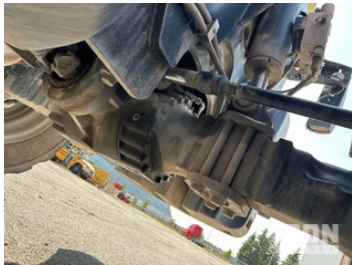
| Item | Assessment | Photo |
|---|---|---|
| Rear Drive Axle | ★★★☆ | |

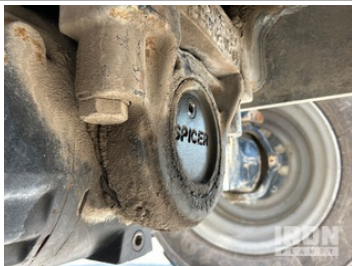
| Item | Assessment | Photo |
|---|---|---|
| Rear Axle Oscillating Pin | ★★★☆ | |

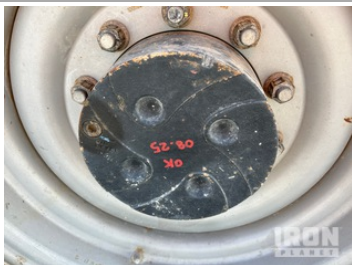
| Item | Assessment | Photo |
|---|---|---|
| Final Drives | ★★★☆ | |

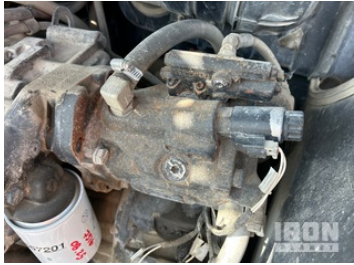
| Hydraulics | | |
|---|---|---|
| Pumps (Hydraulics) | ★★★★☆ | |

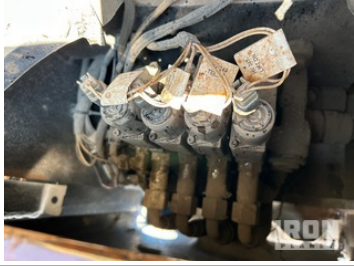
| Hydraulics | | |
|---|---|---|
| Valves | ★★★★☆ | |

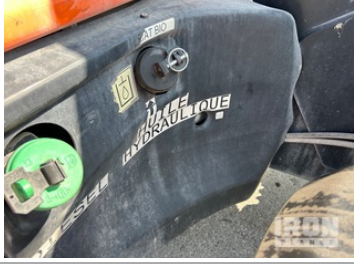
| Hydraulics | | |
|---|---|---|
| Hydraulic Tank | ★★★★☆ | |

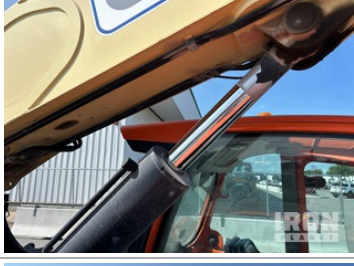
| Hydraulics | | |
|---|---|---|
| Boom Lift Cylinder(s) | ★★★★☆ | |

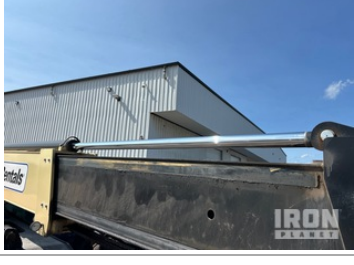
| Hydraulics | | |
|---|---|---|
| Telescopic Boom Cylinders | ★★★★☆ | |

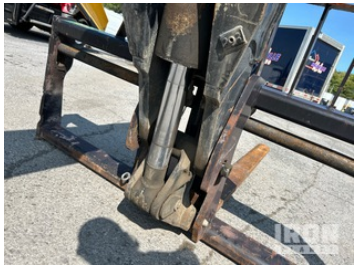
| Carriage Tilt Cylinder | ★★★★☆ | |

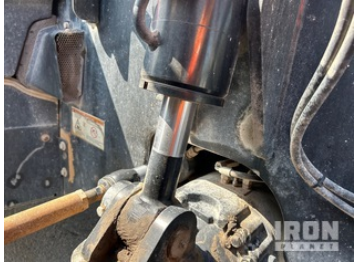
| Frame Leveling Cylinders | ★★★★☆ | |

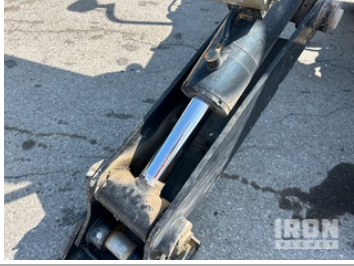
| Outrigger Cylinders | ★★★★☆ | |

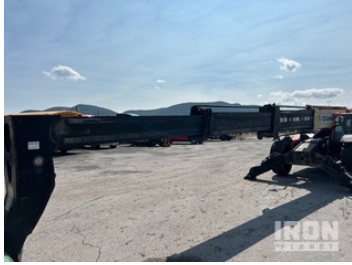
| Boom Condition | ★★★★☆ | |

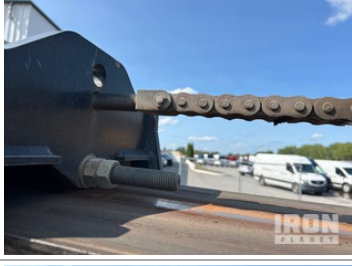
| Chain / Tensioners | ★★★★☆ | |

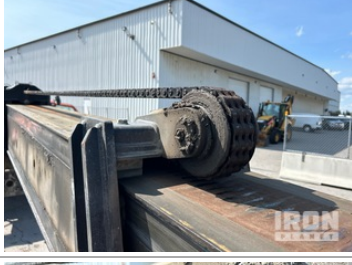
| Rollers and Guides | ★★★★☆ | |

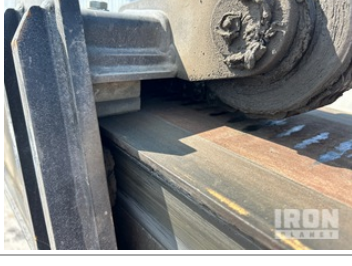
| Boom Wear Guides | ★★★★☆ | |

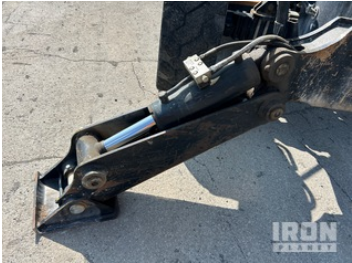
| Outriggers | ☆☆☆☆ | |

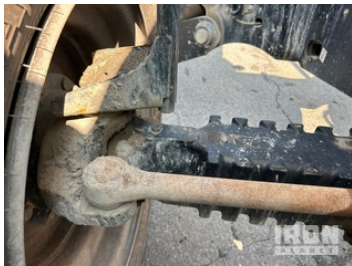
| Item | Assessment | Photo |
|---|---|---|
| Steering Linkage | ★★★★☆ | |

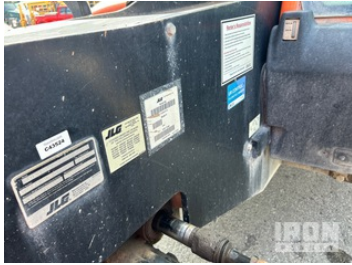
| Item | Assessment | Photo |
|---|---|---|
| Frame Condition | ★★★★☆ | |

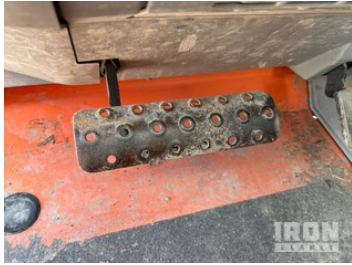
| Item | Assessment | Photo |
|---|---|---|
| Brake Control | ★★★★☆ | |

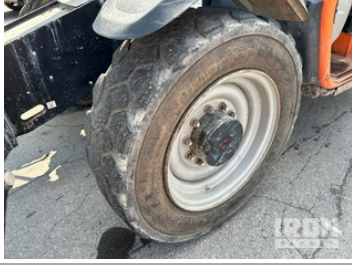
| Item | Assessment | Photo |
|---|---|---|
| Left Front Tire | Size: 400/75-28 Brand: Firestone<br>Model: DuraForce MH Tread Depth: 5/32 | |

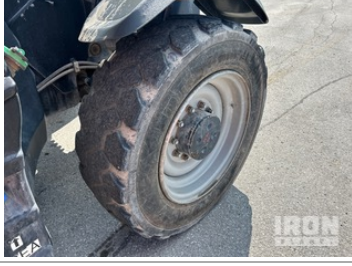
| Item | Assessment | Photo |
|---|---|---|
| Left Rear Tire | Size: 400/75-28 Brand: Firestone<br>Model: DuraForce MH Tread Depth: 12/32 | |

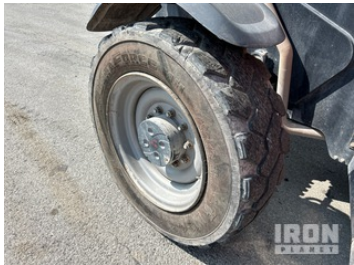
| Right Rear Tire | Size: 400/75-28 Brand: Firestone<br>Model: DuraForce MH Tread Depth:<br>14/32 | |

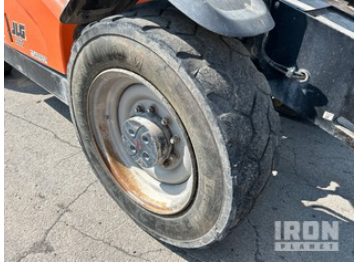
| Right Front Tire | Size: 400/75-28 Brand: Firestone<br>Model: DuraForce MH Tread Depth:<br>6/32 | |

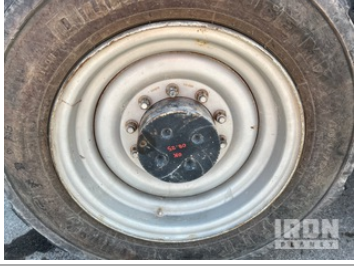
| Wheel Condition | No visible damage or missing<br>components | |

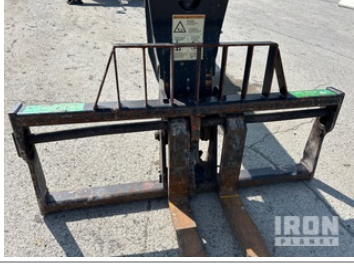
| Load Back Rest | ☆☆☆☆ | |

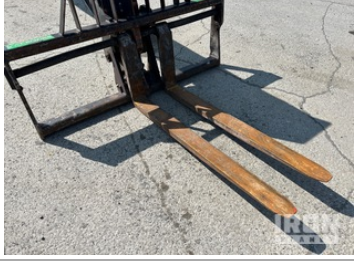
| Forks | ☆☆☆☆ | |
