## Item #13869134 - 2017 Genie GTH-844 Telehandler

# Inspection Report

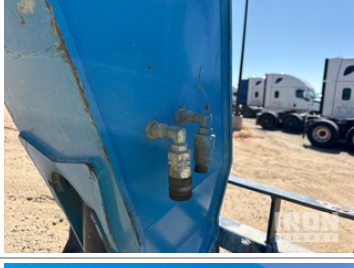
| Hydraulics | | |
|---|---|---|
| Auxiliary Hydraulic Plumbing | Not operationally checked | |

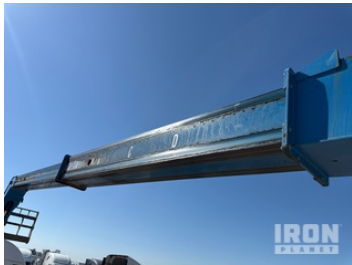
| Telescopic Boom Cylinders | ★★★★☆ | |

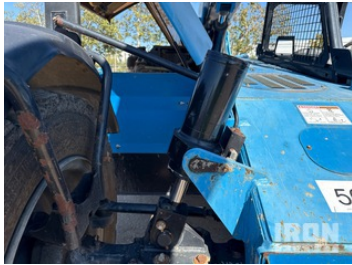
| Carriage Tilt Cylinder | ★★★★☆ | |

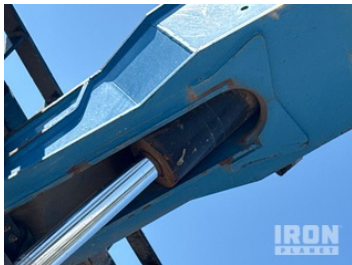
| Fork Positioning Cylinder (on fork carriage) | ★★★★☆ | |

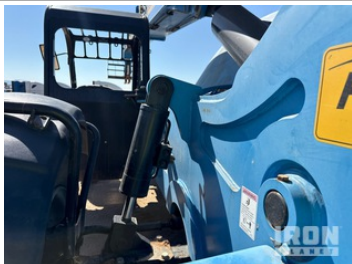
| Frame Leveling Cylinders | ★★★★☆ | |

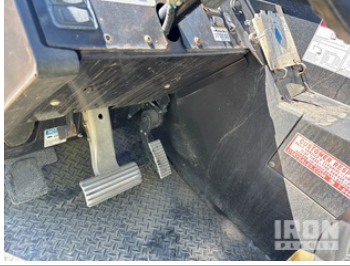
| Item | Assessment | Photo |
|---|---|---|
| Brake Control | ★★★★☆ | |

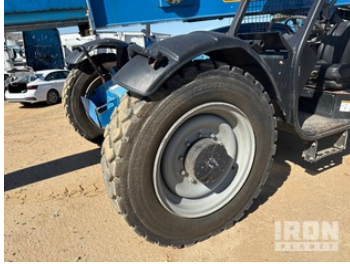
| Item | Assessment | Photo |
|---|---|---|
| Left Front Tire | Size: 330/85-28 Brand: Extremelift Model: EXL-T1 Tread Depth: 31/32 | |

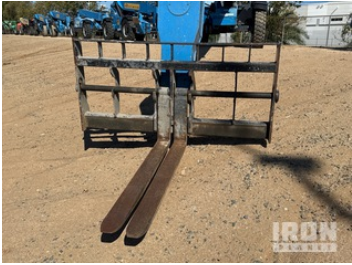
| Forks | ☆☆☆☆ | |
