## Item #13869098 - 2019 Skyjack SJ1256THS Telehandler

# Inspection Report

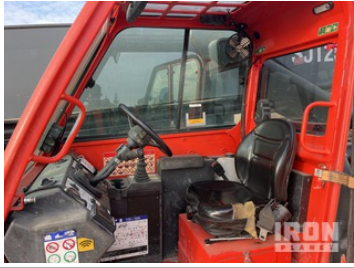
| Hand Rails | No visible damage or missing components | |

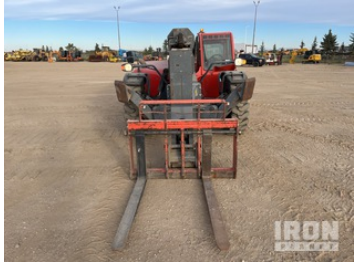
| Exterior Lights | All lights operational | |

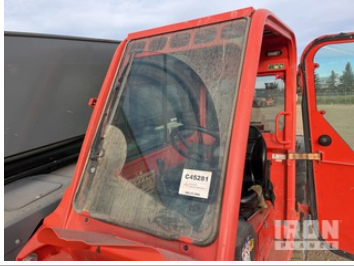
| Control Station | | |
|---|---|---|
| Glass | No visible damage or missing components | |

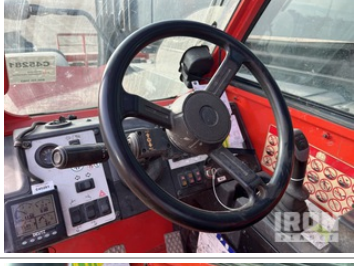
| Control Station | | |
|---|---|---|
| Steering Control | ★★★★☆ | |

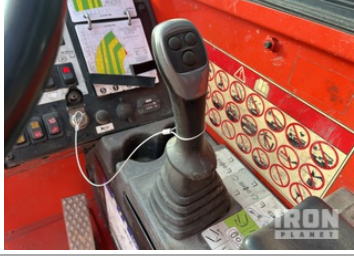
| Control Station | | |
|---|---|---|
| Hydraulic Controls | ★★★★☆ | |

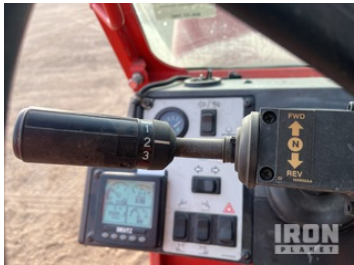
| Drivetrain Controls | ☆☆☆☆ | |

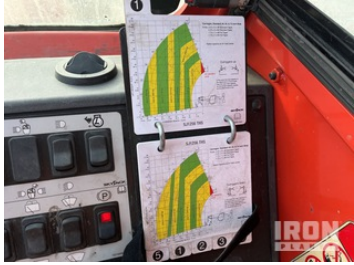
| Load Charts | Chart book in cab | |

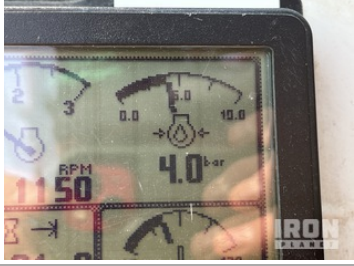
| Engine Oil Pressure | The gauge registers in the operating range. | |

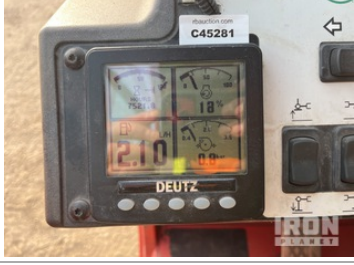
| Gauges | Operational | |

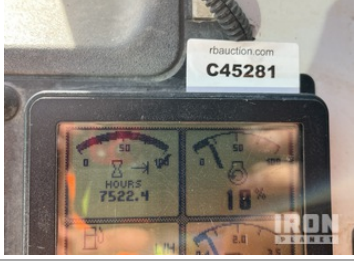
| Hour Meter / Odometer | 7522 hrs | |

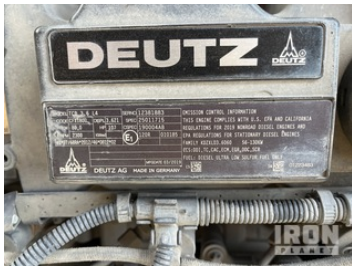
| Engine | | |
|---|---|---|
| Emission Label | | |

| Engine | | |
|---|---|---|
| Engine | 2019 US EPA Label, CARB Compliant, Requires Diesel Exhaust Fluid | |

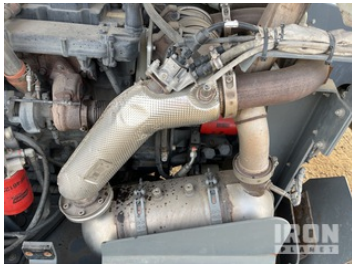
| Engine | | |
|---|---|---|
| Exhaust System | No visible damage or missing components | |

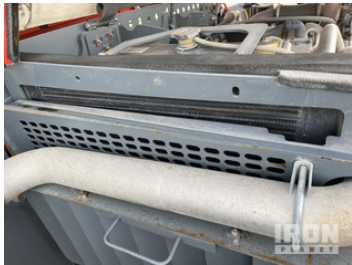
| Engine | | |
|---|---|---|
| Radiator | ★★★★☆ | |

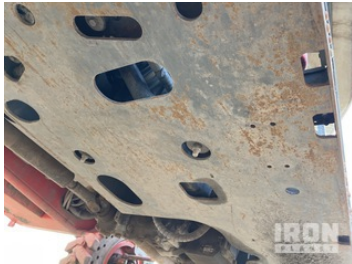
| Engine | | |
|---|---|---|
| Oil Leaks | No dripping leaks | |

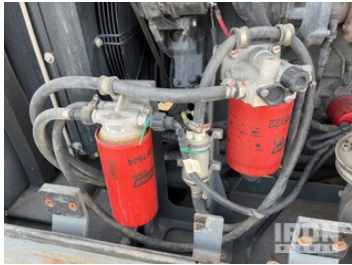
| Engine | | |
|---|---|---|
| Fuel Leaks | No dripping leaks | |

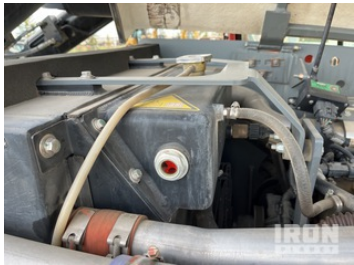
| Cooling System Leaks | No dripping leaks | |

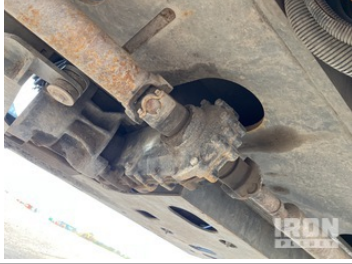
| Item | Assessment | Photo |
|---|---|---|
| Transfer Case / Drop Box | ★★☆☆<br>Operational | |

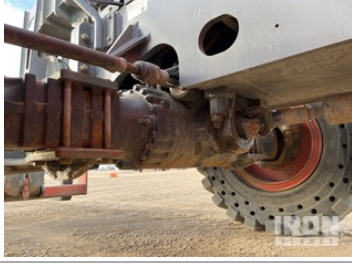
| Item | Assessment | Photo |
|---|---|---|
| Front Drive Axle | ★★☆☆ | |

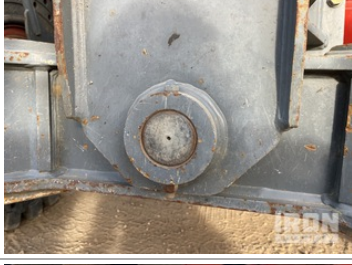
| Item | Assessment | Photo |
|---|---|---|
| Front Axle Oscillating Pin | ★★☆☆ | |

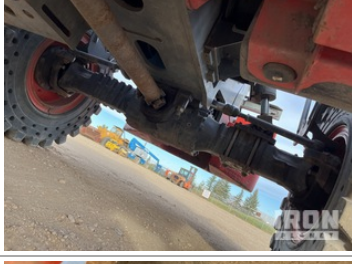
| Item | Assessment | Photo |
|---|---|---|
| Rear Drive Axle | ★★☆☆ | |

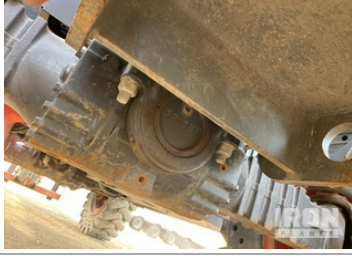
| Item | Assessment | Photo |
|---|---|---|
| Rear Axle Oscillating Pin | ★★☆☆ | |

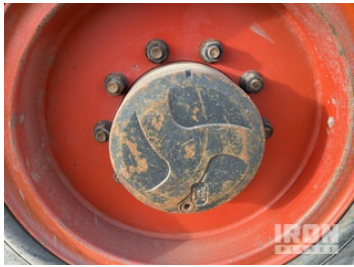
| Final Drives | ☆☆☆☆ | |

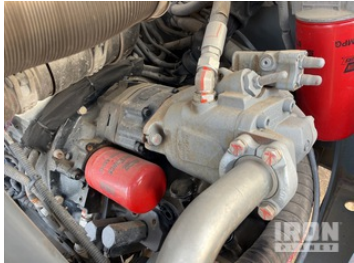
| Hydraulics | | |
|---|---|---|
| Pumps (Hydraulics) | ★★★★☆ | |

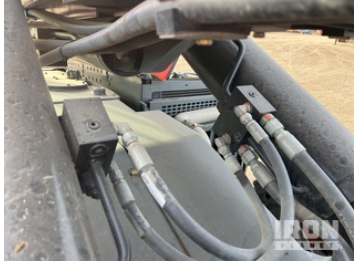
| Hydraulics | | |
|---|---|---|
| Valves | ★★★★☆ | |

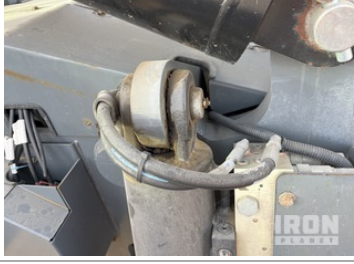
| Hydraulics | | |
|---|---|---|
| Hoses (Hydraulics) | ★★★★☆ | |

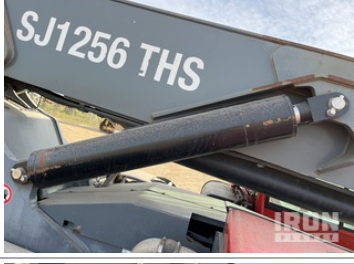
| Hydraulics | | |
|---|---|---|
| Boom Lift Cylinder(s) | ★★★★☆ | |

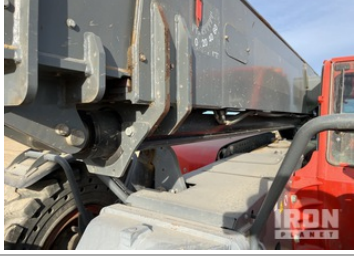
| Hydraulics | | |
|---|---|---|
| Telescopic Boom Cylinders | ★★★★☆ | |

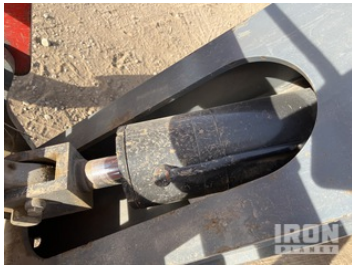
| Carriage Tilt Cylinder | ★★★★☆ | |

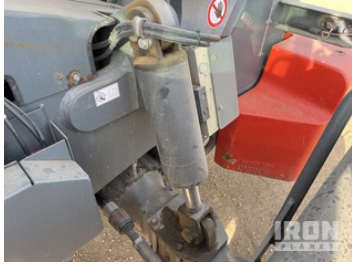
| Frame Leveling Cylinders | ★★★★☆ | |

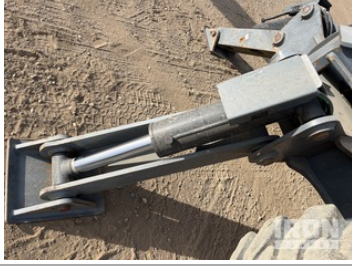
| Outrigger Cylinders | ★★★★☆ | |

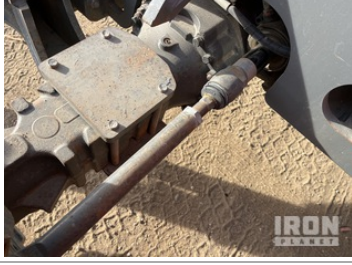
| Steering Cylinders | ★★★★☆ | |

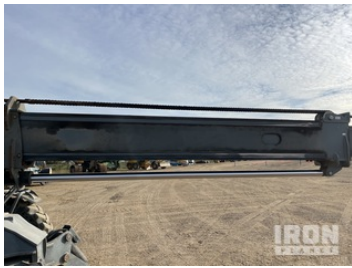
| Item | Assessment | Photo |
|---|---|---|
| Boom Condition | ★★★★☆ | |

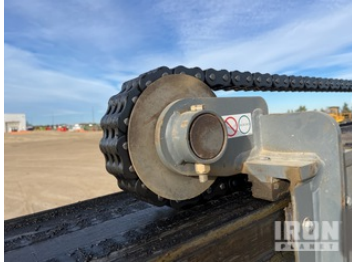
| Item | Assessment | Photo |
|---|---|---|
| Chain / Tensioners | ★★★★☆ | |

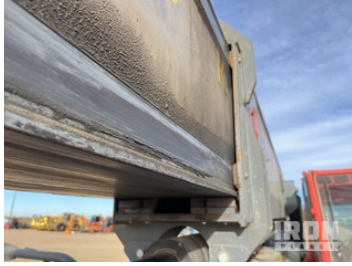
| Item | Assessment | Photo |
|---|---|---|
| Rollers and Guides | ★★★★☆ | |

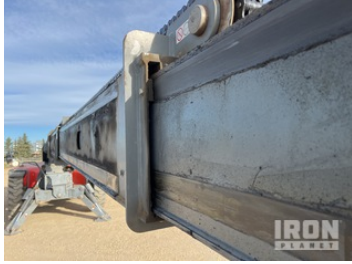
| Item | Assessment | Photo |
|---|---|---|
| Boom Wear Guides | ★★★★☆ | |

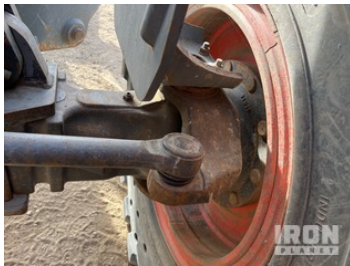
| Item | Assessment | Photo |
|---|---|---|
| Steering Linkage | ★★★★☆ | |

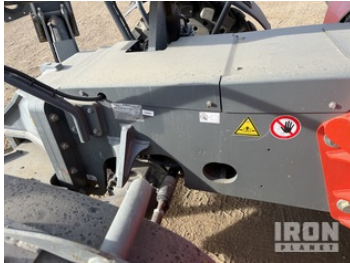
| Item | Assessment | Photo |
|---|---|---|
| Frame Condition | ★★★★☆ | |

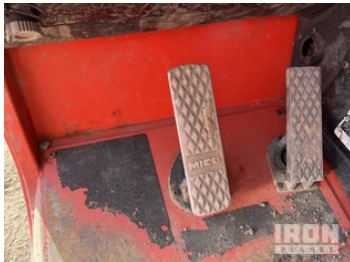
| Item | Assessment | Photo |
|---|---|---|
| Brake Control | ★★★★☆ | |

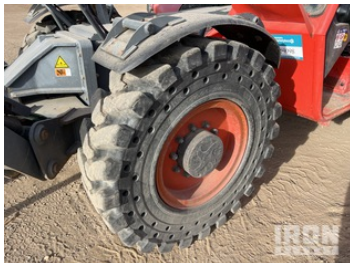
| Item | Assessment | Photo |
|---|---|---|
| Left Front Tire | Size: 14.00-24 Brand: SolidBoss Tread Depth: 23/32 | |

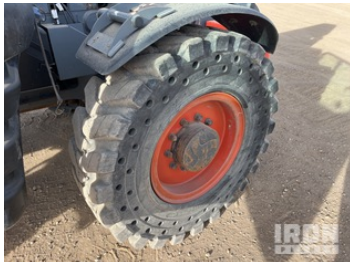
| Item | Assessment | Photo |
|---|---|---|
| Left Rear Tire | Size: " Brand: " Tread Depth: 20/32 | |

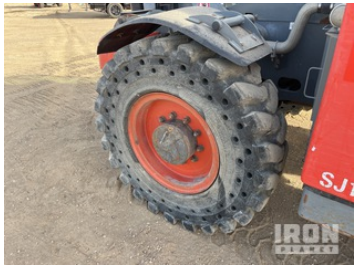
| Right Rear Tire | Size: " Brand: " Tread Depth: 17/32 | |

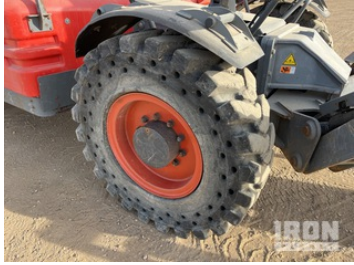
| Right Front Tire | Size: " Brand: " Tread Depth: 19/32 | |

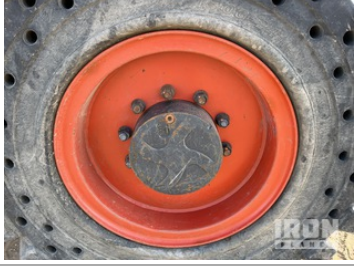
| Wheel Condition | No visible damage or missing components | |

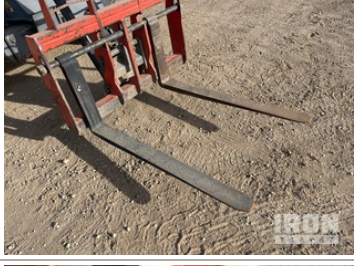
| Forks | ★★★★☆ | |
