## Item #13869136 - 2017 Genie GTH-844 Telehandler

- Features: Open Operator Station, 8000 lb Max Lift Capacity, 2017 US EPA Label, CARB Compliant, 60 in Forks, Frame Leveling, Auxiliary Hydraulic Plumbing
- Meter Reading: 0 Miles
- Serial # : GTH08E-11291
- Inspection Completed: 8/21/25

## Inspection Report

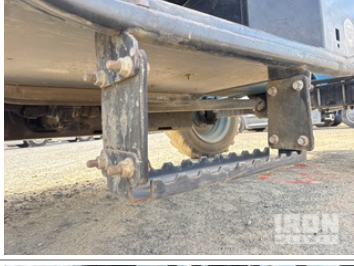
| Steps | No visible damage or missing components | |

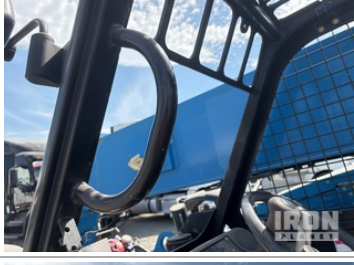
| Hand Rails | No visible damage or missing components | |

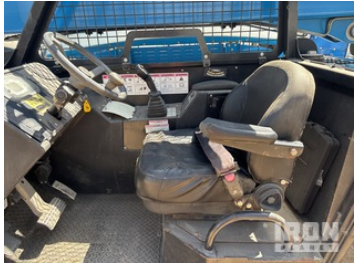
| Control Station | | |
|---|---|---|
| Seat/Armrests | No visible damage or missing components | |

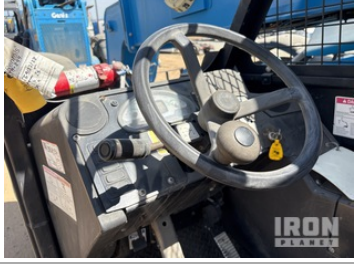
| Control Station | | |
|---|---|---|
| Steering Control | ★★★★☆ | |

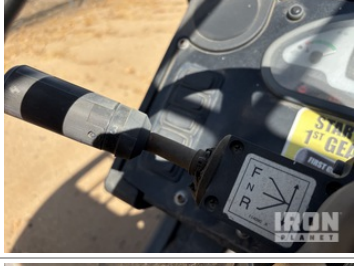
| Control Station | | |
|---|---|---|
| Drivetrain Controls | ★★★★☆ | |

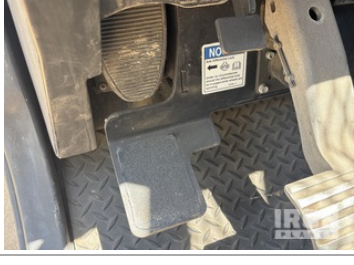
| Control Station | | |
|---|---|---|
| Transmission Disconnect Control | ★★★★☆ | |

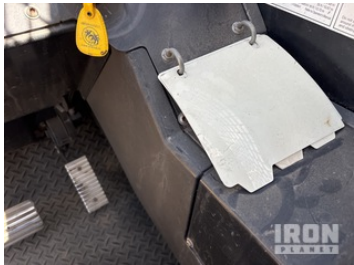
| Load Charts | Chart book in cab | |

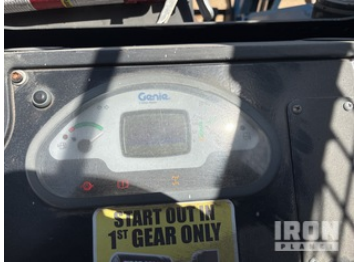
| Engine Oil Pressure | The gauge registers in the operating range. | |

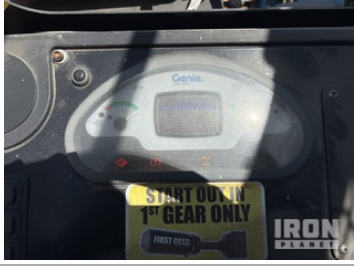
| Warning Lights | Operational | |

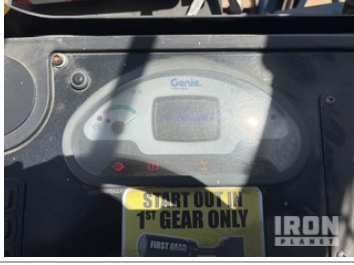
| Gauges | Operational | |

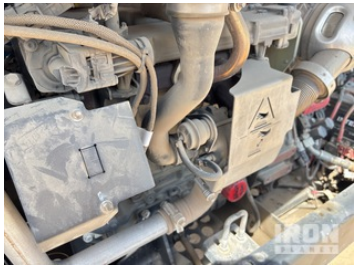
| Engine | | |
|---|---|---|
| Exhaust System | No visible damage or missing components | |

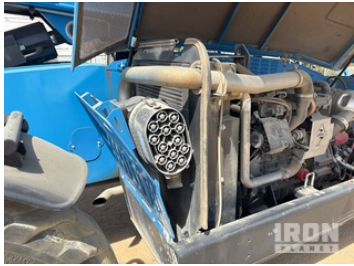
| Engine | | |
|---|---|---|
| Radiator | ★★★★☆ | |

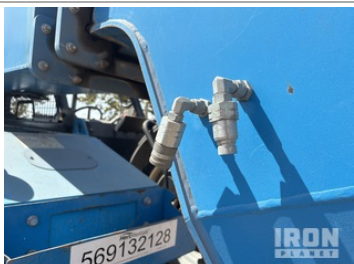
| Hydraulics | | |
|---|---|---|
| Auxiliary Hydraulic Plumbing | Capped off, Front | |

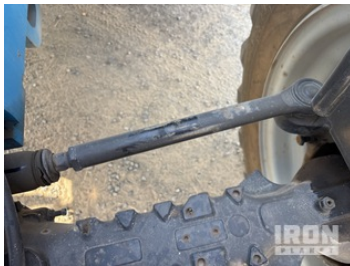
| Item | Assessment | Photo |
|---|---|---|
| Steering Linkage | ★★★★☆ | |

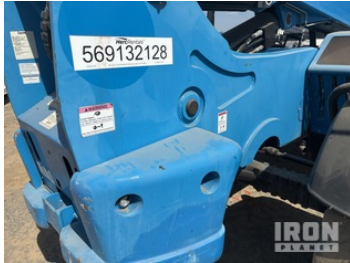
| Item | Assessment | Photo |
|---|---|---|
| Frame Condition | ★★★★☆ | |

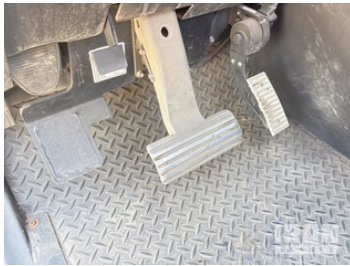
| Item | Assessment | Photo |
|---|---|---|
| Brake Control | ★★★★☆<br>Brakes sound really dry | |

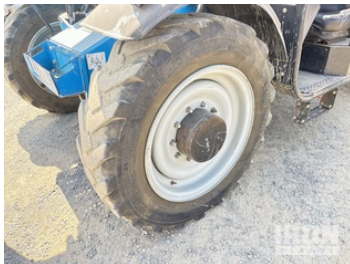
| Item | Assessment | Photo |
|---|---|---|
| Left Front Tire | Size: 330/85-28 Brand: EXTREME<br>Model: EXL-T1 Tread Depth: 9/32 | |

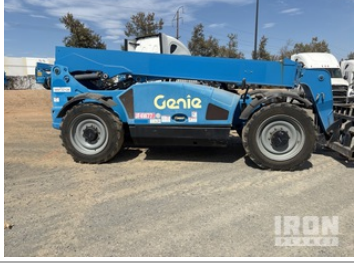
| Wheel Condition | No visible damage or missing components | |

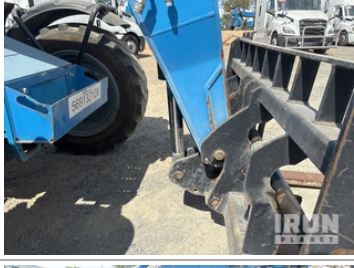
| Loader Quick Coupler | ★★★★☆ | |

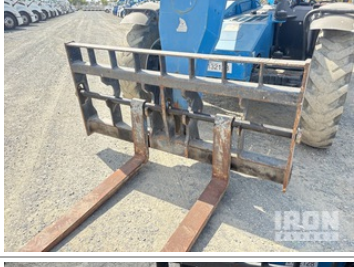
| Load Back Rest | ★★★★☆ | |

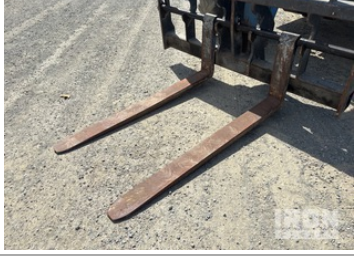
| Forks | ★★★★☆ | |
