## Item #13869145 - 2018 Genie GTH-844 Telehandler

# Inspection Report

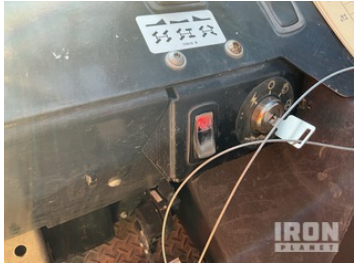
| <b>Safety</b> | | |
|---|---|---|
| Safety Lock Out/Stop | Operational | |

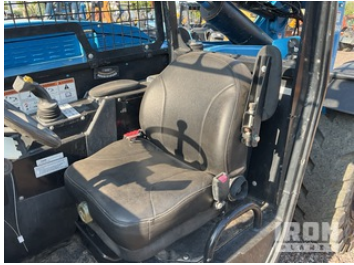
| Control Station | | |
|---|---|---|
| Seat/Armrests | No visible damage or missing components | |

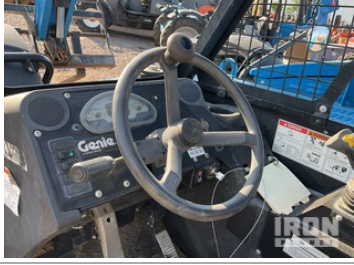
| Control Station | | |
|---|---|---|
| Steering Control | ★★★★☆ | |

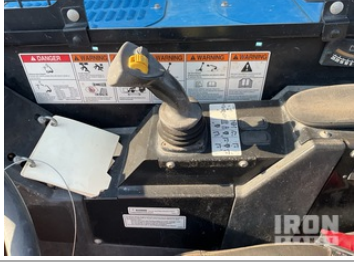
| Control Station | | |
|---|---|---|
| Hydraulic Controls | ★★★★☆ | |

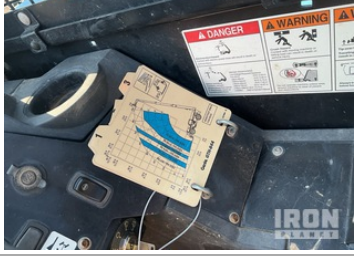
| Control Station | | |
|---|---|---|
| Load Charts | Chart book in cab | |

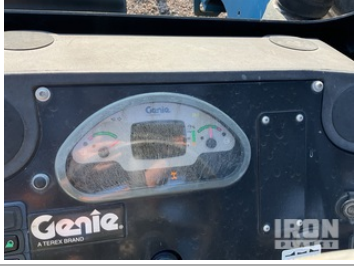
| Gauges | Operational | |

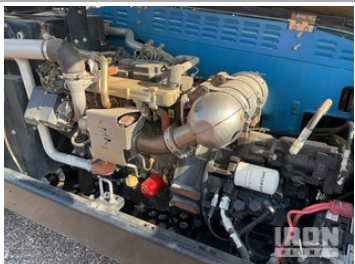
| Engine | | |
|---|---|---|
| Exhaust System | No visible damage or missing components | |

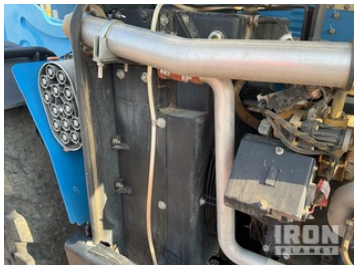
| Engine | | |
|---|---|---|
| Radiator | ★★★★☆ | |

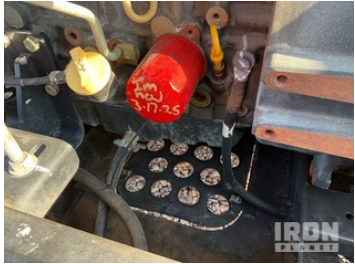
| Engine | | |
|---|---|---|
| Oil Leaks | No dripping leaks | |

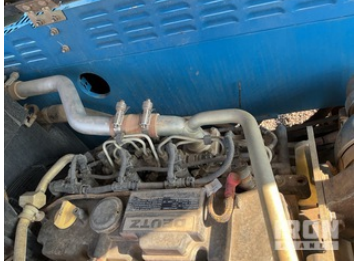
| Engine | | |
|---|---|---|
| Fuel Leaks | No dripping leaks | |

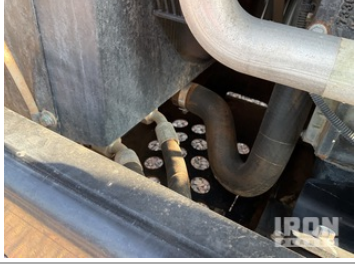
| Engine | | |
|---|---|---|
| Cooling System Leaks | No dripping leaks | |

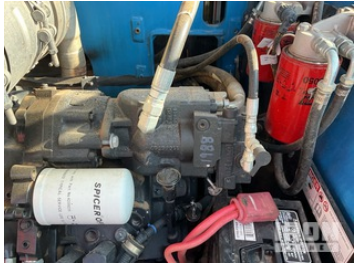
| Hydraulics | | |
|---|---|---|
| Pumps (Hydraulics) | ★★★★☆ | |

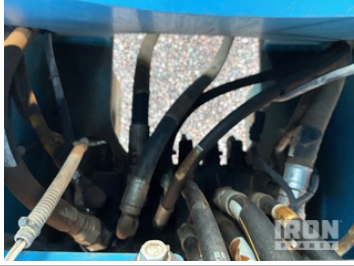
| Hydraulics | | |
|---|---|---|
| Valves | ★★★★☆ | |

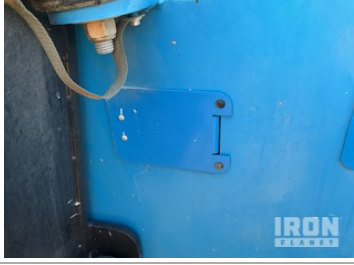
| Hydraulics | | |
|---|---|---|
| Hydraulic Tank | ★★★★☆ | |

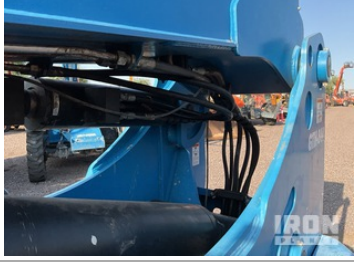
| Hydraulics | | |
|---|---|---|
| Hoses (Hydraulics) | ★★★★☆ | |

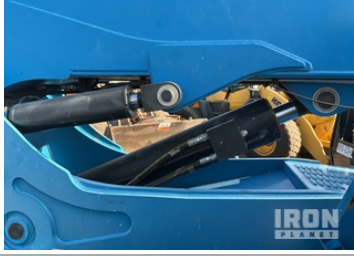
| Hydraulics | | |
|---|---|---|
| Boom Lift Cylinder(s) | ★★★★☆ | |

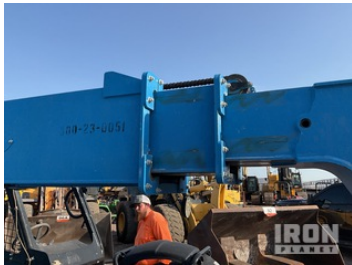
| Telescopic Boom Cylinders | ★★★★☆ | |

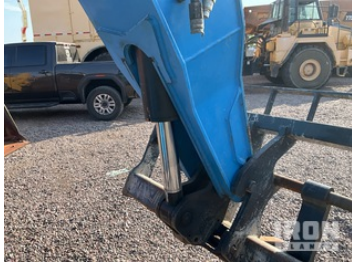
| Carriage Tilt Cylinder | ★★★★☆ | |

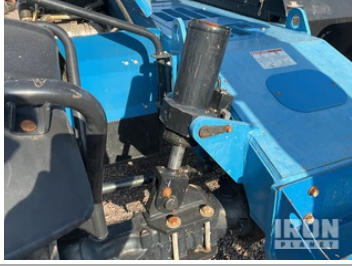
| Frame Leveling Cylinders | ★★★★☆ | |

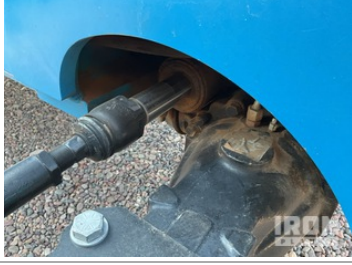
| Steering Cylinders | ★★★★☆ | |

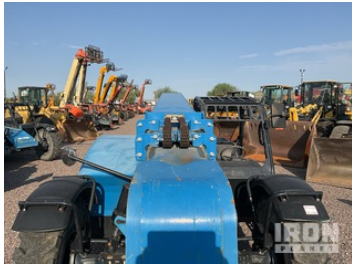
| Item | Assessment | Photo |
|---|---|---|
| Boom Condition | ★★★★☆ | |

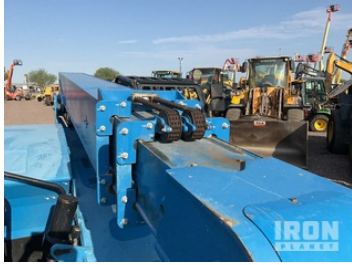
| Item | Assessment | Photo |
|---|---|---|
| Chain / Tensioners | ★★★★☆ | |

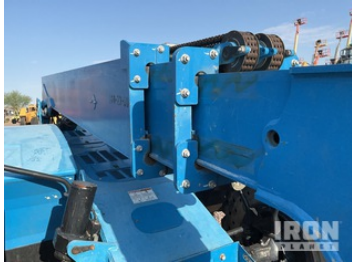
| Item | Assessment | Photo |
|---|---|---|
| Boom Wear Guides | ★★★★☆ | |

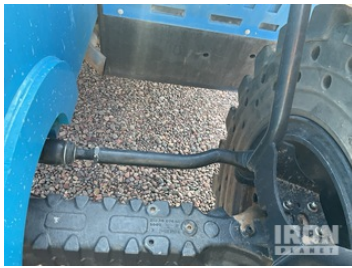
| Item | Assessment | Photo |
|---|---|---|
| Steering Linkage | ★★★★☆ | |

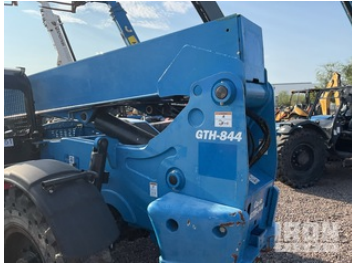
| Item | Assessment | Photo |
|---|---|---|
| Frame Condition | ★★★★☆ | |

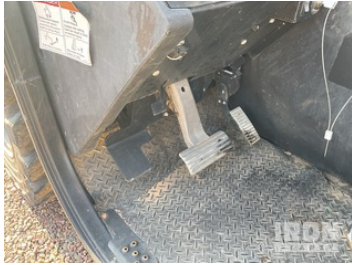
| Item | Assessment | Photo |
|---|---|---|
| Master Cylinder | ★★★★☆ | |

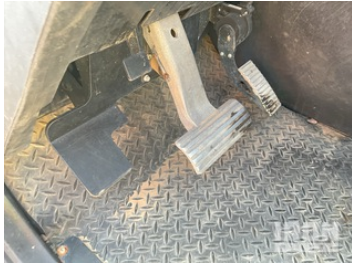
| Item | Assessment | Photo |
|---|---|---|
| Brake Control | ★★★★☆ | |

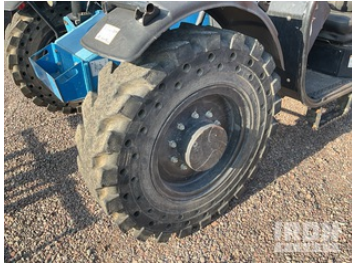
| Item | Assessment | Photo |
|---|---|---|
| Left Front Tire | Size: 1300 x 24 Brand: Solid BOSS Model: TH Tread Depth: 44/32 | |

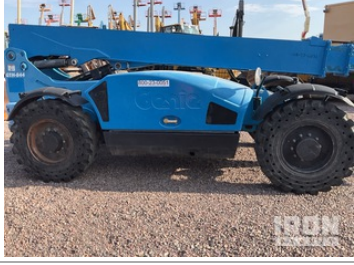
| Wheel Condition | No visible damage or missing components | |

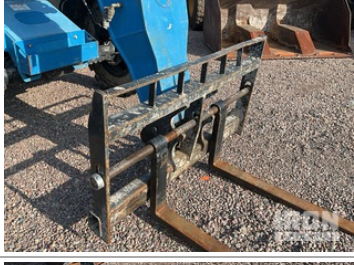
| Load Back Rest | ★★★★☆ | |

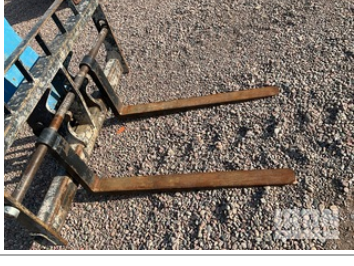
| Forks | ★★★★☆ | |
