## Item #13810734 - 2017 Skyjack SJ643 TH Telehandler

- Features: Enclosed Cab, Air Conditioner, 43 ft Max Lift Height, 6000 lb Max Lift Capacity, 2016 US EPA Label, CARB Compliant, 48 in Forks, Tilt Carriage, Manual Coupler, Auxiliary Hydraulic Plumbing
- Meter Reading: 2,683 Hours
- Serial # : 87110528
- Inspection Completed: 8/21/25

# Inspection Report

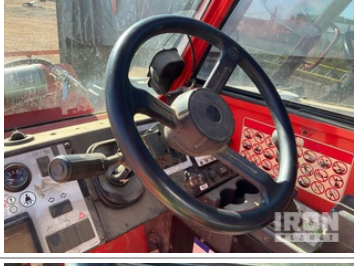
| Control Station | | |
|---|---|---|
| Steering Control | ★★★★☆ | |

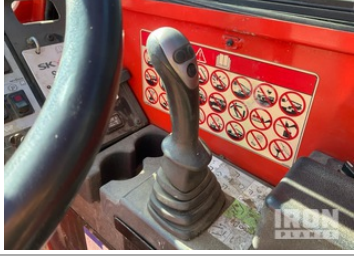
| Control Station | | |
|---|---|---|
| Hydraulic Controls | ★★★★☆ | |

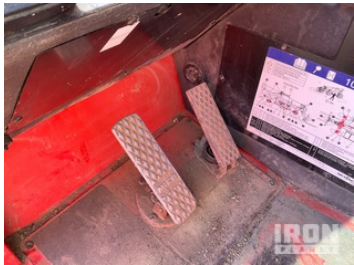
| Drivetrain Controls | ★★★★☆ | |

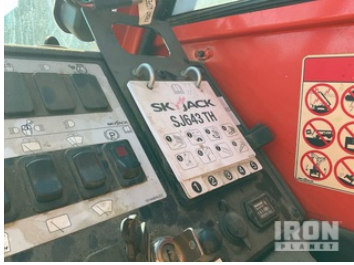
| Load Charts | Chart book in cab | |

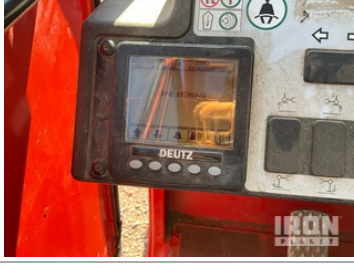
| Warning Lights | Operational | |

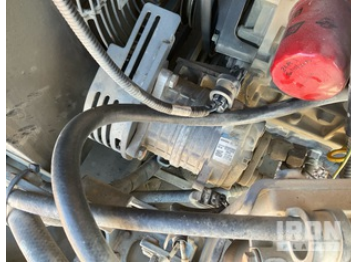
| Engine | | |
|---|---|---|
| A/C Compressor | Operational | |

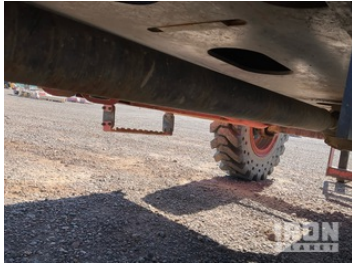
| Item | Assessment | Photo |
|---|---|---|
| Transfer Case / Drop Box | ★★☆☆<br>Operational | |

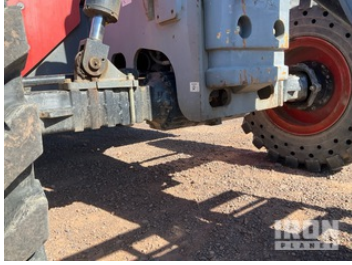
| Item | Assessment | Photo |
|---|---|---|
| Front Drive Axle | ★★☆☆ | |

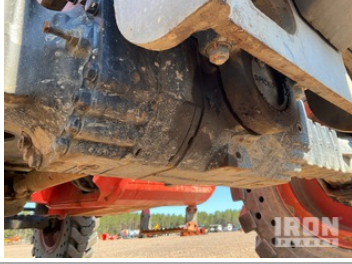
| Item | Assessment | Photo |
|---|---|---|
| Front Axle Oscillating Pin | ★★☆☆ | |

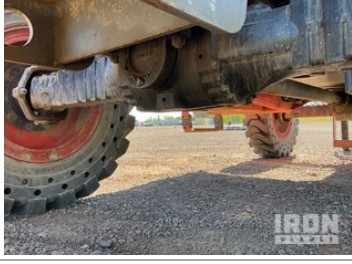
| Item | Assessment | Photo |
|---|---|---|
| Rear Drive Axle | ★★☆☆ | |

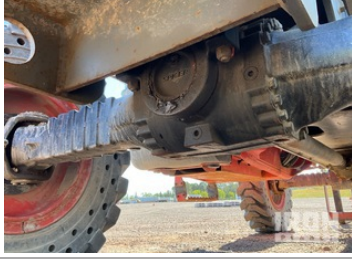
| Item | Assessment | Photo |
|---|---|---|
| Rear Axle Oscillating Pin | ★★☆☆ | |

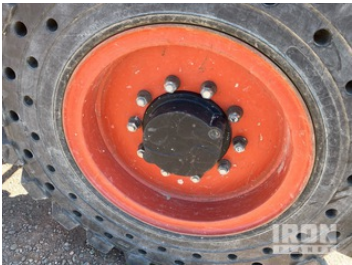
| Final Drives | ☆☆☆☆ | |

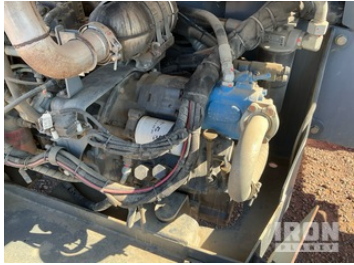
| Hydraulics | | |
|---|---|---|
| Pumps (Hydraulics) | ★★★★☆ | |

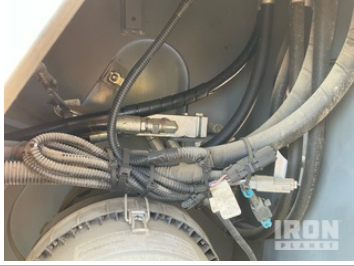
| Hydraulics | | |
|---|---|---|
| Valves | ★★★★☆ | |

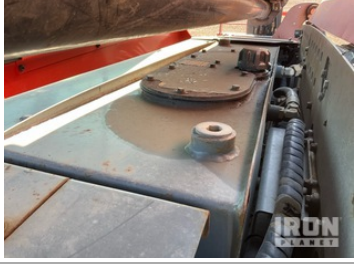
| Hydraulics | | |
|---|---|---|
| Hydraulic Tank | ★★★★☆ | |

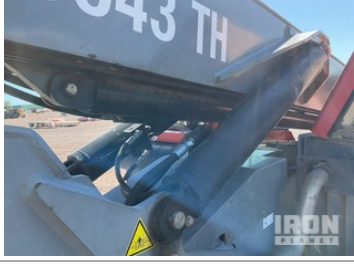
| Hydraulics | | |
|---|---|---|
| Hoses (Hydraulics) | ★★★★☆ | |

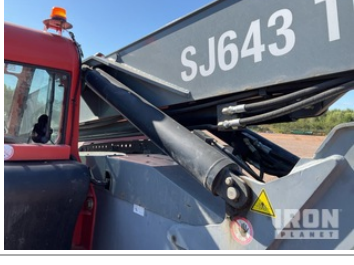
| Hydraulics | | |
|---|---|---|
| Boom Lift Cylinder(s) | ★★★★☆ | |

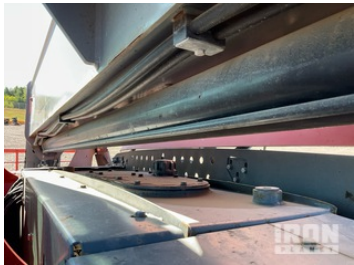
| Telescopic Boom Cylinders | ★★★★☆ | |

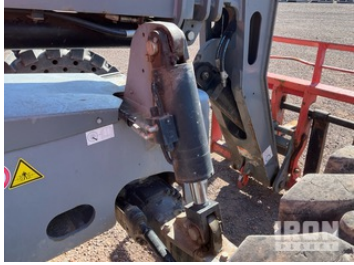
| Carriage Tilt Cylinder | ★★★★☆ | |

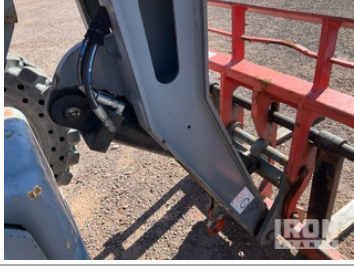
| Fork Positioning Cylinder (on fork carriage) | ★★★★☆ | |

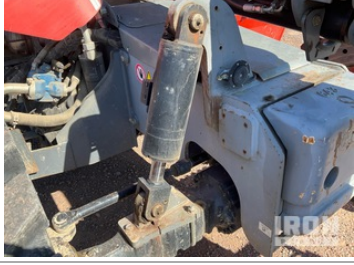
| Frame Leveling Cylinders | ★★★★☆ | |

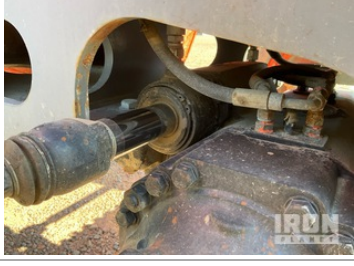
| Steering Cylinders | ★★★★☆ | |

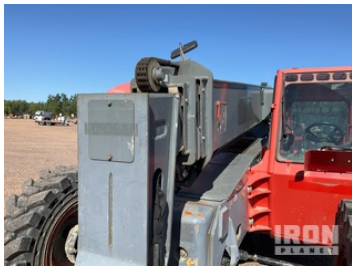
| Item | Assessment | Photo |
|---|---|---|
| Boom Condition | ★★★★☆ | |

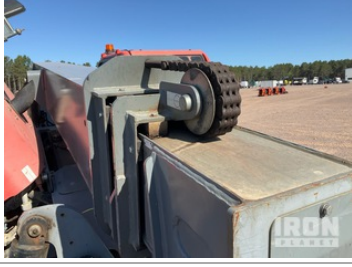
| Item | Assessment | Photo |
|---|---|---|
| Chain / Tensioners | ★★★★☆ | |

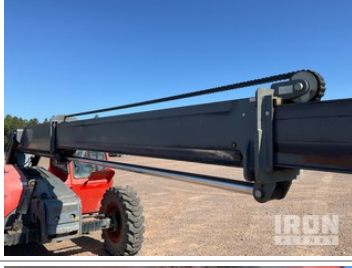
| Item | Assessment | Photo |
|---|---|---|
| Rollers and Guides | ★★★★☆ | |

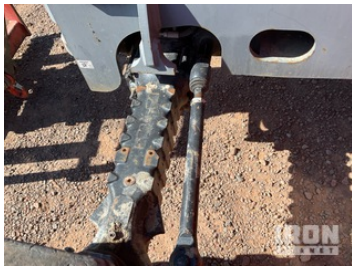
| Item | Assessment | Photo |
|---|---|---|
| Steering Linkage | ★★★★☆ | |

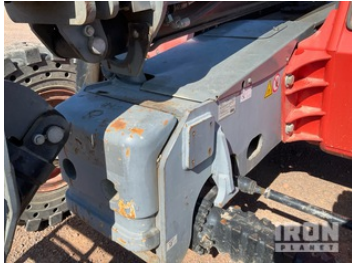
| Item | Assessment | Photo |
|---|---|---|
| Frame Condition | ★★★★☆ | |

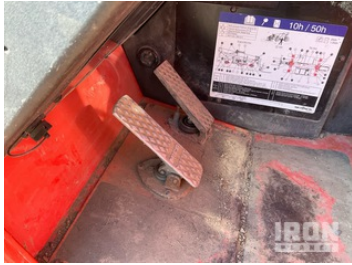
| Item | Assessment | Photo |
|---|---|---|
| Brake Control | ★★★★☆ | |

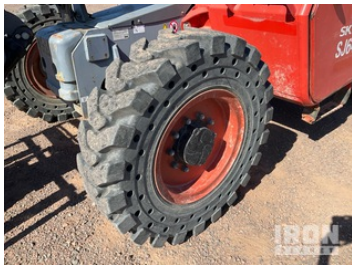
| Item | Assessment | Photo |
|---|---|---|
| Left Front Tire | Size: 13.00-24 Brand: Solid boss | |

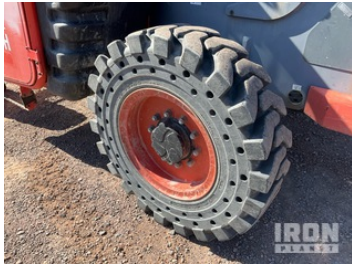
| Item | Assessment | Photo |
|---|---|---|
| Left Rear Tire | Size: 13.00-24 Brand: Solid Boss | |

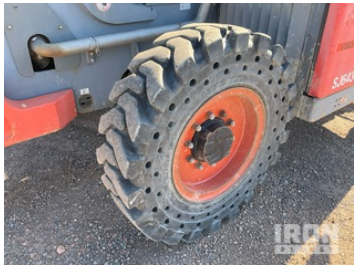
| Right Rear Tire | Size: 13.00-24 Brand: Solid boss | |

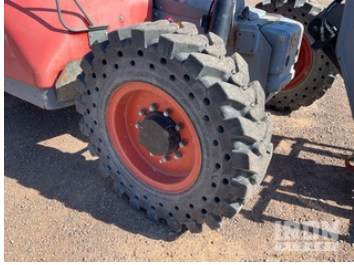
| Right Front Tire | Size: 13.00-24 Brand: Solid Boss | |

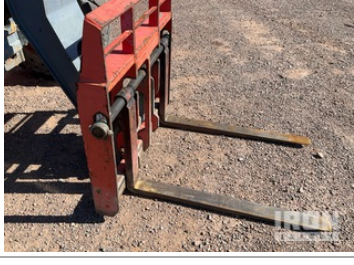
| Forks | ★★★★☆ | |
