## Item #14096208 - 2017 Skyjack SJ843TH Telehandler

# Inspection Report

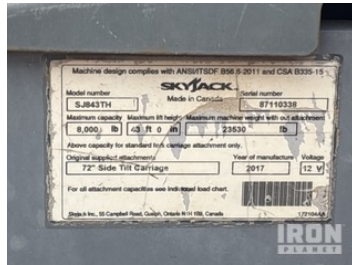
| Serial Number / VIN | 87110338 | |

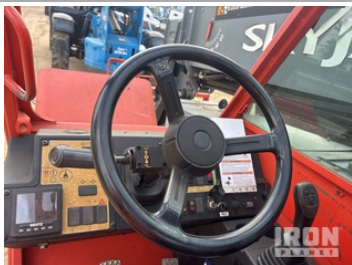
| Control Station | | |
|---|---|---|
| Steering Control | ★★★★☆ | |

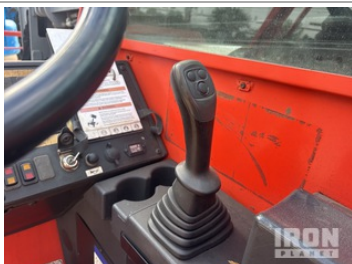
| Control Station | | |
|---|---|---|
| Hydraulic Controls | ★★★★☆ | |

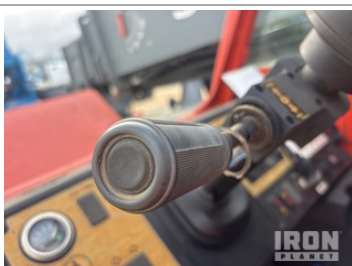
| Control Station | | |
|---|---|---|
| Drivetrain Controls | ★★★★☆ | |

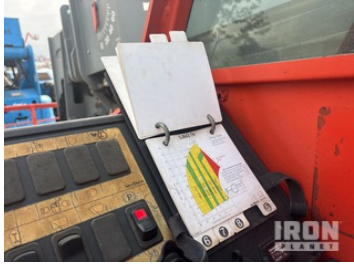
| Load Charts | Posted on cab wall | |

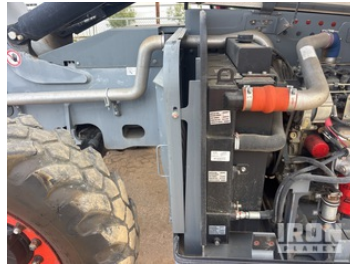
| Engine | | |
|---|---|---|
| Radiator | ★★★★☆ | |

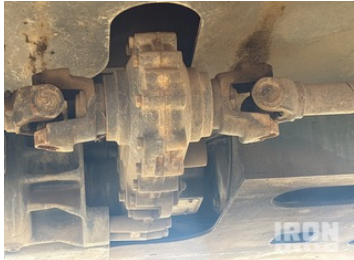
| Item | Assessment | Photo |
|---|---|---|
| Transfer Case / Drop Box | ★★☆☆<br>Operational | |

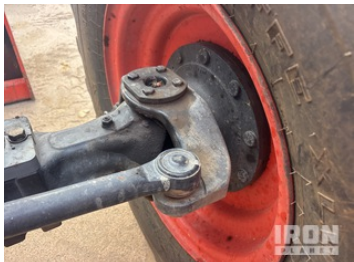
| Item | Assessment | Photo |
|---|---|---|
| Drive Motors | ★★☆☆ | |

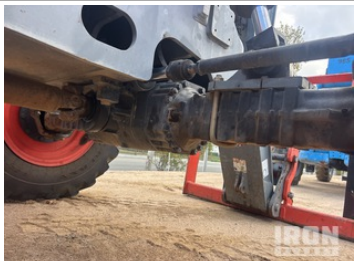
| Item | Assessment | Photo |
|---|---|---|
| Front Drive Axle | ★★☆☆ | |

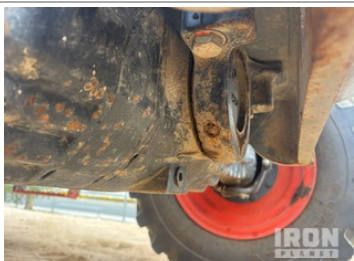
| Item | Assessment | Photo |
|---|---|---|
| Front Axle Oscillating Pin | ★★☆☆ | |

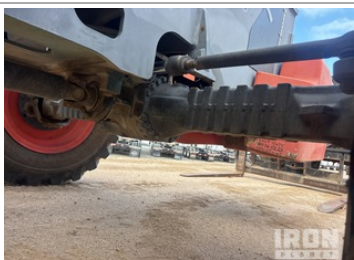
| Item | Assessment | Photo |
|---|---|---|
| Rear Drive Axle | ★★☆☆ | |

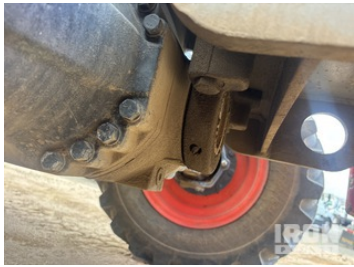
| Rear Axle Oscillating Pin | ★★★★☆ | |

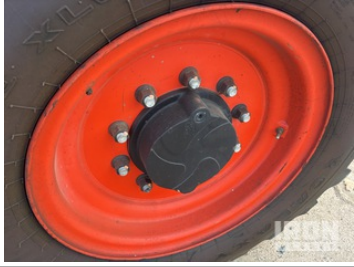
| Final Drives | ★★★★☆ | |

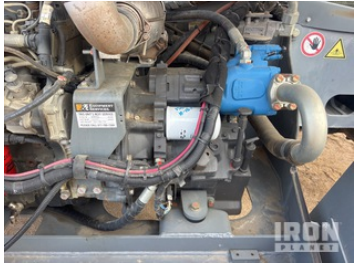
| Hydraulics | | |
|---|---|---|
| Pumps (Hydraulics) | ★★★★☆ | |

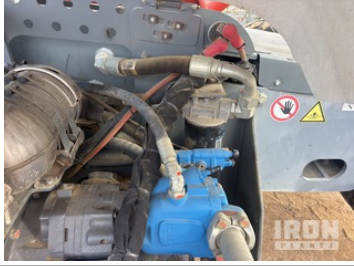
| Hydraulics | | |
|---|---|---|
| Valves | ★★★★☆ | |

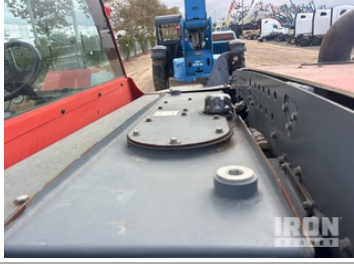
| Hydraulics | | |
|---|---|---|
| Hydraulic Tank | ★★★★☆ | |

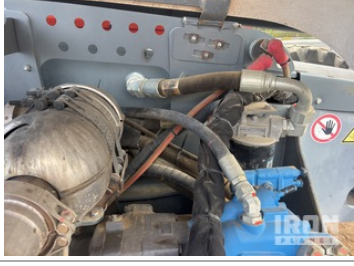
| Hydraulics | | |
|---|---|---|
| Hoses (Hydraulics) | ★★★★☆ | |

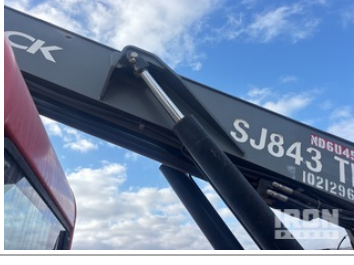
| Hydraulics | | |
|---|---|---|
| Boom Lift Cylinder(s) | ★★★★☆ | |

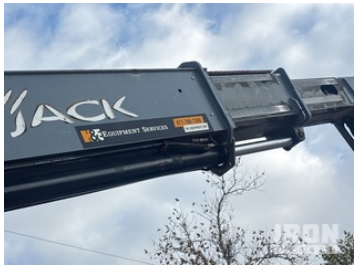
| Telescopic Boom Cylinders | ★★★★☆ | |

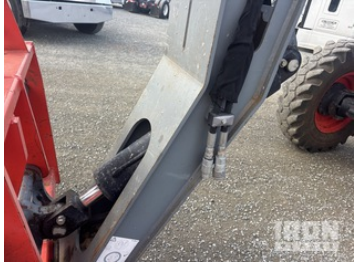
| Carriage Tilt Cylinder | ★★★★☆ | |

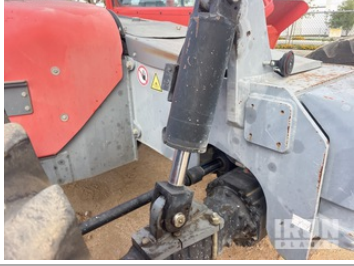
| Frame Leveling Cylinders | ★★★★☆ | |

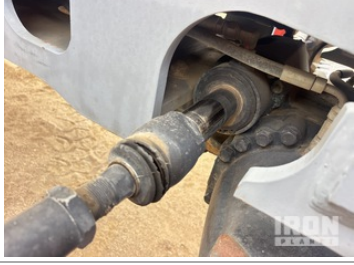
| Steering Cylinders | ★★★★☆ | |

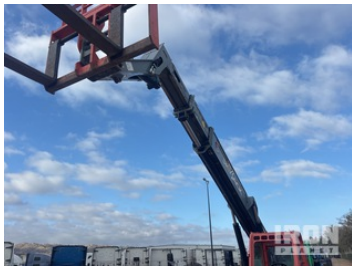
| Item | Assessment | Photo |
|---|---|---|
| Boom Condition | ★★★★☆ | |

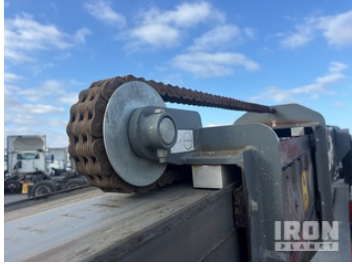
| Item | Assessment | Photo |
|---|---|---|
| Chain / Tensioners | ★★★★☆ | |

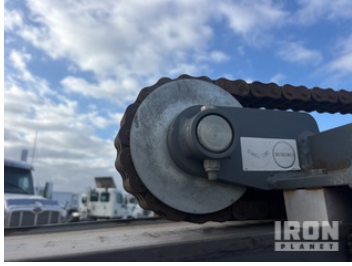
| Item | Assessment | Photo |
|---|---|---|
| Rollers and Guides | ★★★★☆ | |

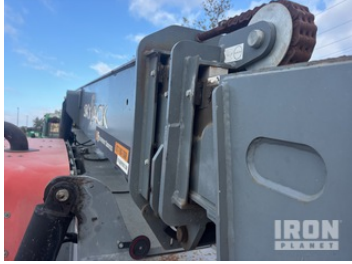
| Item | Assessment | Photo |
|---|---|---|
| Boom Wear Guides | ★★★★☆ | |

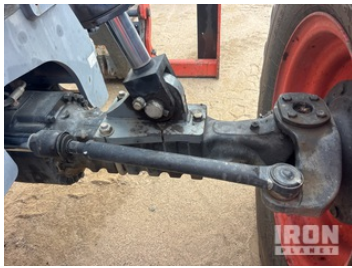
| Item | Assessment | Photo |
|---|---|---|
| Steering Linkage | ★★★★☆ | |

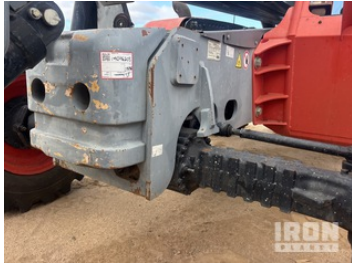
| Item | Assessment | Photo |
|---|---|---|
| Frame Condition | ★★★★☆ | |

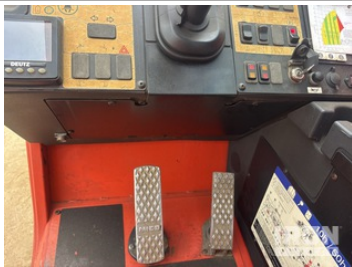
| Item | Assessment | Photo |
|---|---|---|
| Brake Control | ★★★★☆ | |

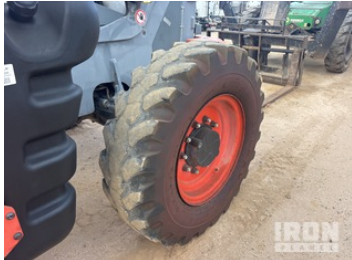
| Item | Assessment | Photo |
|---|---|---|
| Left Rear Tire | Size: 300-24 Brand: Galaxy Model: Giraffe XLW Tread Depth: 1 /32 | |

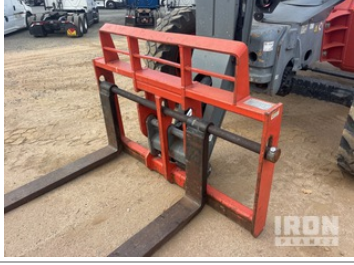
| Load Back Rest | ★★★★☆ | |

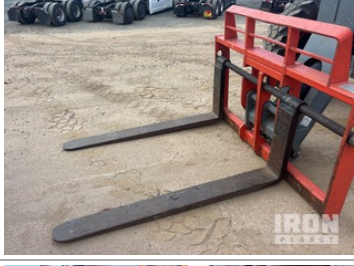
| Forks | ★★★★☆ | |
