## Item #14095045 - 2016 Skyjack SJ63AJ 4WD Diesel Articulating Boom Lift

# Inspection Report

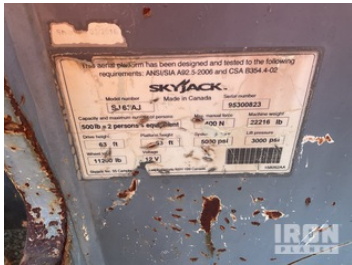
| Serial Number / VIN | 95300823 | |

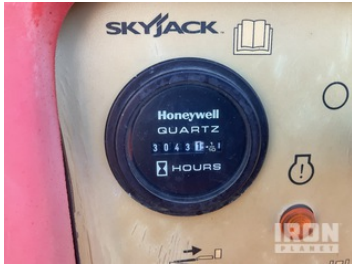
| Hour Meter / Odometer | 3043 mi | |

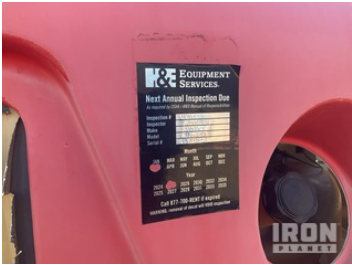
| Safety | | |
|---|---|---|
| ANSI Guidelines | Yes | |
