## Item #14522849 - 2016 JLG 800 AJ 4WD Diesel Articulating Boom Lift

# Inspection Report

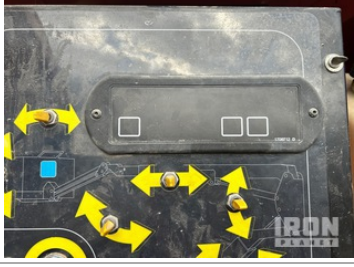
Function Controls	★★★★	 
Oil Pressure	The fault indicator shuts off after the engine oil pressure rises.

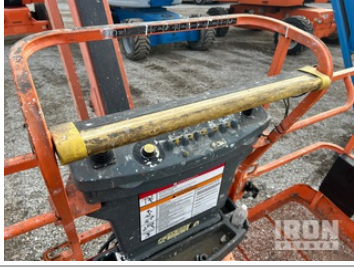
Safety Control Hand/Foot Switch	★★★★☆ Operational

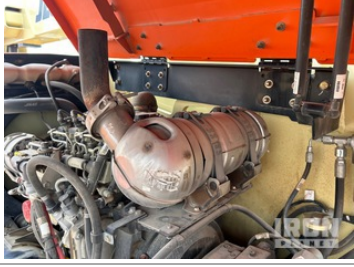
Exhaust System	No visible damage or missing components

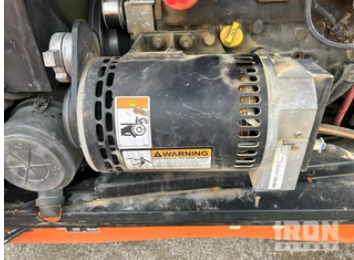
Oil Leaks	No dripping leaks	
Fuel Leaks	No dripping leaks	
Cooling System Leaks	No dripping leaks	
Onboard Generator	Not operationally checked

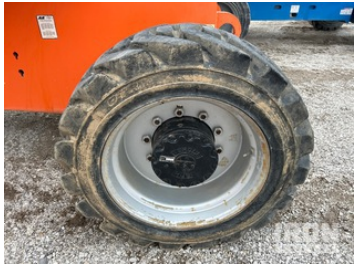
<b>Drivetrain</b>		
Operational test is limited to low speed in a confined flat area without load. Differential interlocks, full transmission shifting and functionality of all drive axles cannot be fully verified. Inspector listens for abnormal noises, observes leaks and notes physical damage.		
<b>Item</b>	<b>Assessment</b>	<b>Photo</b>
Left Front Final Drive	★ ★ ★ ☆

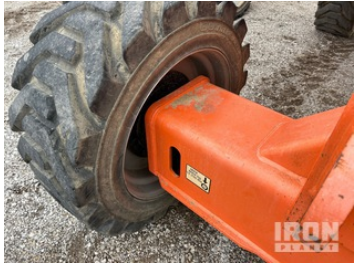
Left Front Drive Motor	★ ★ ★ ☆

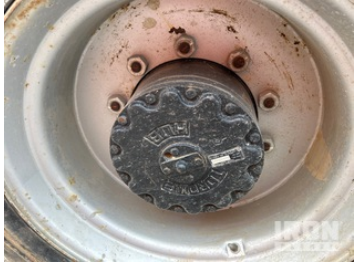
Left Rear Final Drive	★ ★ ★ ☆

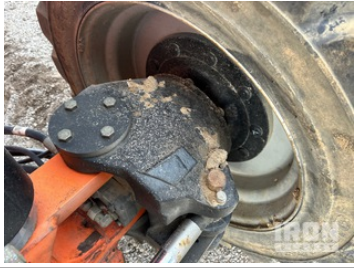
Left Rear Drive Motor	★ ★ ★ ☆

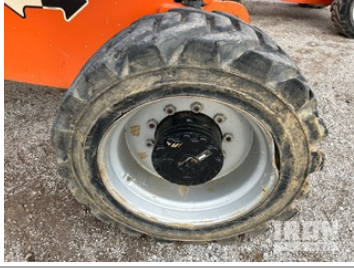
Right Rear Final Drive	★ ★ ★ ☆

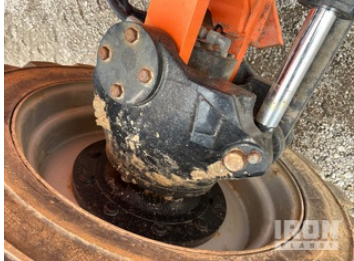
Right Rear Drive Motor	★ ★ ★ ☆

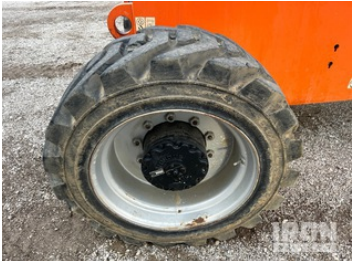
Right Front Final Drive	★★★★☆

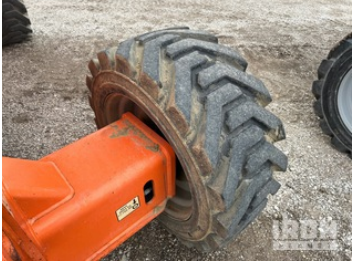
Right Front Drive Motor	★★★★☆

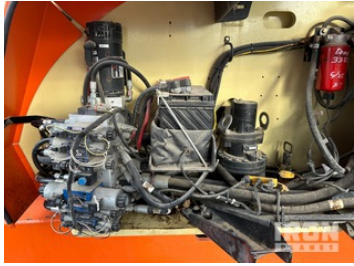
Hydraulics		
See photos for condition		
Item	Assessment	Photo
Pumps (Hydraulics)	★★★★☆

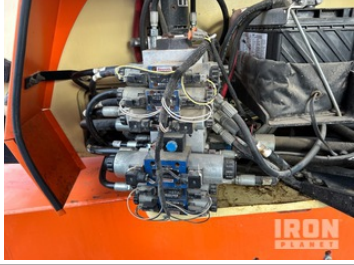
Valves	★★★★☆

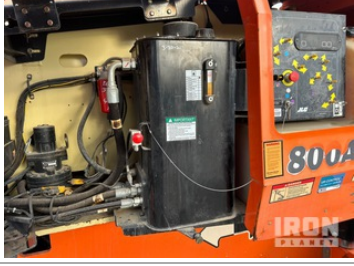
Hydraulic Tank	★★★★☆

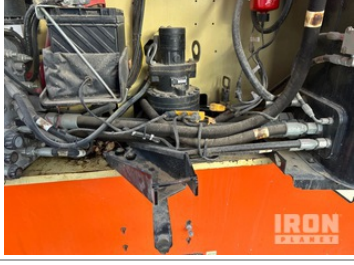
Hoses (Hydraulic)	★★★★☆

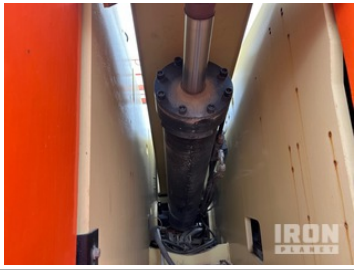
<p>Secondary Boom Cylinder</p>	<p>★★★★☆</p>

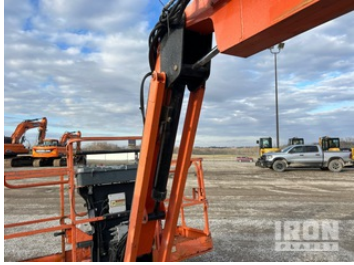
<p>Boom Extension Cylinder Jib Cylinder</p>	<p>★★★★☆ ★★★★☆</p>

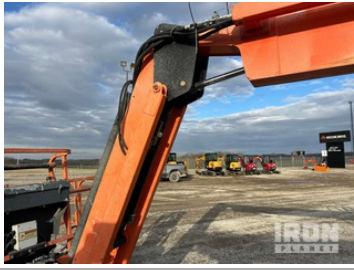
<p>Basket Tilt Cylinder</p>	<p>★★★★☆</p>

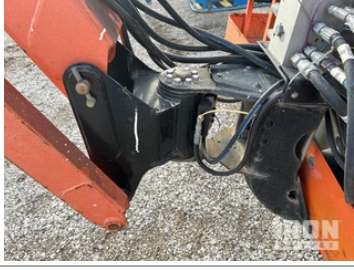
<p>Basket Rotator Motor</p>	<p>★★★★☆</p>

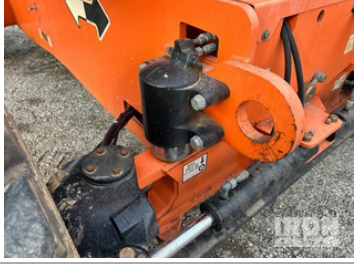
<p>Frame Leveling Cylinders</p>	<p>★★★★☆</p>

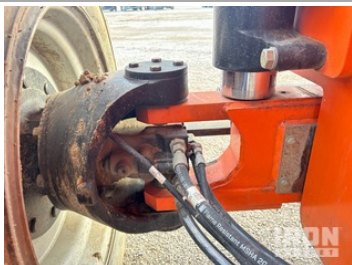
Steering Linkage	★★★★☆

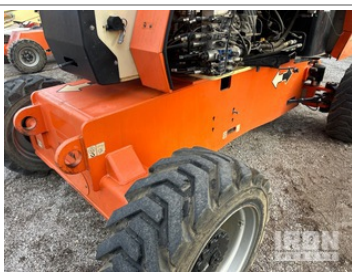
Frame Condition	★★★★☆

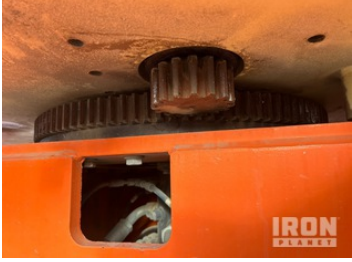
Turntable Bearing	★★★★☆

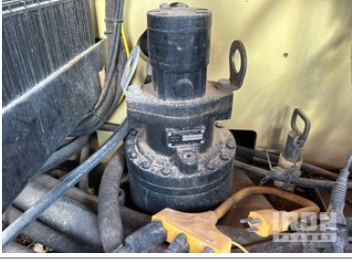
Swing Motor	★★★★☆

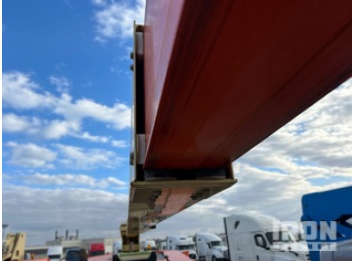
A photograph showing the right side of the boom of a JLG articulating boom lift. The boom is orange and white, extending horizontally. The background shows a clear sky with some clouds and other equipment in the distance.
Boom Wear Guides	★★★★☆

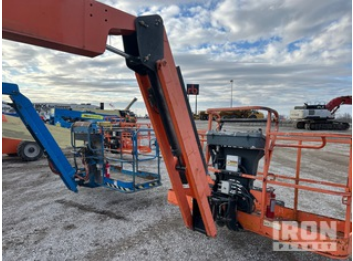
A close-up photograph of the boom wear guides on a JLG articulating boom lift. The boom is orange, and the wear guides are visible as a series of metal brackets along the bottom edge of the boom.
Jib Condition	★★★★☆
