## Item #14787074 - 2017 JLG 600S 4WD Diesel Telescopic Boom Lift

# Inspection Report

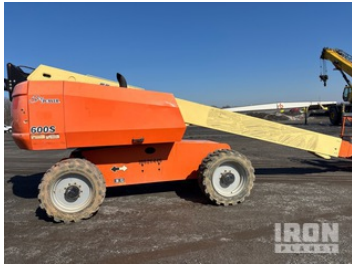
<p>Paint</p>	<p>No visible damage</p>

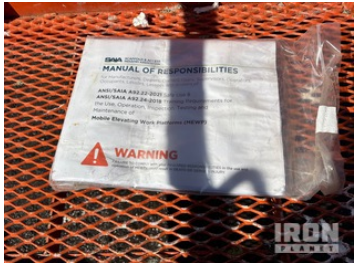
<b>Safety</b>		
<b>Item</b>	<b>Assessment</b>	<b>Photo</b>
Travel Alarm	Inoperable	
Horn	Inoperable	
Swing Brake	Operational	
Current Safety Manual	Yes	
Current Operator/Maintenance Manual	Yes	
ANSI Guidelines	Yes

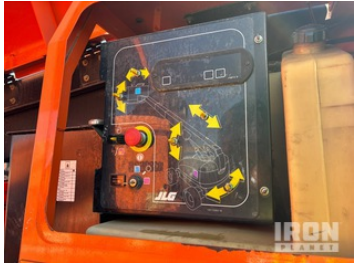
Control Station Ground		
Item	Assessment	Photo
Function Controls	★★★☆☆

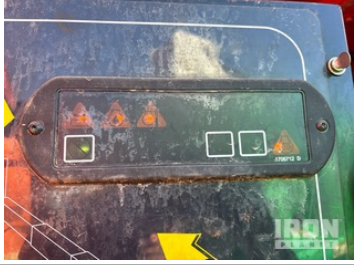
Oil Pressure	The fault indicator shuts off after the engine oil pressure rises.

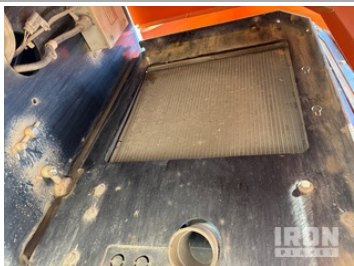
Radiator	★★★★☆

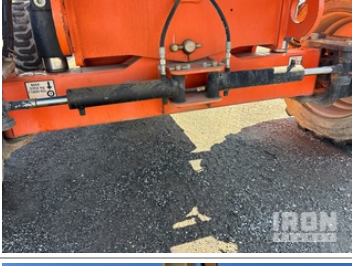
Steering Cylinders	★★★☆☆

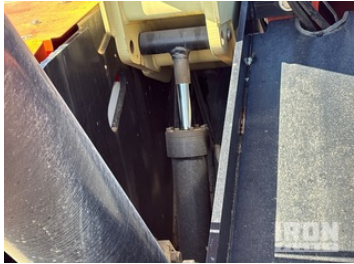
<p>Secondary Boom Cylinder</p>	<p>★★★★☆</p>

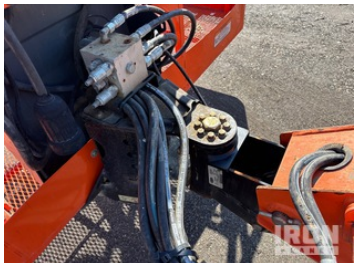
<p>Basket Rotator Motor</p>	<p>★★★★☆</p>

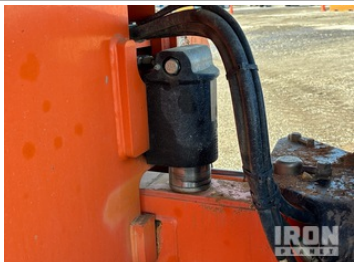
<p>Frame Leveling Cylinders</p>	<p>★★★★☆</p>

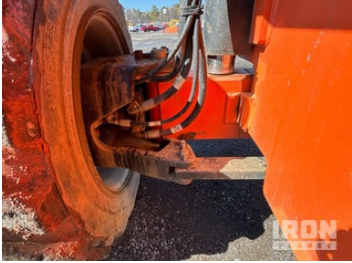
<b>Chassis</b>		
IronPlanet pin connection pivot point wear inspections are limited to sound, sight and feel observations. Dial indicator testing is not performed.		
<b>Item</b>	<b>Assessment</b>	<b>Photo</b>
Steering Linkage	★★★☆☆

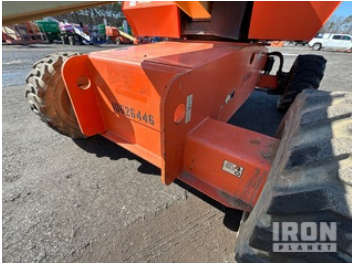
Frame Condition	★★★☆☆

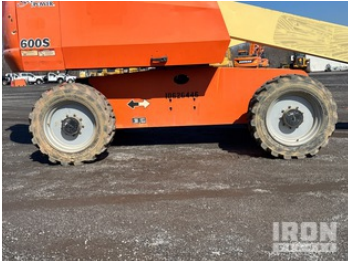
Wheel Condition	No visible damage or missing components

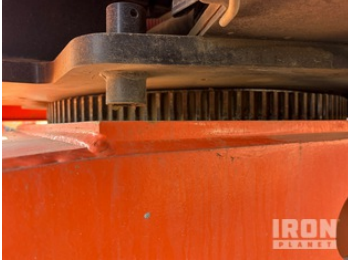
Turntable Bearing	★★★★☆

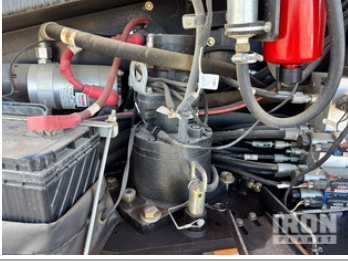
Swing Motor	★★★★☆

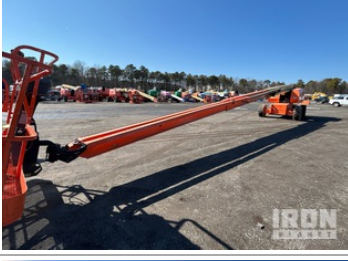
Boom Condition	★★★★☆

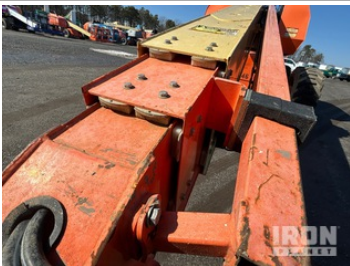
Boom Wear Guides	★★★★☆
