## Item #14786806 - 2017 JLG 8042 Telehandler

# Inspection Report

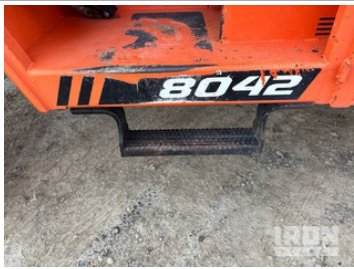
Steps	No visible damage or missing components

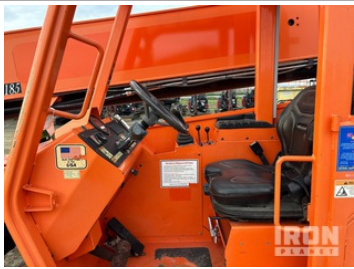
Hand Rails	No visible damage or missing components

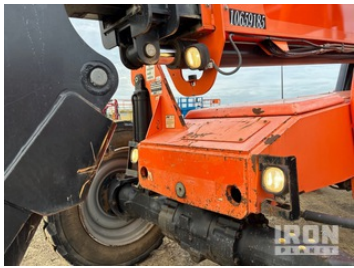
Exterior Lights	All lights operational

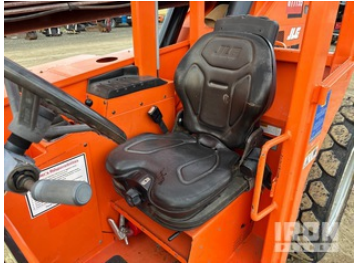
Control Station		
Item	Assessment	Photo
Seat/Armrests	No visible damage or missing components

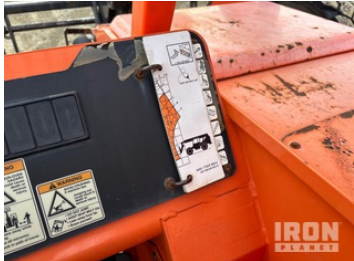
Load Charts	Chart book in cab

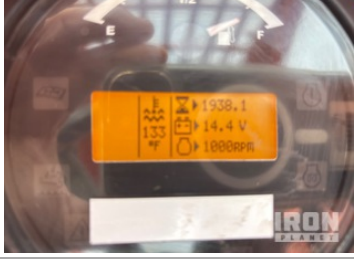
Hour Meter / Odometer	1938 hrs

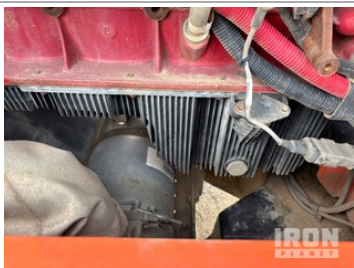
Oil Leaks	No dripping leaks

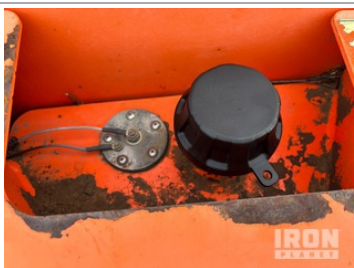
Fuel Leaks	No dripping leaks

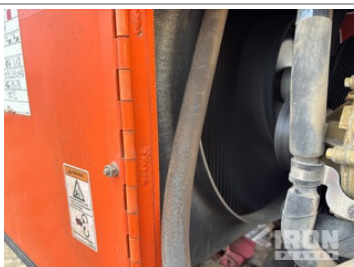
Cooling System Leaks	No dripping leaks

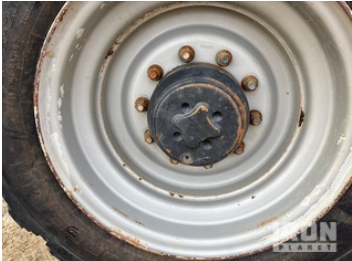
Final Drives	★★★★☆

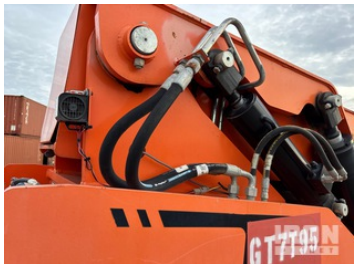
Hoses (Hydraulics)	★★★★☆

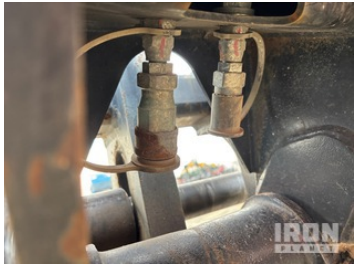
Auxiliary Hydraulic Plumbing	Not operationally checked, Front

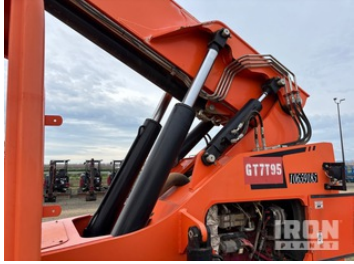
Boom Lift Cylinder(s)	★★★★☆

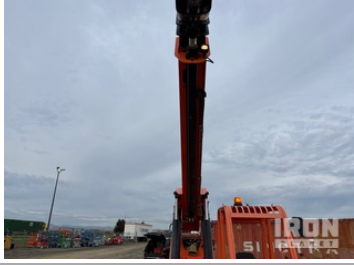
Telescopic Boom Cylinders	★★★★☆

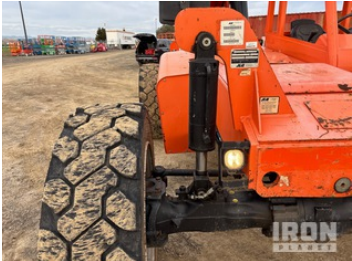
Frame Leveling Cylinders	★★★★☆

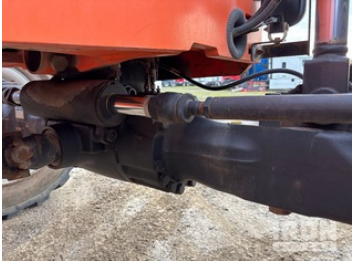
Steering Cylinders	★★★★☆

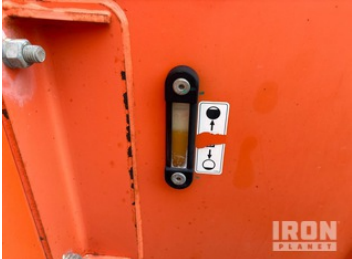
Limited Function Check	The hydraulic system was operational.	
Hydraulics #1

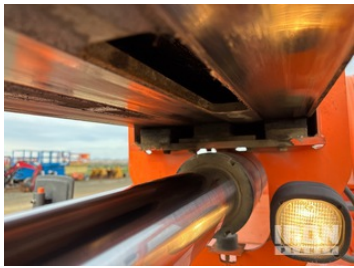
<b>Chassis</b>		
IronPlanet pin connection pivot point wear inspections are limited to sound, sight and feel observations. Dial indicator testing is not performed.		
<b>Item</b>	<b>Assessment</b>	<b>Photo</b>
Chassis #1

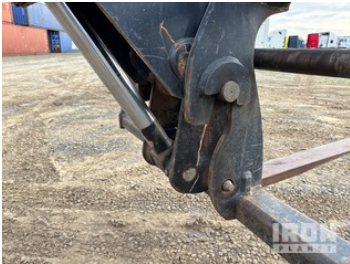
Loader Quick Coupler	★★★★☆ Operational
