Item #14855866 - 2016 SkyTrak 6042 Telehandler

Inspection Report

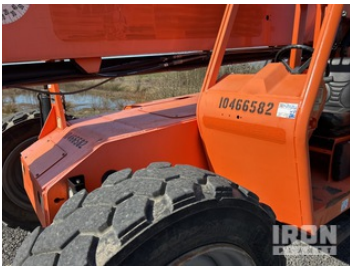
<p>Body Panels</p>	<p>No visible damage or missing components</p>

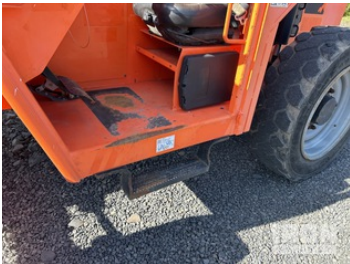
<p>Steps</p>	<p>No visible damage or missing components</p>

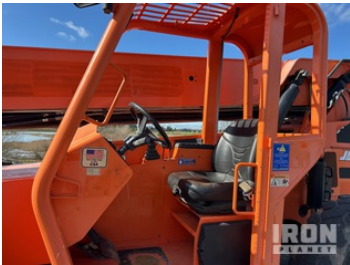
<p>Hand Rails</p>	<p>No visible damage or missing components</p>

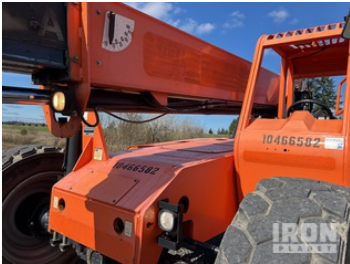
<p>Exterior Lights</p>	<p>All lights operational</p>

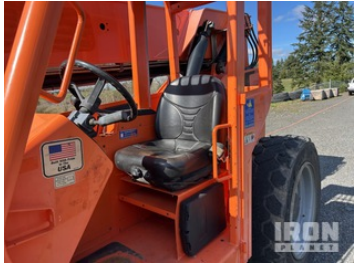
Control Station		
Item	Assessment	Photo
Seat/Armrests	No visible damage or missing components

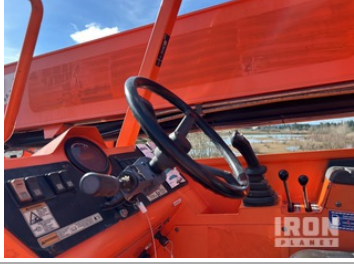
Steering Control	★★★★☆

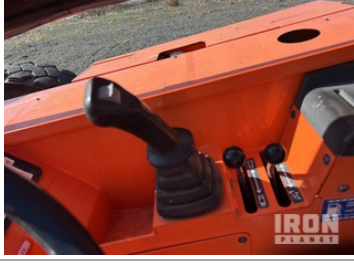
Hydraulic Controls	★★★★☆

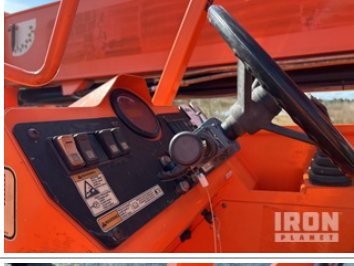
Drivetrain Controls	★★★★☆

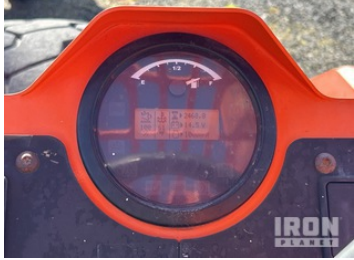
Warning Lights	Operational

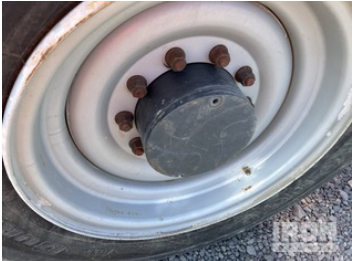
Final Drives	★★★★☆

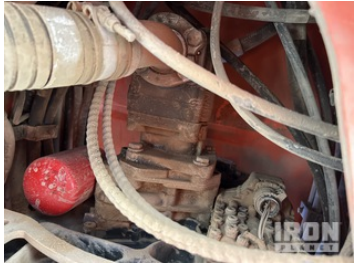
Hydraulics		
Item	Assessment	Photo
Pumps (Hydraulics)	★★★★☆

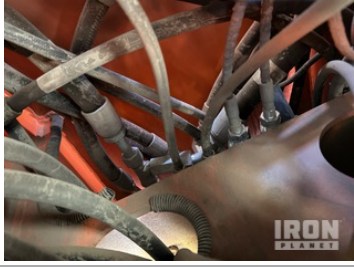
Valves	★★★★☆

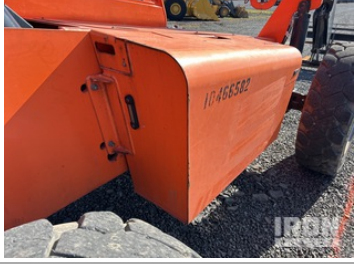
Hydraulic Tank	★★★★☆

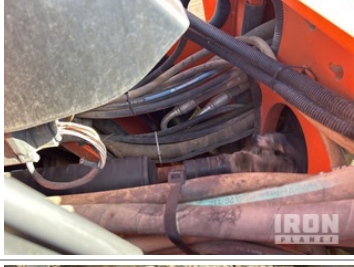
Hoses (Hydraulics)	★★★★☆

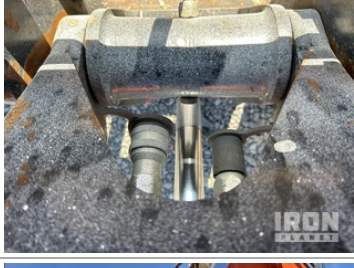
Auxiliary Hydraulic Plumbing	Not operationally checked, Front

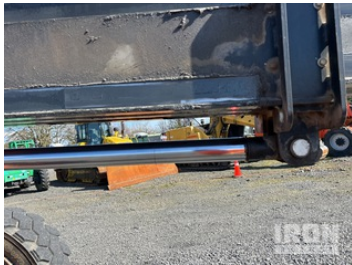
Telescopic Boom Cylinders	★★★★☆

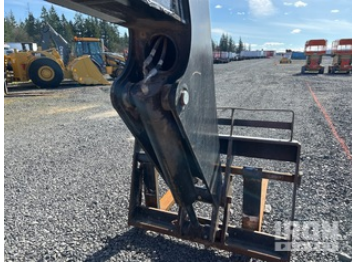
Carriage Tilt Cylinder	★★★★☆

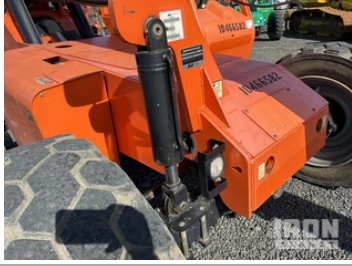
Frame Leveling Cylinders	★★★★☆

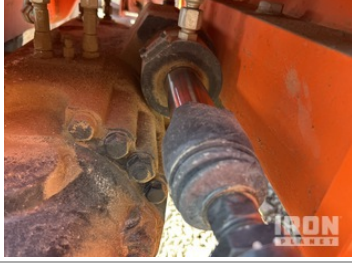
Steering Cylinders	★★★★☆

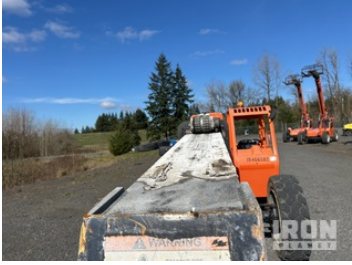
Chassis		
IronPlanet pin connection pivot point wear inspections are limited to sound, sight and feel observations. Dial indicator testing is not performed.		
Item	Assessment	Photo
Boom Condition	★★★★☆

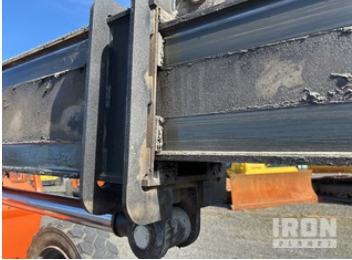
Boom Wear Guides	★★★★☆

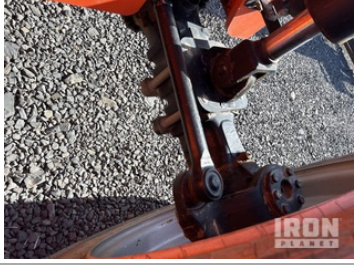
Telehandler*		
IronPlanet pin connection pivot point wear inspections are limited to sound, sight and feel observations. Dial indicator testing is not performed.		
Item	Assessment	Photo
Steering Linkage	★★★☆☆

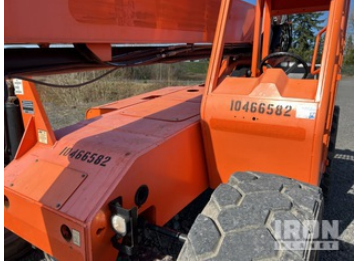
Frame Condition	★★★☆☆

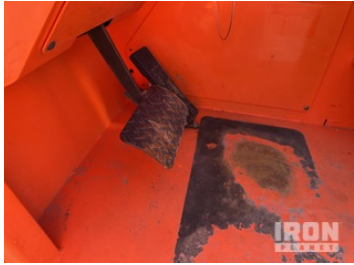
Limited Function Check	The main chassis components functioned during a limited check.	
Brake Control	★★★☆☆

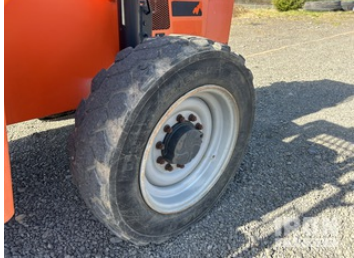
Left Rear Tire	Size: 370/75-28 Brand: Firestone Model: DuraForce Tread Depth: 16/32

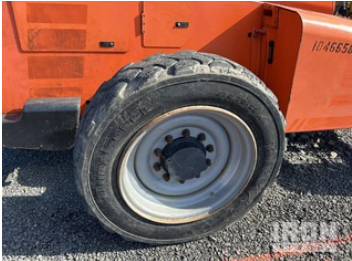
<p>Right Rear Tire</p>	<p>Size: 370/75-28 Brand: Firestone Model: DuraForce Tread Depth: 16/32</p>

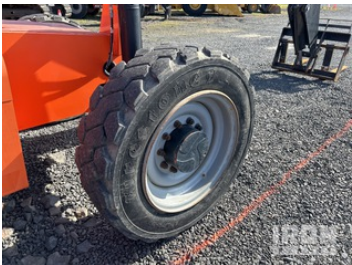
<p>Right Front Tire</p>	<p>Size: 370/75-28 Brand: Firestone Model: DuraForce Tread Depth: 20/32</p>

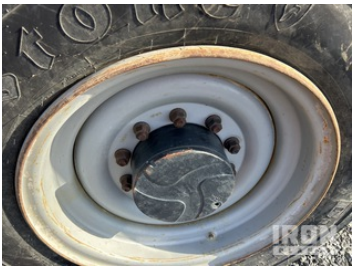
<p>Wheel Condition</p>	<p>No visible damage or missing components</p>

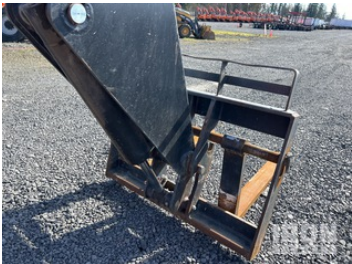
<p>Loader Quick Coupler</p>	<p>★★★★☆ Operational</p>

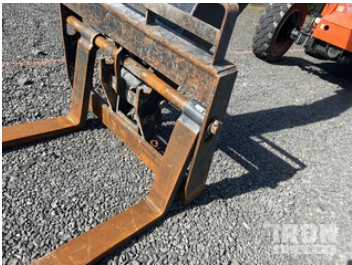
<p>Load Back Rest</p>	<p>★★★★☆</p>

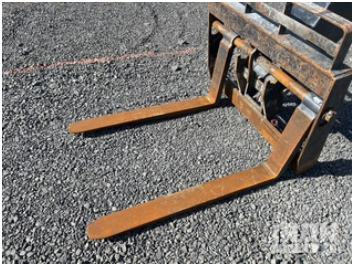
<p>Forks</p>	<p>★★★★☆</p>
