## Item #14787005 - 2017 JLG 600S 4WD Diesel Telescopic Boom Lift

- Features: 60 ft Max Platform Height, 1000 lb Max Weight Capacity, Power to Platform, Onboard Generator, 2017 US EPA Label, Deutz TD 2.9 L4 4 Cylinder 67 hp 2.925 L Diesel Engine, 39x15-22.5 Foam-Filled Tires
- Meter Reading: 4,476 Hours
- Serial # : 300230369
- Inspection Completed: 3/11/26

# Inspection Report

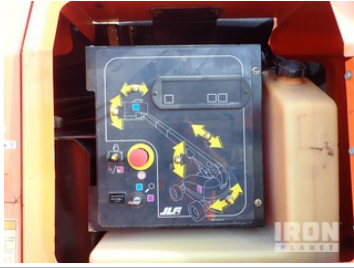
<b>Control Station Ground</b>		
<b>Item</b>	<b>Assessment</b>	<b>Photo</b>
Function Controls	★★★☆☆

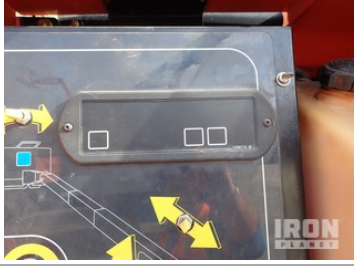
Oil Pressure	The fault indicator shuts off after the engine oil pressure rises.

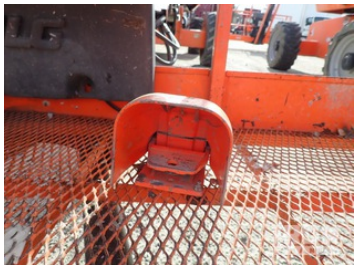
Safety Control Hand/Foot Switch	★★★★☆ Operational

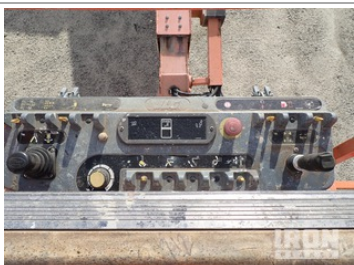
Function Controls	★★★★☆

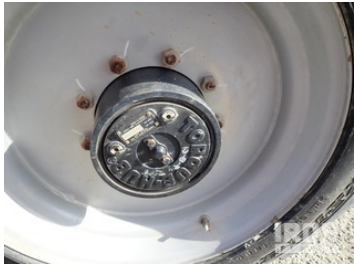
<b>Drivetrain</b>		
Operational test is limited to low speed in a confined flat area without load. Differential interlocks, full transmission shifting and functionality of all drive axles cannot be fully verified. Inspector listens for abnormal noises, observes leaks and notes physical damage.		
<b>Item</b>	<b>Assessment</b>	<b>Photo</b>
Left Front Final Drive	★★★★☆

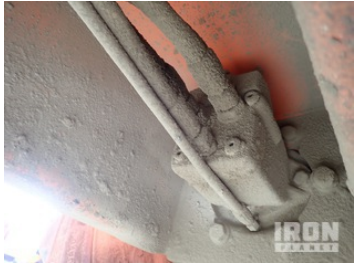
Left Front Drive Motor	★★★★☆

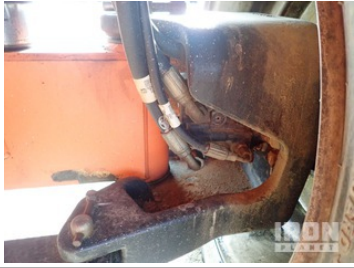
Left Rear Drive Motor	★★★★☆

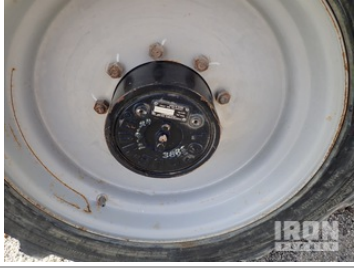
Right Rear Final Drive	★★★★☆

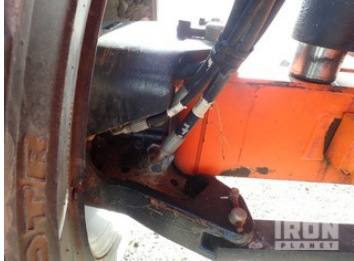
Right Rear Drive Motor	★★★★☆

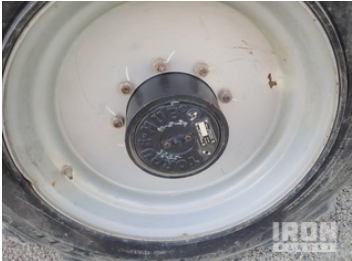
Right Front Final Drive	★★★★☆

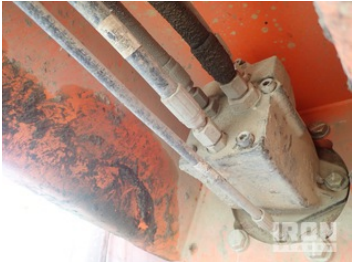
Right Front Drive Motor	★★★★☆

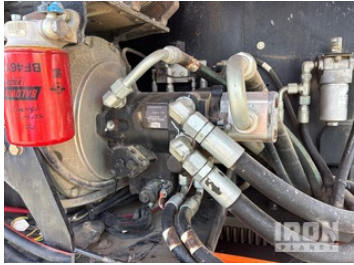
Hydraulics		
See photos for condition		
Item	Assessment	Photo
Pumps (Hydraulics)	★★★★☆

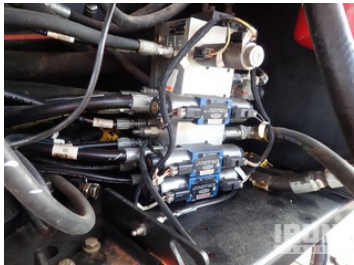
Valves	★★★★☆

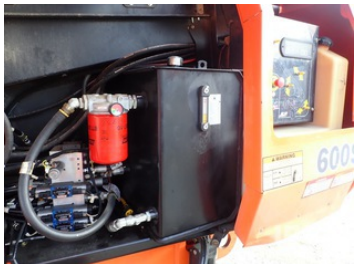
Hydraulic Tank	★★★★☆

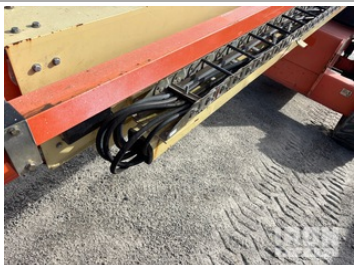
Hoses (Hydraulic)	★★★★☆

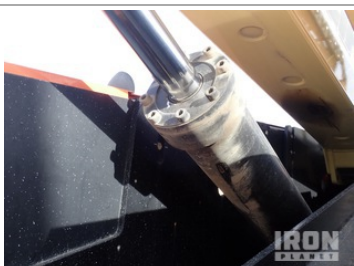
Boom Lift Cylinder	★★★★☆

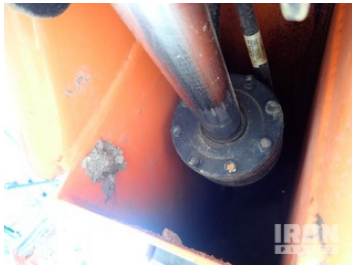
Basket Tilt Cylinder	★★★★☆

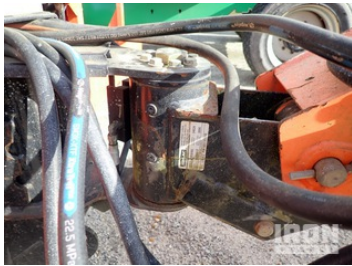
Basket Rotator Motor	★★★★☆

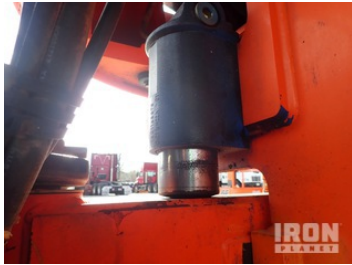
Frame Leveling Cylinders	★★★★☆

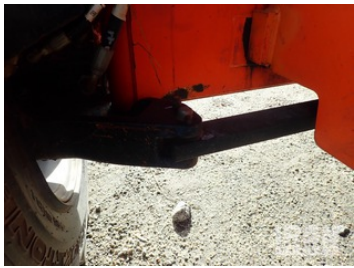
<b>Chassis</b>		
IronPlanet pin connection pivot point wear inspections are limited to sound, sight and feel observations. Dial indicator testing is not performed.		
<b>Item</b>	<b>Assessment</b>	<b>Photo</b>
Steering Linkage	★ ★ ★ ☆

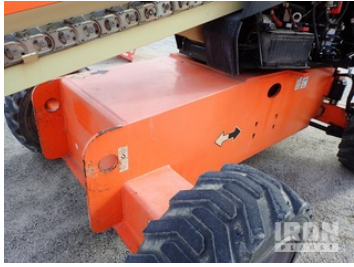
Frame Condition	★ ★ ★ ☆

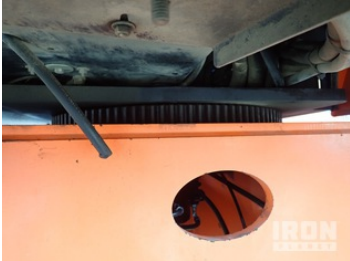
Turntable Bearing	★★★★☆

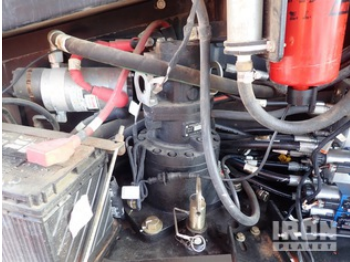
Swing Motor	★★★★☆

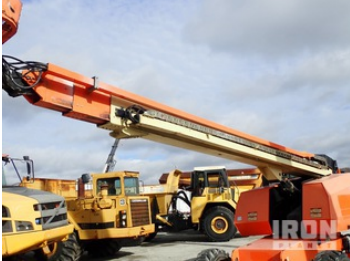
Boom Condition	★★★★☆
