Item #15029341 - 2019 JLG 4069LE Electric Scissor Lift

Inspection Report

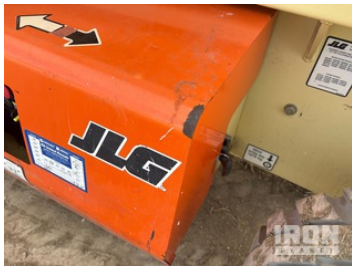
<p>Paint</p>	<p>No visible damage</p>

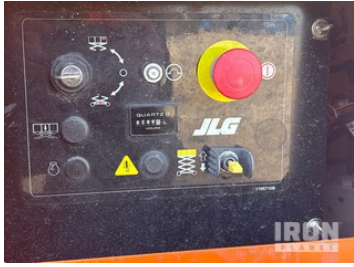
Control Station Ground		
Item	Assessment	Photo
Gauges	Operational

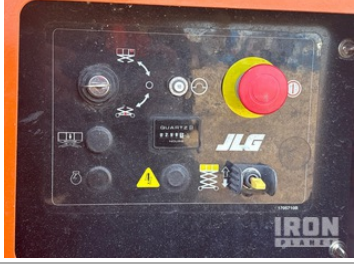
Warning Lights	Operational

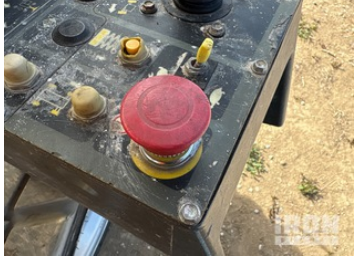
Emergency Shut Off Switch	Operational

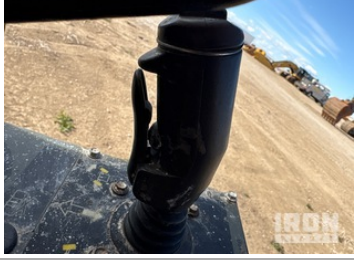
Safety Control Hand/Foot Switch	★★☆☆ Operational

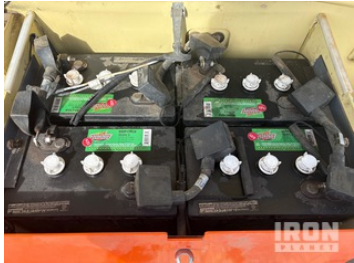
Electrical Operating System		
Item	Assessment	Photo
Operating Voltage	48 Volts	
Battery Condition	Functioned during the inspection	
Cables and Connections	No visible damage or missing components

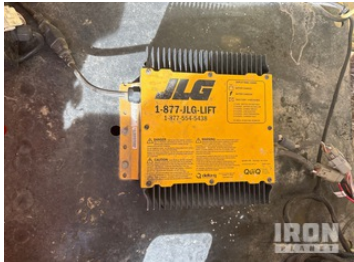
Battery Charger	Appears normal - Not operationally checked, 100-240 Volt, Single Phase

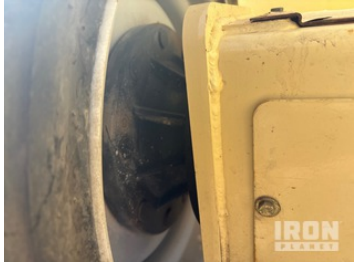
Drivetrain		
Operational test is limited to low speed in a confined flat area without load. Differential interlocks, full transmission shifting and functionality of all drive axles cannot be fully verified. Inspector listens for abnormal noises, observes leaks and notes physical damage.		
Item	Assessment	Photo
Drive Motors	★★★☆☆

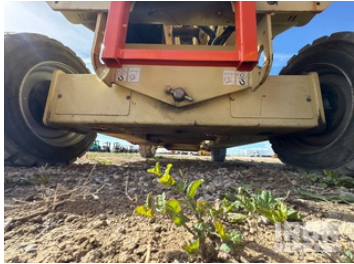
Front Drive Axle	★★★☆☆

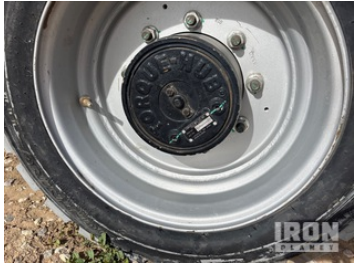
Final Drives	★★★☆☆

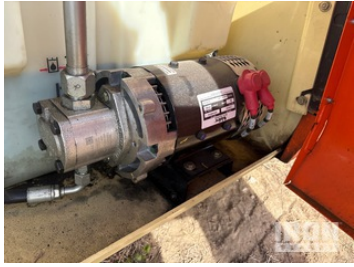
Hydraulics		
Item	Assessment	Photo
Pumps (Hydraulics)	★★★★☆

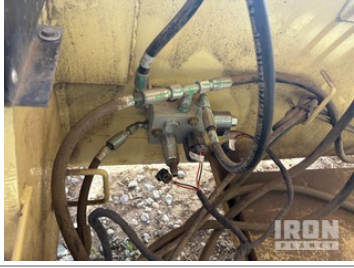
Valves	★★★★☆

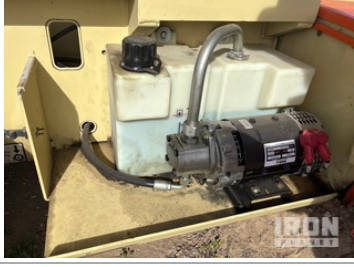
Hydraulic Tank	★★★★☆

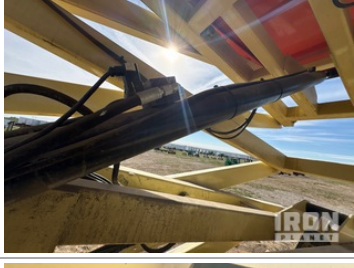
Lift Cylinders	★★★★☆

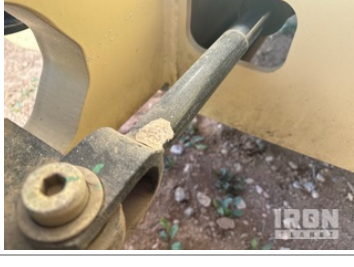
Steering Cylinder	★★★★☆

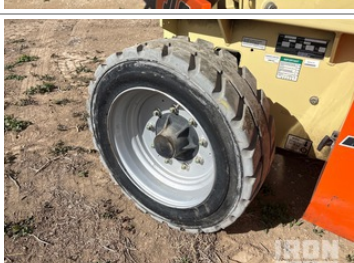
Left Front Tire	No visible defects

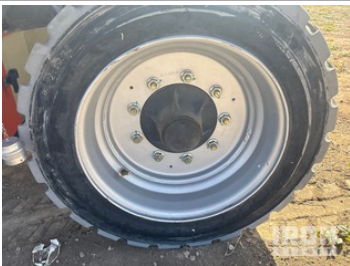
Wheel Condition	No visible damage or missing components
