Item #15111381 - 2017 Skyjack SJ45T 4WD Diesel Telescopic Boom Lift

Inspection Report

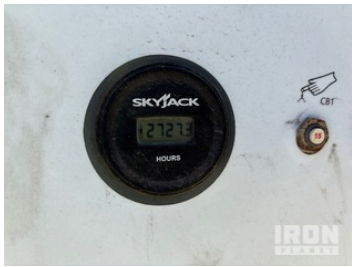
CE Mark	No CE mark found	
Hour Meter / Odometer	2727 hrs

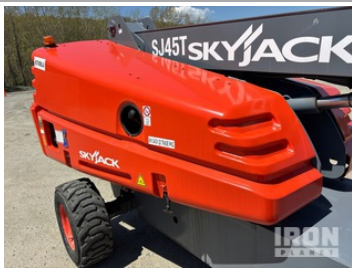
Paint	No visible damage

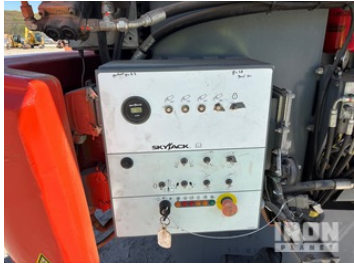
Control Station Ground		
Item	Assessment	Photo
Function Controls	★ ★ ★ ☆

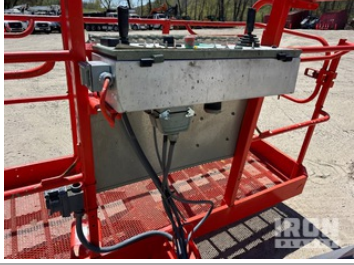
Control Station		
Pin connection pivot point wear inspections are limited to sound, sight and feel observations. Dial indicator testing is not performed.		
Item	Assessment	Photo
Control Console	No visible damage or missing components

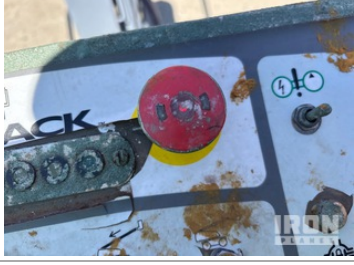
Emergency Shut Off Switch	Operational

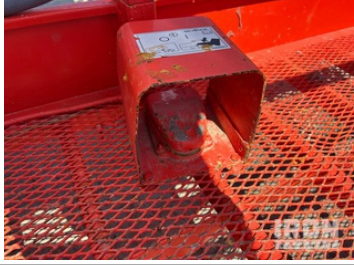
Safety Control Hand/Foot Switch	★★★★☆ Operational

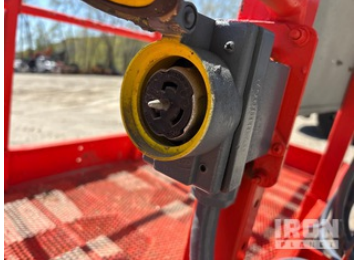
Engine Warning Lights	Operational	
Limited Function Check	The main components are in place and operational as noted. Glow-plug switch must be pressed in order to start.	
Control Station #1

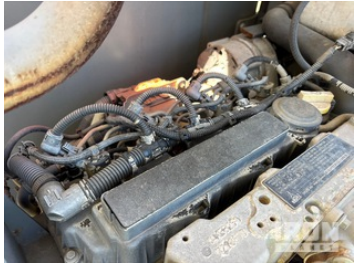
Blow-by (subjective visual observation)	No noticeable vapor or pressure	
Starter	Operational	
Fuel System	Operational

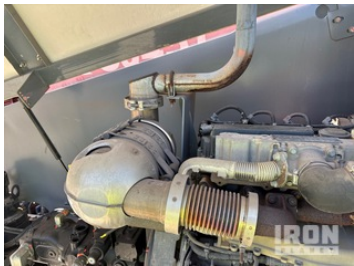
Exhaust System	No visible damage or missing components

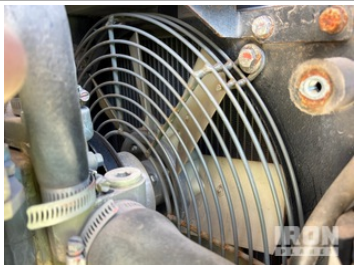
Radiator	★★★★☆

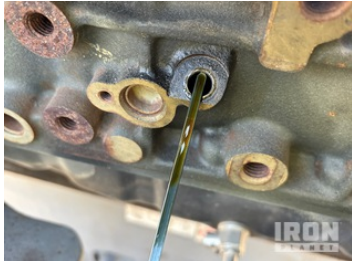
Oil Leaks	No dripping leaks

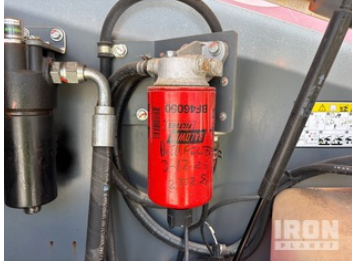
Fuel Leaks	No dripping leaks

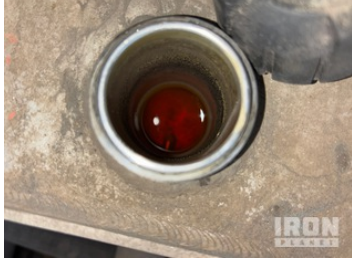
Cooling System Leaks	No dripping leaks

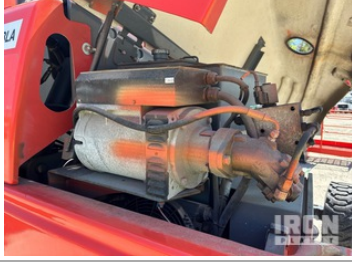
Onboard Generator	Operational

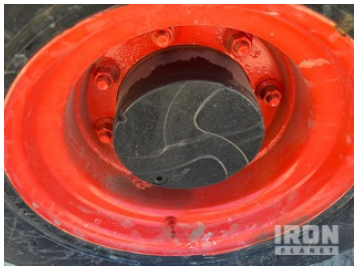
Drivetrain		
Operational test is limited to low speed in a confined flat area without load. Differential interlocks, full transmission shifting and functionality of all drive axles cannot be fully verified. Inspector listens for abnormal noises, observes leaks and notes physical damage.		
Item	Assessment	Photo
Left Front Final Drive	★★★☆☆

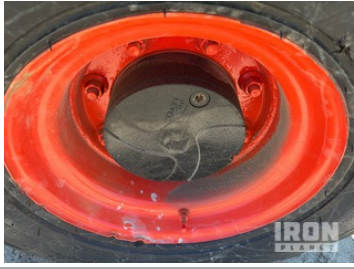
Left Rear Final Drive	★★★☆☆

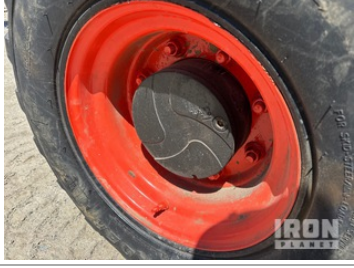
Right Rear Final Drive	★★★☆☆

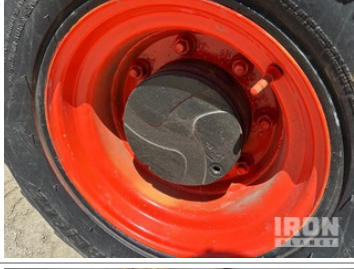
Right Front Final Drive	★★★☆☆

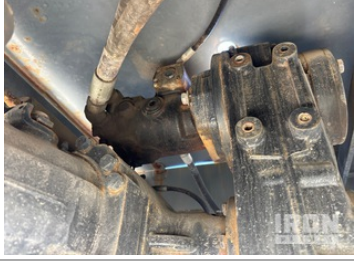
Rear Center Drive Motor	★★★☆☆

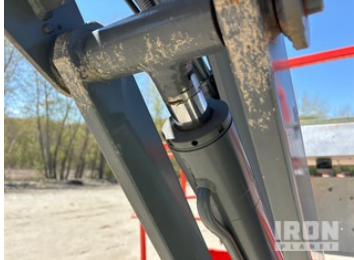
<p>Boom Extension Cylinder</p> <p>Jib Cylinder</p>	<p>★★★★☆</p> <p>★★★★☆</p>

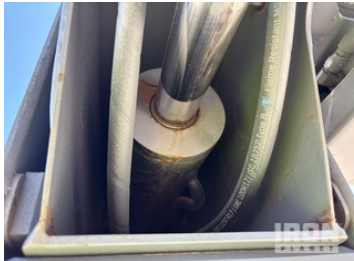
<p>Basket Tilt Cylinder</p>	<p>★★★★☆</p>

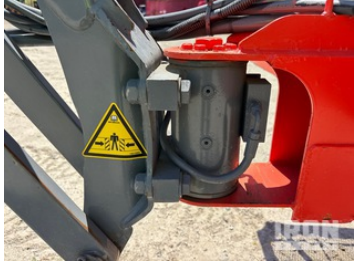
<p>Basket Rotator Motor</p>	<p>★★★★☆</p>

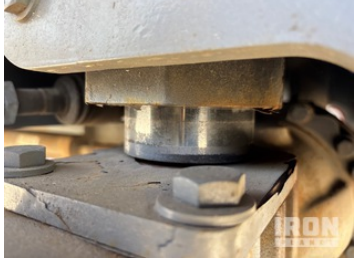
<p>Frame Leveling Cylinders</p>	<p>★★★★☆</p>

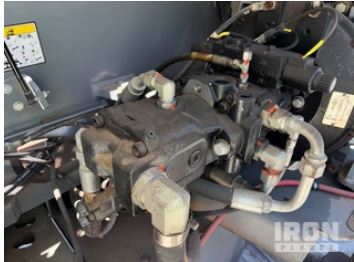
<p>Limited Function Check</p>	<p>The hydraulic system was operational.</p>	
<p>Hydraulics #1</p>

Hydraulics		
See photos for condition		
Item	Assessment	Photo
Pumps (Hydraulics)	★ ★ ☆ ☆ Dripping leak	 
Valves	★ ★ ★ ☆	 
Hydraulic Tank	★ ★ ★ ☆	 
Hoses (Hydraulic)	★ ★ ★ ☆	 
Steering Cylinders	★ ★ ★ ☆	 
Boom Lift Cylinder	★ ★ ★ ☆

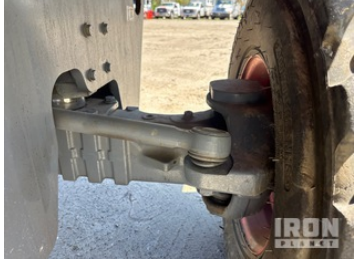
Chassis		
IronPlanet pin connection pivot point wear inspections are limited to sound, sight and feel observations. Dial indicator testing is not performed.		
Item	Assessment	Photo
Steering Linkage	☆☆☆☆

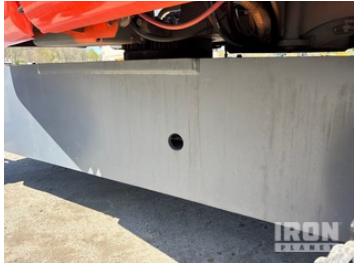
Frame Condition	☆☆☆☆

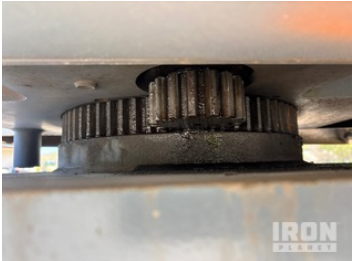
Turntable Bearing	★★★★☆

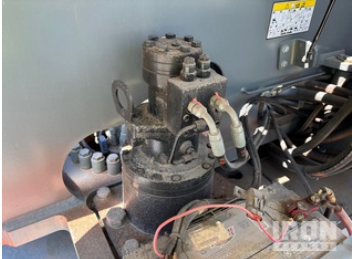
Swing Motor	★★★★☆

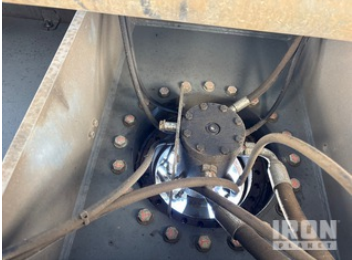
Hydraulic Center Swivel	★★★★☆

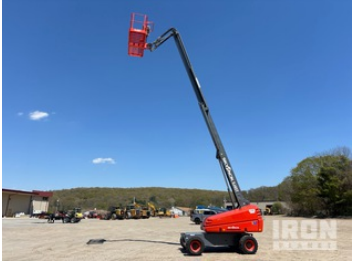
Boom Condition	★★★★☆

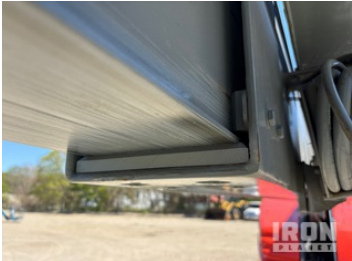
Boom Wear Guides	☆☆☆☆

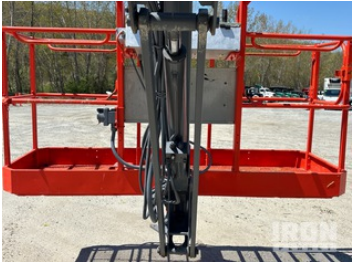
Jib Condition	☆☆☆☆
