## Item #15110976 - 2018 JLG 600S 4WD Diesel Telescopic Boom Lift

# Inspection Report

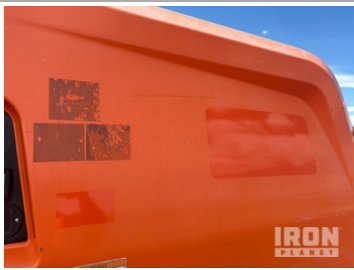
Paint	No visible damage

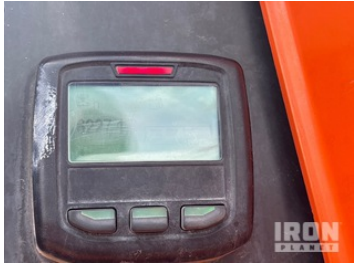
Control Station Ground		
Item	Assessment	Photo
Gauges	Operational

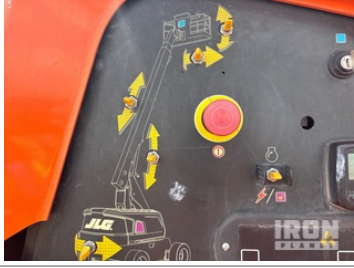
Function Controls	★★★★☆

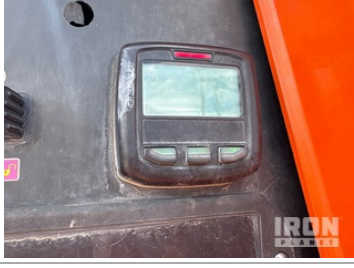
Oil Pressure	The gauge registers in the operating range.

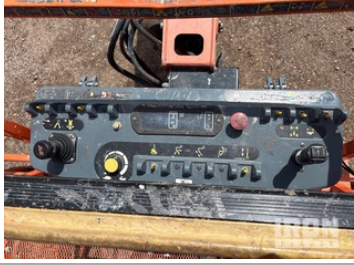
<b>Control Station</b>		
Pin connection pivot point wear inspections are limited to sound, sight and feel observations. Dial indicator testing is not performed.		
<b>Item</b>	<b>Assessment</b>	<b>Photo</b>
Control Console	No visible damage or missing components

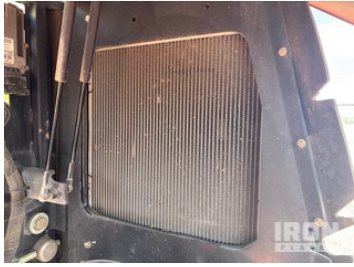
Radiator	★★★★☆

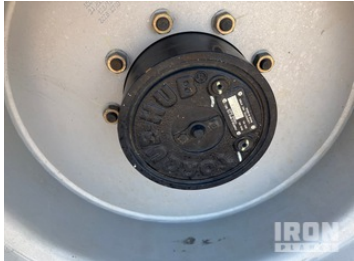
Right Front Final Drive	★★★★☆

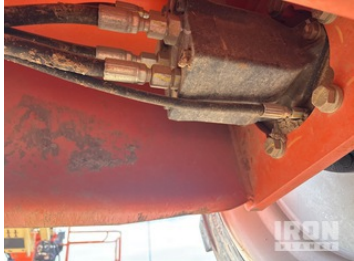
Right Front Drive Motor	★★★★☆

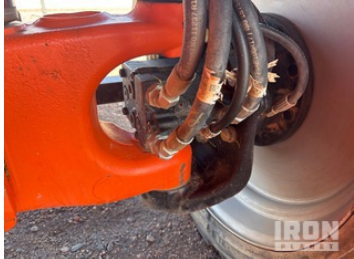
<b>Hydraulics</b>		
See photos for condition		
<b>Item</b>	<b>Assessment</b>	<b>Photo</b>
Pumps (Hydraulics)	★ ★ ★ ☆

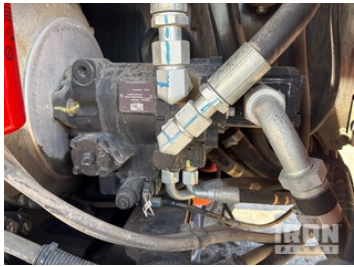
Valves	★ ★ ★ ☆

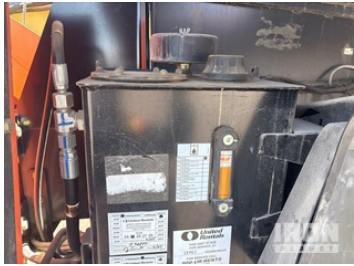
Hoses (Hydraulic)	★ ★ ★ ☆

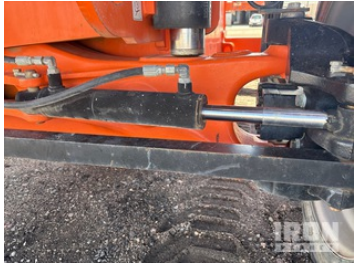
Boom Lift Cylinder	★ ★ ★ ☆

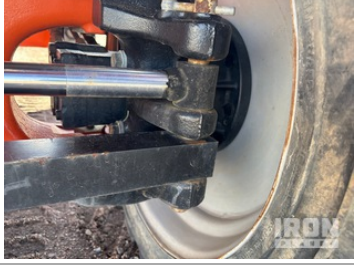
<b>Chassis</b>		
IronPlanet pin connection pivot point wear inspections are limited to sound, sight and feel observations. Dial indicator testing is not performed.		
<b>Item</b>	<b>Assessment</b>	<b>Photo</b>
Steering Linkage	★★★☆☆

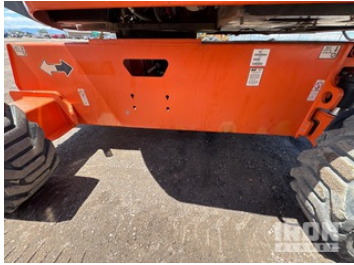
Frame Condition	★★★☆☆

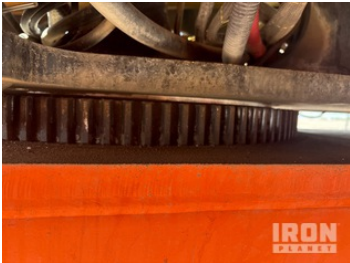
Turntable Bearing	★★★★☆

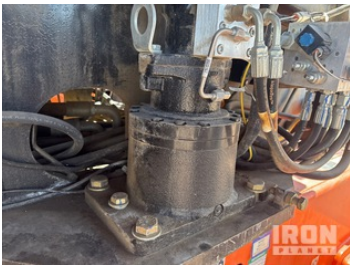
Swing Motor	★★★★☆

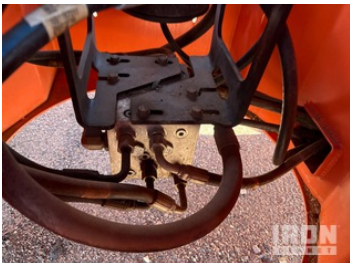
Hydraulic Center Swivel	★★★★☆

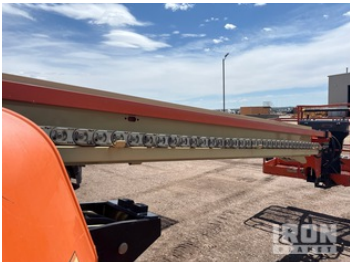
Boom Condition	★★★★☆

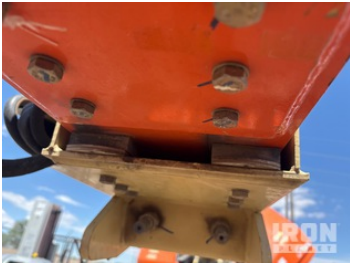
Boom Wear Guides	★★★★☆
