### Item #15110212 - 2018 JLG 1043 Telehandler

# Inspection Report

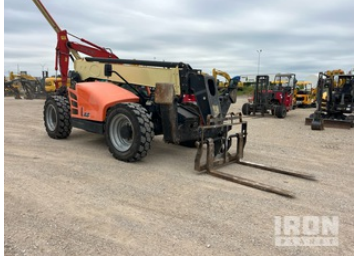
Picture, Right Front Corner

<p>Serial Number / VIN</p>	<p>0160089840</p>	 
<p>CE Mark</p>	<p>No CE mark found</p>	
<p>Paint</p>	<p>Damaged</p>	 
<p>Body Panels</p>	<p>Engine cover damaged</p>	 
<p>Fenders</p>	<p>No visible damage or missing components.</p>	 
<p>Hand Rails</p>	<p>No visible damage or missing components</p>	 
<p>Exterior Lights</p>	<p>1 Inoperable / damaged / missing</p>	 
<p>General Appearance #1</p>

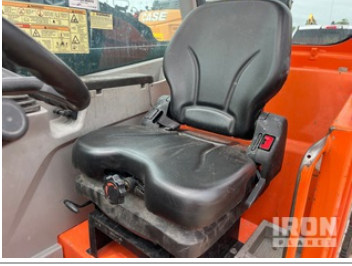
Seat/Armrests	No visible damage or missing components

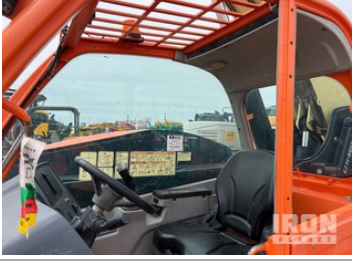
Glass	No visible damage or missing components

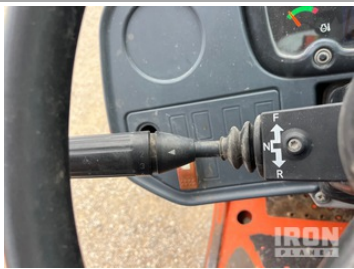
<p>Drivetrain Controls</p>	<p>★★★★☆</p>

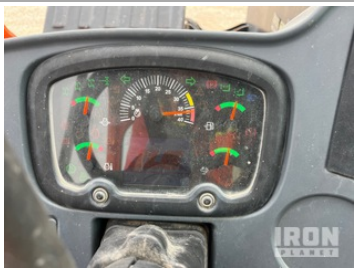
<p>Load Charts</p>	<p>None found</p>	
<p>Engine Oil Pressure</p>	<p>The fault indicator shuts off after the engine oil pressure rises.</p>	
<p>Warning Lights</p>	<p>Operational</p>

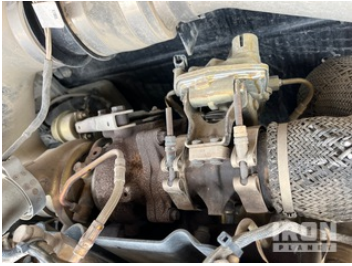
Blow-by (subjective visual observation)	Minor	
Starter	Operational	
Exhaust System	No visible damage or missing components

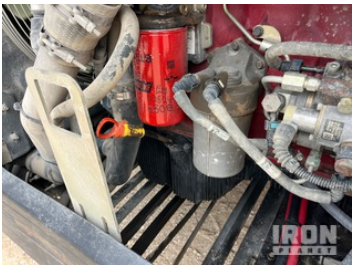
Oil Leaks	No dripping leaks

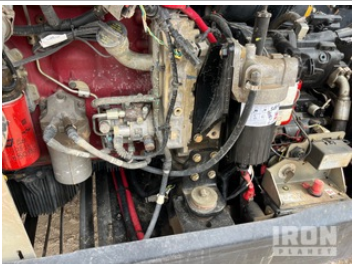
Fuel Leaks	No dripping leaks

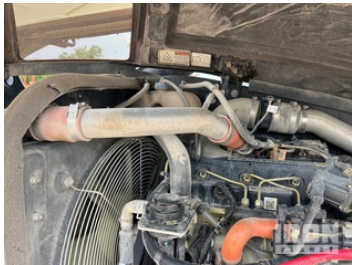
Cooling System Leaks	No dripping leaks

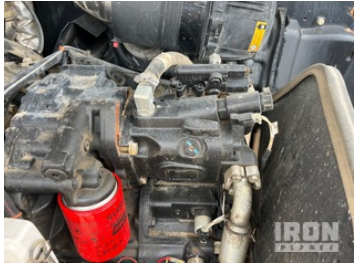
Hydraulics		
Item	Assessment	Photo
Pumps (Hydraulics)	★★★★☆

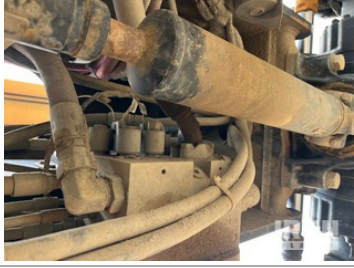
Valves	★★★★☆

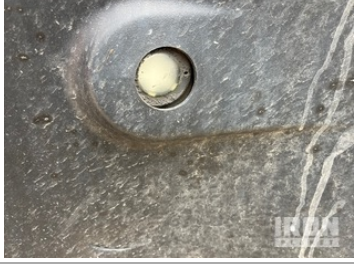
Hydraulic Tank	★★★★☆

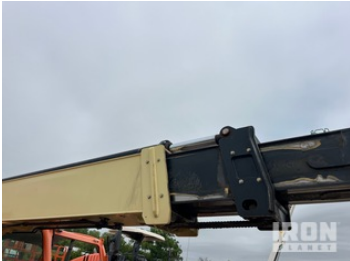
Telescopic Boom Cylinders	★★★★☆

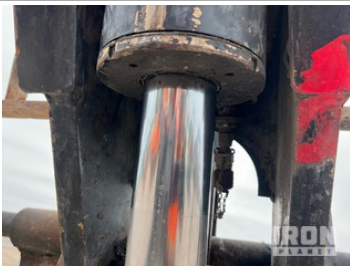
Carriage Tilt Cylinder	★★★★☆

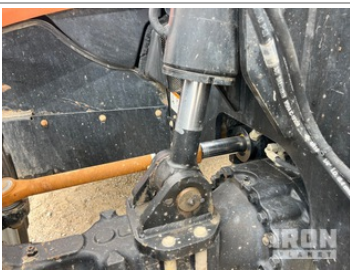
Frame Leveling Cylinders	★★★★☆

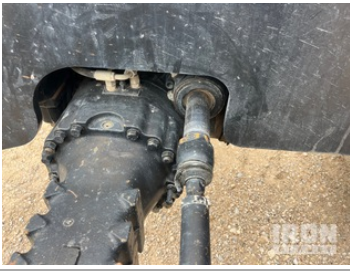
Steering Cylinders	★★★★☆

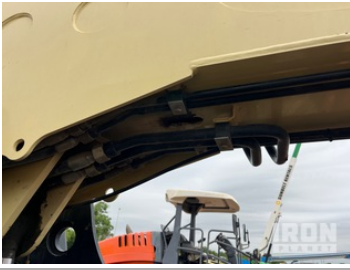
Limited Function Check	The hydraulic system was operational.	
Hydraulics #1

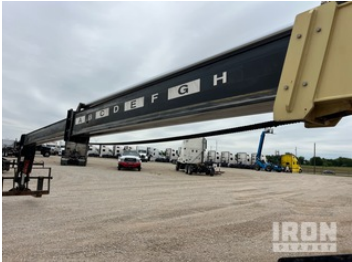
Chain / Tensioners	★★★★☆

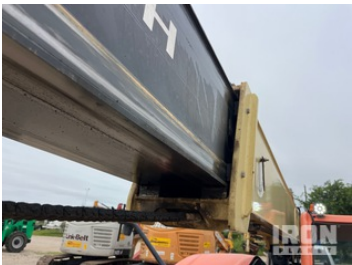
Boom Wear Guides	★★★★☆

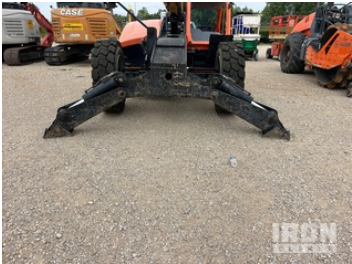
Outriggers	★★★★☆ Street pads

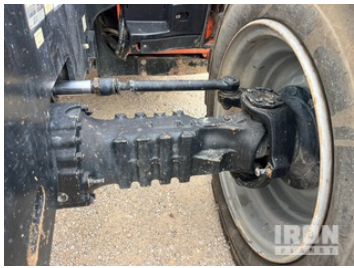
<b>Telehandler*</b>		
IronPlanet pin connection pivot point wear inspections are limited to sound, sight and feel observations. Dial indicator testing is not performed.		
<b>Item</b>	<b>Assessment</b>	<b>Photo</b>
Steering Linkage	★★★★☆

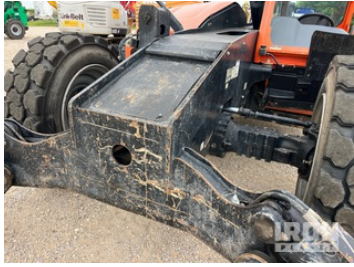
Frame Condition	★★★★☆

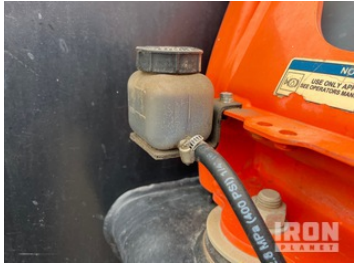
Limited Function Check	The main chassis components functioned during a limited check.	
Master Cylinder	★★★★☆

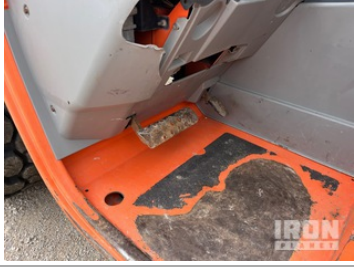
Brake Control	★★★★☆

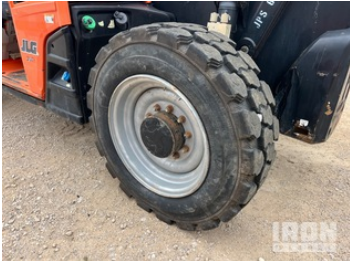
Left Rear Tire	Size: 400/75-28 Brand: OTR Model: LiftBoss Tread Depth: 36/32

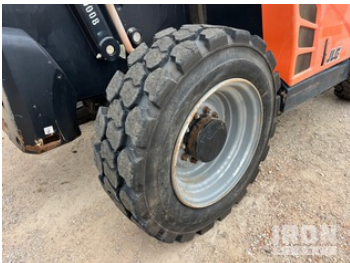
Right Rear Tire	Size: 400-75-28 Brand: OTR Model: LiftBoss Tread Depth: 33 /32

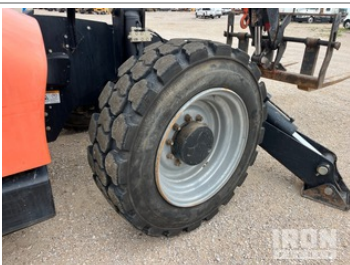
Right Front Tire	Size: 400-75-28 Brand: OTR Model: LiftBoss Tread Depth: 31 /32

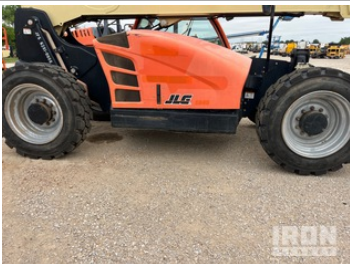
Wheel Condition	No visible damage or missing components
