Inspection Report (Mini Excavator)

Year	2006
Make	Neuson
Model	G - 2203 RD
Serial Number	AE00164
Hour Meter Reading	555.2
Previous Application (e.g., earth moving, mining, demolition, etc)	General construction (plumbing)

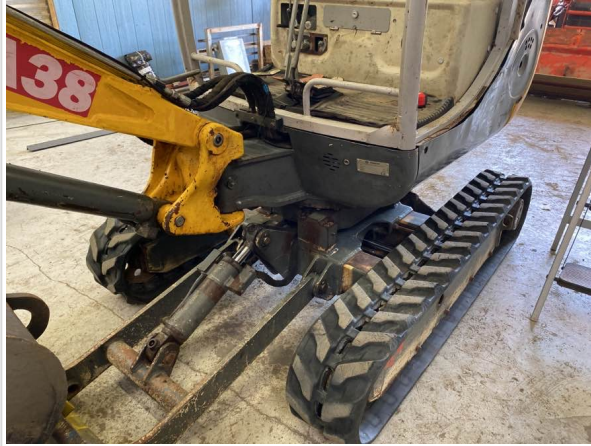
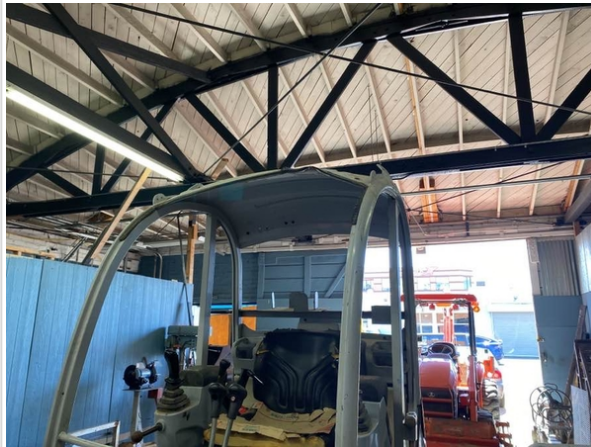
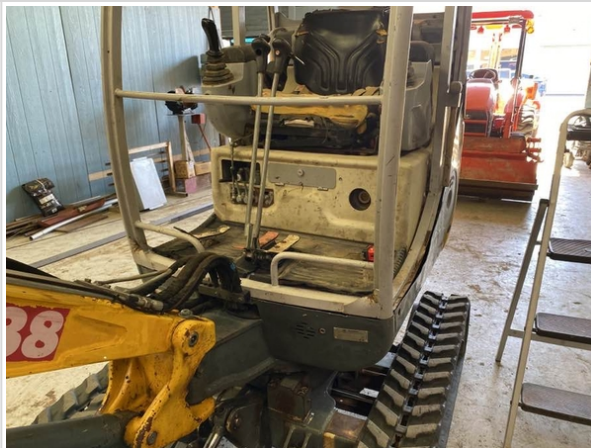
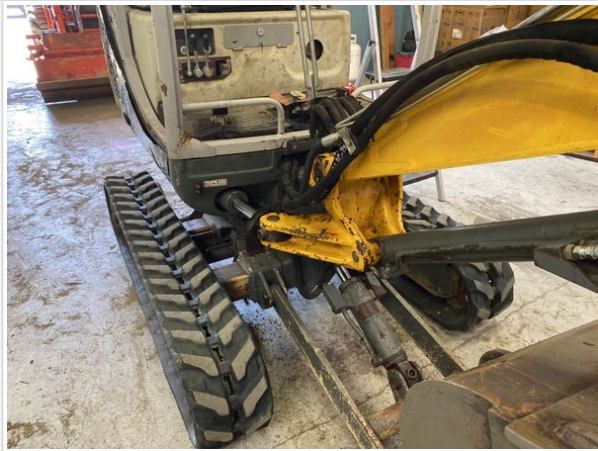
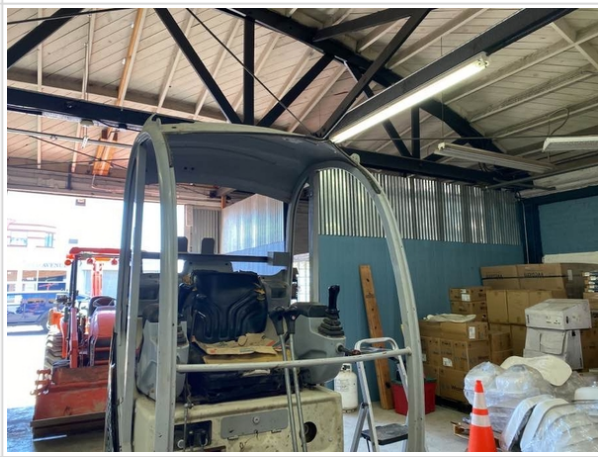
Front Photos

Front	3 - Normal Wear & Tear
Front Condition	Visible chipped paint or dents, Other (see comments)

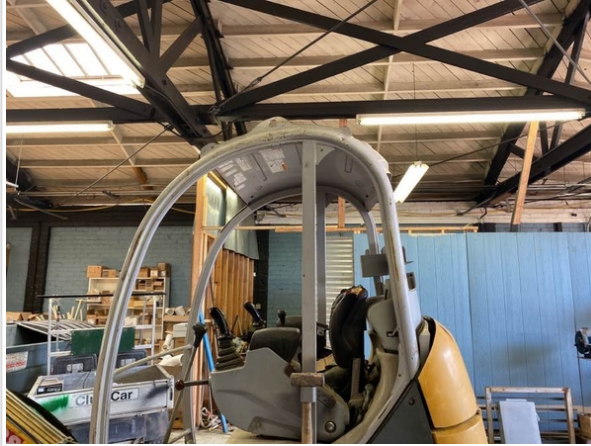
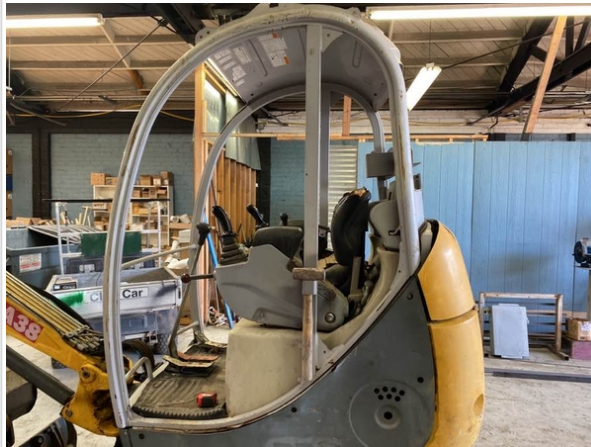
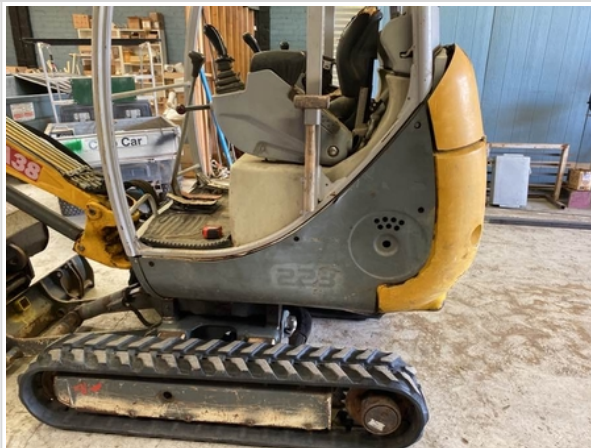
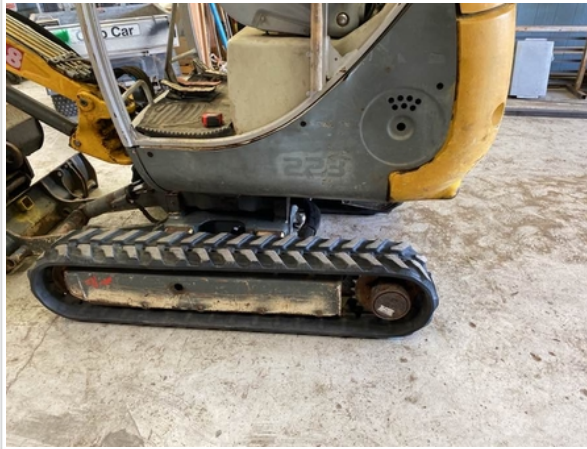
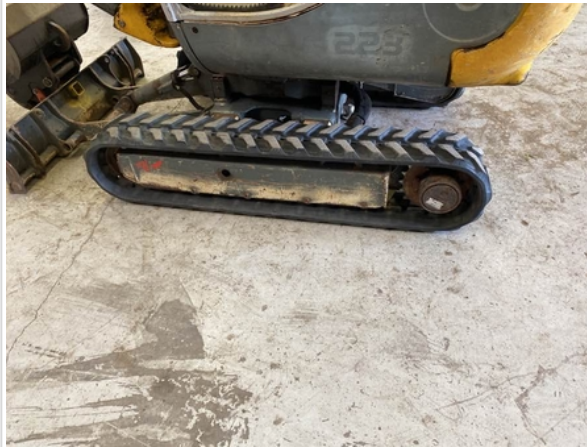
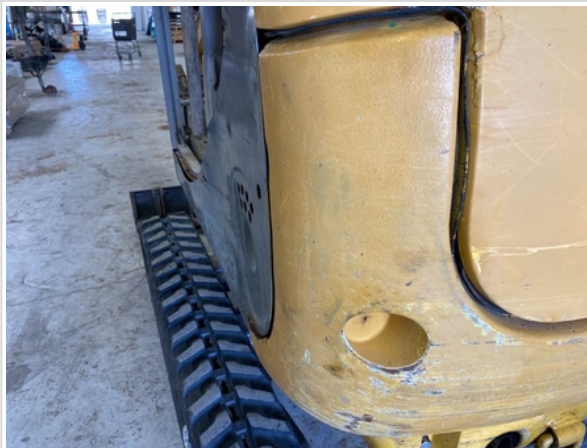
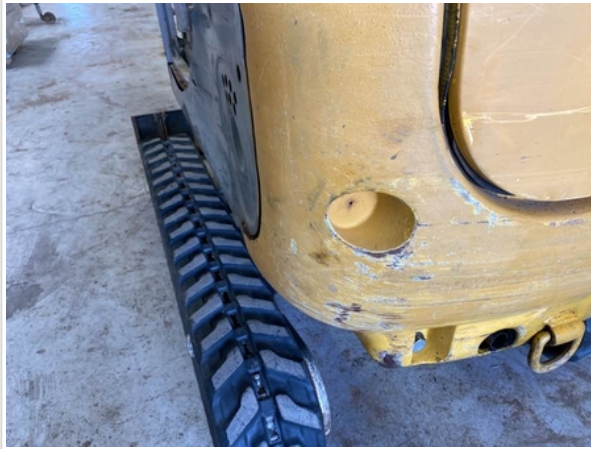
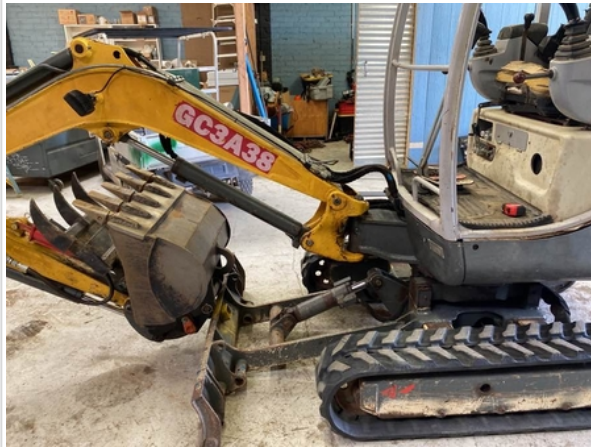
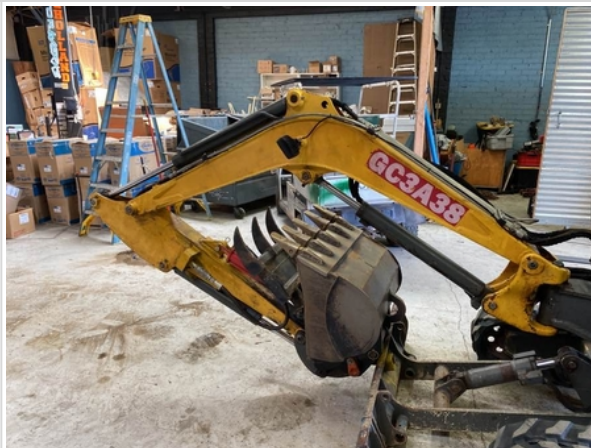
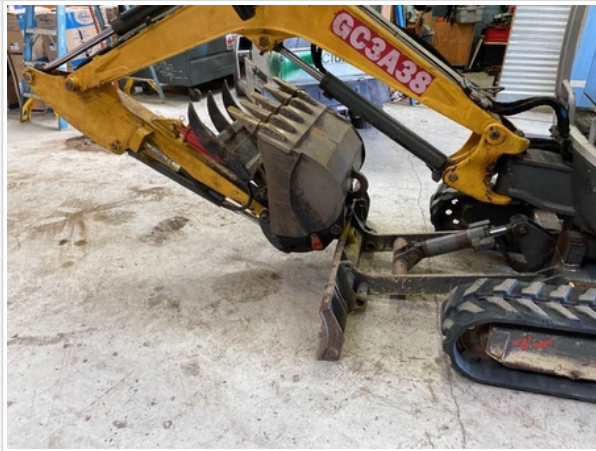
Left Photos

Left	3 - Normal Wear & Tear
Left Condition	Visible chipped paint or dents, Other (see comments)
Comments	Normal wear

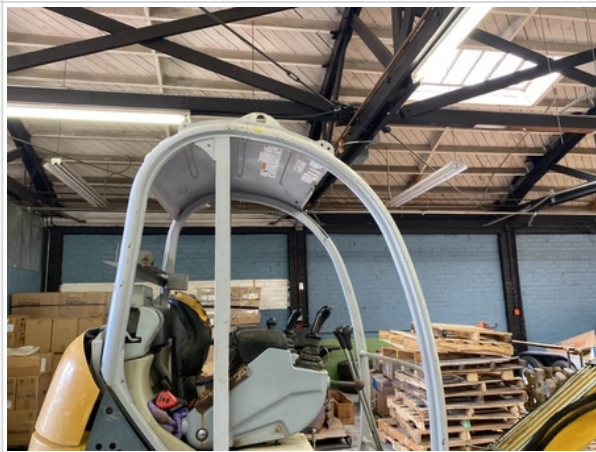
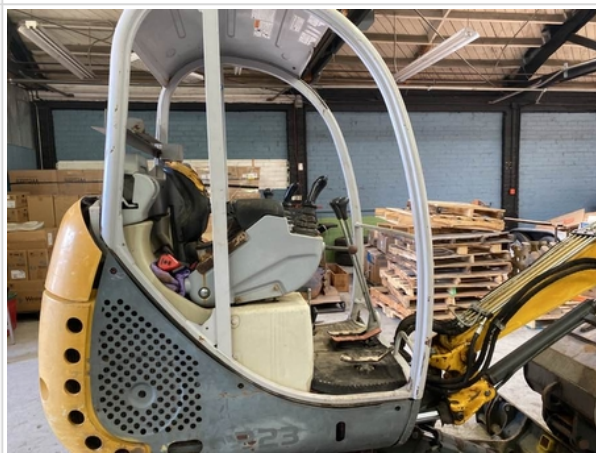
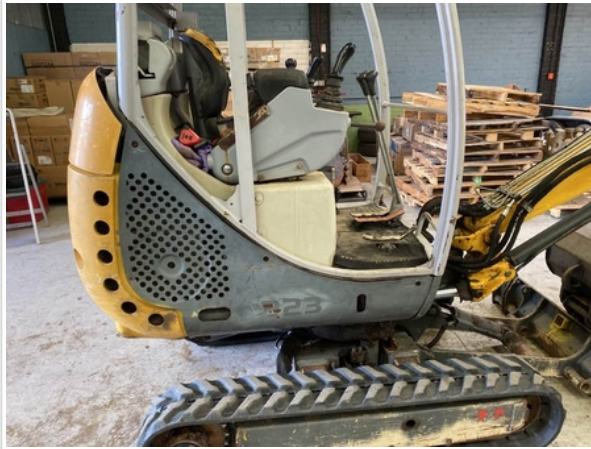
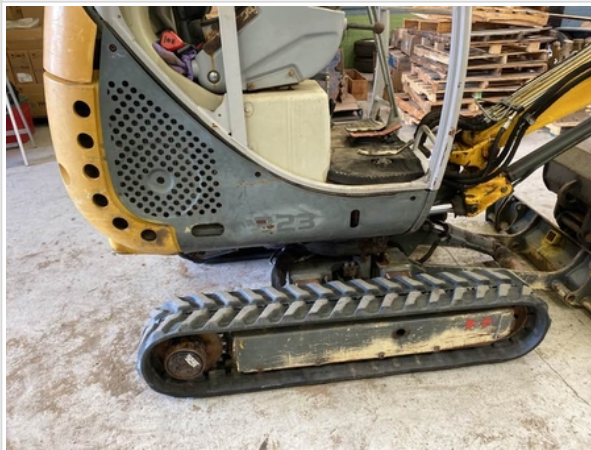
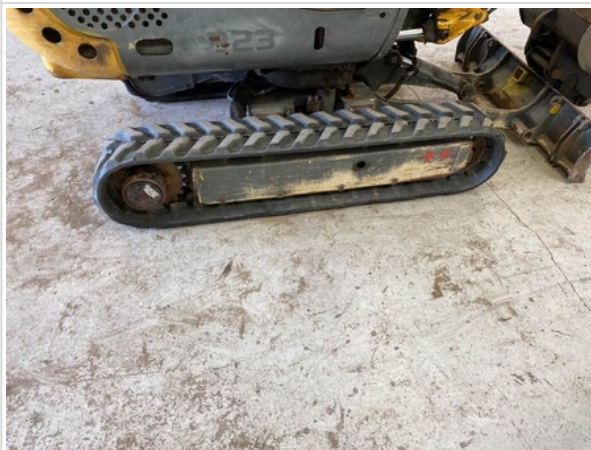
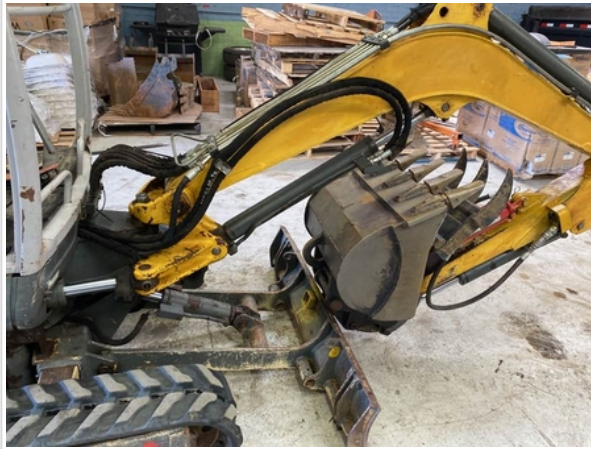
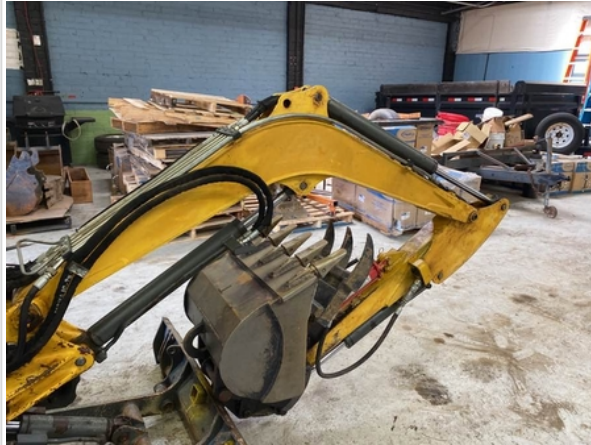
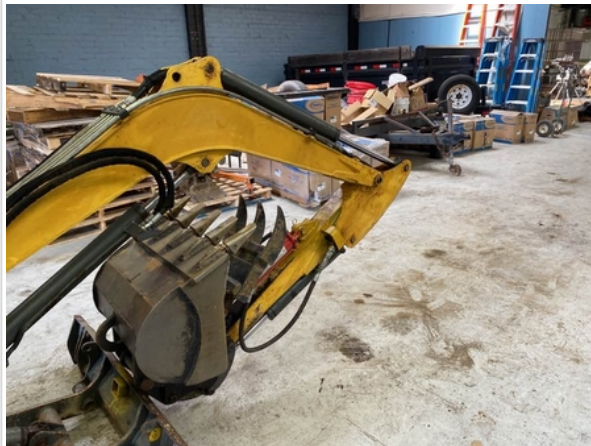
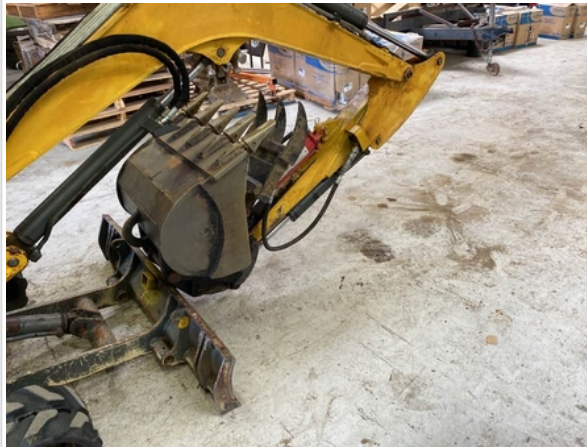
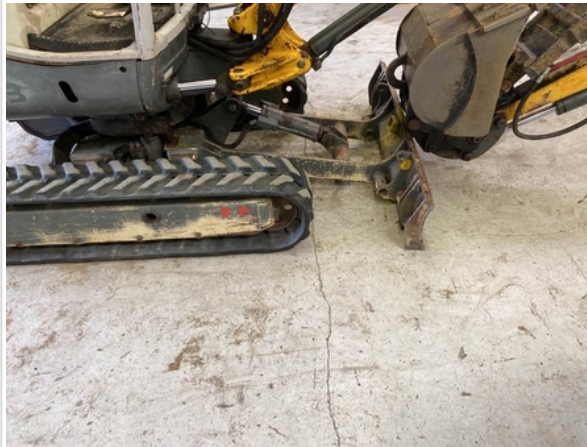
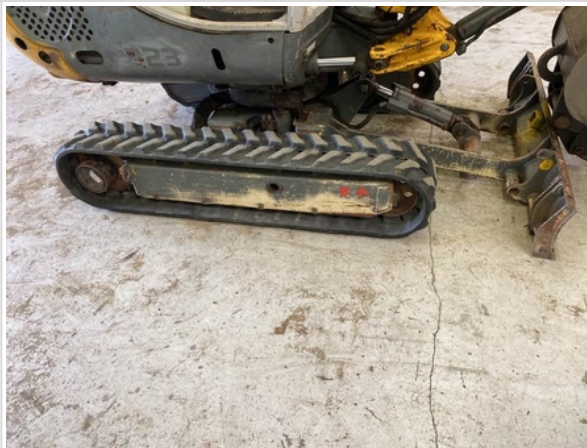
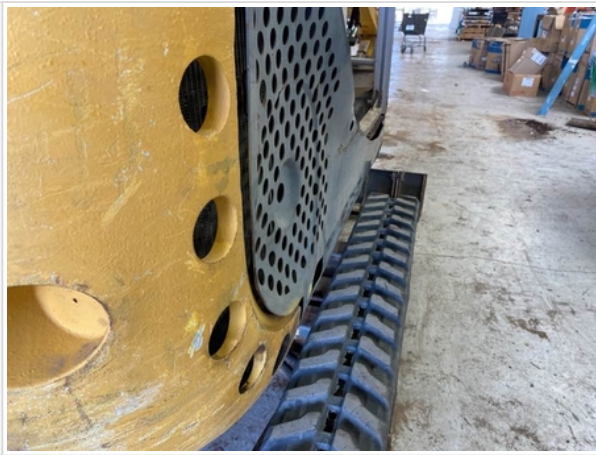
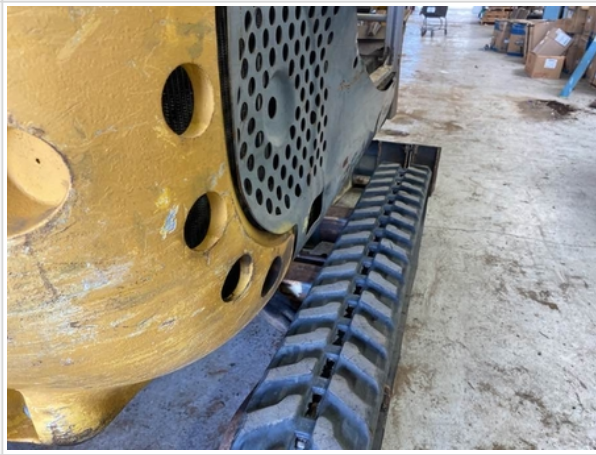
<p>Right</p>	<p>3 - Normal Wear & Tear</p>	
<p>Right Condition</p>	<p>Visible chipped paint or dents</p>	
<p>Right Photos</p>

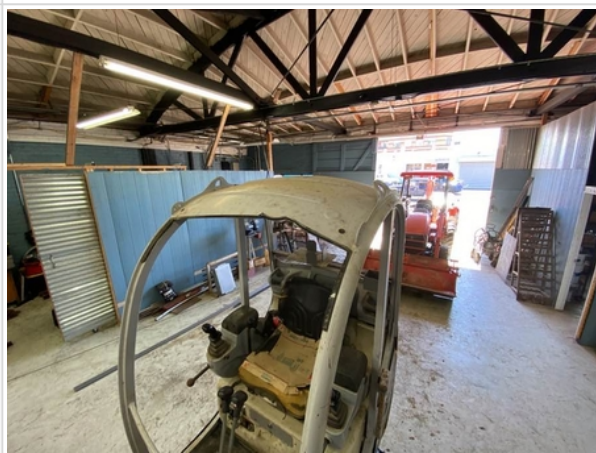
Upper	3 - Normal Wear & Tear
Upper Condition	Visible chipped paint or dents
Upper Photos

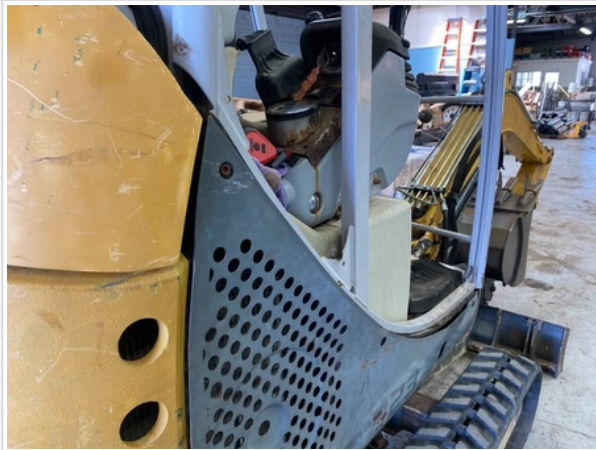
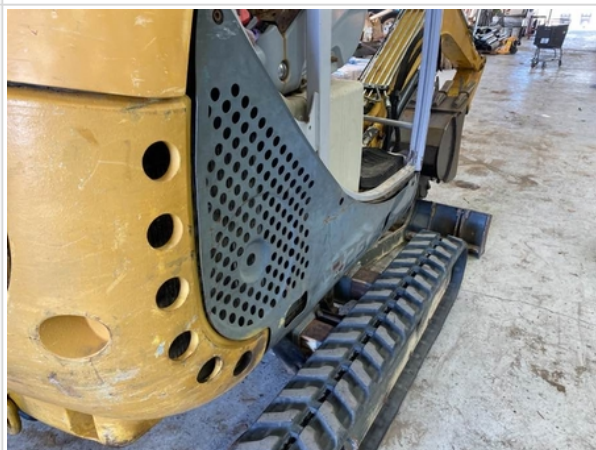
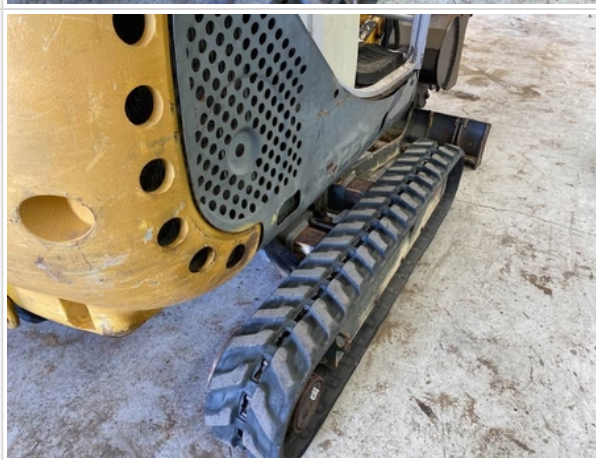
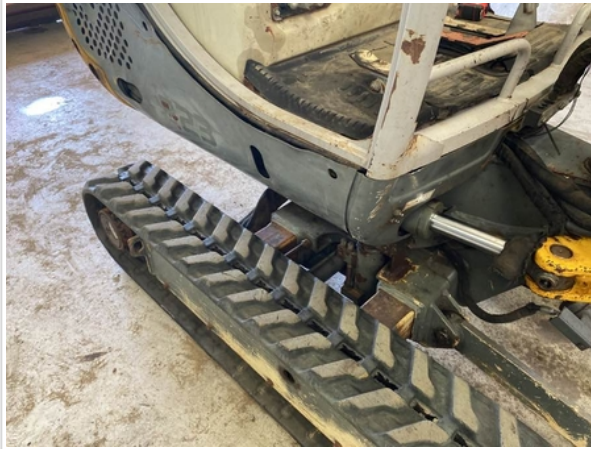
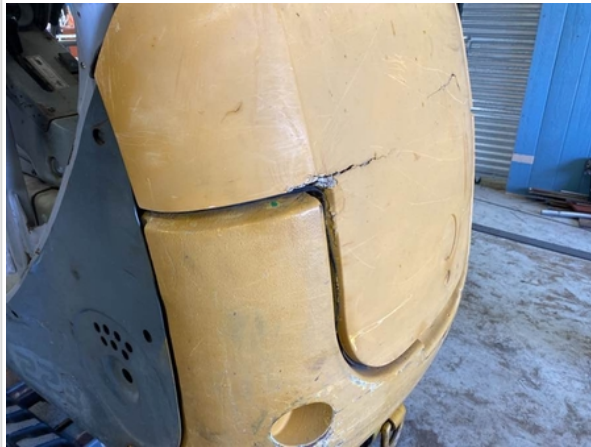
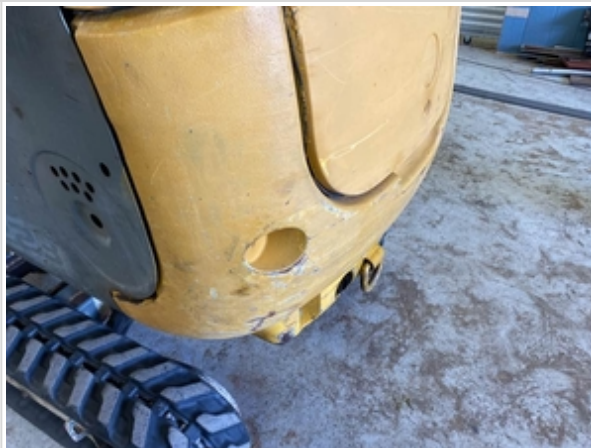
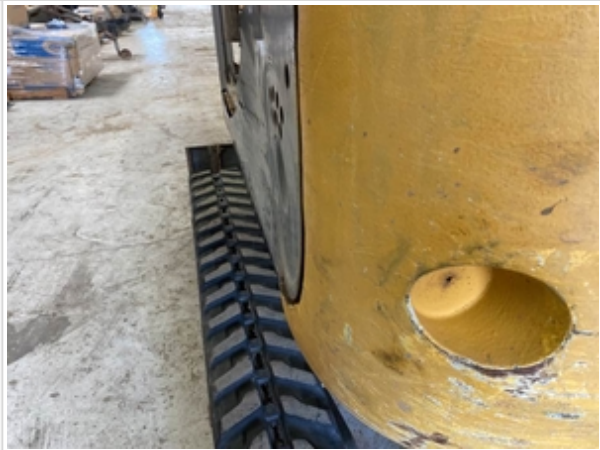
<p>Body Panels Photos</p>

<p>Body Panels (Any Rust Damage?)</p>	<p>3 - Normal Wear & Tear</p>
<p>Body Panel Condition</p>	<p>Some panel misalignment observed, Visible chipped paint or dents</p>

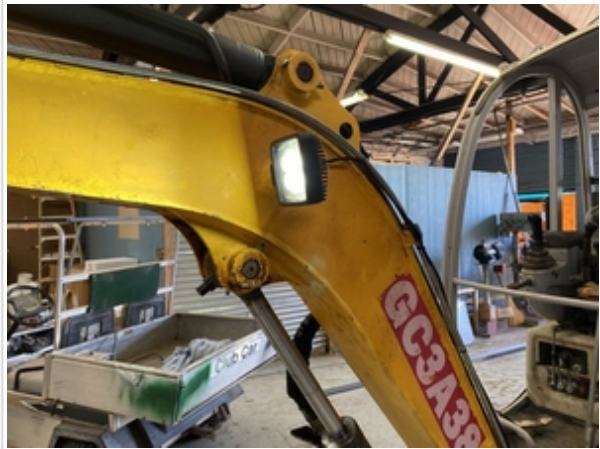
Doors / Canopy Latches	0	
Glass Condition	0	
Mirrors	0	
Lighting System	3 - Normal Wear & Tear	
Lighting System Condition	No visible damage, lighting system is operational	
Lighting System Photos

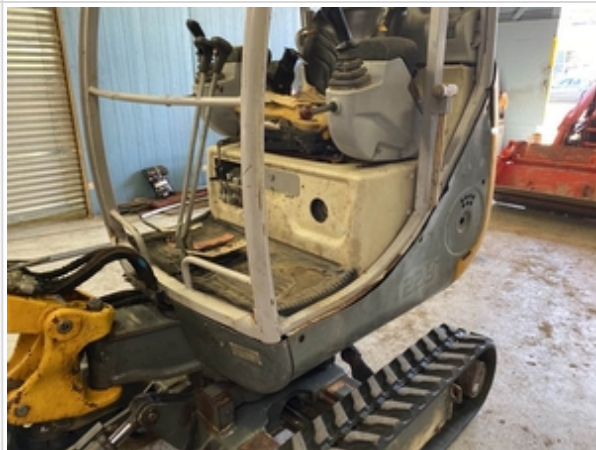
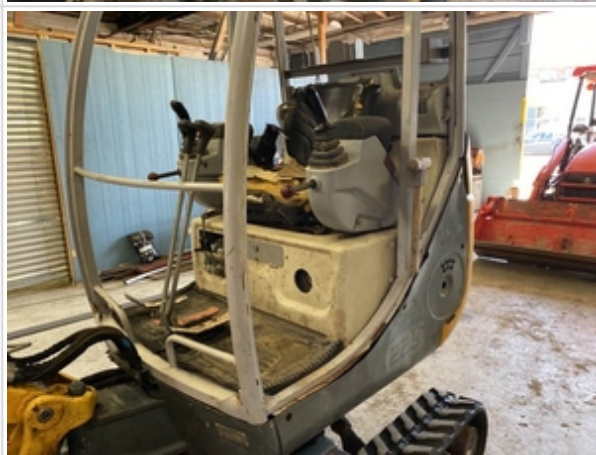
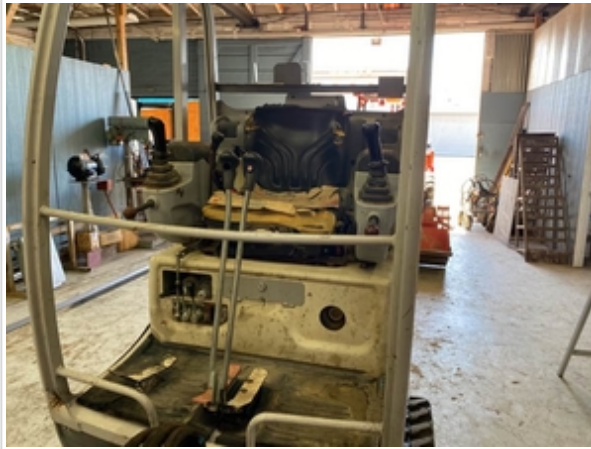
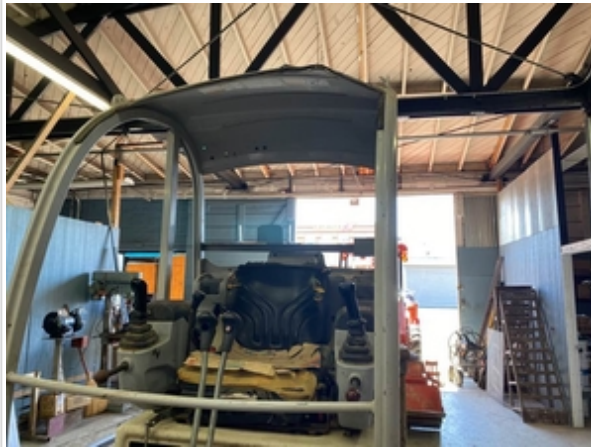
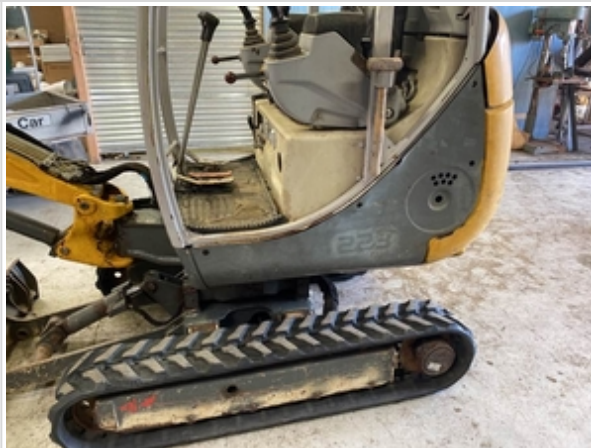
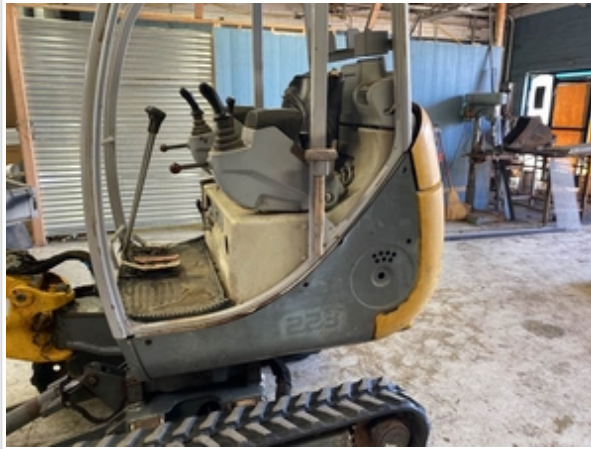
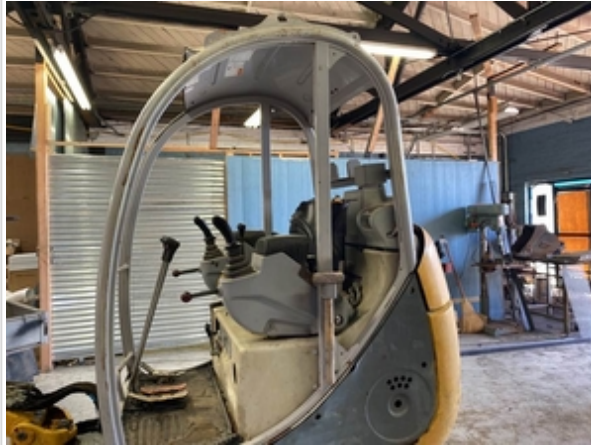
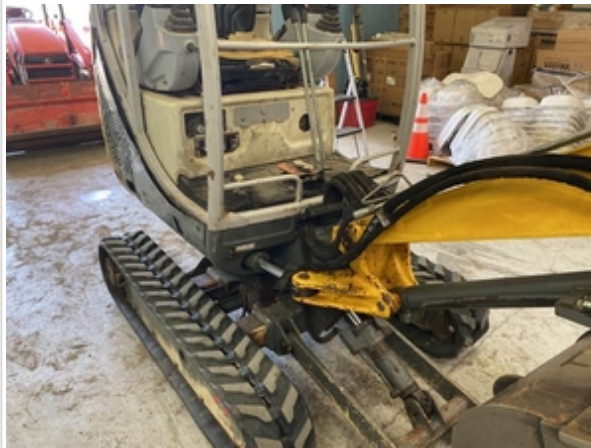
Operator Cabin Overall	3 - Normal Wear & Tear
Operator Cabin Overall Condition	Minor cosmetic wear to cabin surfaces, floors, panels, and ceiling
Operator Cabin Photos

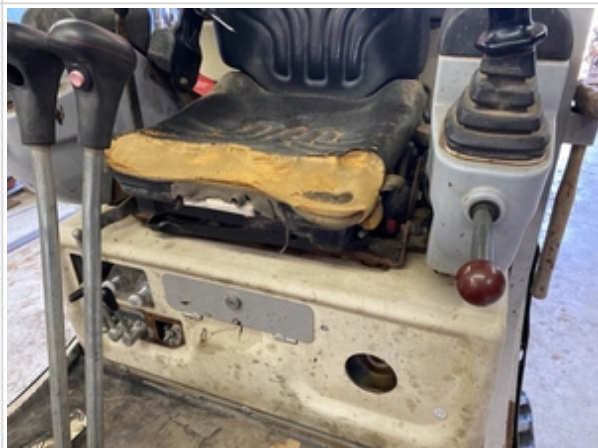
<p>Operator's Seat & Arm Rests</p>	<p>2 - Above Average Wear</p>	
<p>Operator's Seat & Arm Rests Condition</p>	<p>Seat(s) is damaged due to sun exposure; fading, cracking observed, Seat(s) has major surface staining or tears</p>	
<p>Operator's Seat & Arm Rests Photos</p>

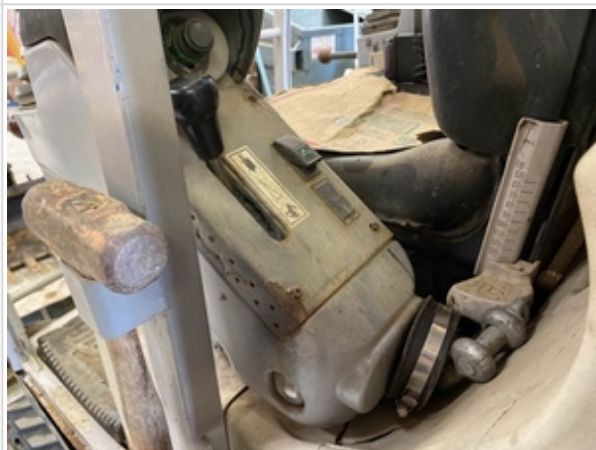
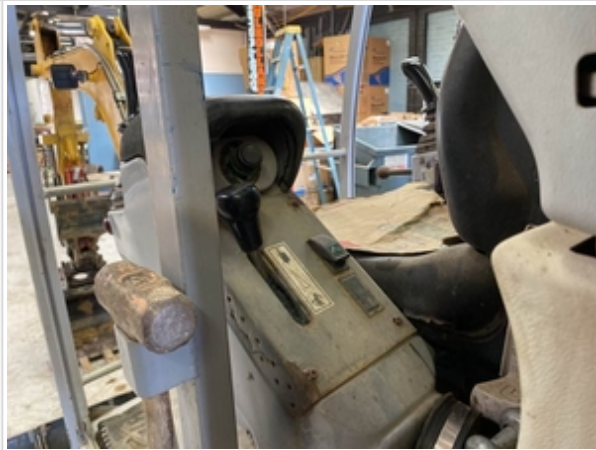
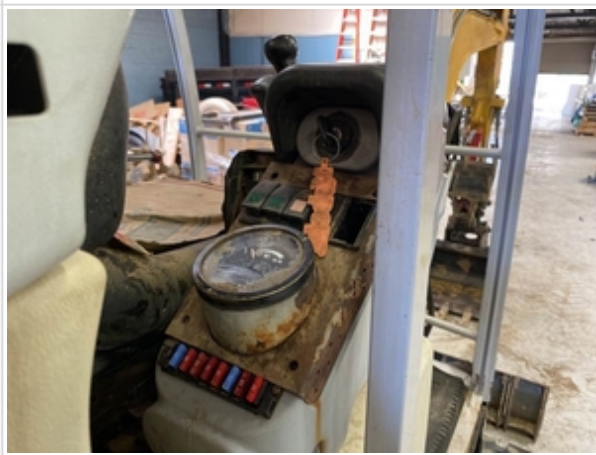
<p>Controls & Switches</p>	<p>3 - Normal Wear & Tear</p>
<p>Controls & Switches Condition</p>	<p>All switches are installed and functional</p>
<p>Controls & Switches Photos</p>

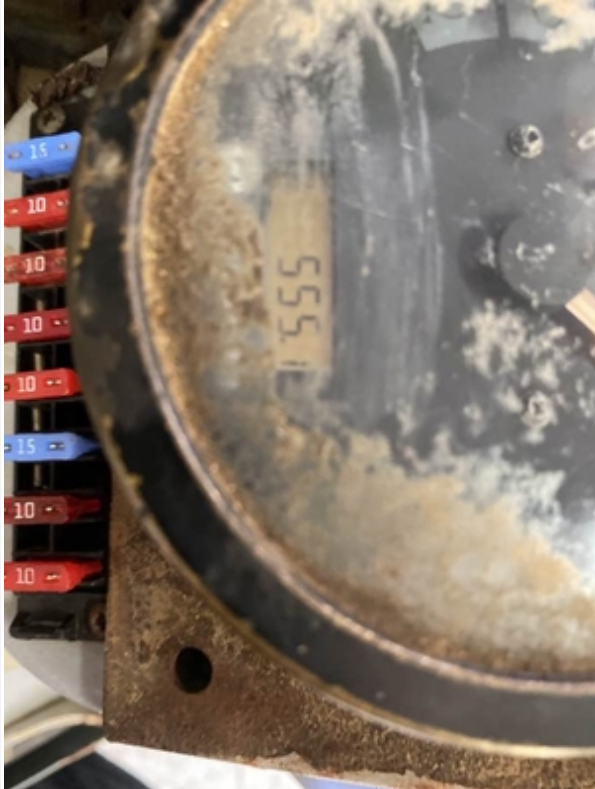
Hour Meter Activity Photos

Hour Meter Activity	3 - Normal Wear & Tear
Hour Meter Condition	Hour meter is functional and in good condition

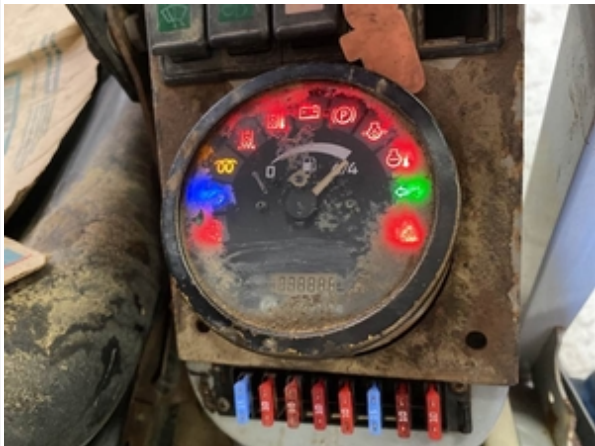
Other Gauge Activity	3 - Normal Wear & Tear
Other Gauge Condition	All cockpit gauges are functional and in good condition
Other Gauge Activity Photos

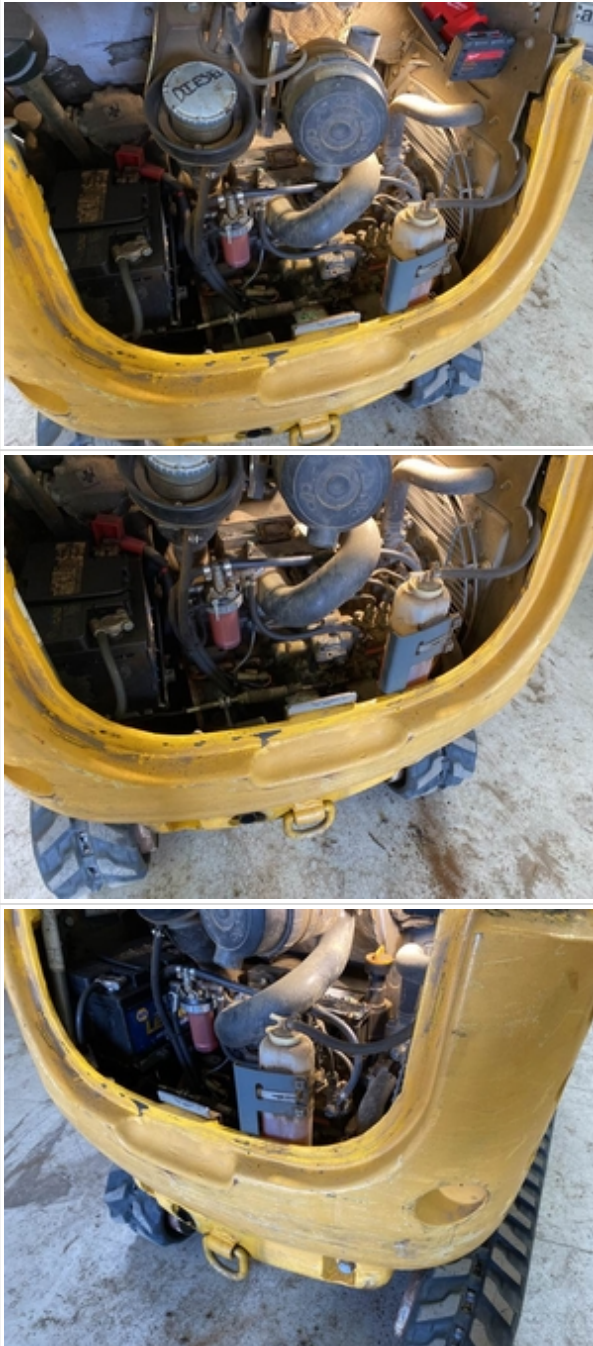
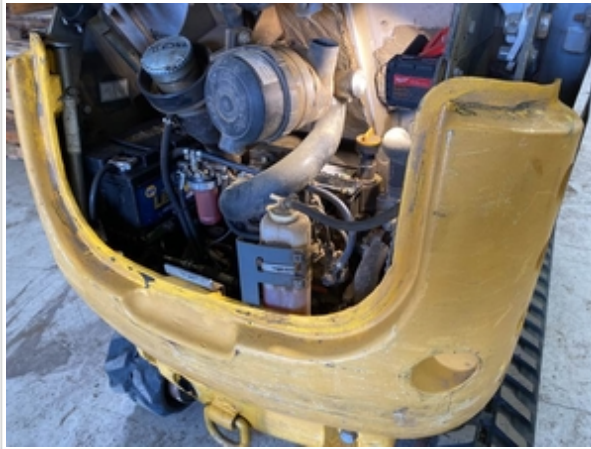
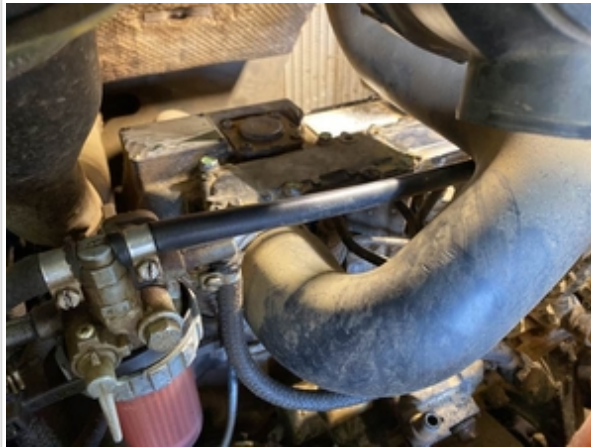
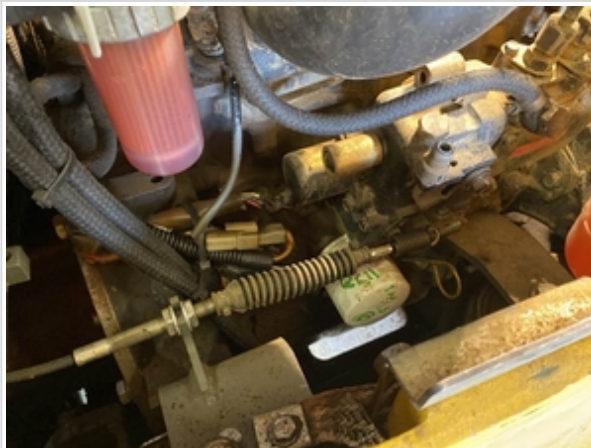
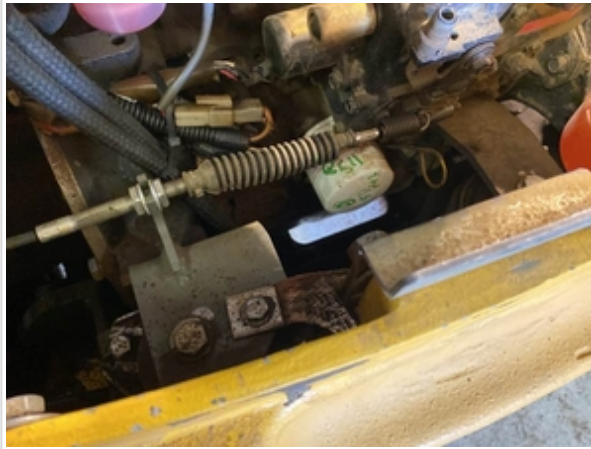
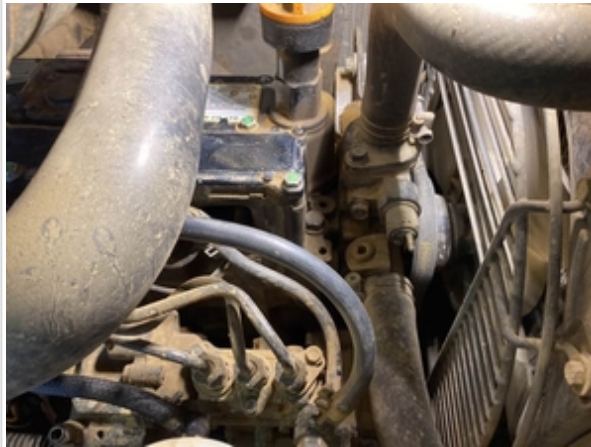
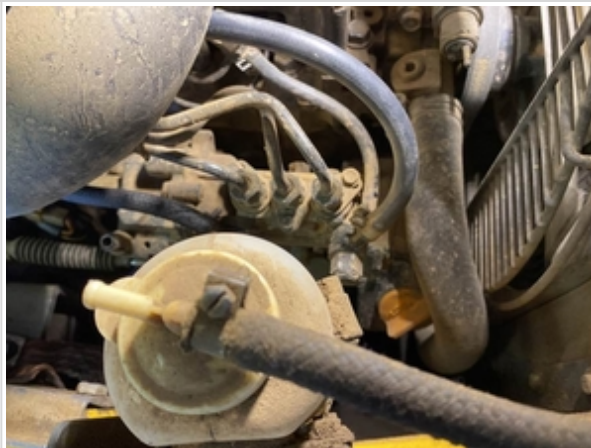
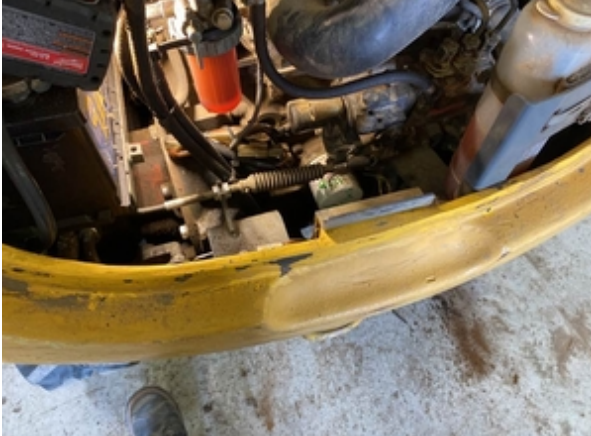
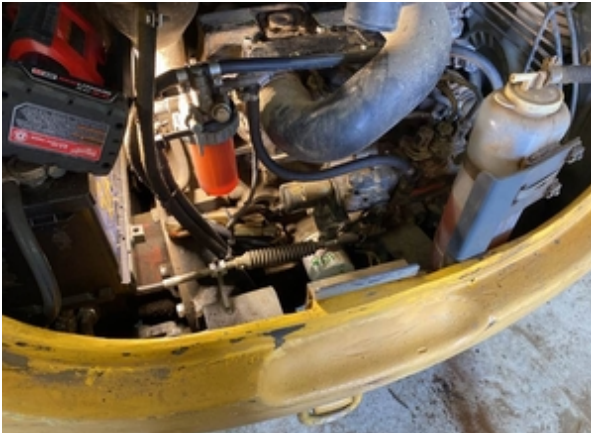
Engine Type (Make, Model, Cylinders, Hp)	Yanmar 3TNV76-S / 1.12 L. / 18.3 HP
Engine Serial Number	09842
Engine Fuel Type	Diesel
Engine Photos

Blow-by (Visual Observation Check)	No
Unusual Noises (Upon Start-up, Idle, Shutdown)	Yes
Unusual Noise Notes	Other (see comments)
Comments	Sounds like metal brackets or muffler loose (only at idle)
Engine Smoke (Upon Start-up, Idle, Shutdown)	Yes
Engine Smoke Notes	Engine smoke observed upon start up, Other (see comments)
Comments	Normal diesel smoke at startup, fine at idle and high rpm
Engine Exhaust Color	Clear
Battery	3 - Normal Wear & Tear
Battery Condition	Other (see comments)
Comments	Just needs to be cleaned

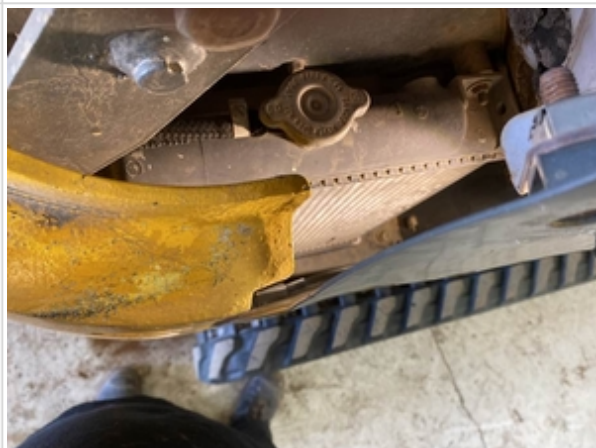
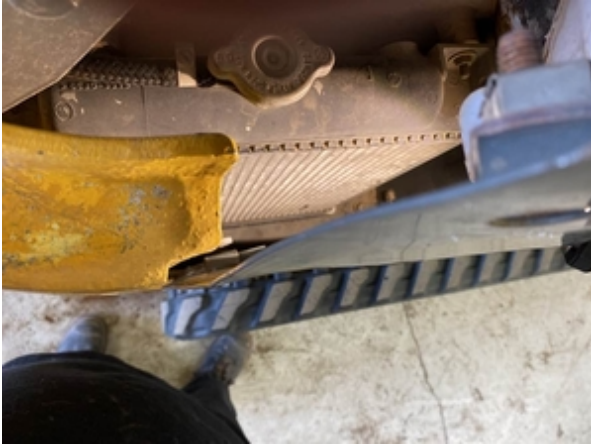
<p>Radiator</p>	<p>3 - Normal Wear & Tear</p>
<p>Radiator Condition</p>	<p>Radiator fins & components appear to be in good working order, no signs of damage or leaks</p>
<p>Radiator Photos</p>

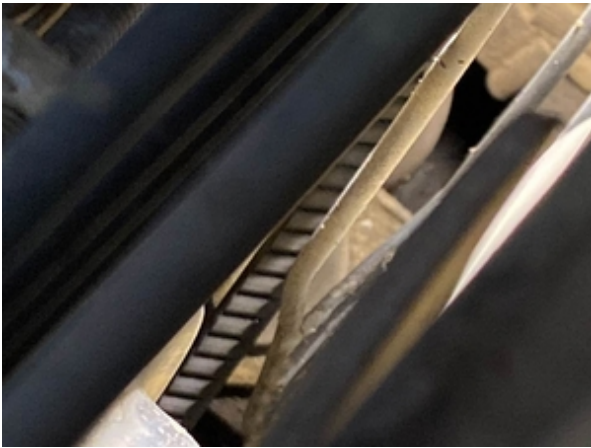
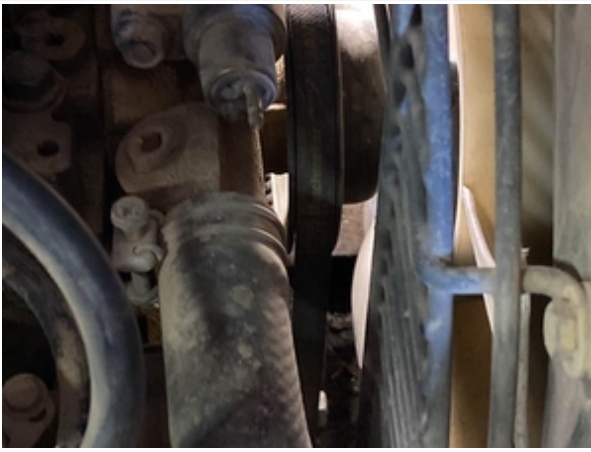
Belts	2 - Above Average Wear
Belt Condition	Frayed belt edges observed
Belt Photos

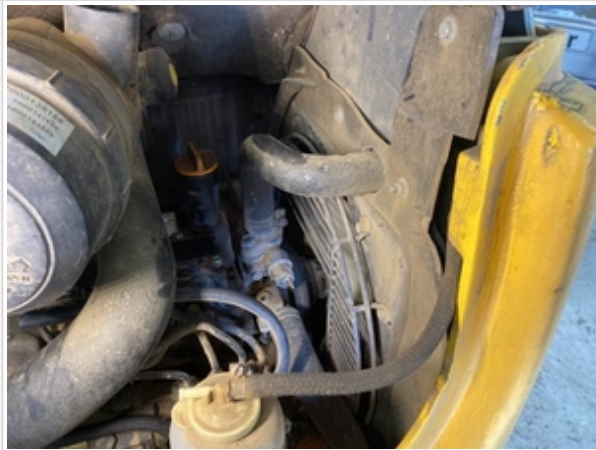
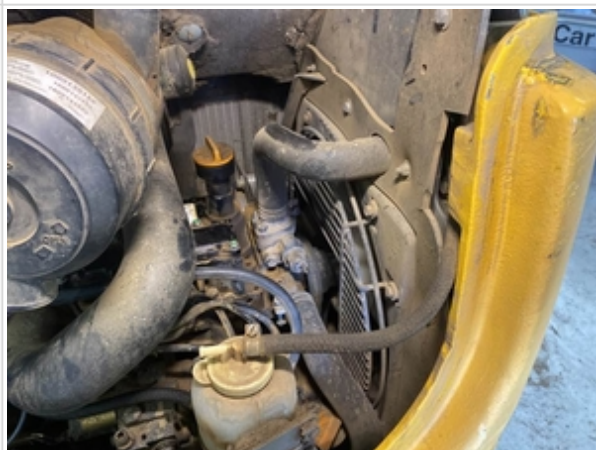
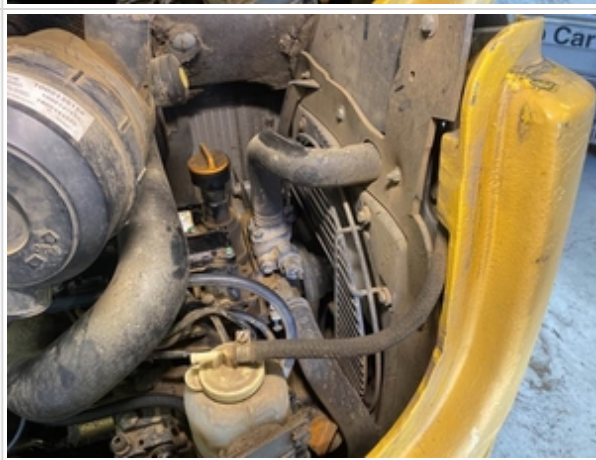
<p>Hose Photos</p>

Hoses	3 - Normal Wear & Tear
Hose Condition	Firm, pliant hoses with no signs of wear or leaks

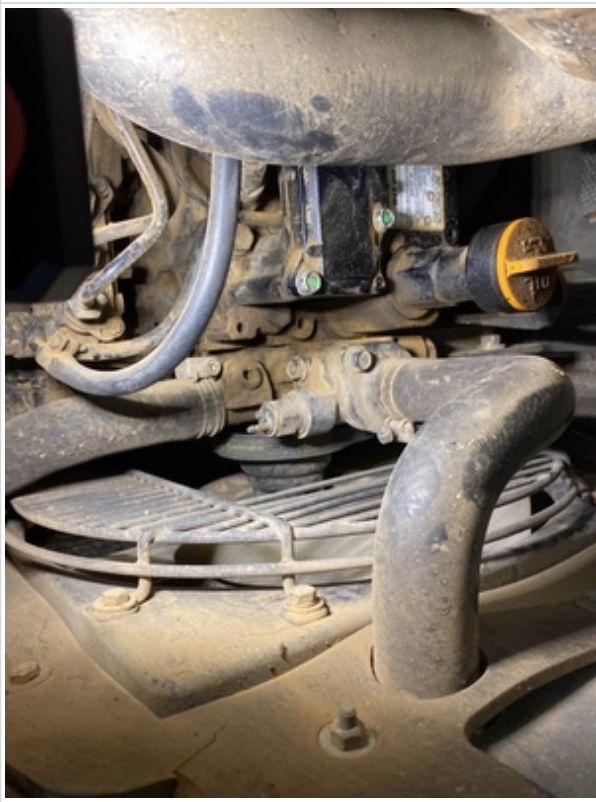
Water Pump	3 - Normal Wear & Tear	
Water Pump Condition	No unusual pump noises heard	
Water Pump Photos

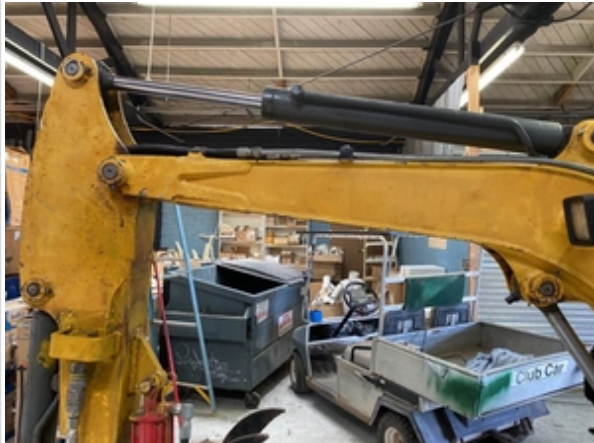
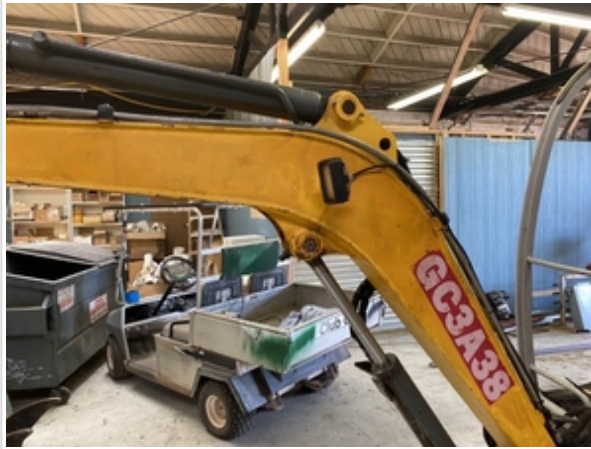
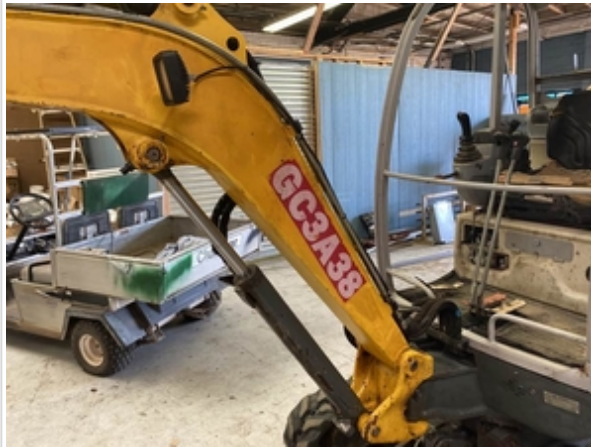
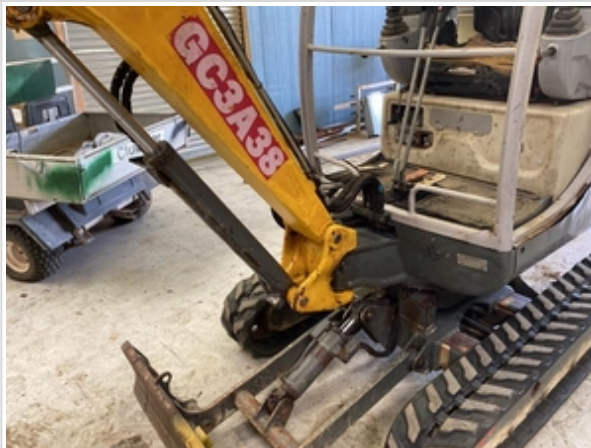
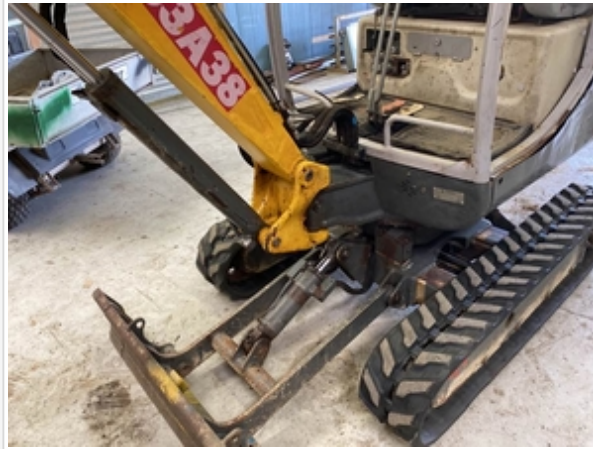
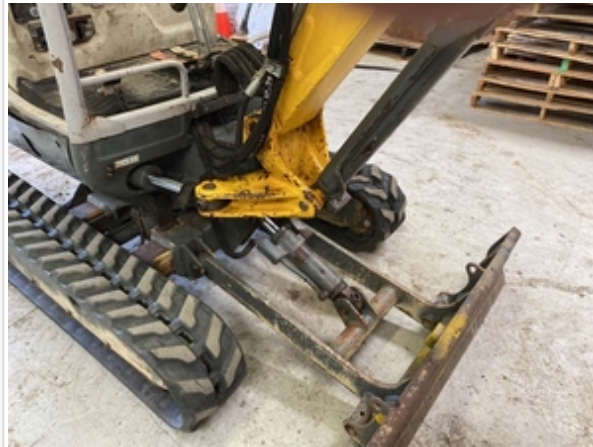
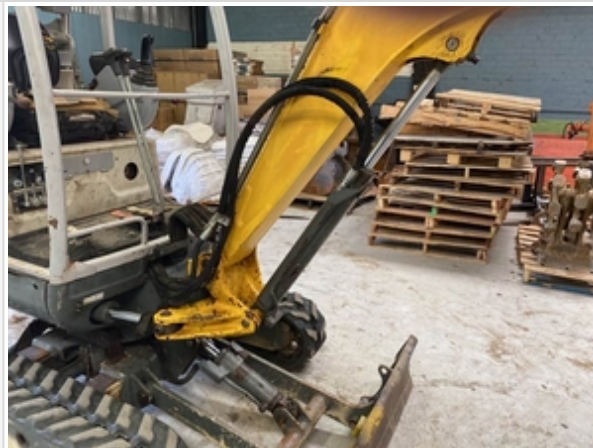
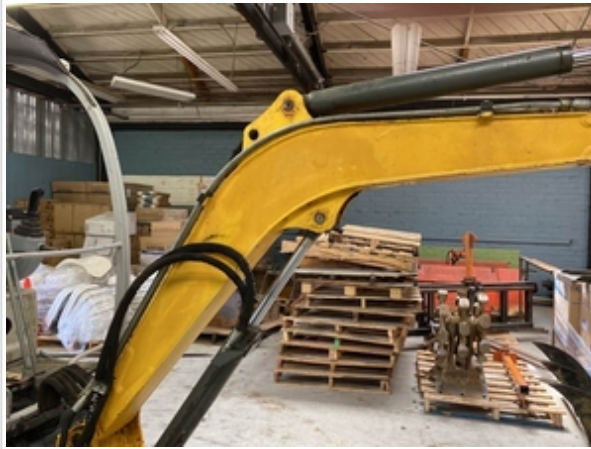
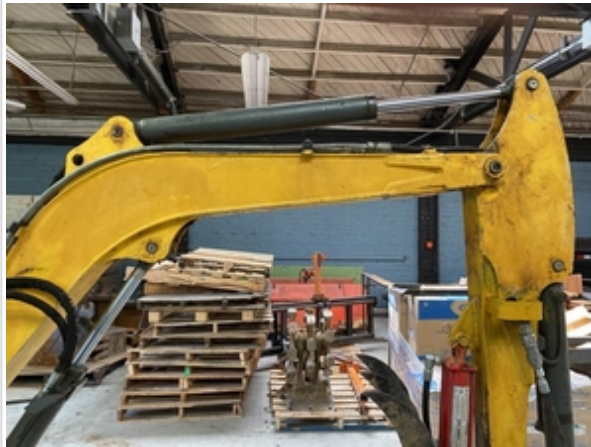
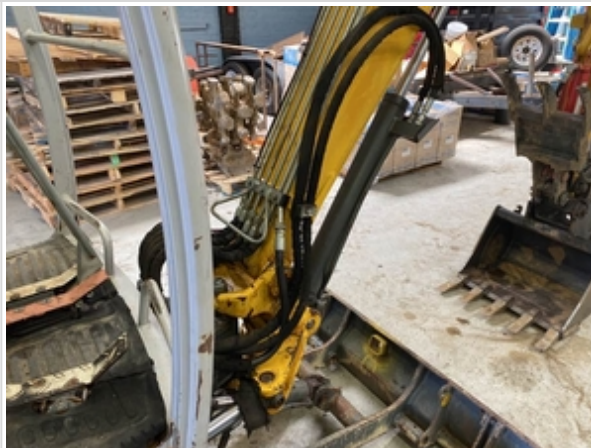
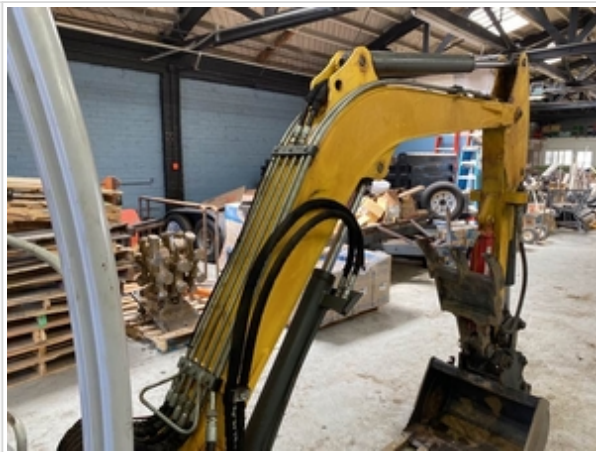
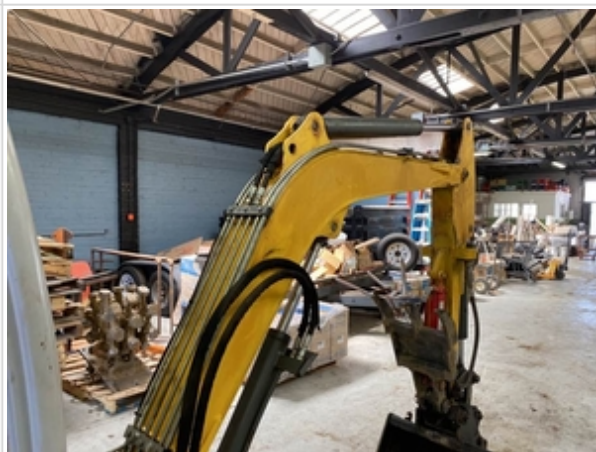
Instructions	<p>Evaluate the following on a 4 point scale (leave comments where an explanation is appropriate):</p> <p>4 = Like New, Recently Replaced 3 = Normal Wear & Tear 2 = Above Average Wear 1 = Service Required</p>
Boom Condition	3 - Normal Wear & Tear
Boom Photos
