Inspection Report (Mini Excavator)

Year	2006
Make	Neuson
Model	G - 2203 RD
Serial Number	AE00164
Hour Meter Reading	555.2
Previous Application (e.g., earth moving, mining, demolition, etc)	General construction (plumbing)

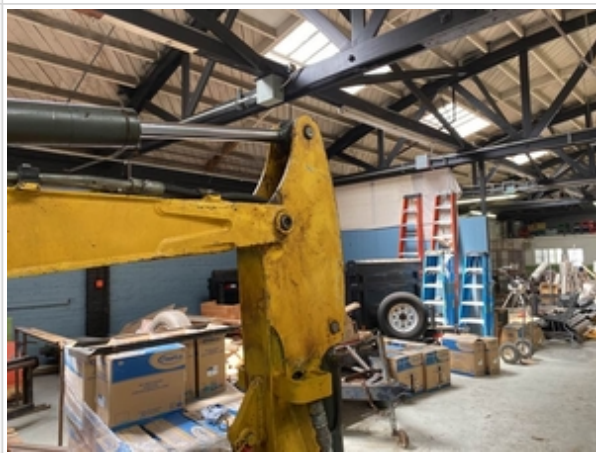
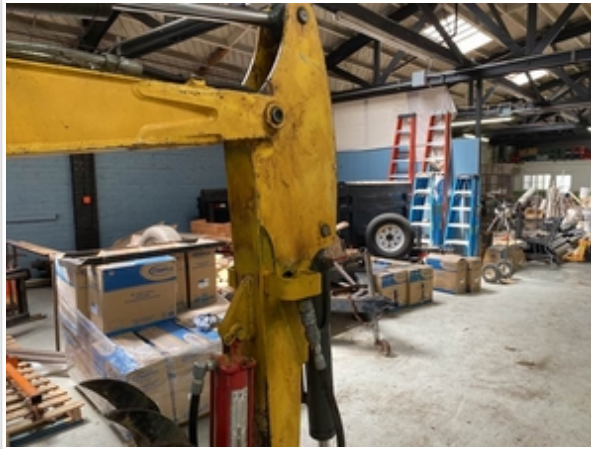
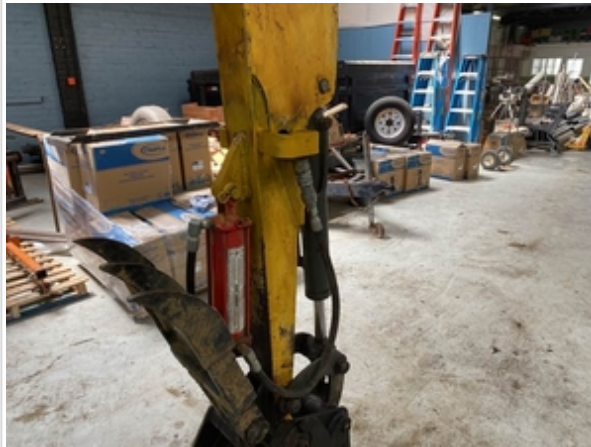
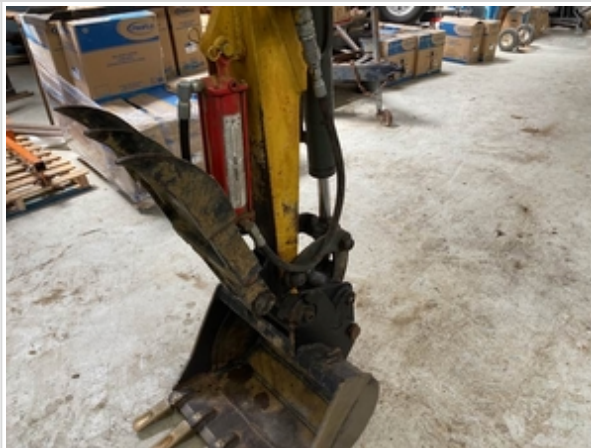
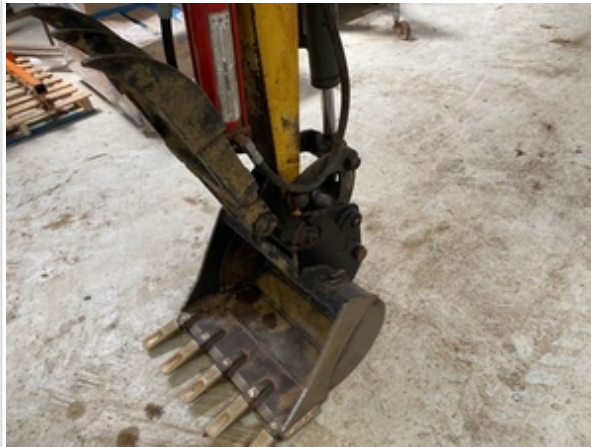
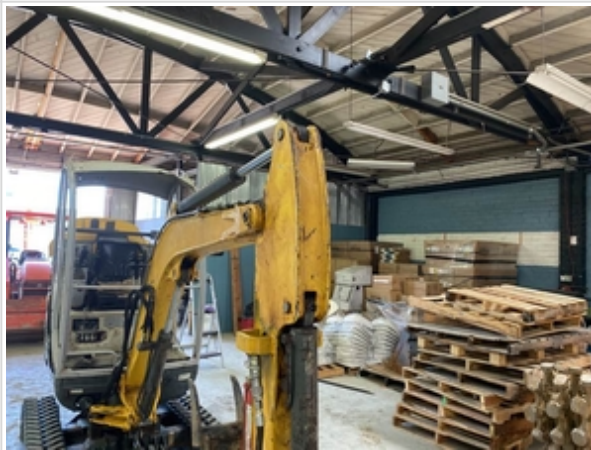
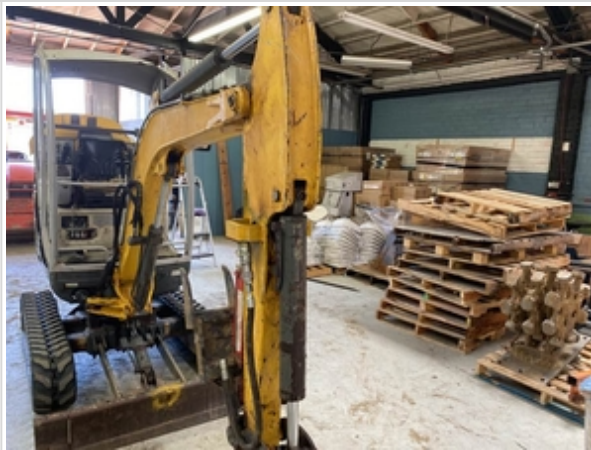
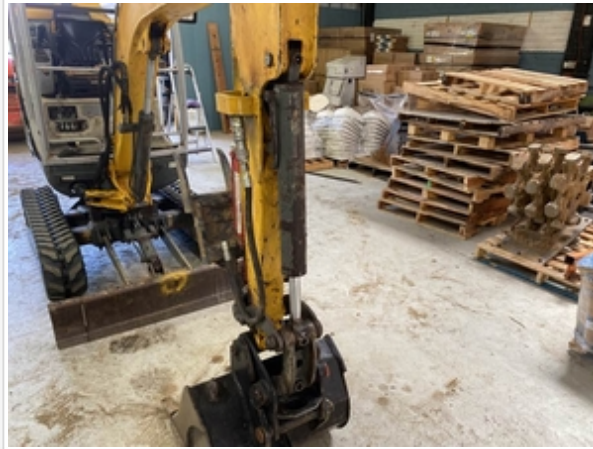
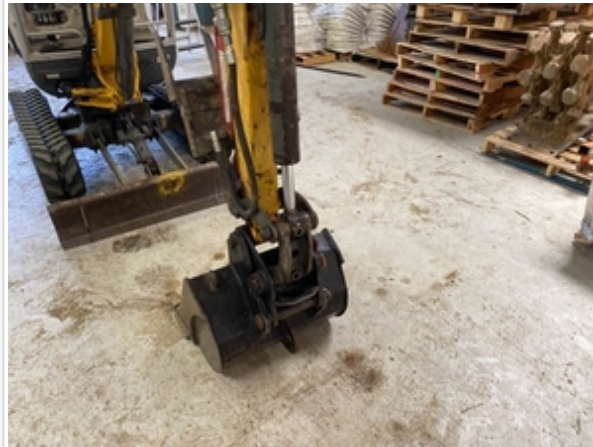
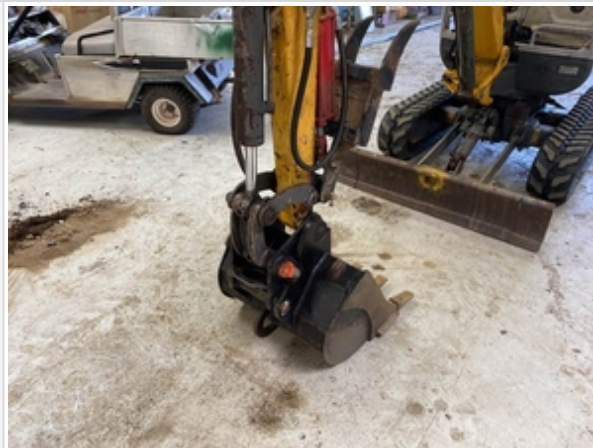
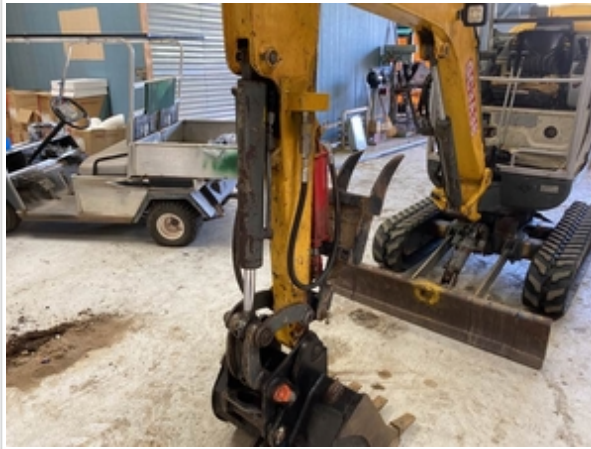
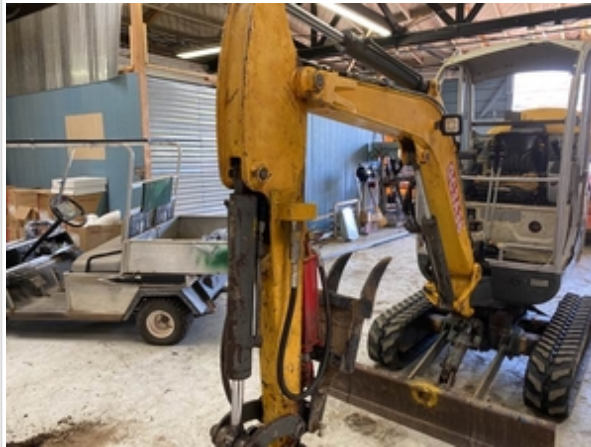
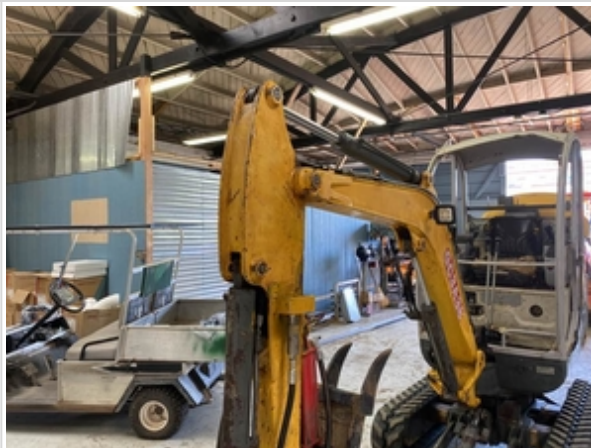
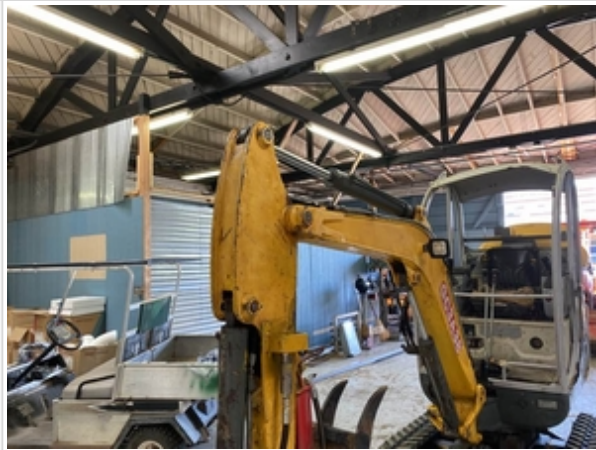
<p>Stick Condition</p>	<p>3 - Normal Wear & Tear</p>	
<p>Stick Photos</p>

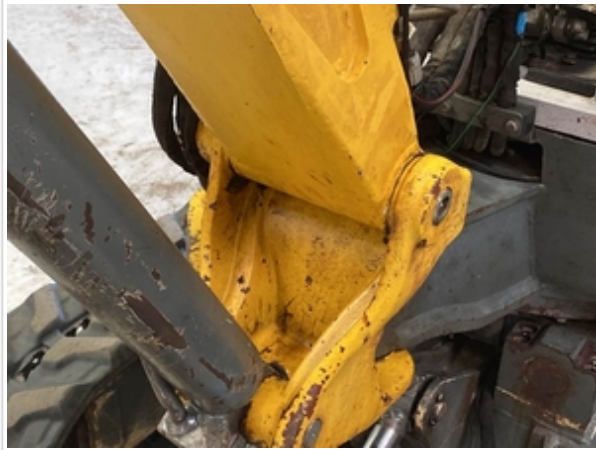
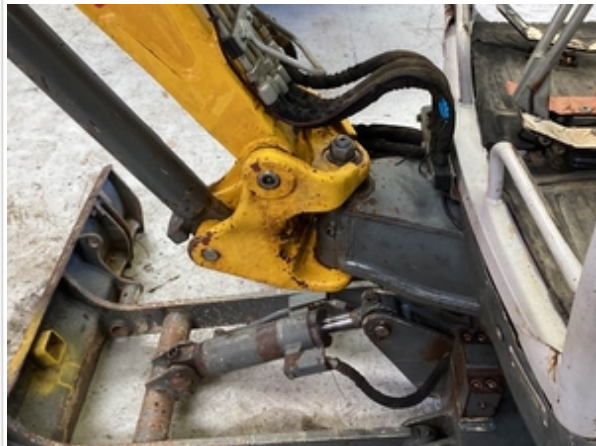
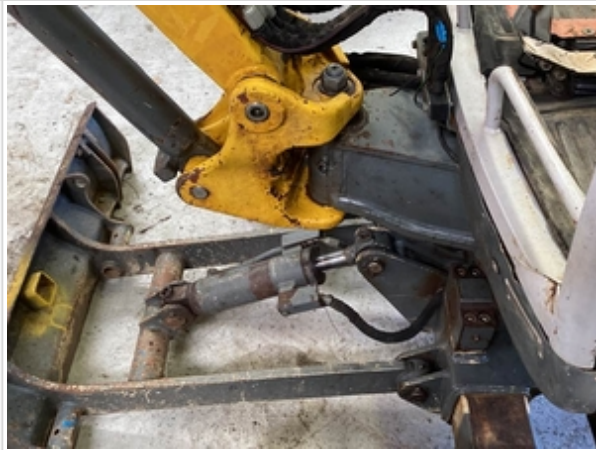
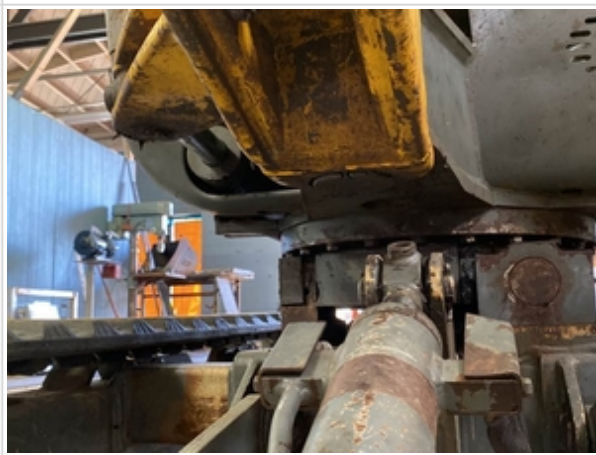
<p>Boom Base Pin & Bushings</p>	<p>3 - Normal Wear & Tear</p>	
<p>Boom Base Pin & Bushings Photos</p>

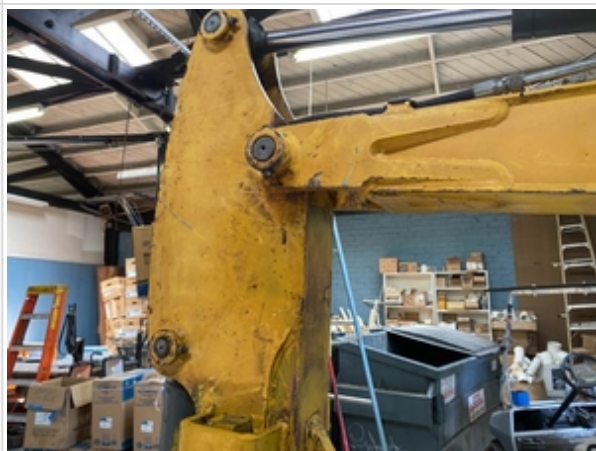
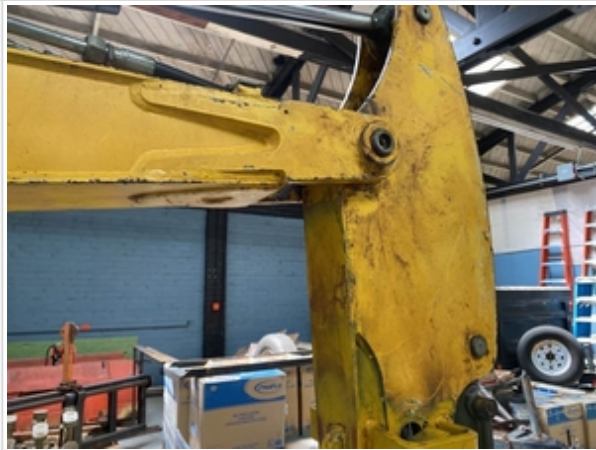
<p>Boom to Stick Pin & Bushings</p>	<p>3 - Normal Wear & Tear</p>	
<p>Boom to Stick Pin & Bushings Photos</p>

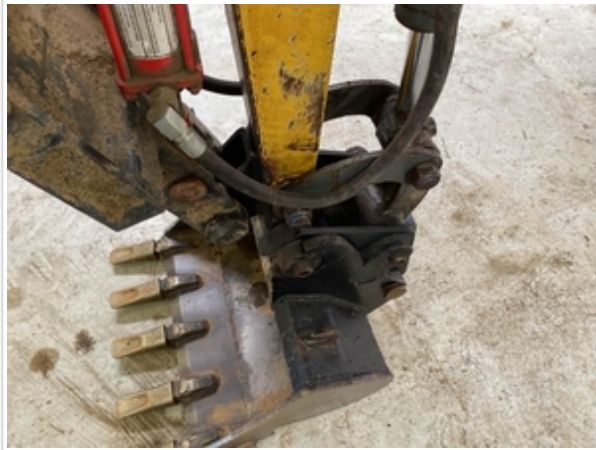
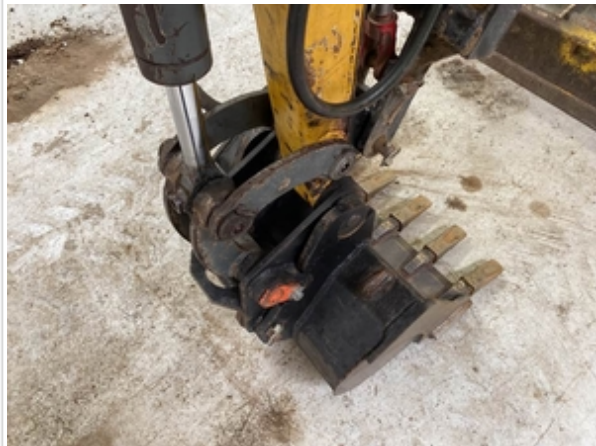
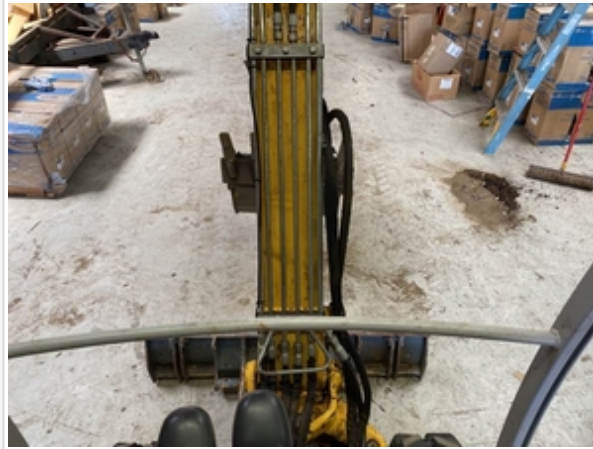
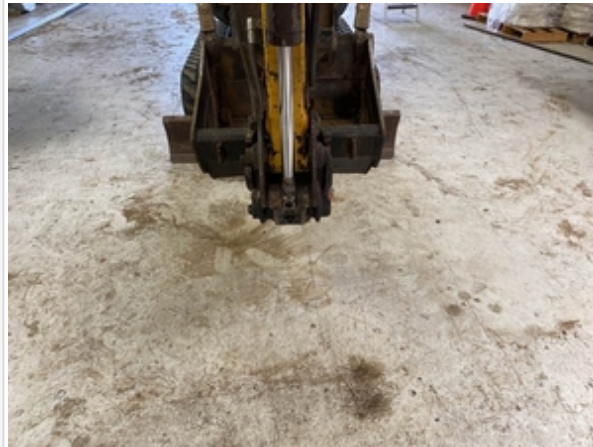
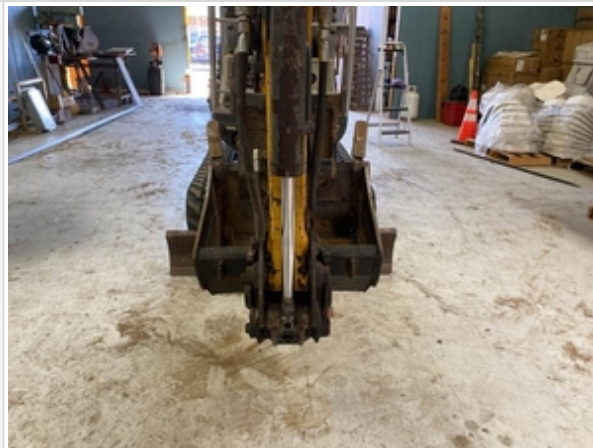
<p>Stick to Bucket Pin & Bushings</p>	<p>3 - Normal Wear & Tear</p>
<p>Stick to Bucket Pin & Bushings Photos</p>

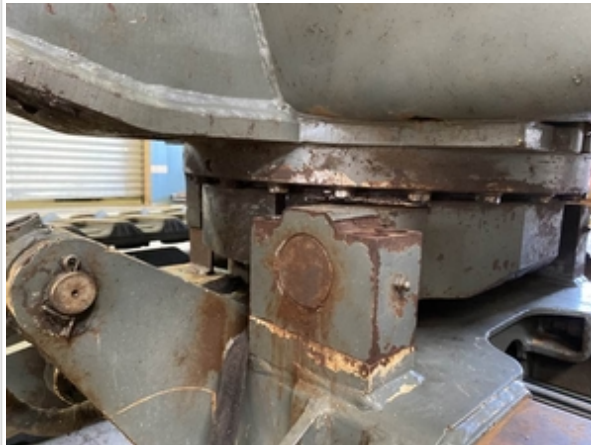
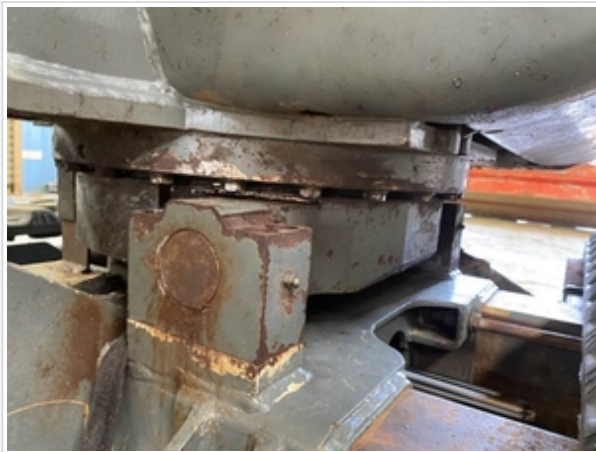
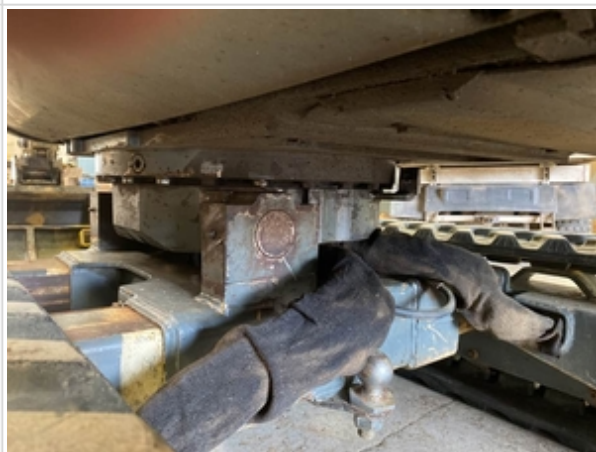
Turntable Bearing

3 - Normal Wear & Tear

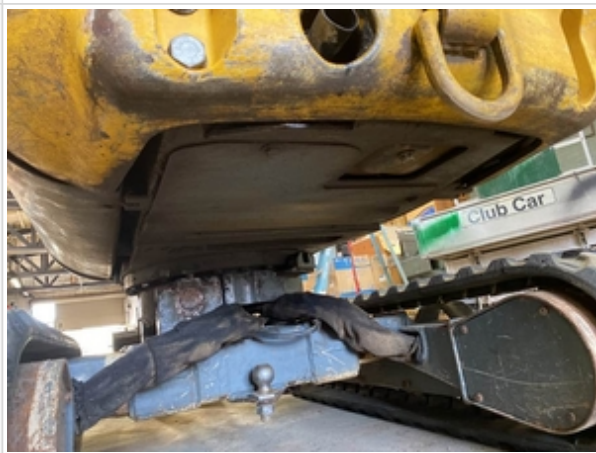
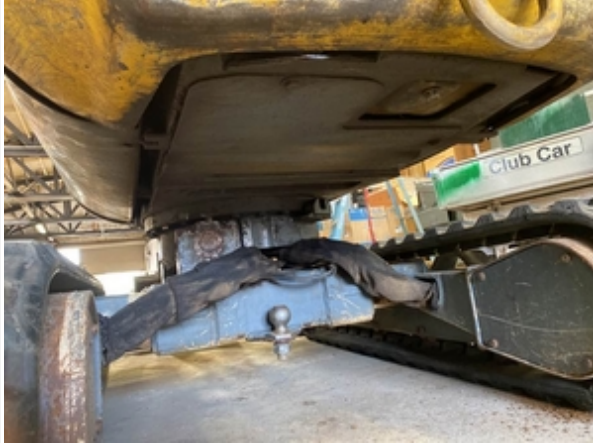
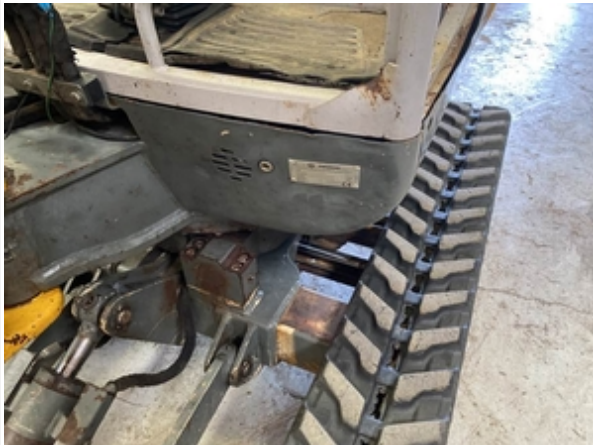
<p>Bottom Covers</p>	<p>3 - Normal Wear & Tear</p>	
<p>Bottom Covers Photos</p>

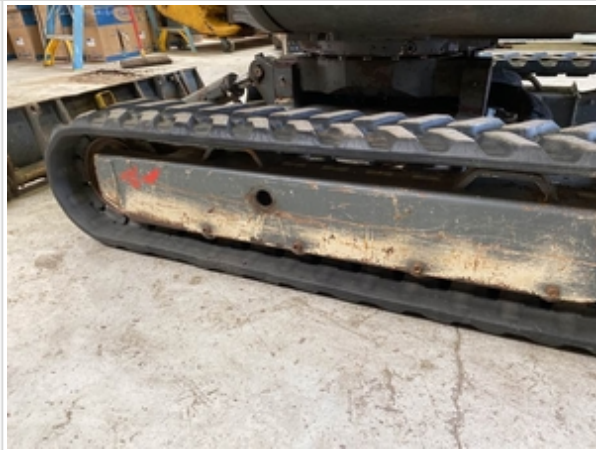
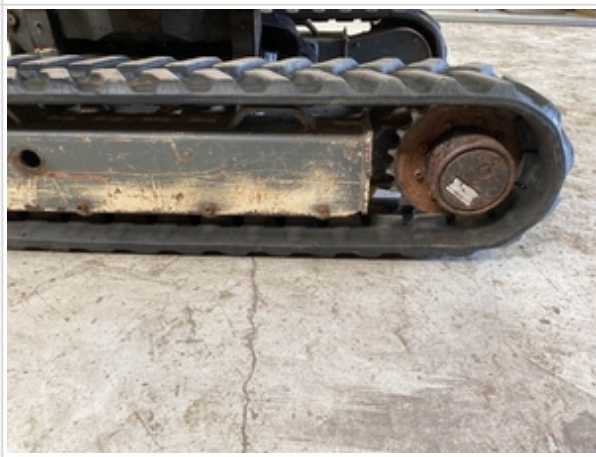
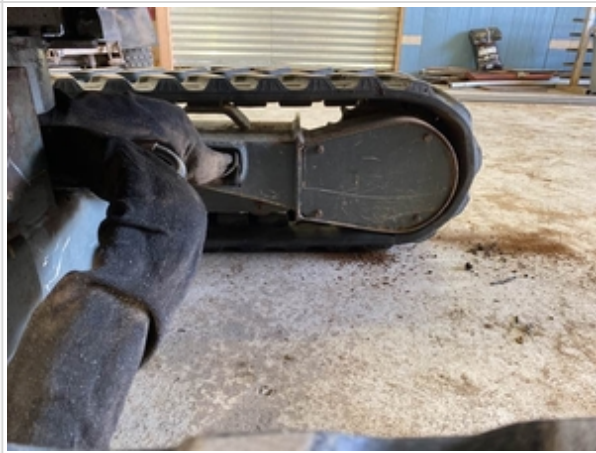
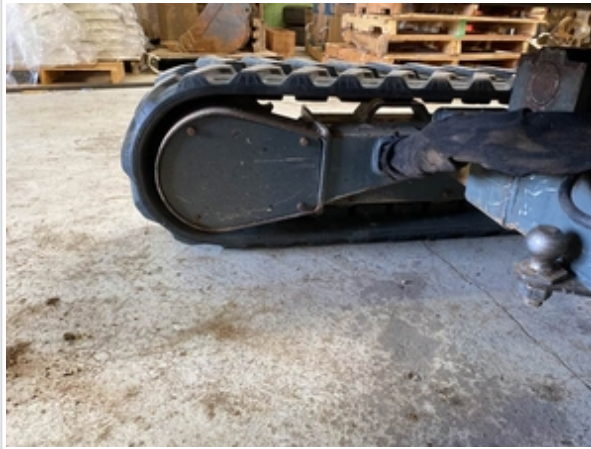
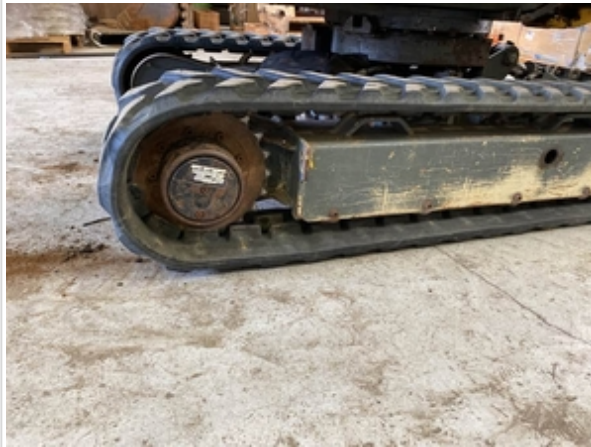
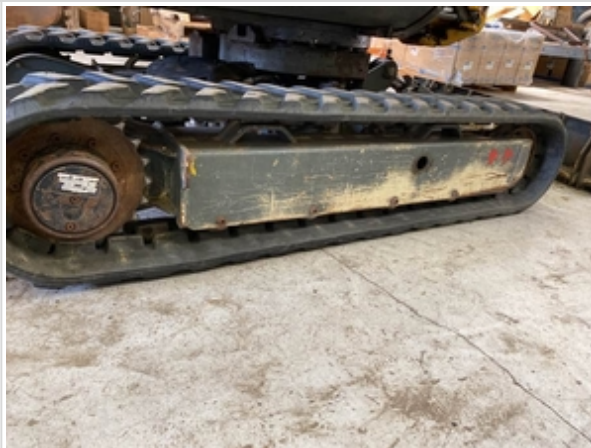
<p>Roller Frames Photos</p>

Instructions	<p>Evaluate the following on a 4 point scale (leave comments where an explanation is appropriate):</p> <p>4 = Like New, Recently Replaced 3 = Normal Wear & Tear 2 = Above Average Wear 1 = Service Required</p>
Roller Frames	3 - Normal Wear & Tear

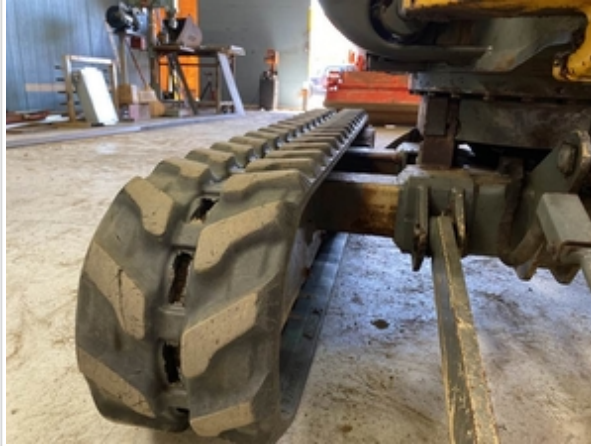
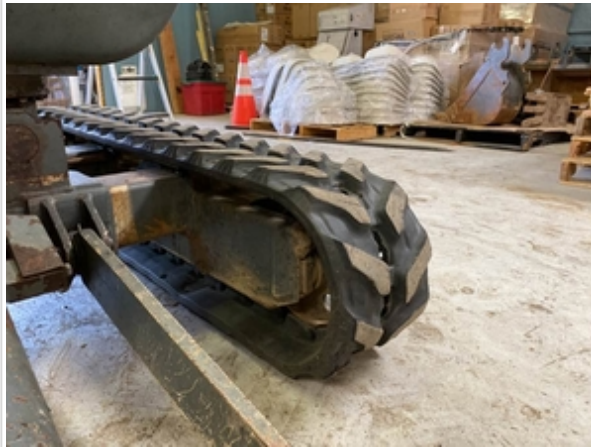
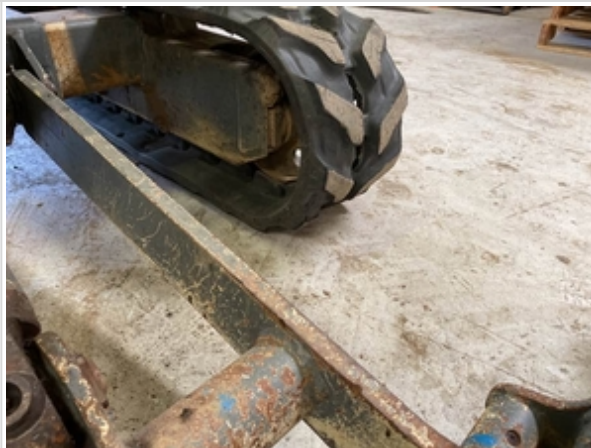
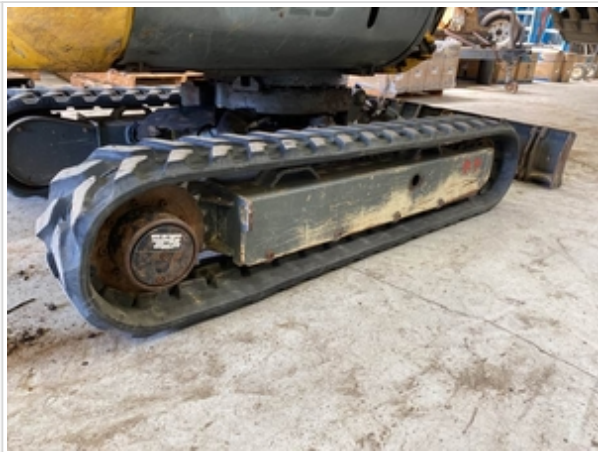
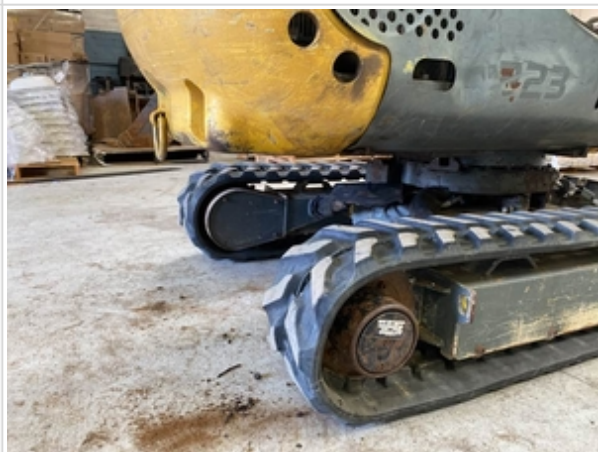
Track Belt Photos

Track Belt

3 - Normal Wear & Tear

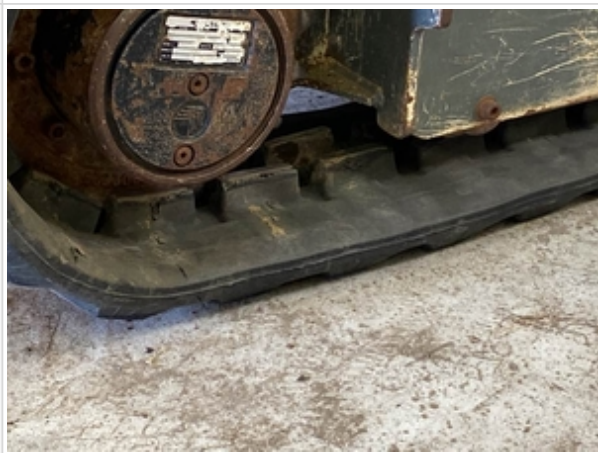
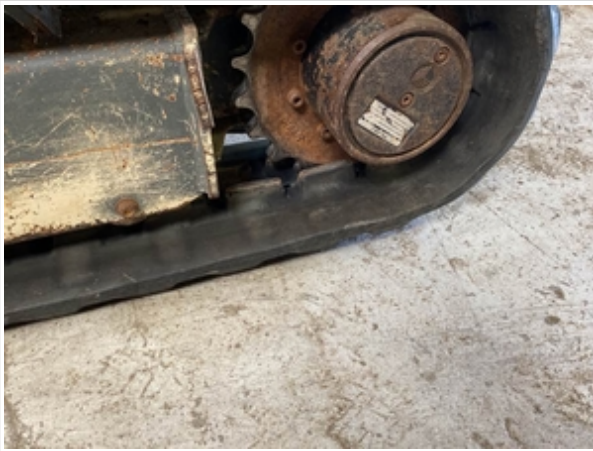
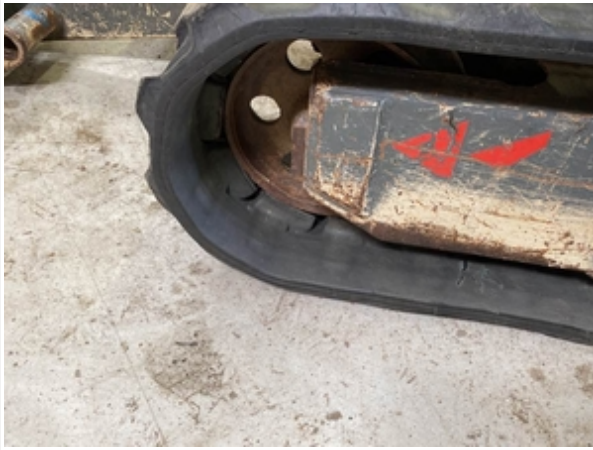
<p>Rubber Belt Drive Lugs</p>	<p>3 - Normal Wear & Tear</p>	
<p>Rubber Belt Drive Lugs Photos</p>

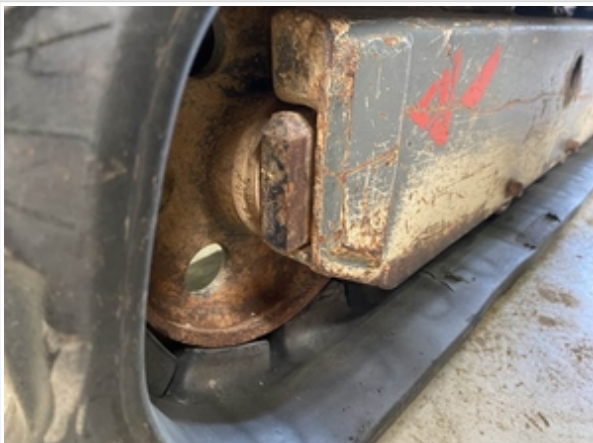
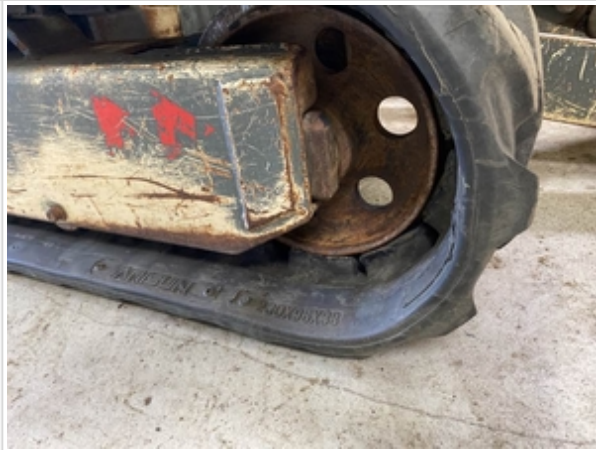
<p>Track Tensioners</p>	<p>3 - Normal Wear & Tear</p>	
<p>Comments</p>	<p>Track tension okay</p>	
<p>Track Tensioners Photos</p>

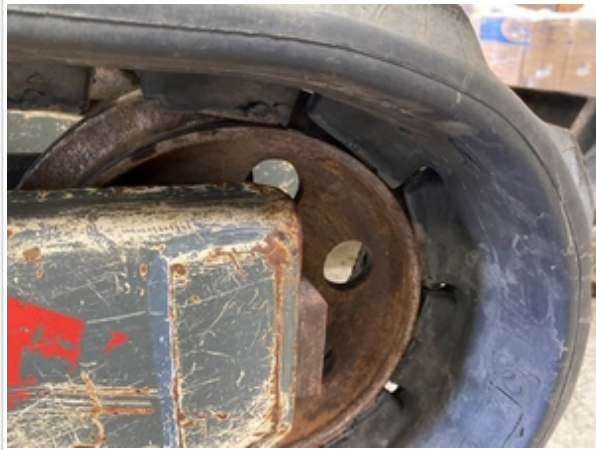
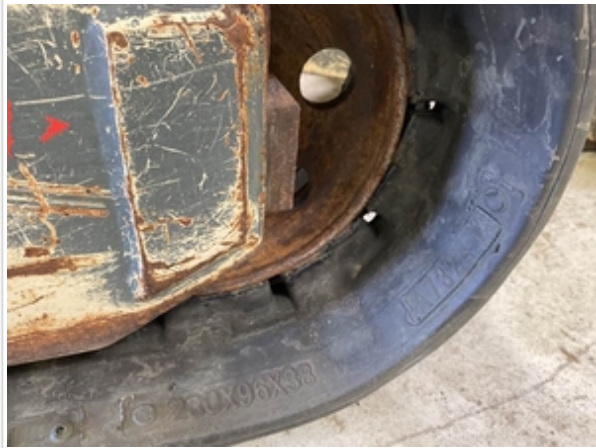
<p>Front Idlers</p>	<p>3 - Normal Wear & Tear</p>	
<p>Front Idlers Photos</p>

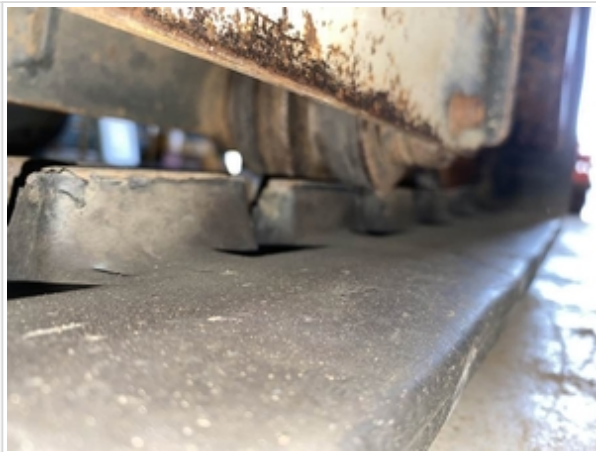
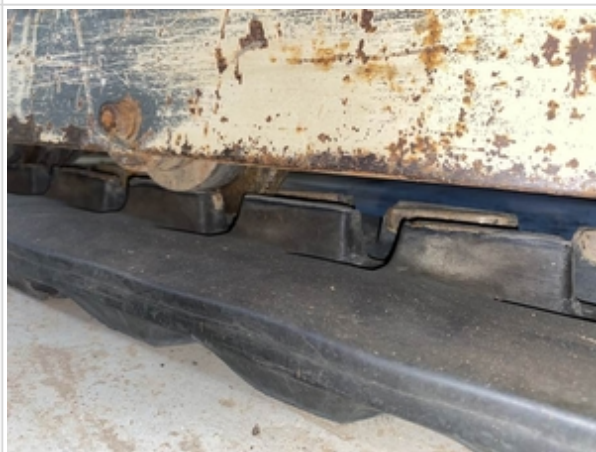
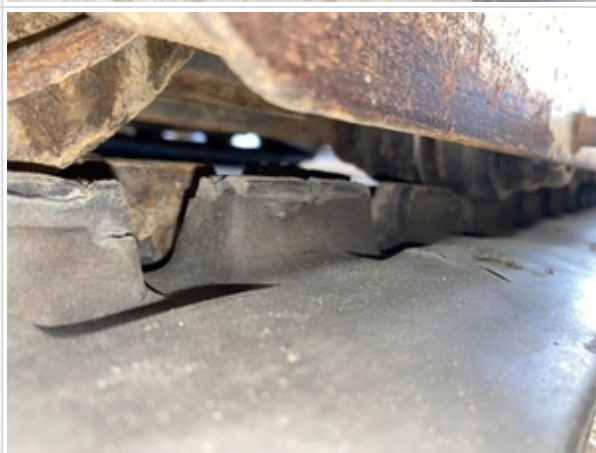
Rear Idlers Photos

Rear Idlers	3 - Normal Wear & Tear

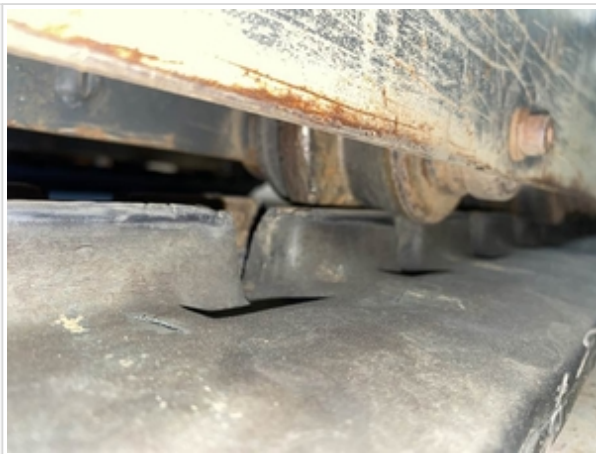
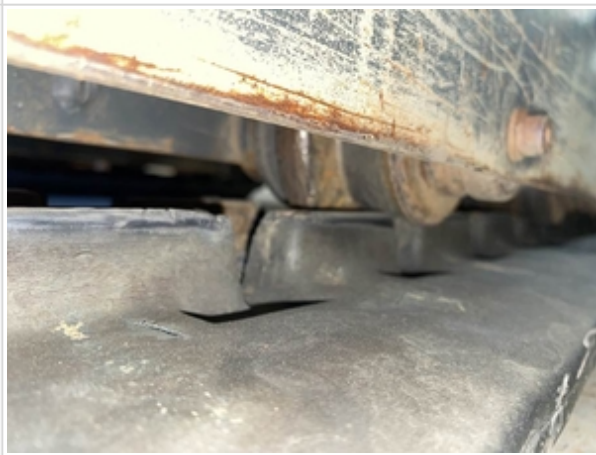
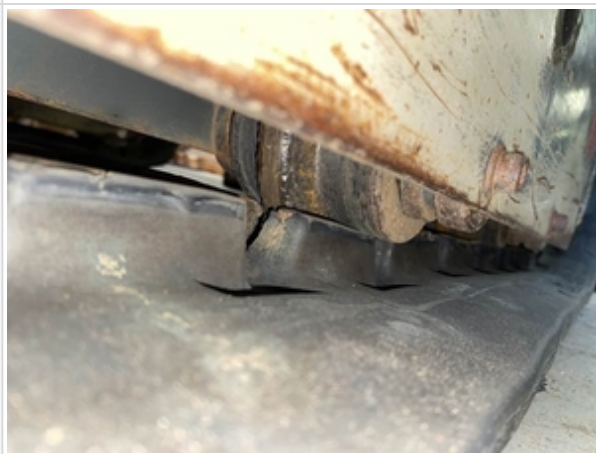
Track Rollers Photos

Track Rollers	3 - Normal Wear & Tear

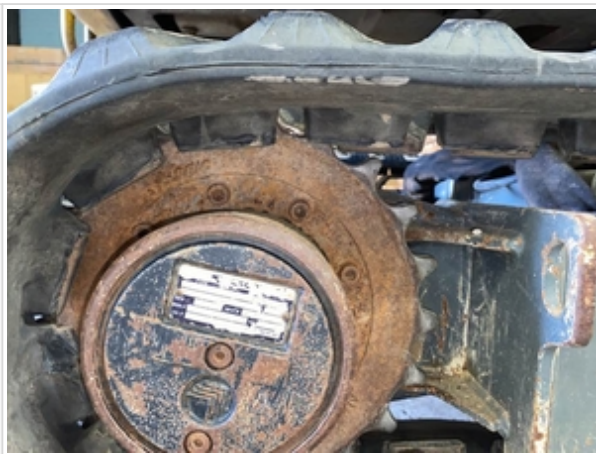
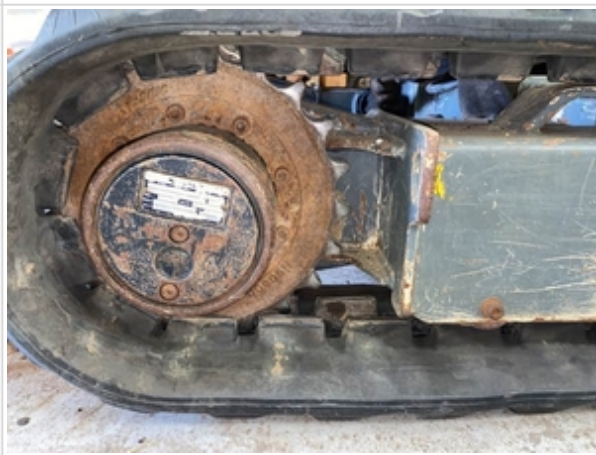
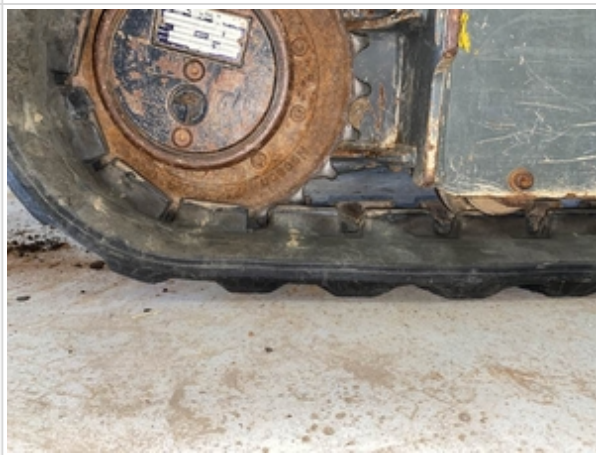
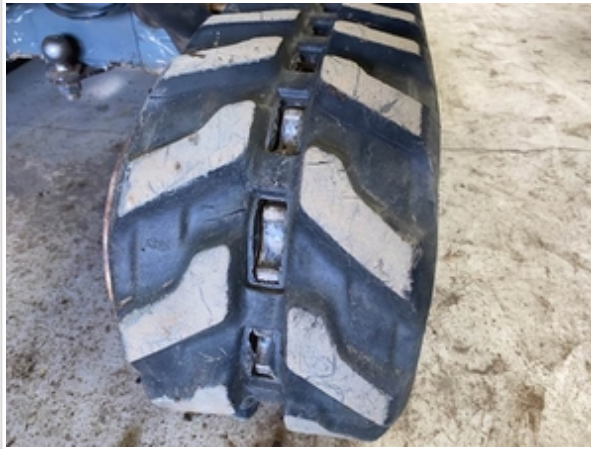
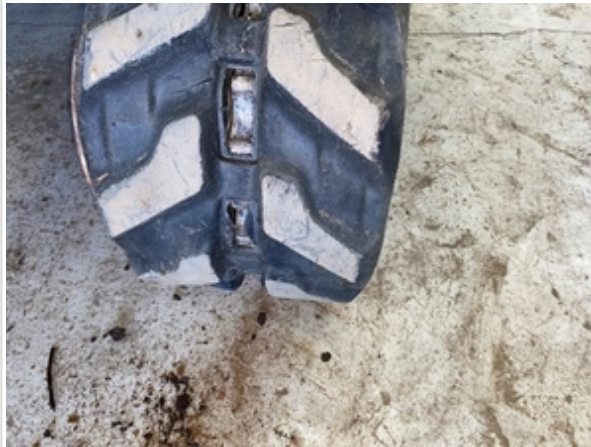
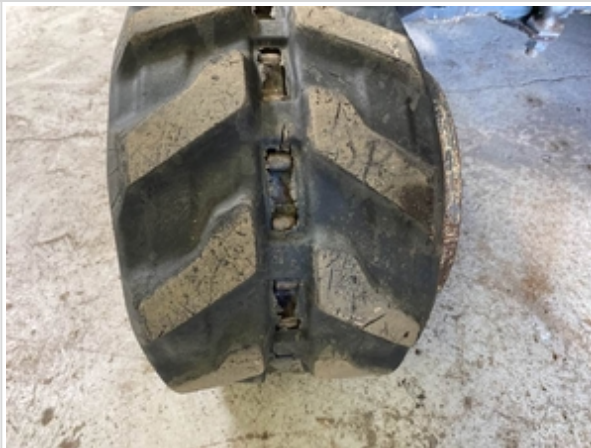
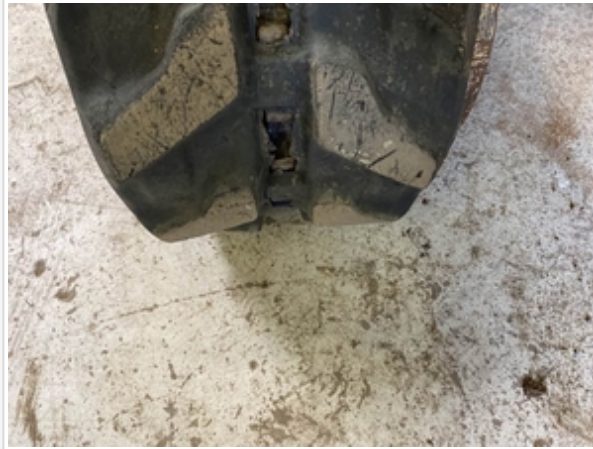
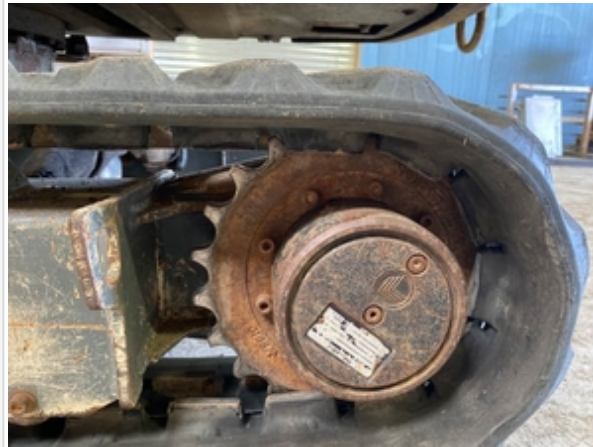
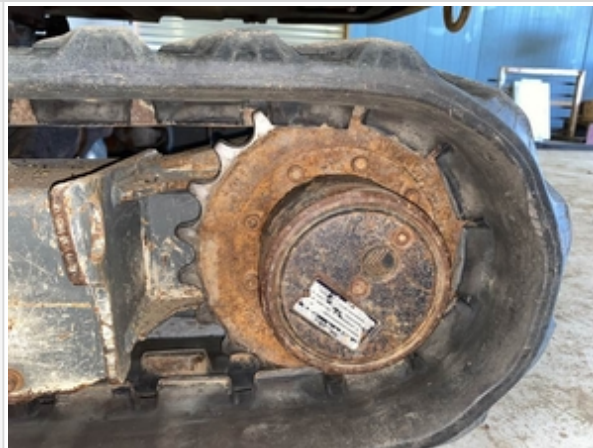
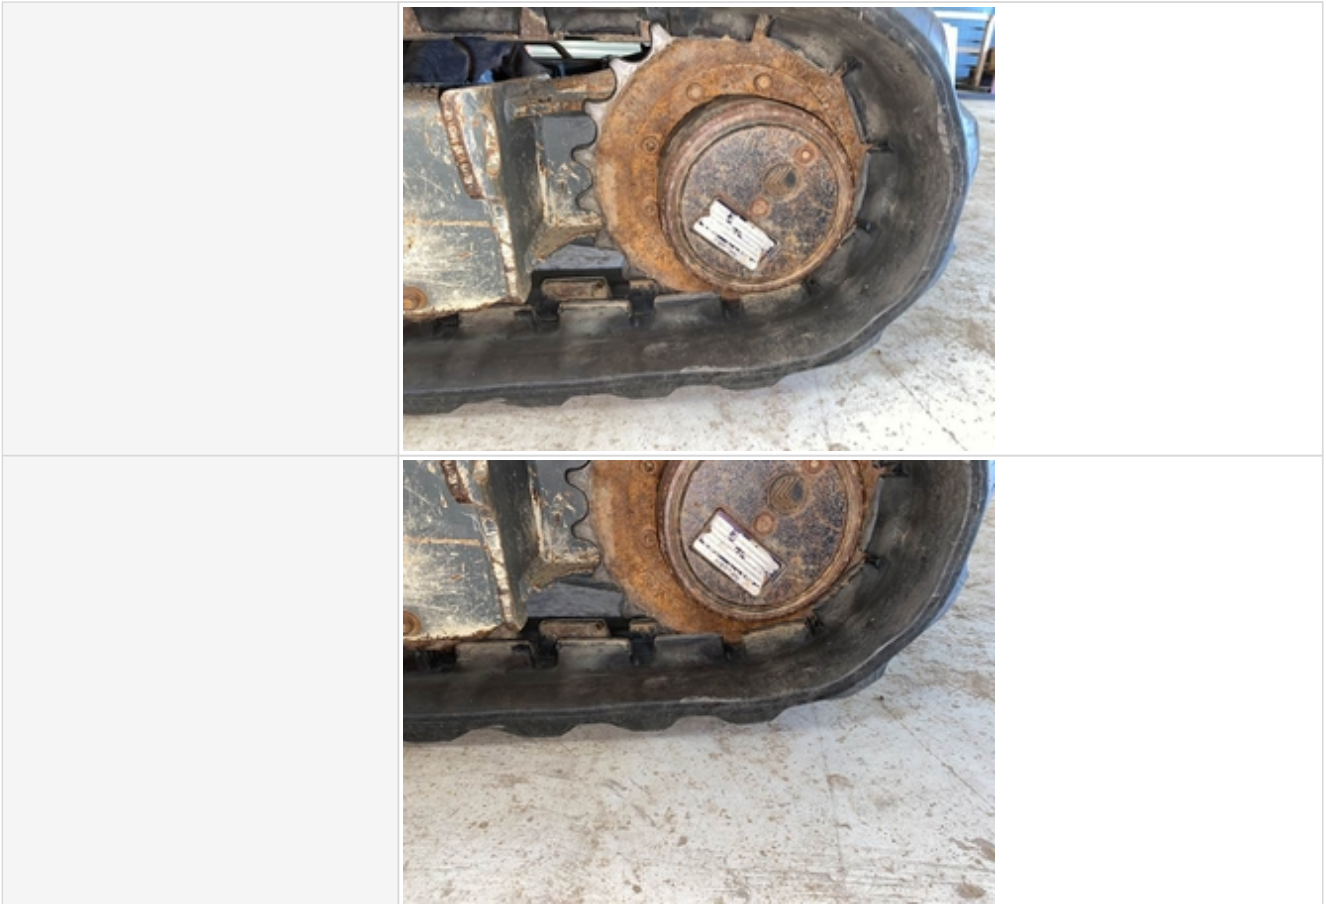
<p>Sprockets Photos</p>

Sprockets	3 - Normal Wear & Tear

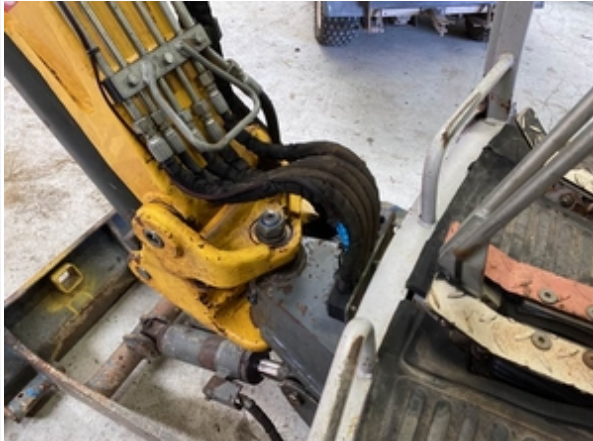
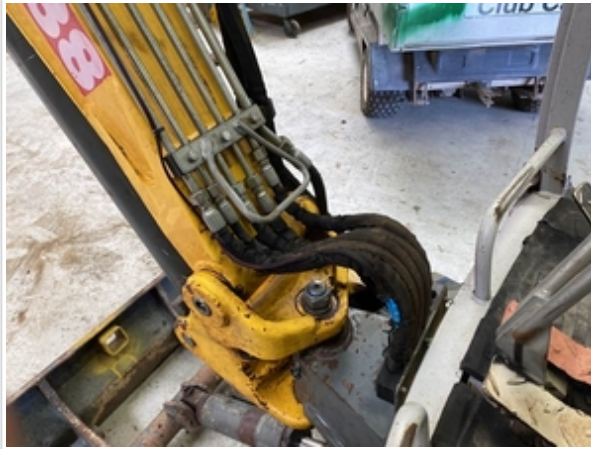
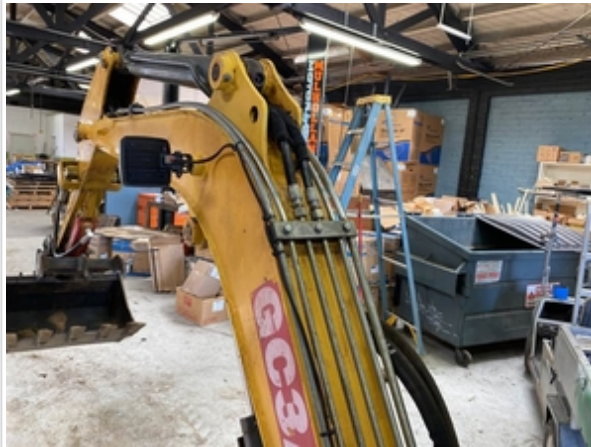
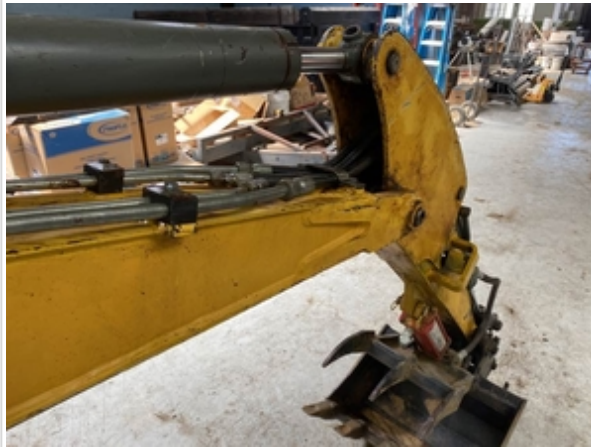
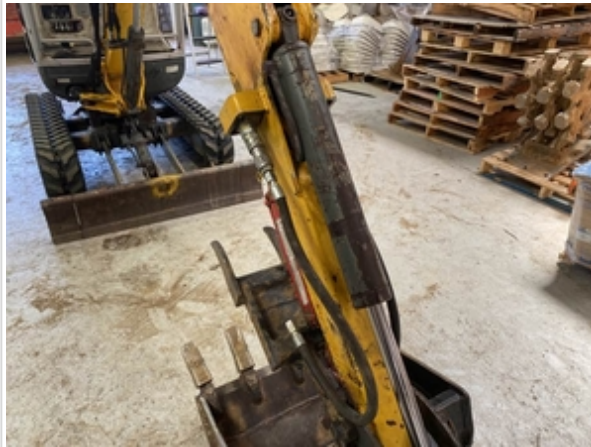
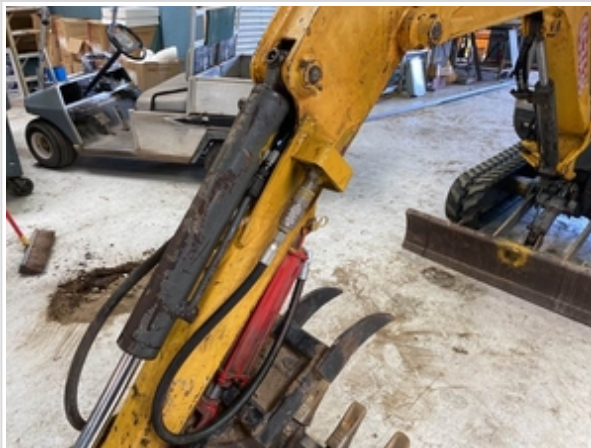
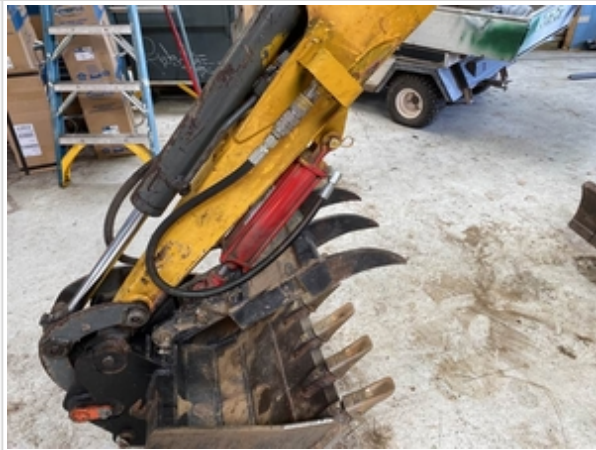
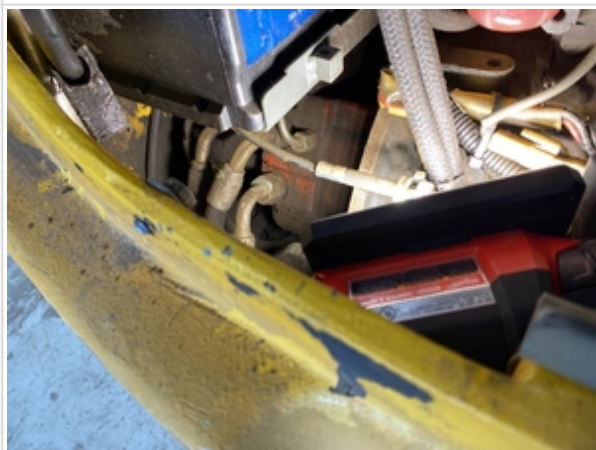
Hydraulics Overall	
Wet or Damp Hydraulic Lines / Fittings	No
Appearance of Hydraulic Lines / Fittings	3
Hydraulic Lines / Fittings Condition	Hydraulic lines & fittings are clean and in good condition
Appearance of Hydraulic Lines / Fittings Photos

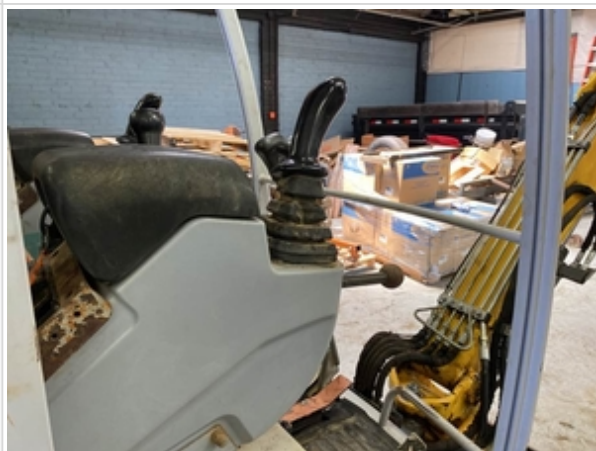
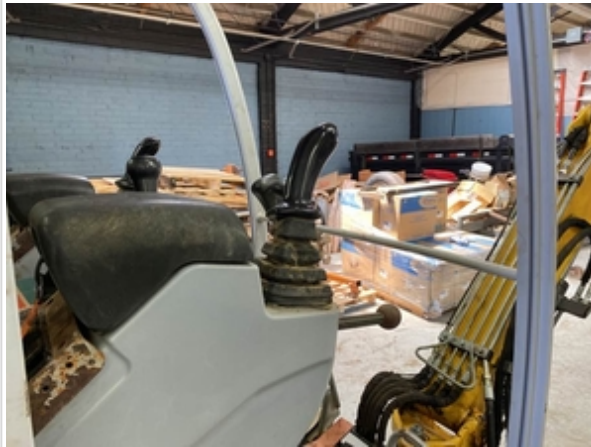
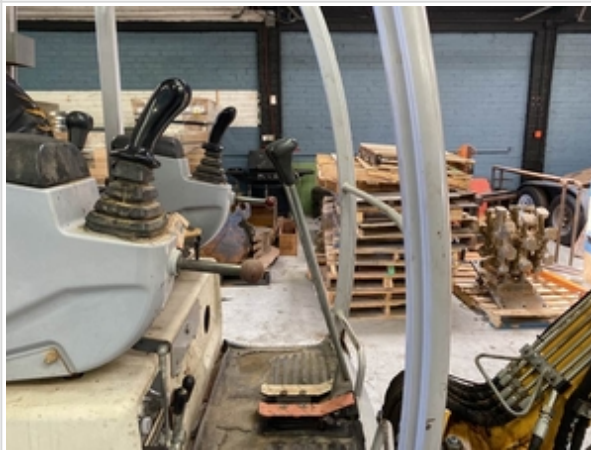
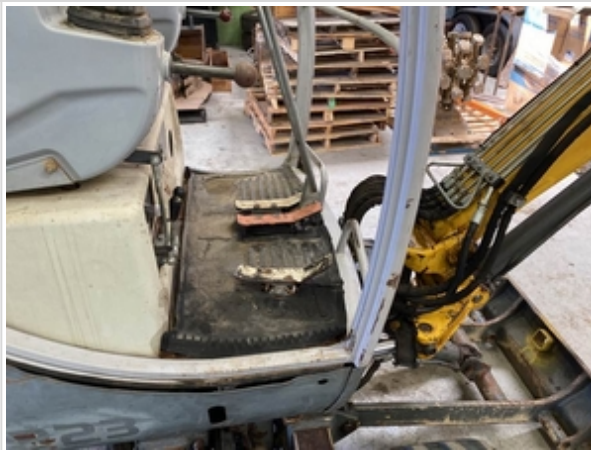
Unusual Noises (Hydraulic Pump)	No	
Hydraulic Pump Notes	No unusual noises heard during operation	
External Controls / Levers	3	
External Controls / Levers Condition	Good function & condition of hydraulic controls	
External Controls / Levers Photos
