Inspection Report (Mini Excavator)

Year	2006
Make	Neuson
Model	G - 2203 RD
Serial Number	AE00164
Hour Meter Reading	555.2
Previous Application (e.g., earth moving, mining, demolition, etc)	General construction (plumbing)

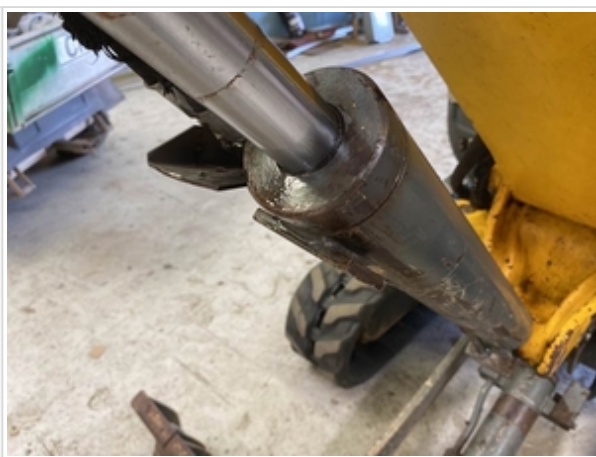
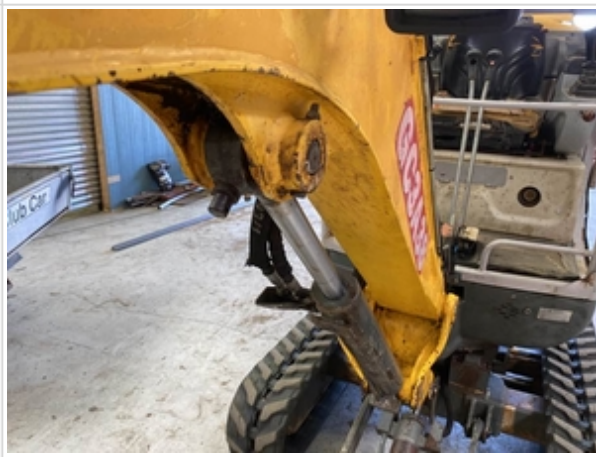
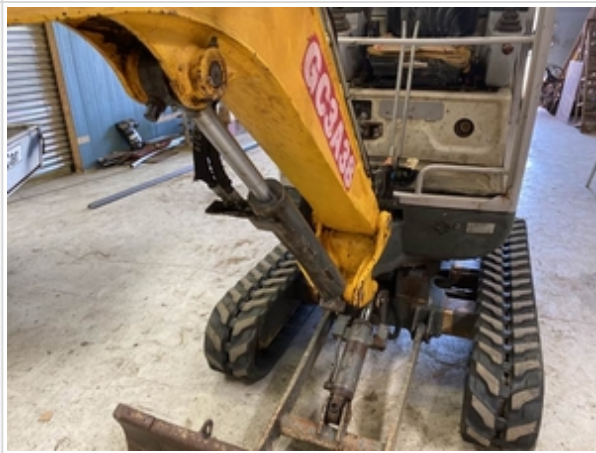
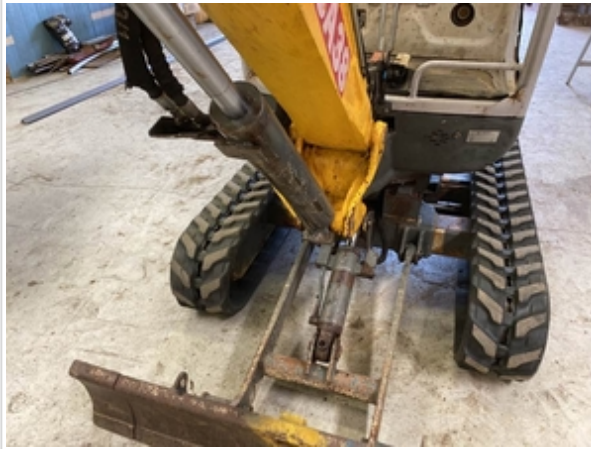
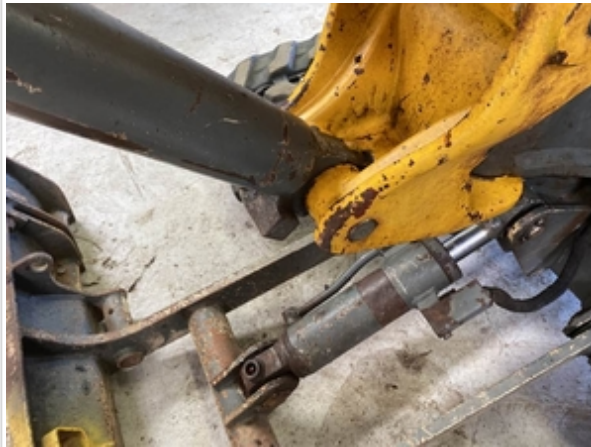
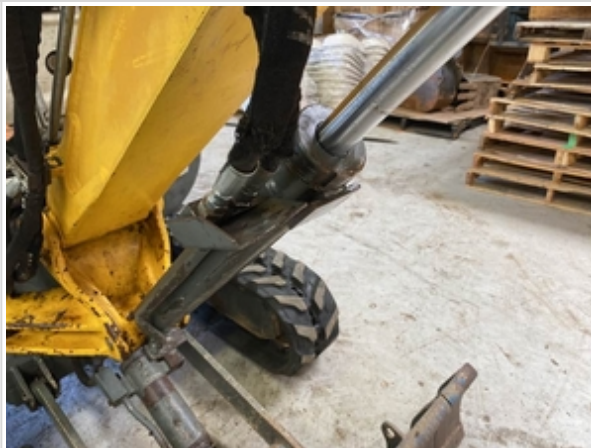
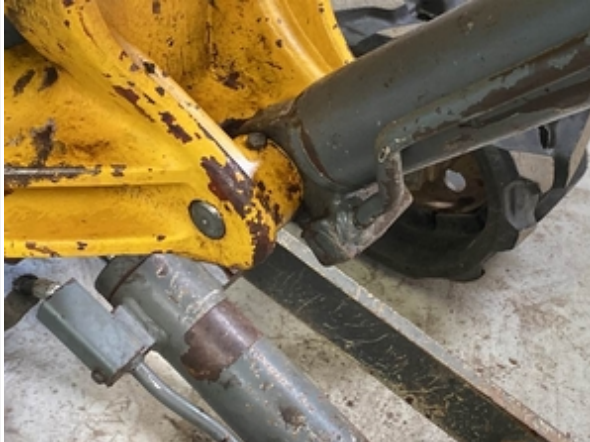
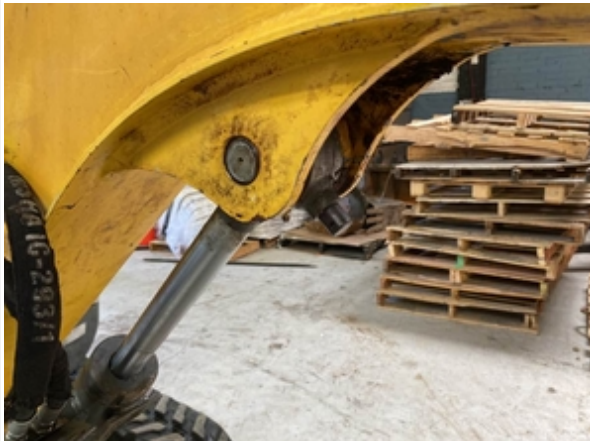
<p>Boom Cylinder Photos</p>

Boom Cylinder	Check the boom cylinder. Note any wear, pitting, discoloration, etc. Take photos.
Boom Cylinder: Mounting Pin	3
Boom Cylinder: Oil Leaks	No
Comments	Seepage coming from boom cylinder rod seal

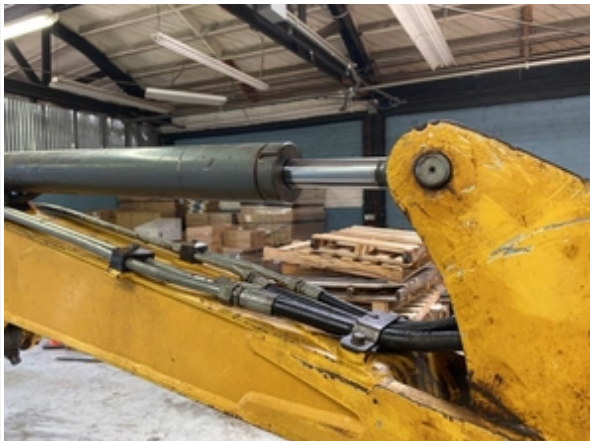
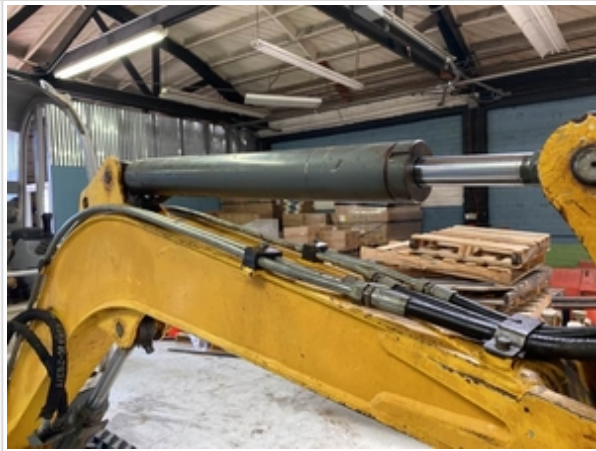
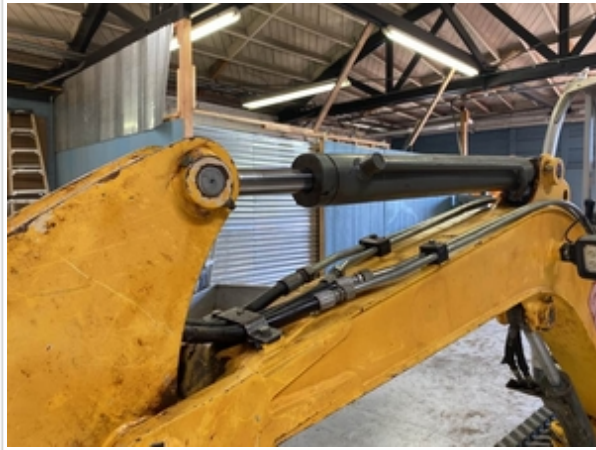
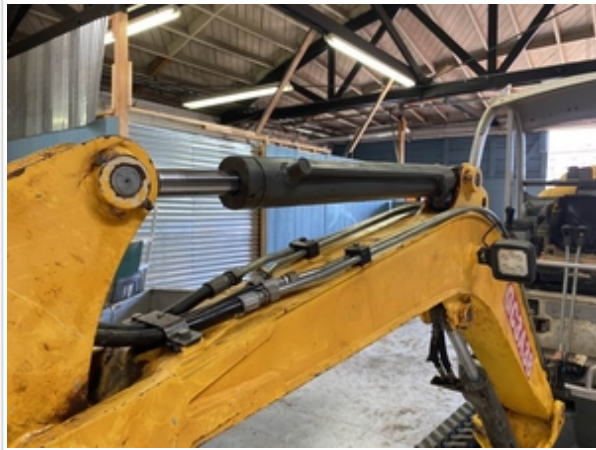
Stick Cylinder	Check the stick cylinder. Note any wear, pitting, discoloration, etc. Take photos.	
Stick Cylinder: Mounting Pin	3	
Stick Cylinder: Oil Leaks	No	
Stick Cylinder Photos

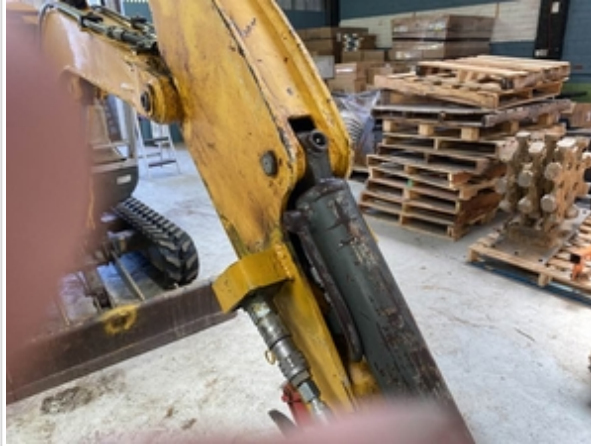
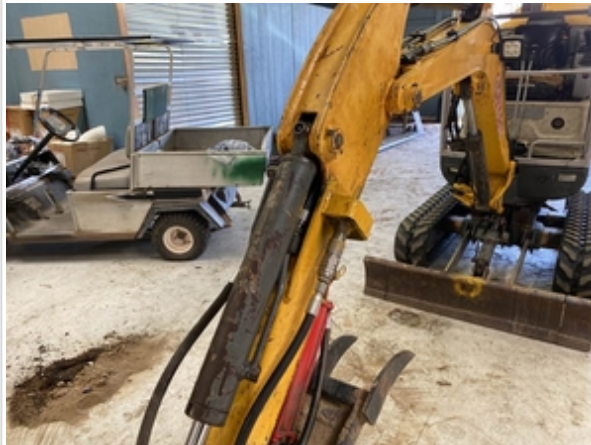
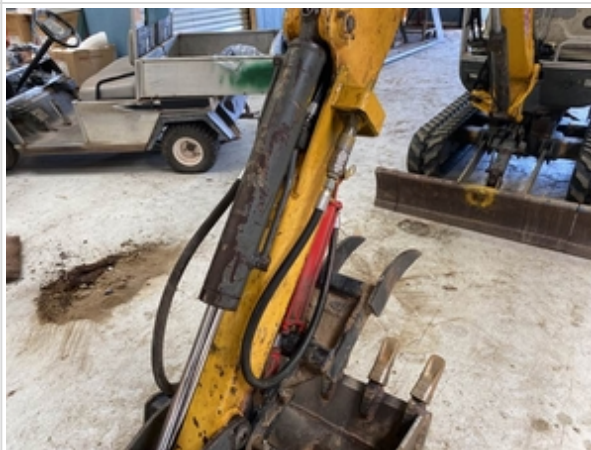
Bucket Cylinder Photos

Bucket Cylinder	Check the bucket cylinder. Note any wear, pitting, discoloration, etc. Take photos.
Bucket Cylinder: Mounting Pin	3
Bucket Cylinder: Oil Leaks	No

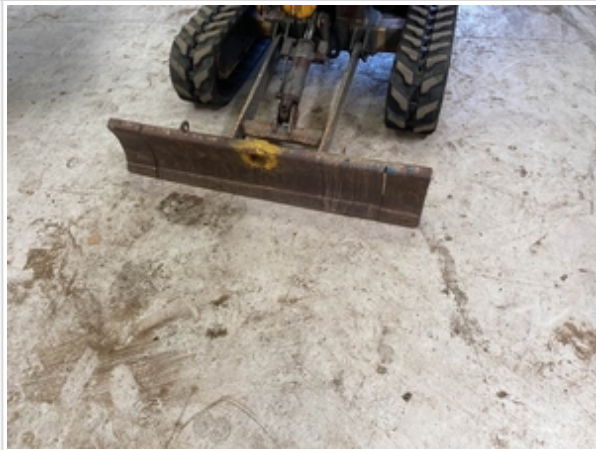
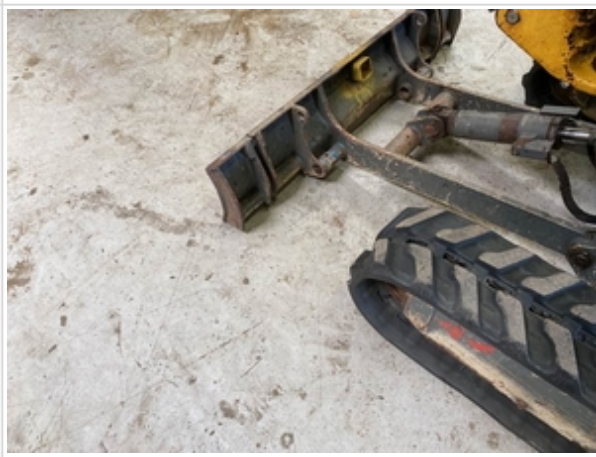
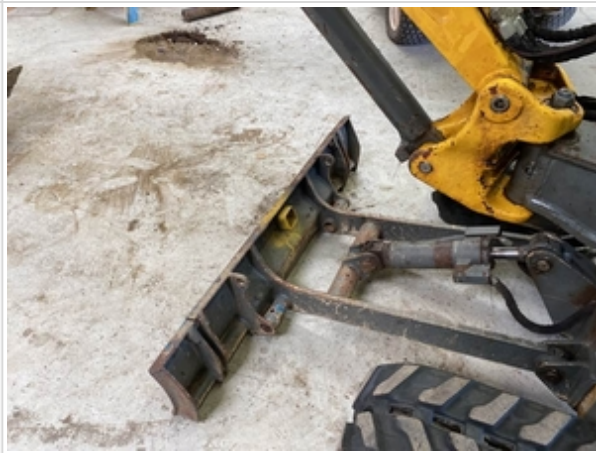
<p>Blade Photos</p>

<p>Blade</p>	<p>Check the blade. Note any wear, pitting, discoloration, etc. Take photos.</p>
<p>Blade</p>	<p>3</p>

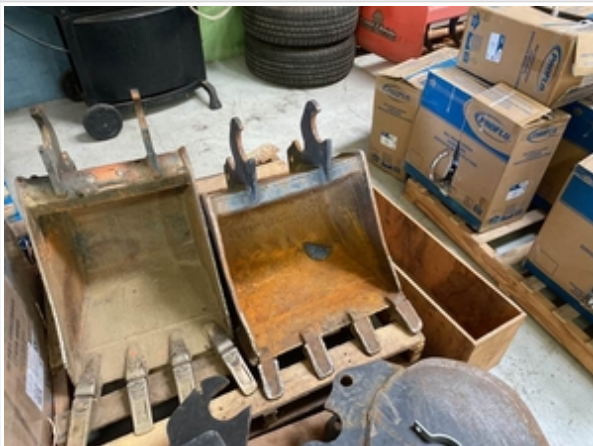
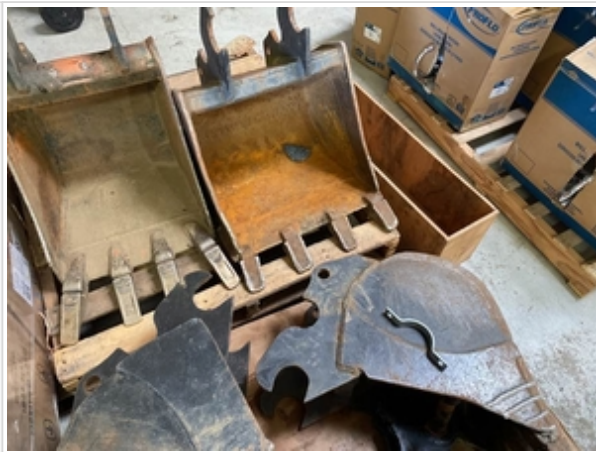
Instructions	<p>Evaluate the following on a 4 point scale (leave comments where an explanation is appropriate):</p> <p>4 = Like New, Recently Replaced 3 = Normal Wear & Tear 2 = Above Average Wear 1 = Service Required</p>
Bucket Condition	<p>3 - Normal Wear & Tear</p>
Bucket Photos

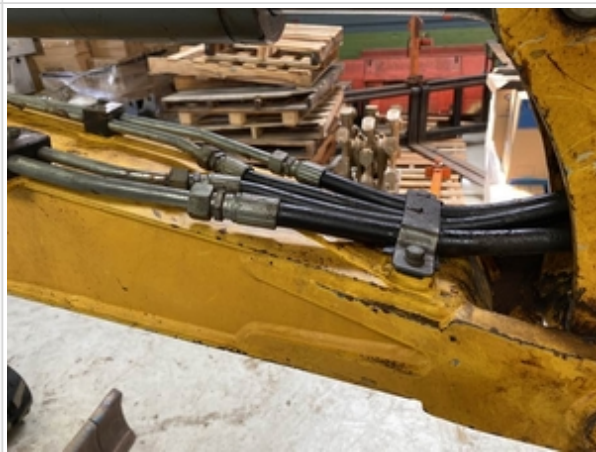
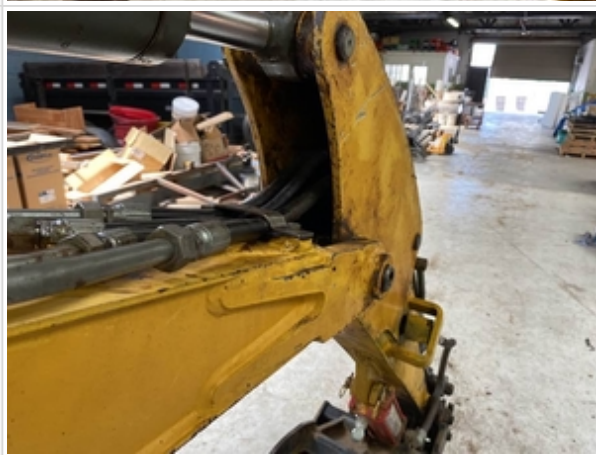
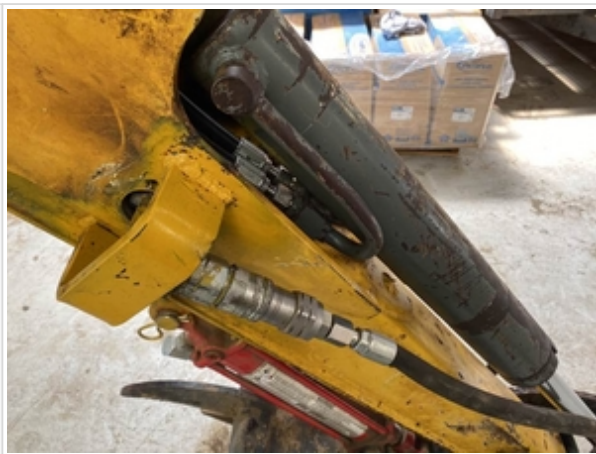
<p>Bucket Hose & Fittings</p>	<p>3 - Normal Wear & Tear</p>
<p>Bucket Hose & Fittings Photos</p>

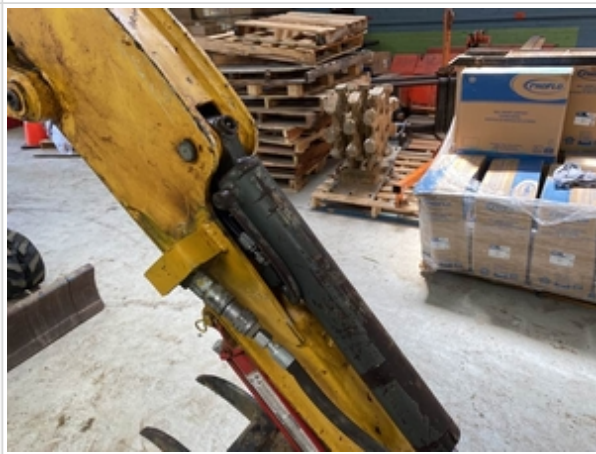
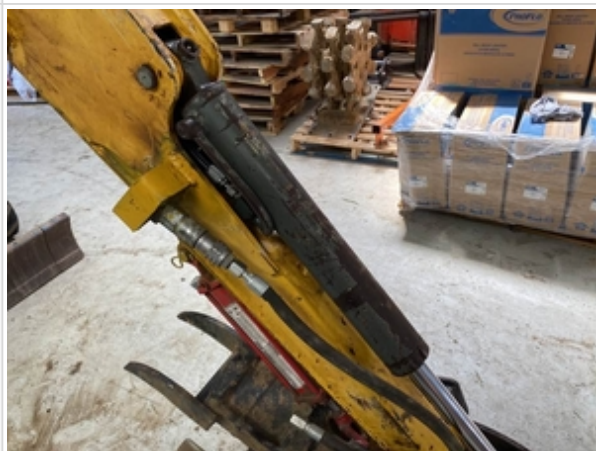
<p>Bucket Cylinder</p>	<p>3 - Normal Wear & Tear</p>	
<p>Bucket Cylinder Photos</p>

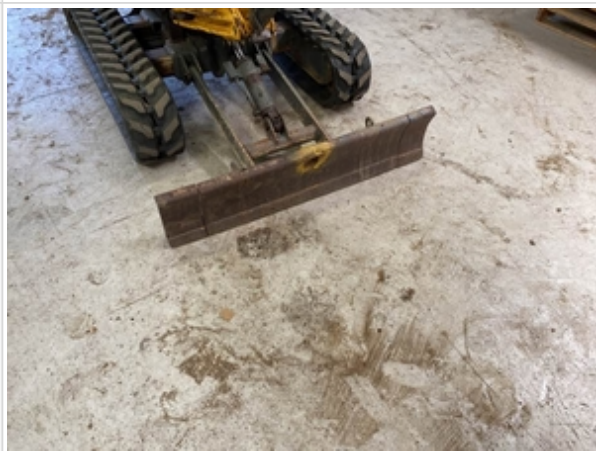
Blade Condition	3 - Normal Wear & Tear
Blade Photos

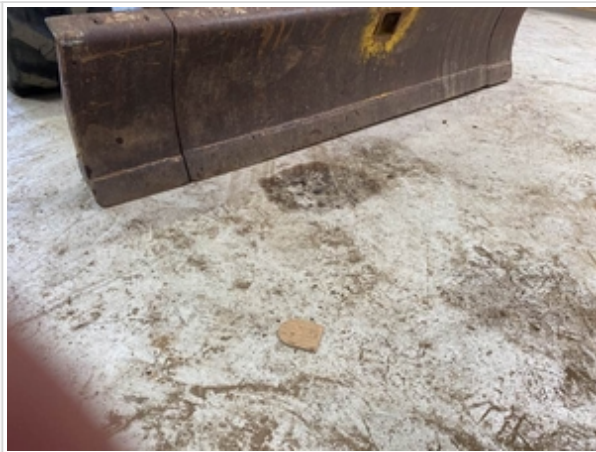
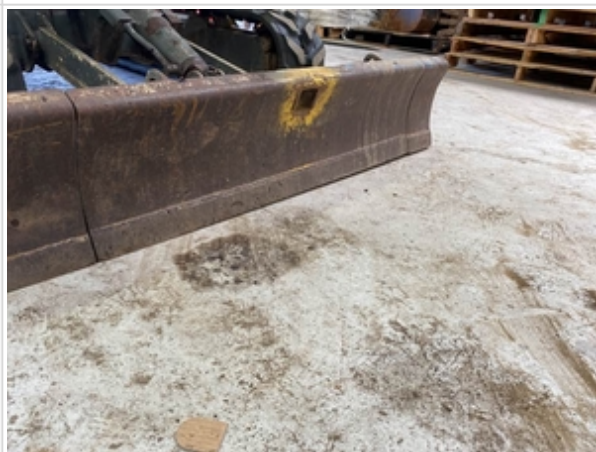
<p>Blade Edge Photos</p>

Blade Edge	3 - Normal Wear & Tear

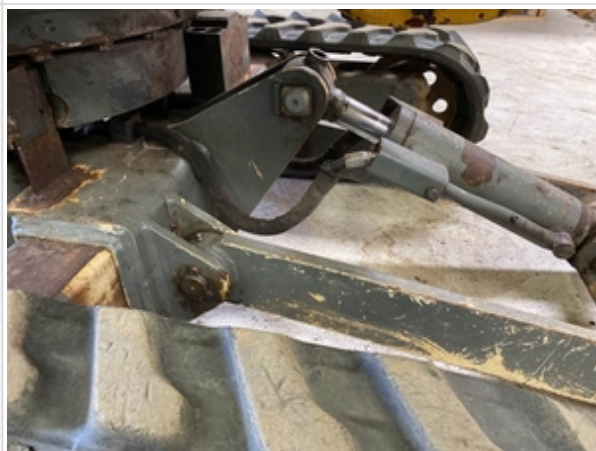
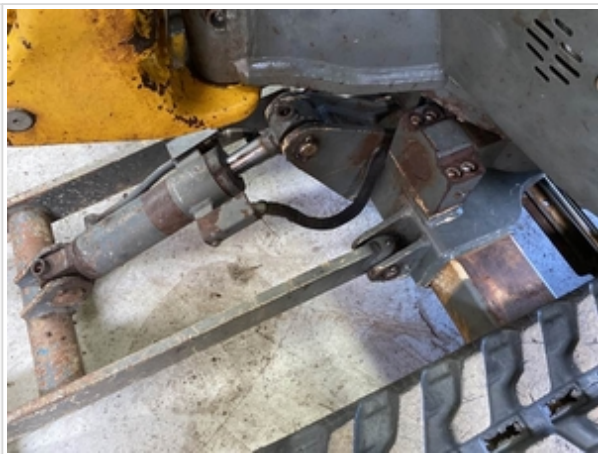
<p>Blade Hose & Fittings</p>	<p>3 - Normal Wear & Tear</p>	
<p>Blade Hose & Fittings Photos</p>

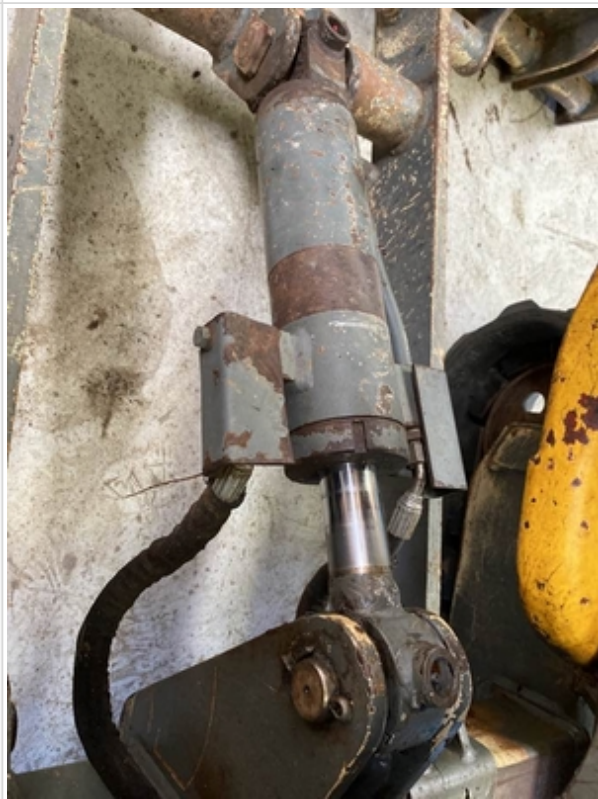
<p>Blade Cylinder</p>	<p>3 - Normal Wear & Tear</p>	
<p>Blade Cylinder Photos</p>

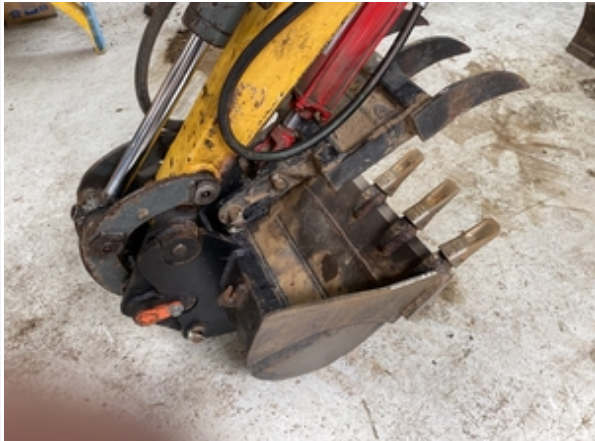
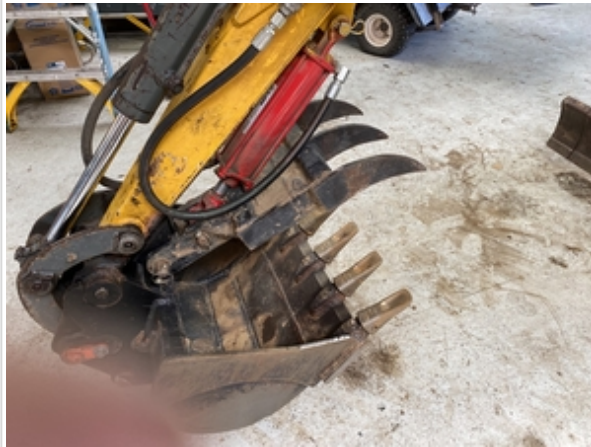
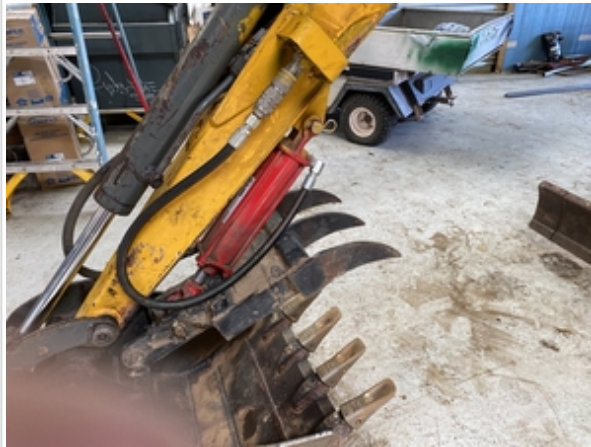
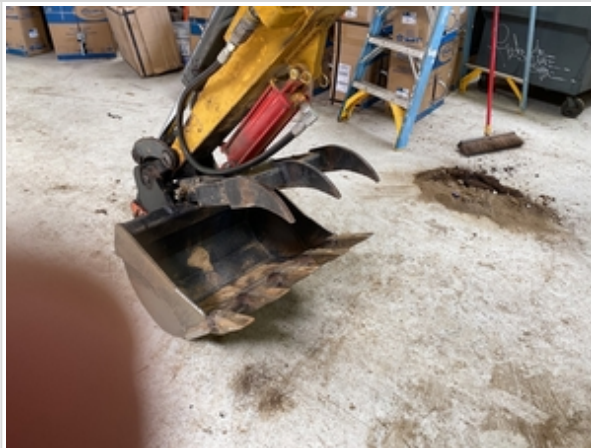
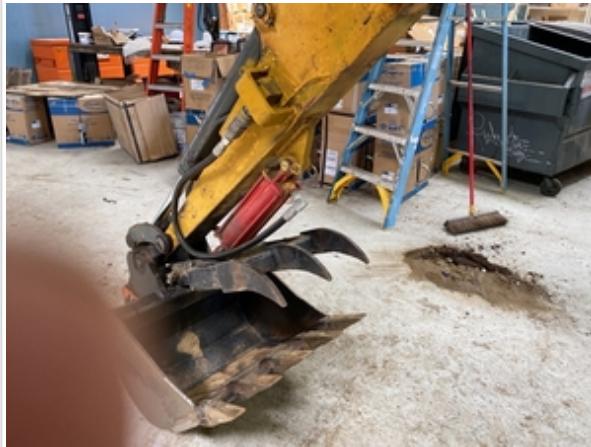
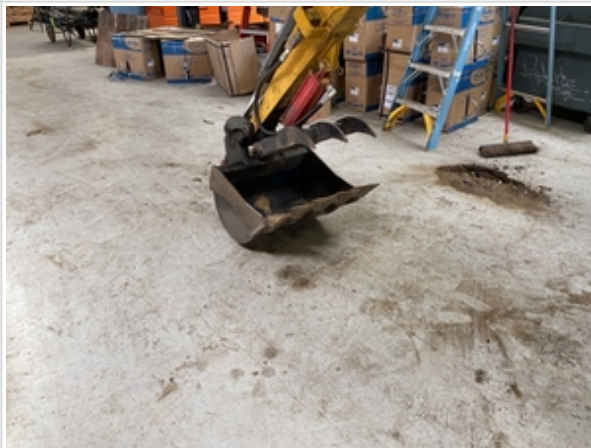
Attachment Type	14" Hydraulic Thumb
Attachment Make	Lynx Hydraulic
Attachment Size / Specs	12 to 14"
Attachment Condition	3 - Normal Wear & Tear
Comments	Works well
Attachment Photos
