Inspection Report (On-Highway Dump Truck)

Year	2014
Make	Caterpillar
Model	CT660
Serial Number	3HTJGTKT3EN019099
Truck Odometer Reading	172,828
Current Inspection / State Cert / DOT	Expired (no d.o.t. Inspection on hand)
Previous Application (e.g., earth moving, mining, demolition, etc)	Asphalt paving construction

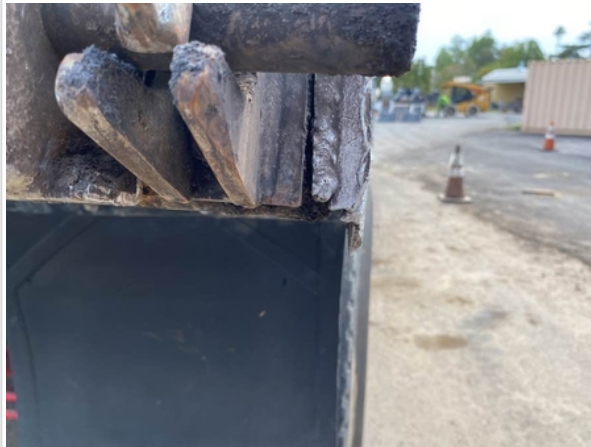
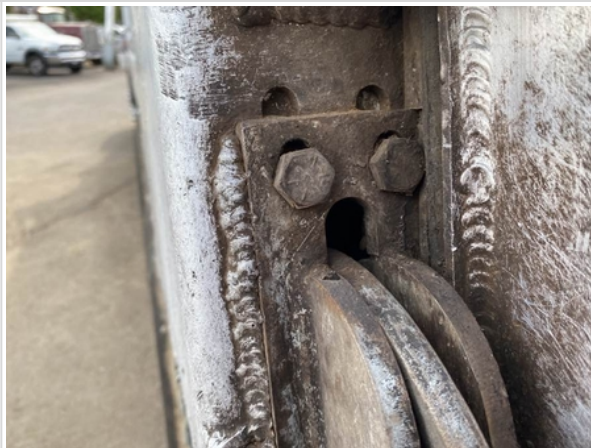
Rear	3 - Normal Wear & Tear	
Rear Condition	No visible damage, Other (see comments)	
Comments	Small crack on aluminum on rear tailgate latches	
Rear Photos

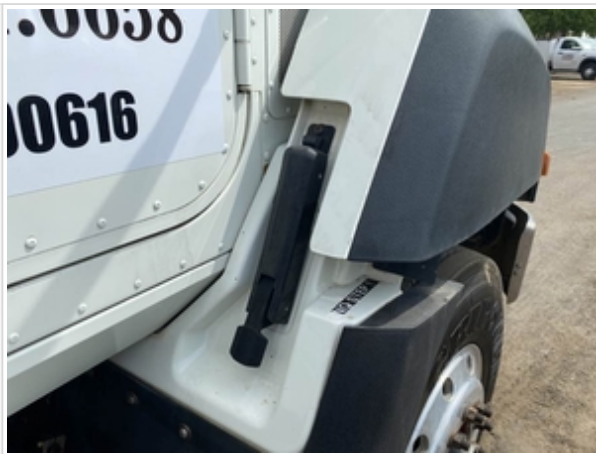
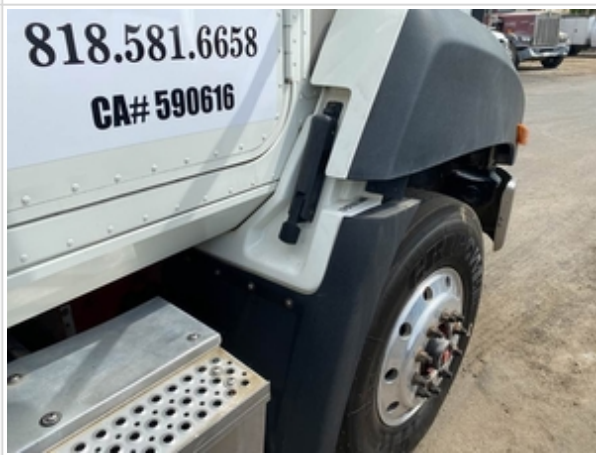
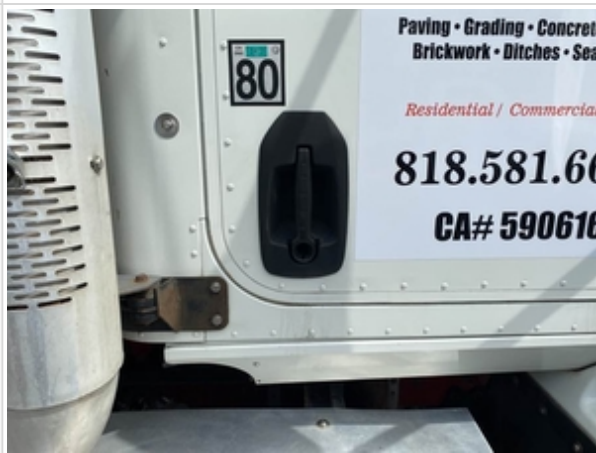
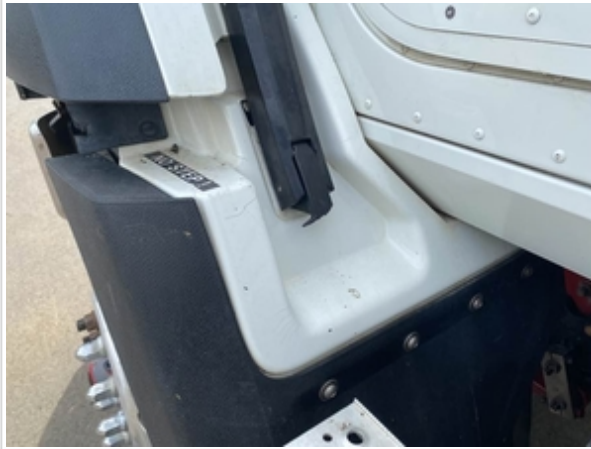
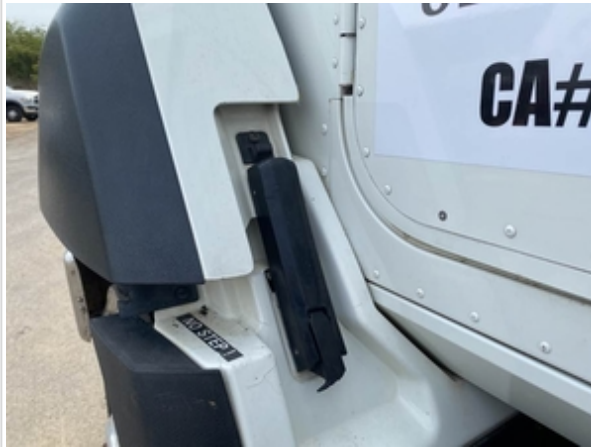
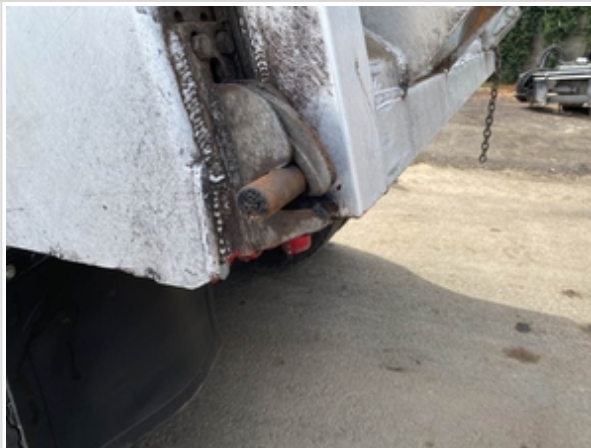
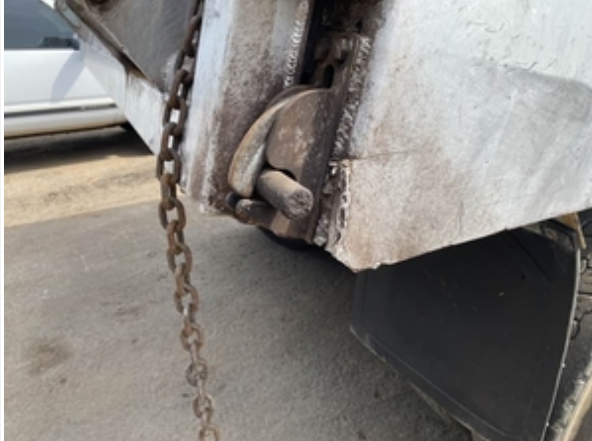
Doors / Canopy Latches	3 - Normal Wear & Tear
Doors / Canopy Latches Condition	No visible damage, Other (see comments)
Comments	Left side hood latch handle broken but still locks, right side door lock in handle missing

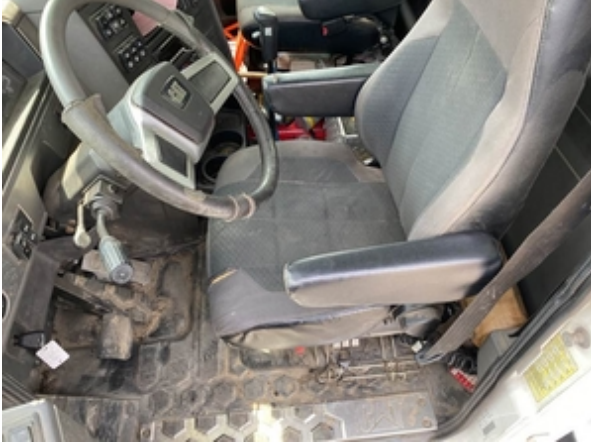
Operator's Seat & Arm Rests	3 - Normal Wear & Tear
Comments	Minor wear and small tear on driver bottom cushion
Operator's Seat & Arm Rests Photos

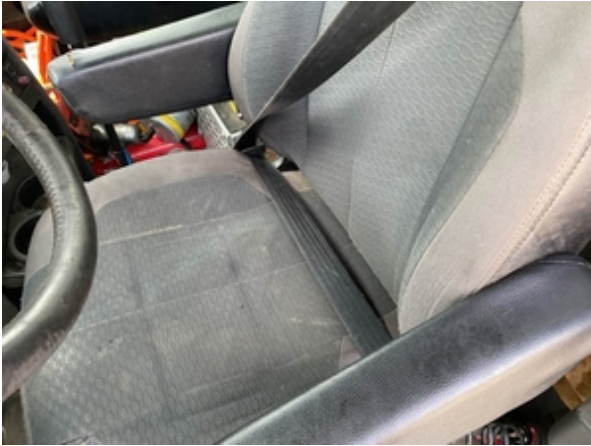
Seat Belt	2 - Above Average Wear
Comments	Driver side seat belt works but not easy to pull out
Seat Belt Photos

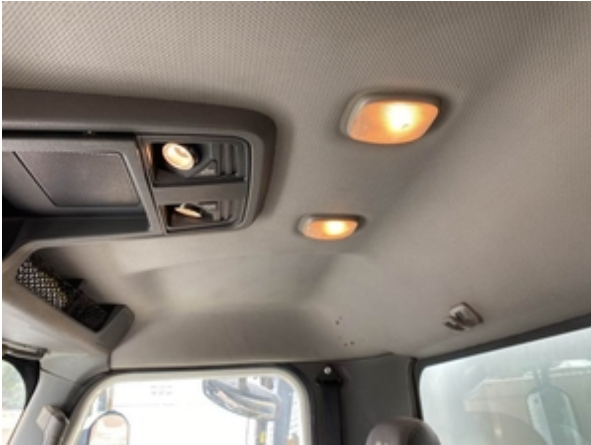
Cabin Lights	3 - Normal Wear & Tear
Cabin Lights Photos

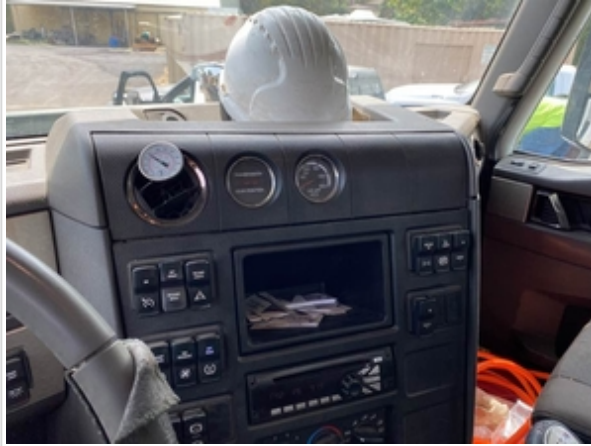
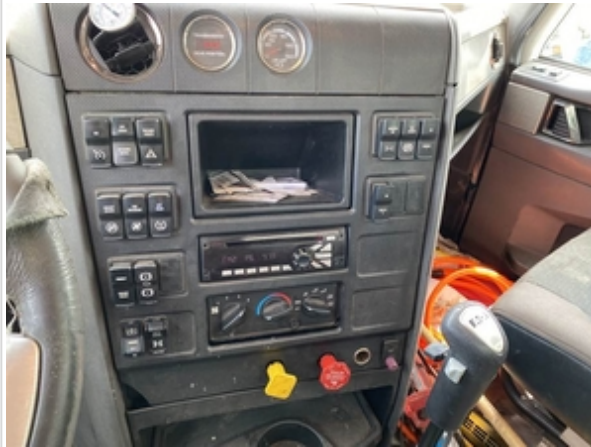
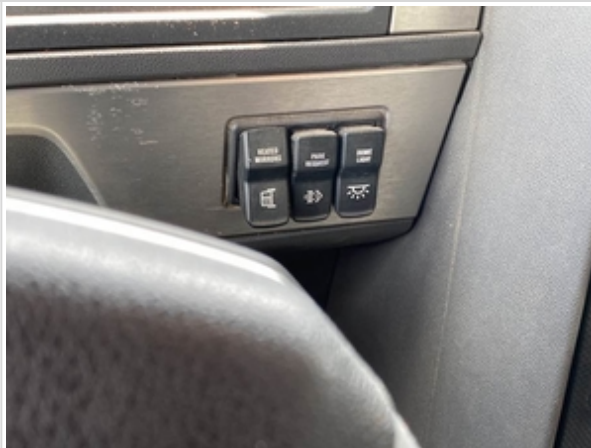
Controls & Switches Photos

Controls & Switches	3 - Normal Wear & Tear

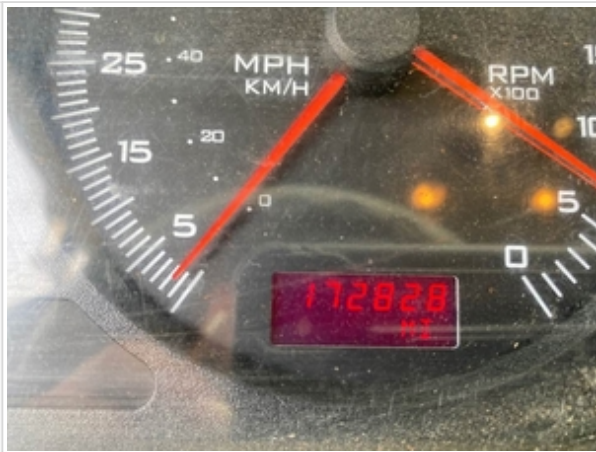
<p>Odometer Activity Photos</p>

<p>Odometer Activity</p>	<p>3 - Normal Wear & Tear</p>

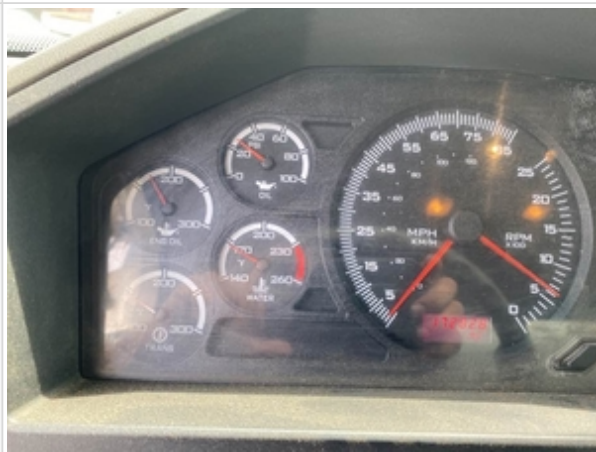
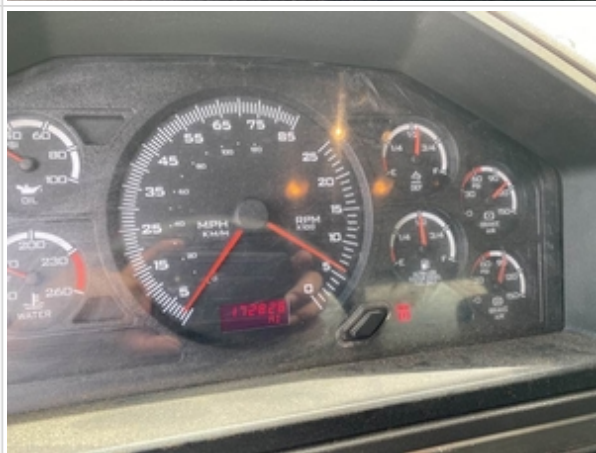
<p>Other Gauge Activity</p>	<p>3 - Normal Wear & Tear</p>
<p>Other Gauge Activity Photos</p>

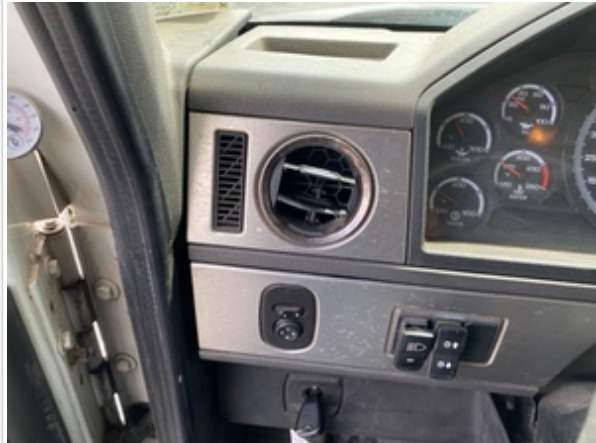
<p>Fans / Vents</p>	<p>3 - Normal Wear & Tear</p>
<p>Comments</p>	<p>Ambient temp 95 ac vent temp 70</p>
<p>Fans / Vents Photos</p>

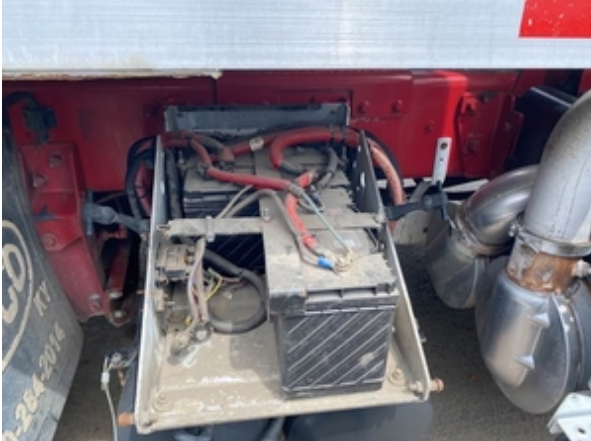
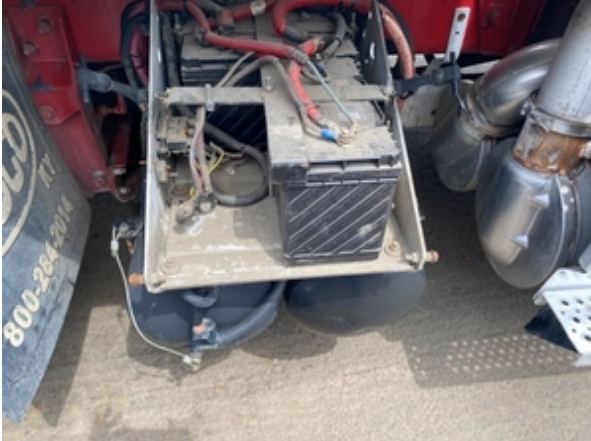
Battery Condition	Like new, recently replaced, Dusty & dirty appearance
Battery Condition Photos

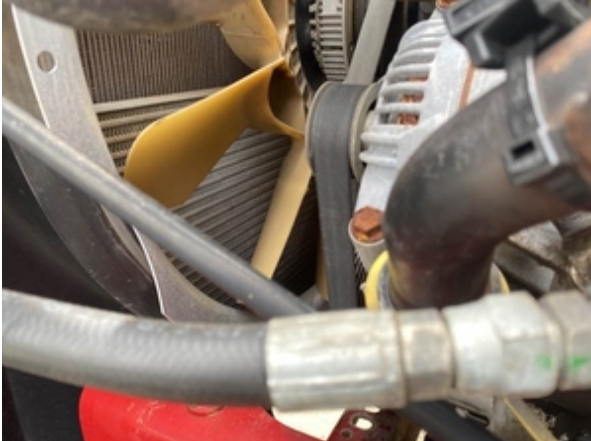
Radiator	3 - Normal Wear & Tear
Radiator Photos

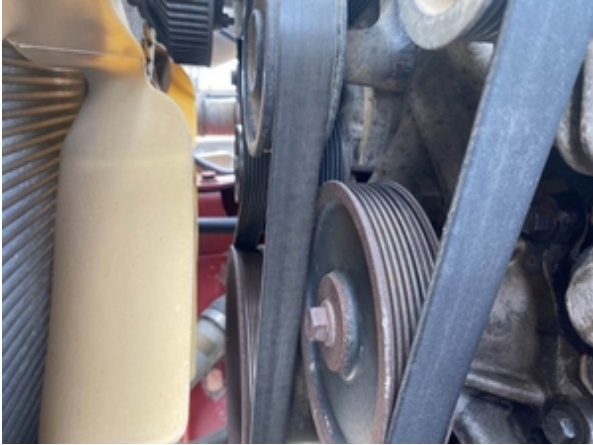
Belts	3 - Normal Wear & Tear	
Belt Condition	Frayed belt edges observed, Belts appear in good condition & alignment with proper tension	
Comments	A/c belt needs to be replaced soon, fan serpentine okay	
Belt Photos

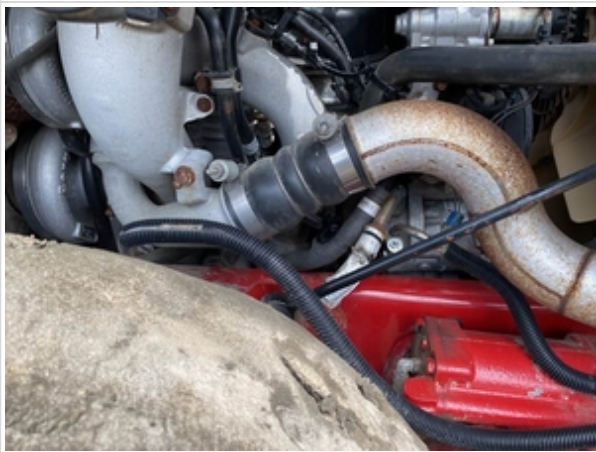
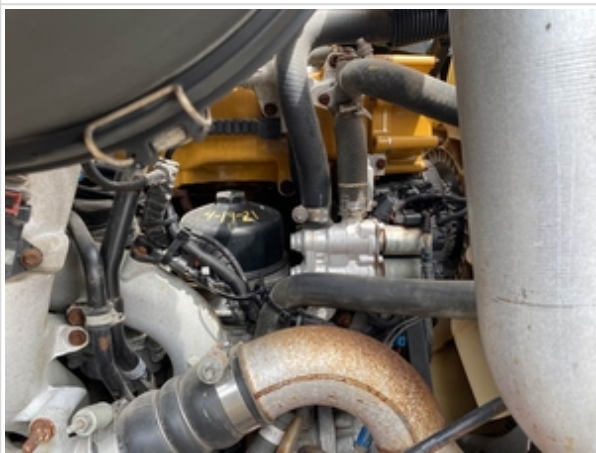
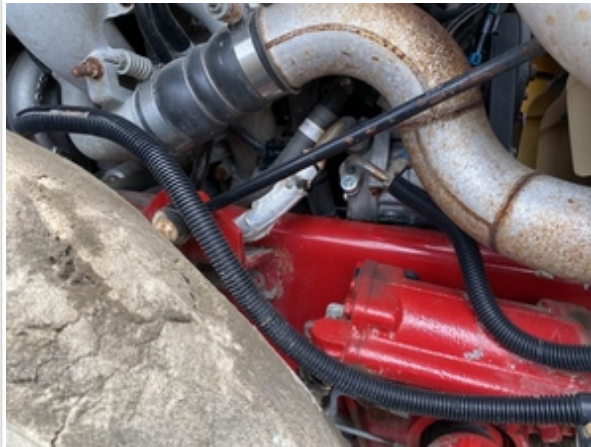
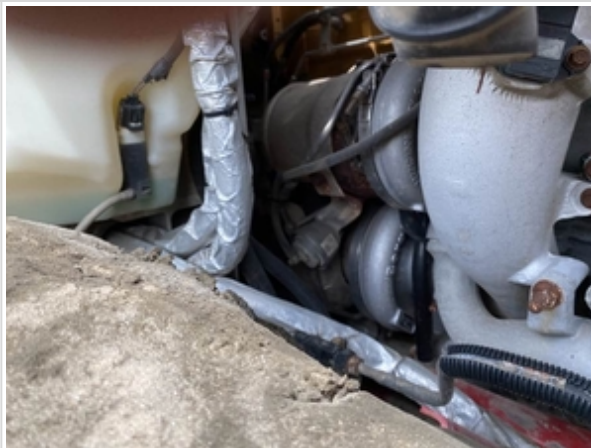
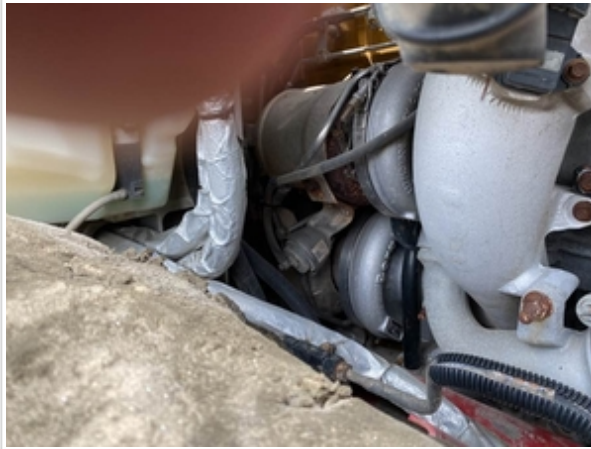
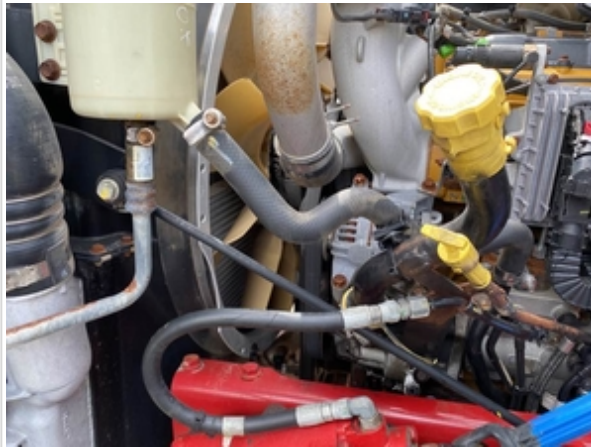
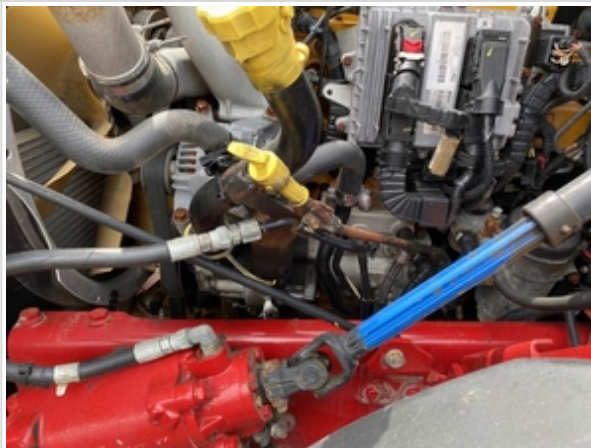
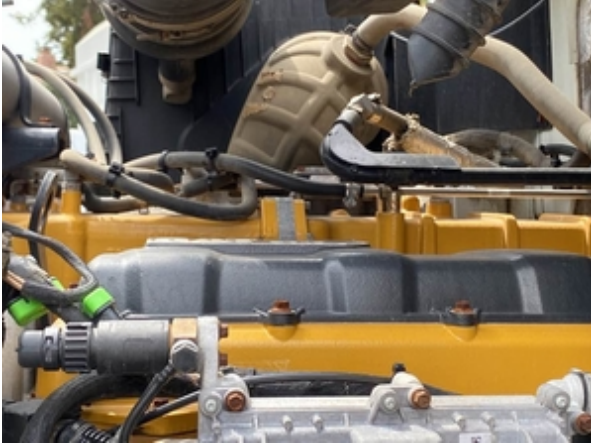
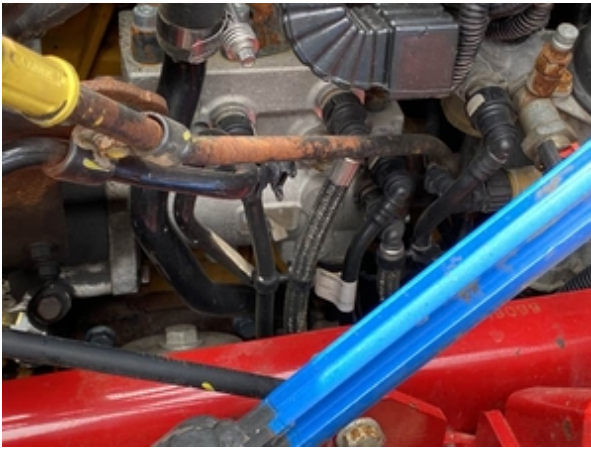
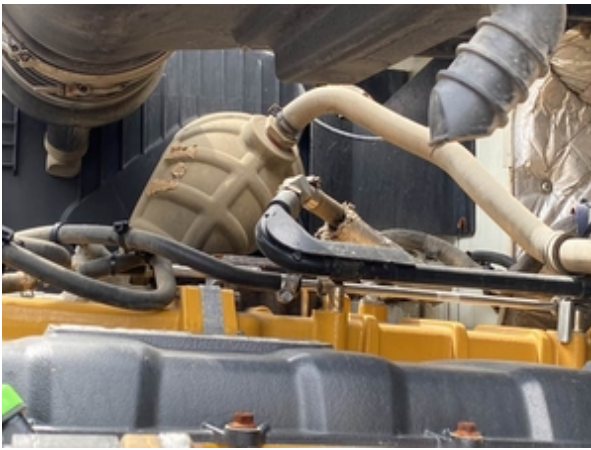
Hoses	3 - Normal Wear & Tear	
Hose Condition	Firm, pliant hoses with no signs of wear or leaks	
Hose Photos

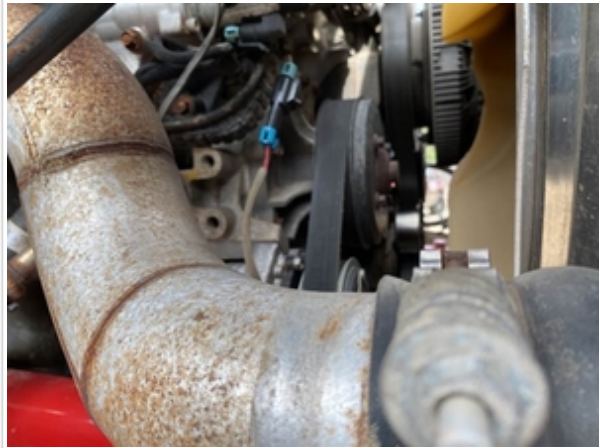
Water Pump Photos

Water Pump	3 - Normal Wear & Tear
Water Pump Condition	No unusual pump noises heard

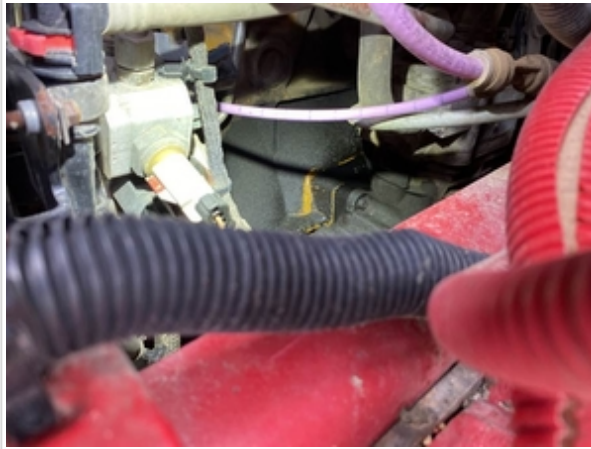
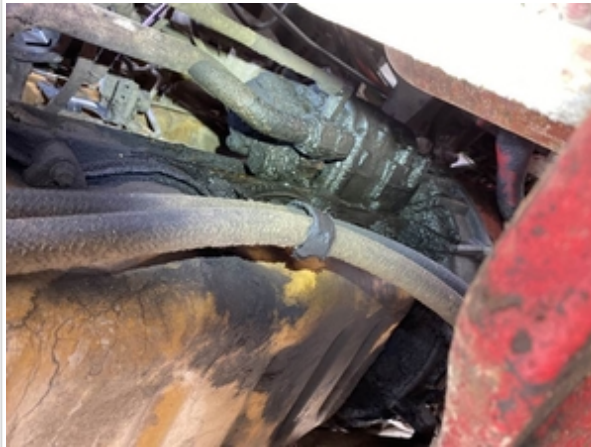
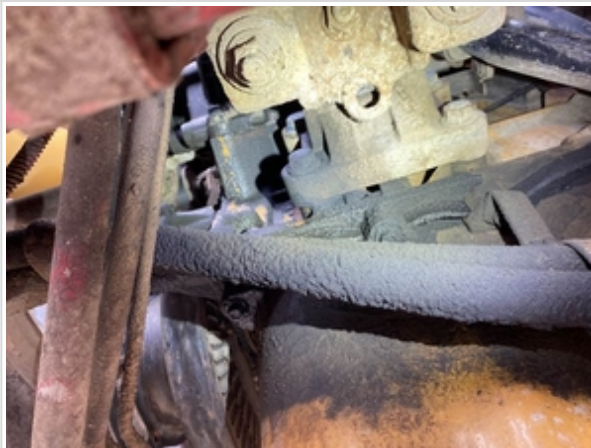
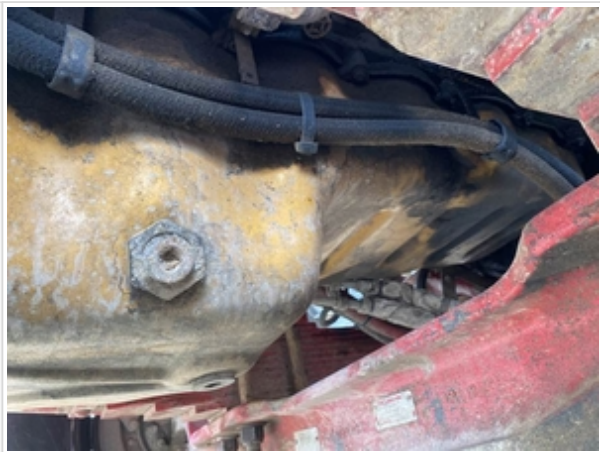
Cooling System Leaks	No	
Coolant Color / Appearance	3 - Normal Wear & Tear	
Coolant Color/Appearance Notes	Normal Translucent appearance, no visual signs of contamination	
Oil Leaks	Yes	
Oil Leak Notes	Dried oil seepages seen, Wetness & discoloration observed	
Comments	Oil leak present at left side oil fill tube to block & left side rear behind air compressor	
Oil Leak Photos

Overall Engine Appearance	Clean & dry
Overall Engine Comments	Overall engine looks good. Only visual issues found would be the two engine oil leaks on left side of engine.

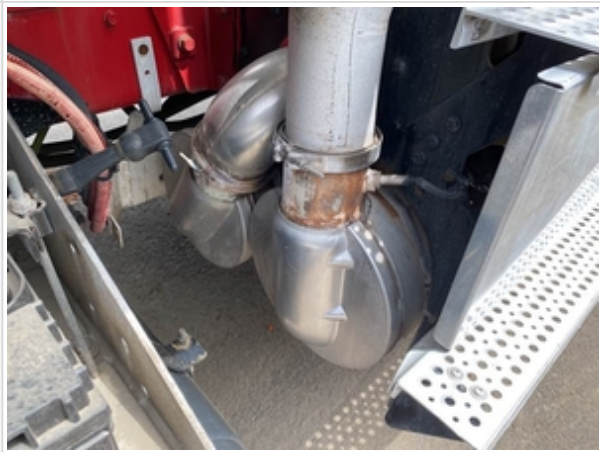
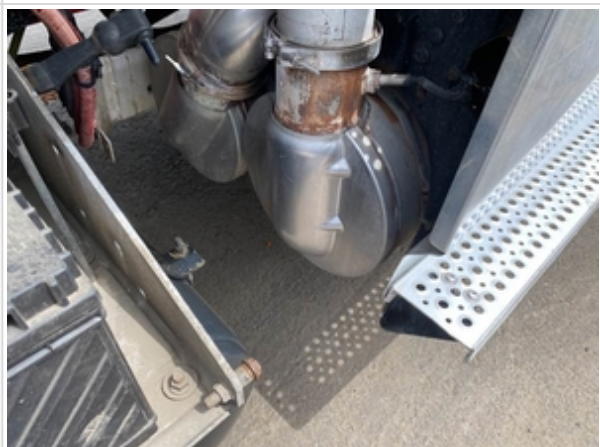
Oil Color / Appearance	3 - Normal Wear & Tear	
Oil Color / Appearance Notes	Appropriate oil level, Clean oil appearance, no signs of cross contamination	
Fuel Leaks	No	
Equipped with DPF (Diesel Particulate Filter)	Yes	
DPF Condition	3 - Normal Wear & Tear	
DPF Condition Notes	Filter housing is intact with no signs of damage or malfunction, DPF indicator is not illuminated	
DPF Photos

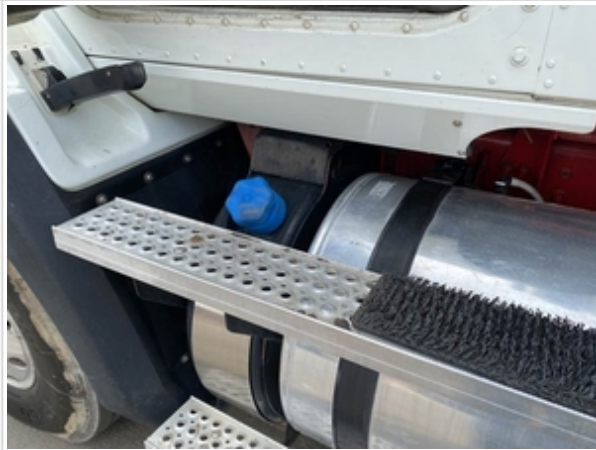
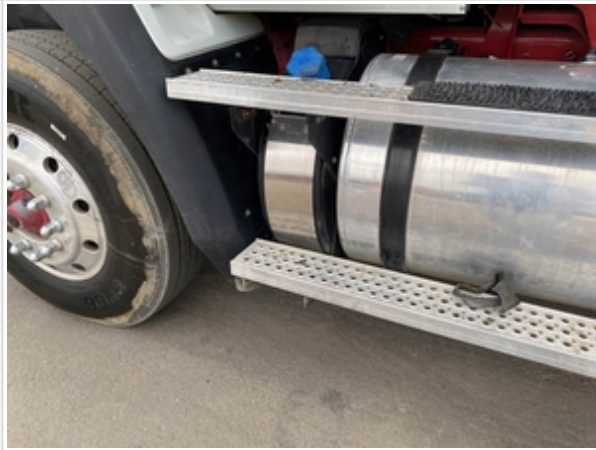
DEF Tank Photos

Requires DEF (Diesel Exhaust Fluid)	Yes
DEF Tank	3 - Normal Wear & Tear
DEF Tank Condition	Area around DEF tank cap is clean, fluid is clear & appears free of contaminants

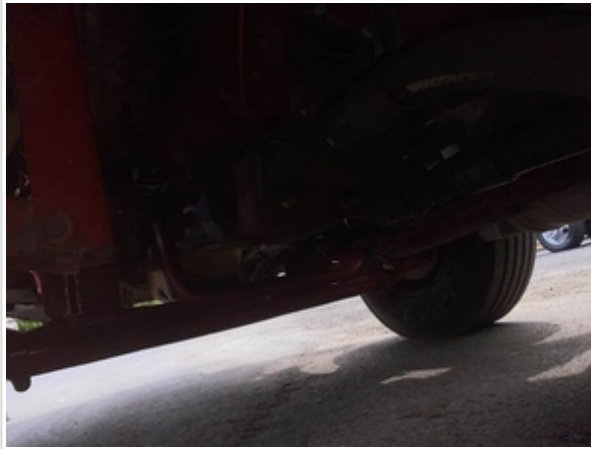
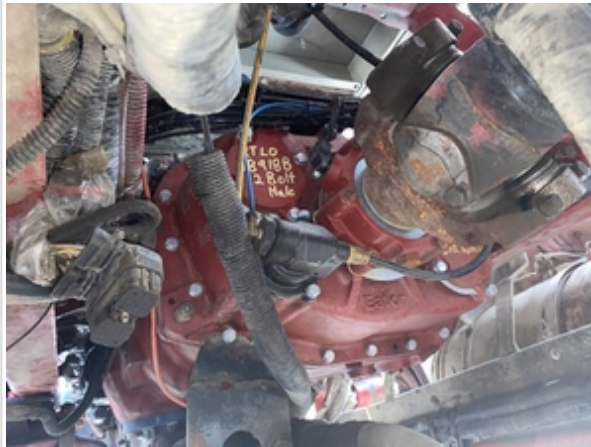
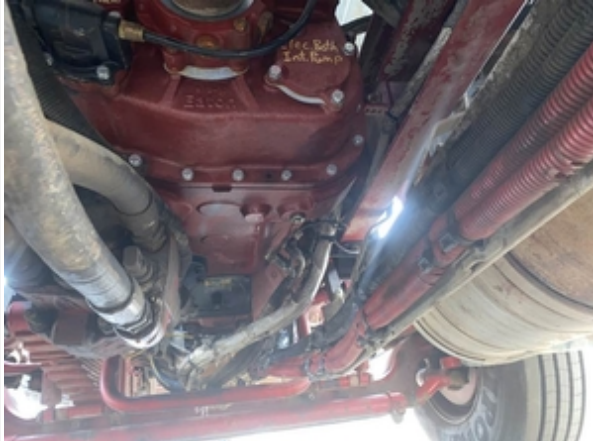
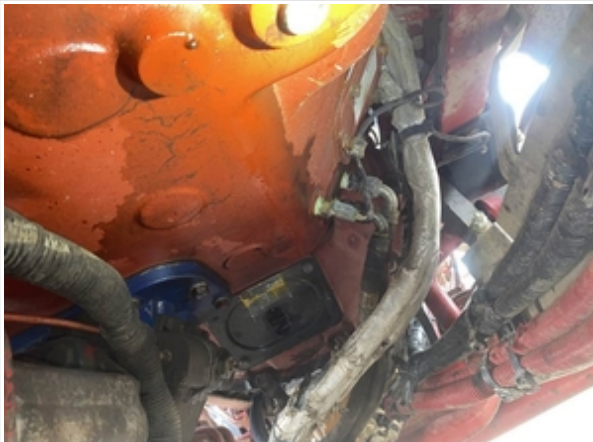
<p>Transmission Condition Photos</p>

Transmission Info (Make/Model)	Eaton 13spd Manual Transmission
Drive Type	4X2
Overdrive	No
Transmission	3 - Normal Wear & Tear
Transmission Condition	No unusual noises or vibrations, Leaking transmission fluid observed

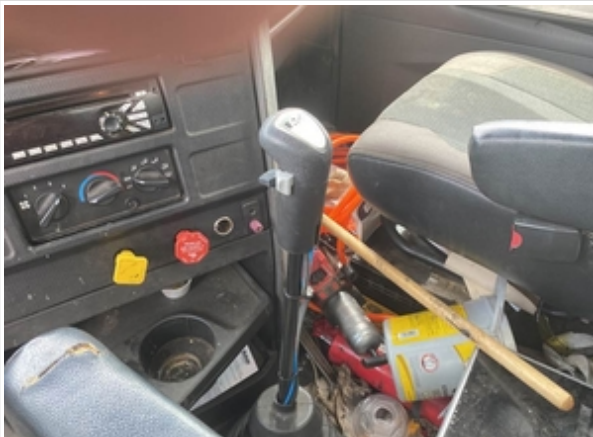
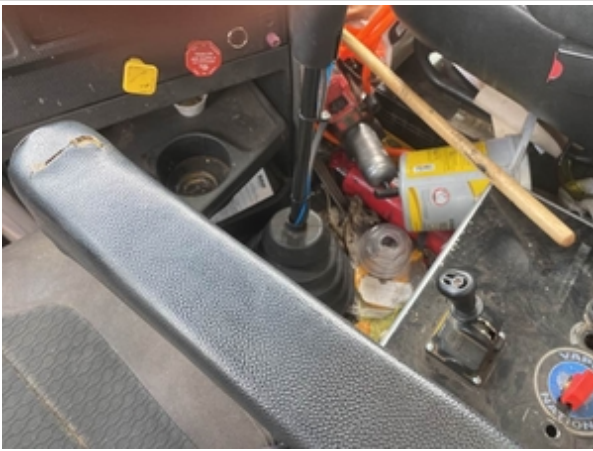
Clutch	3 - Normal Wear & Tear
Clutch Condition	Clutch is functioning as expected
Shift Lever	3 - Normal Wear & Tear
Shift Lever Condition	Good forward and reverse function
Shift Lever Photos

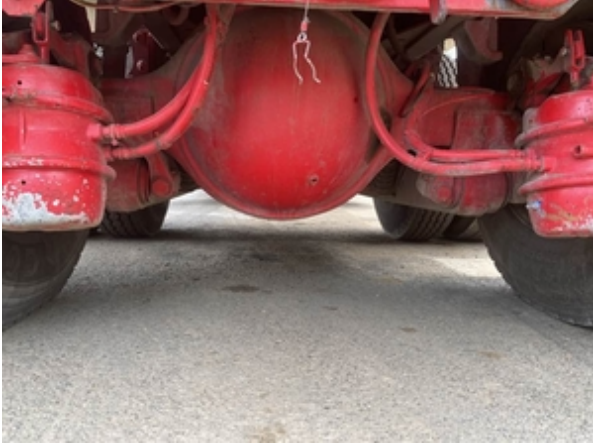
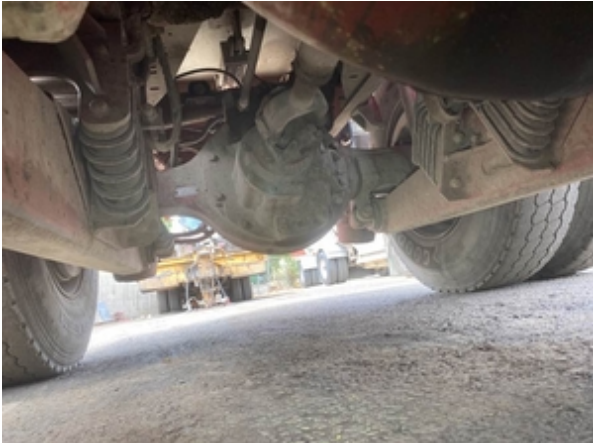
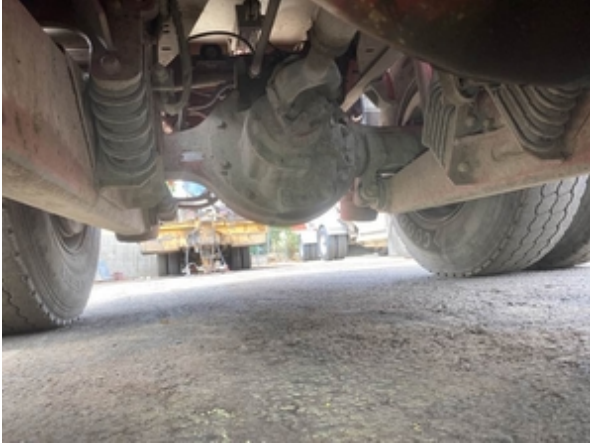
Differential	Check condition of the differential(s). Take photos and notes as relevant.	
Rear Differential	3 - Normal Wear & Tear	
Rear Differential Condition	Dry housing appearance, no unusual noises heard during operation	
Rear Differential Photos

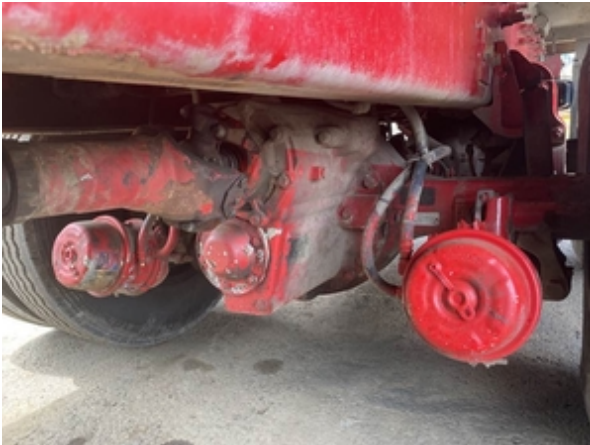
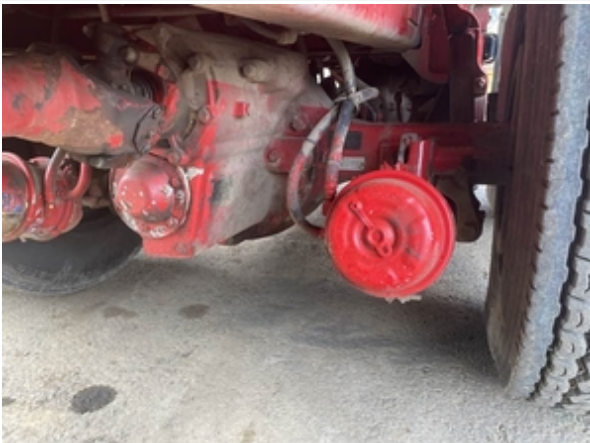
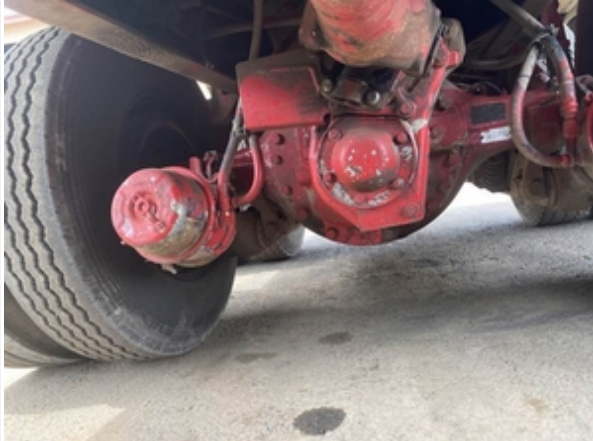
Front Differential	3 - Normal Wear & Tear	
Front Differential Condition	Dry housing appearance, no unusual noises heard during operation	
Front Differential Photos

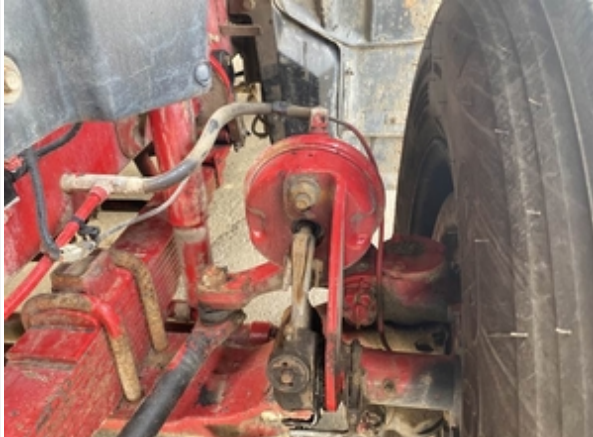
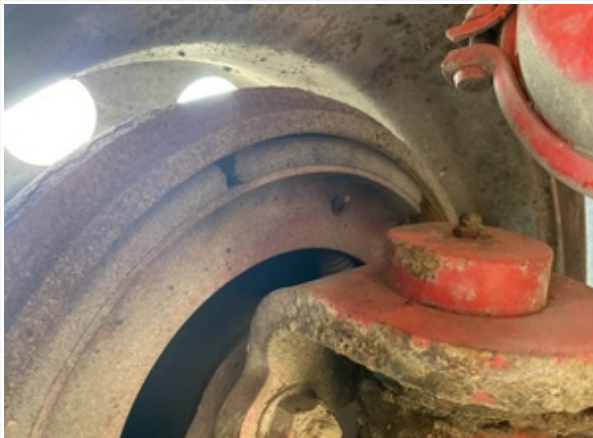
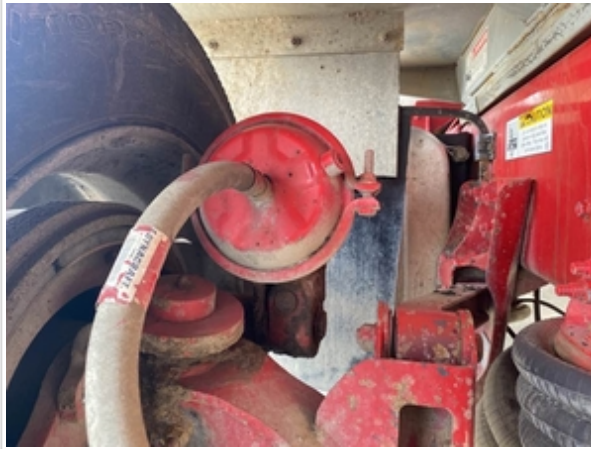
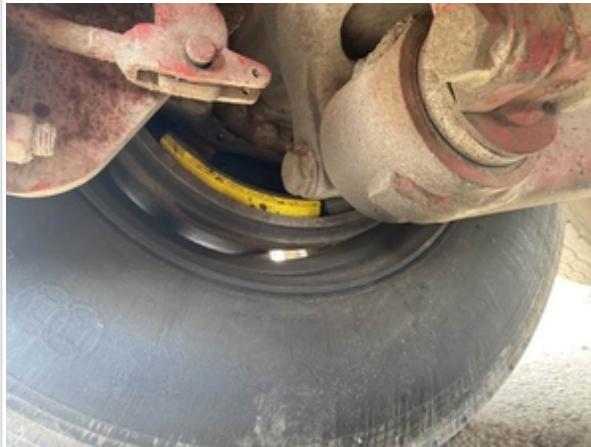
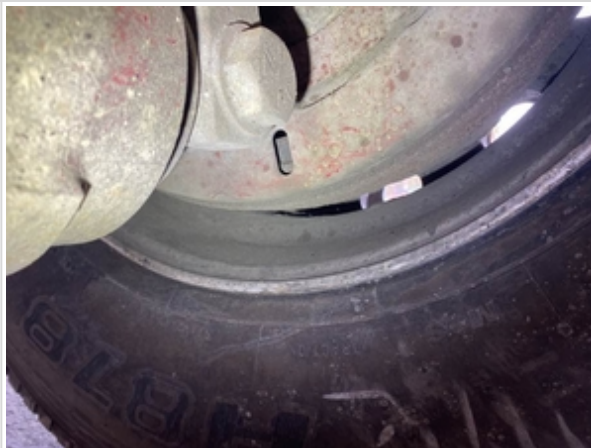
Brake System Type	Air Brakes
Air Brakes Build Correct Pressure	Yes
Air Brake System Leaks	No
Comments	Air brakes passed 1 minute check, rear axle r/s possible wheel seal leak
Air Brake Hose Condition	3 - Normal Wear & Tear
Air Brake System Photos

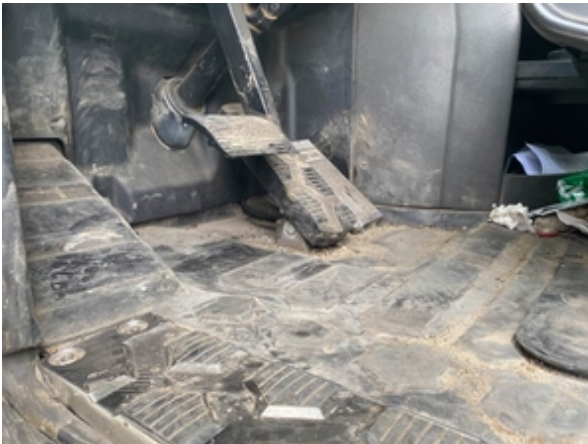
Foot Brake	3 - Normal Wear & Tear	
Foot Brake Condition	Good brake function	
Foot Brake Photos

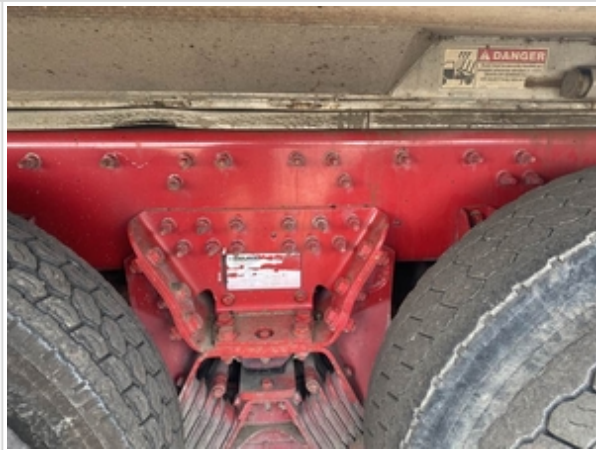
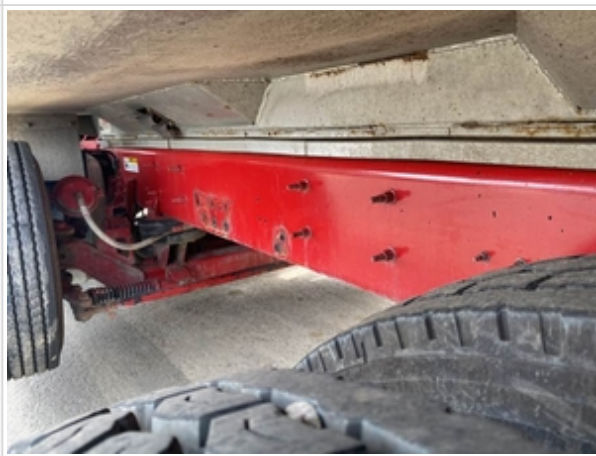
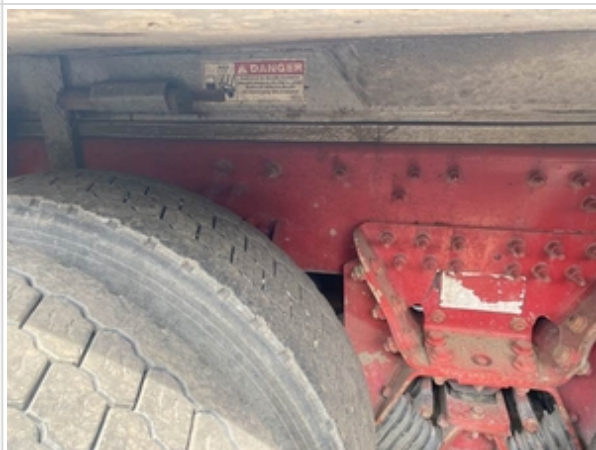
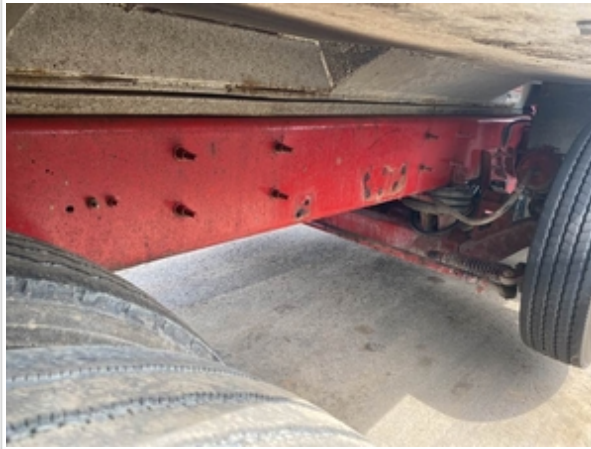
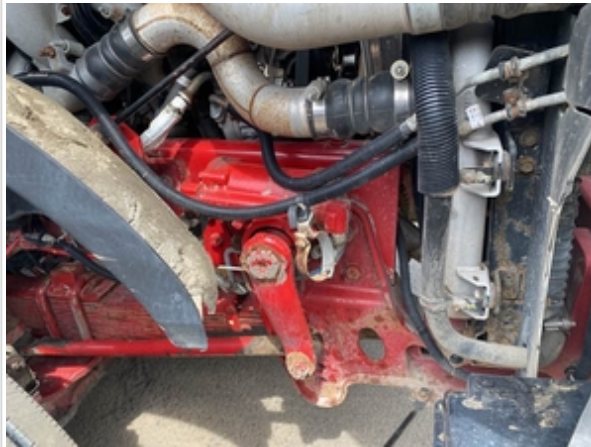
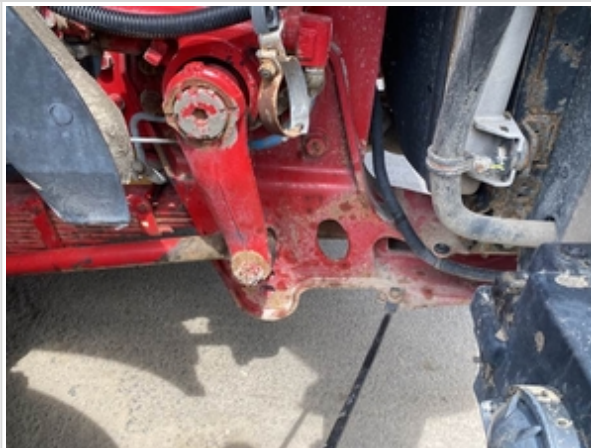
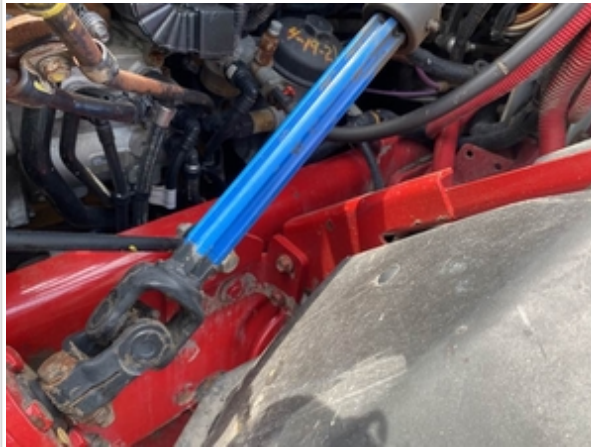
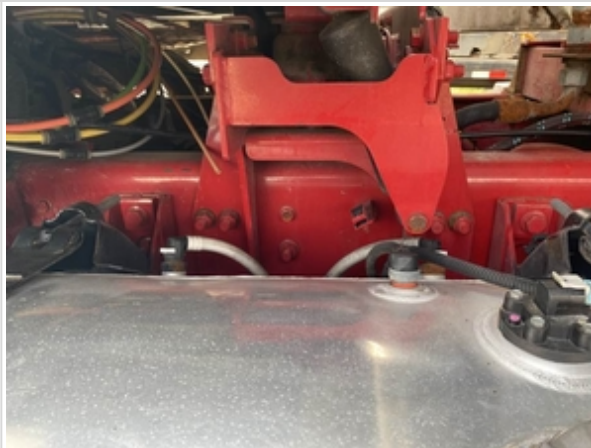
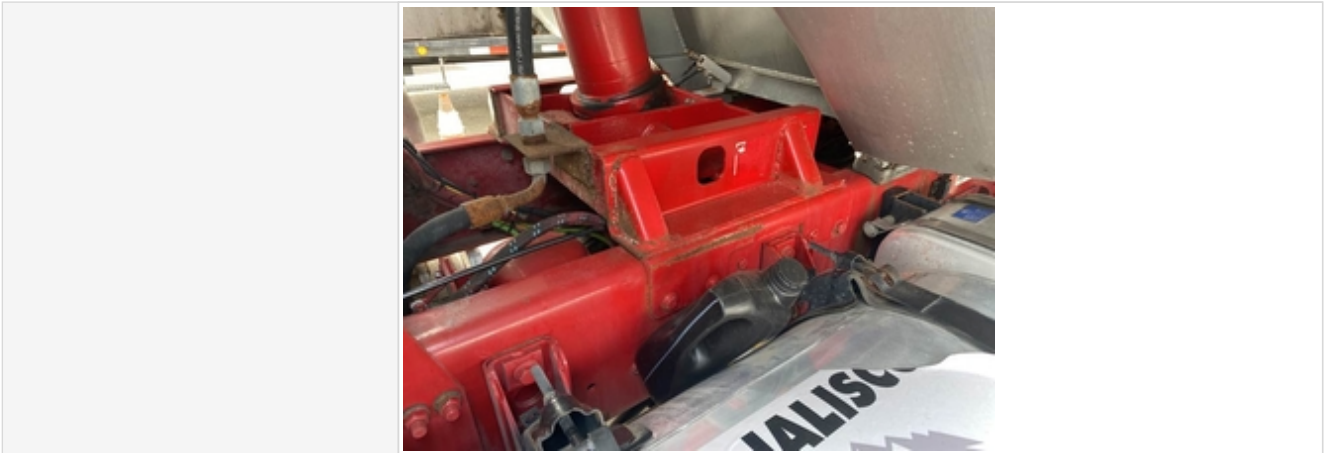
Frame Condition	3
Frame Photos

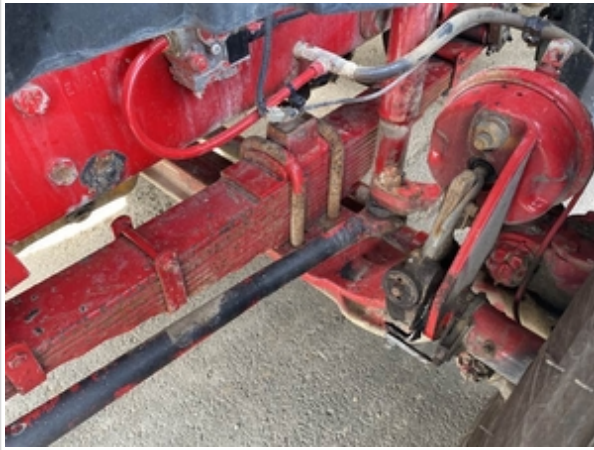
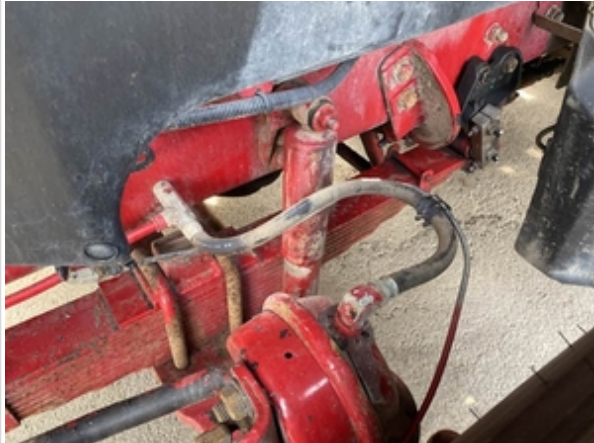
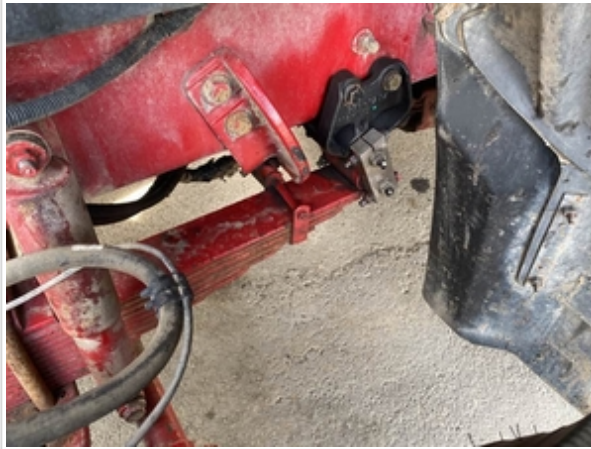
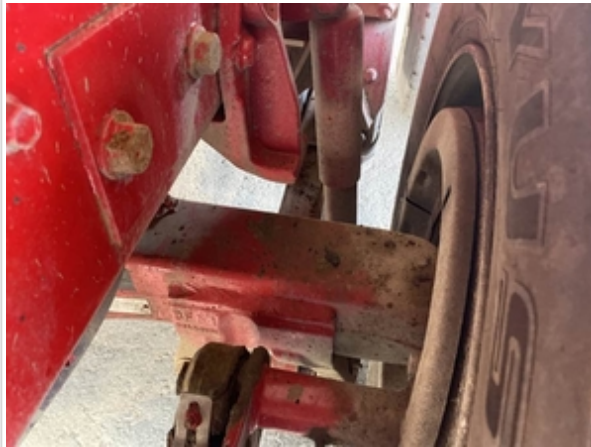
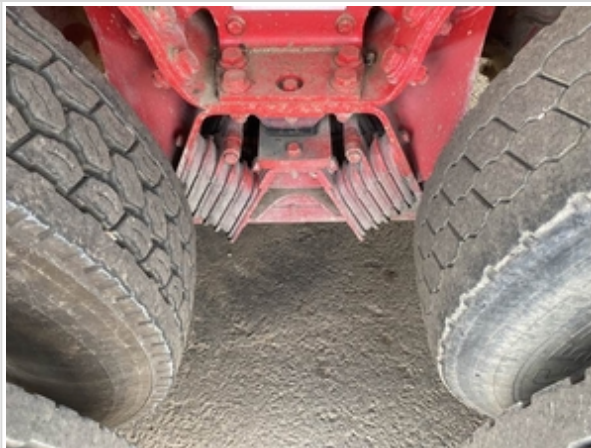
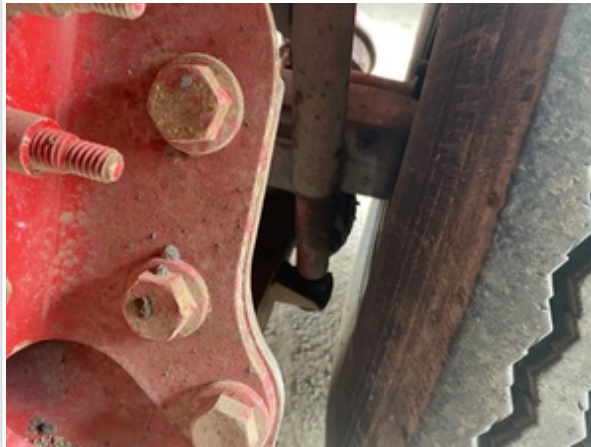
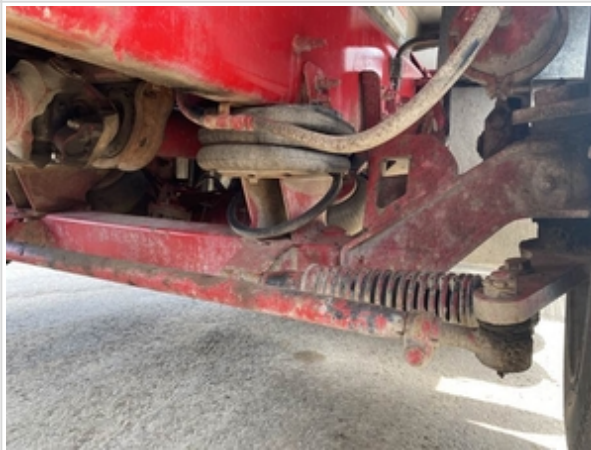
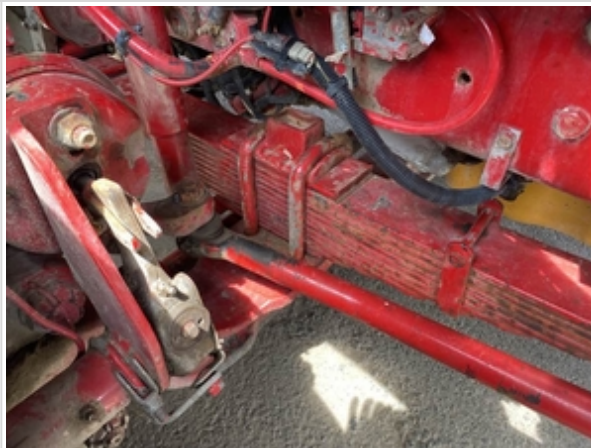
Suspension	3
Suspension Photos
