Inspection Report (On-Highway Dump Truck)

Year	2014
Make	Caterpillar
Model	CT660
Serial Number	3HTJGTKT3EN019099
Truck Odometer Reading	172,828
Current Inspection / State Cert / DOT	Expired (no d.o.t. Inspection on hand)
Previous Application (e.g., earth moving, mining, demolition, etc)	Asphalt paving construction

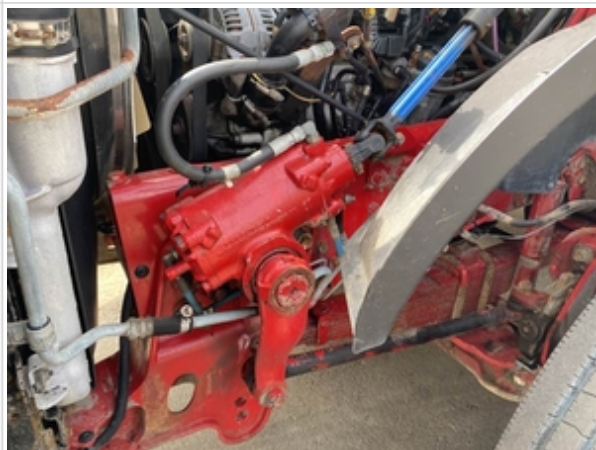
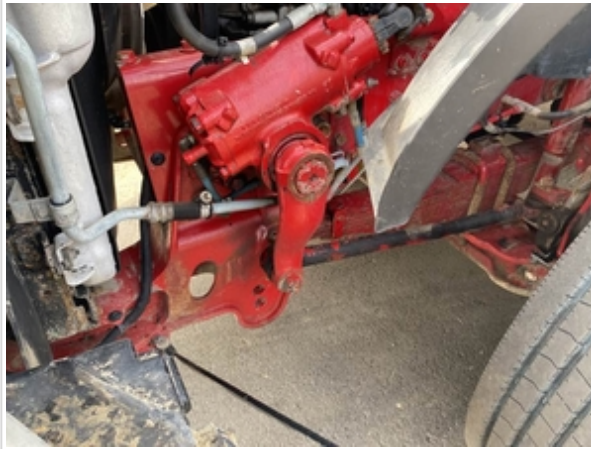
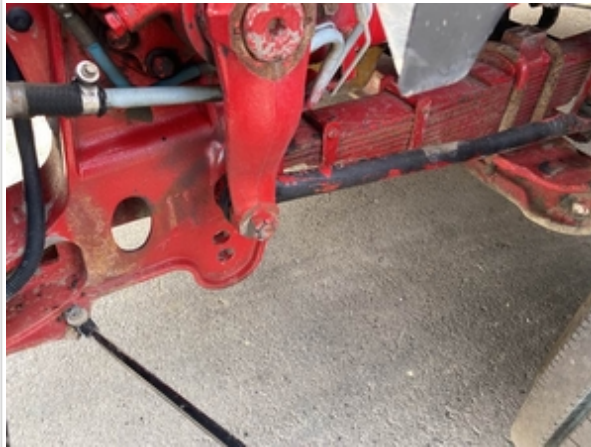
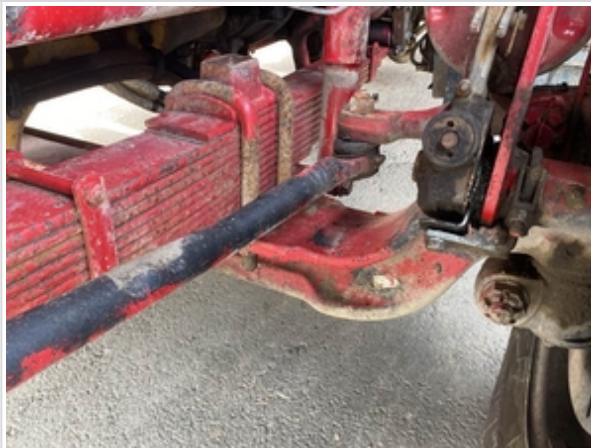
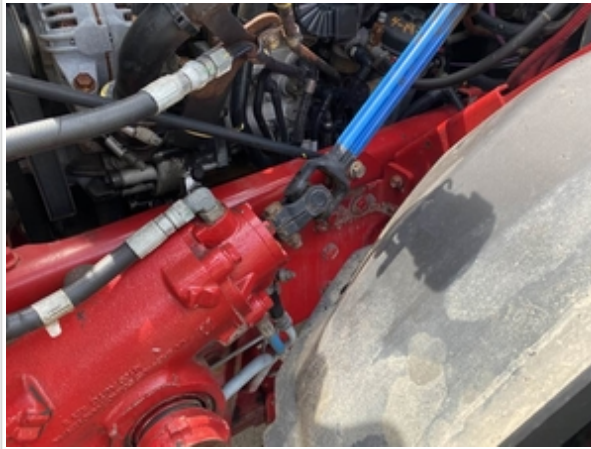
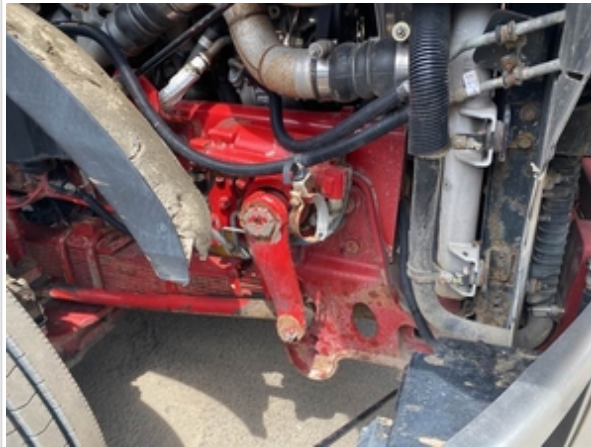
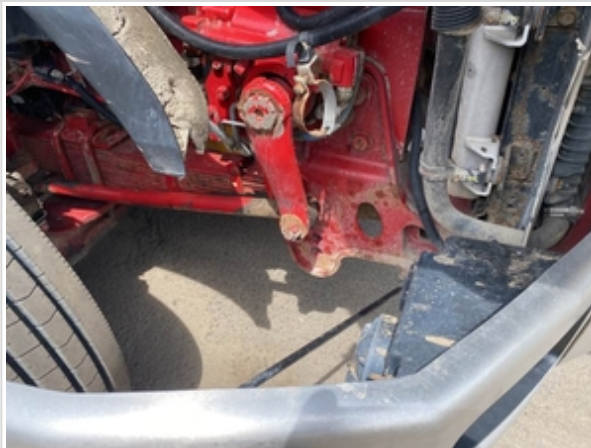
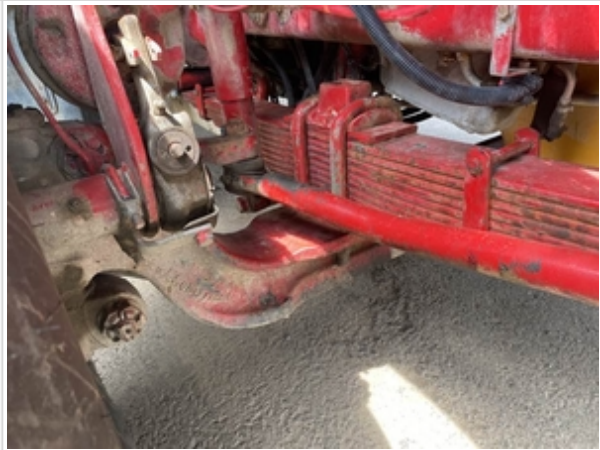
Steering Components	3
Steering Components Photos

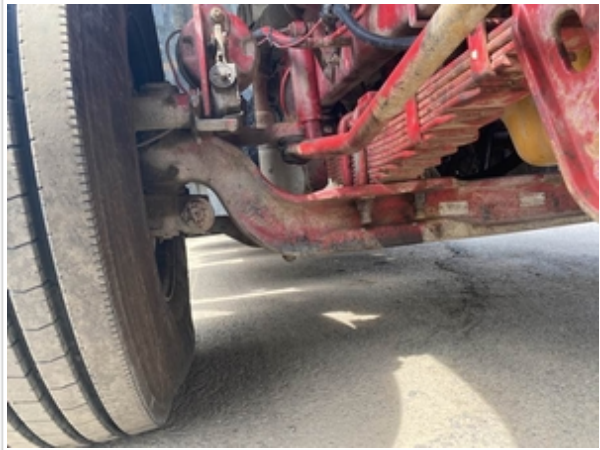
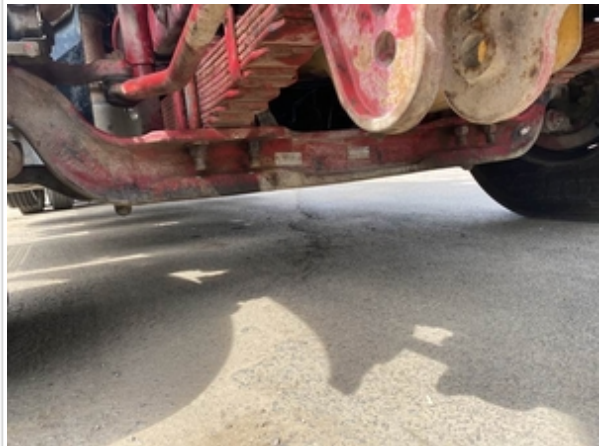
Steer Axle Condition	3	
Steer Axle Photos

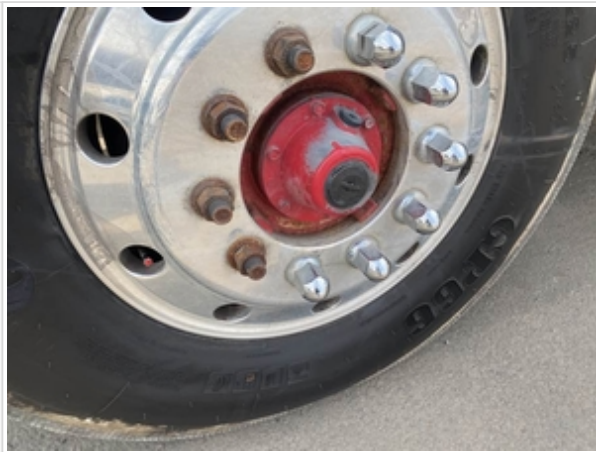
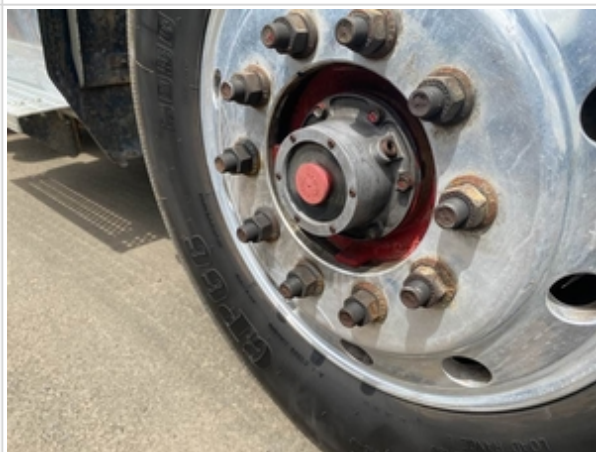
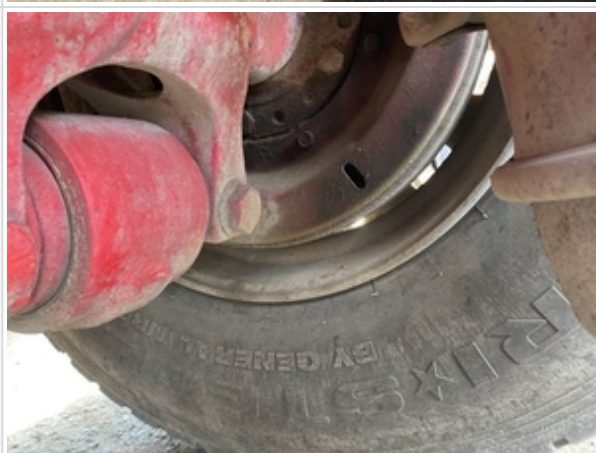
<p>Wheels & Hub Photos</p>

Wheels & Hub Condition	3
------------------------	---

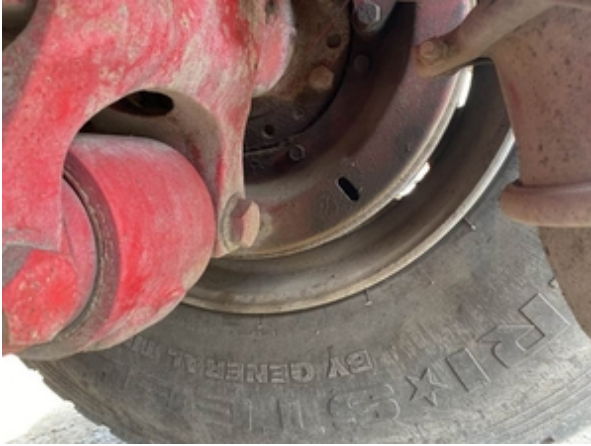
Wheel Seal Leak Photos

Brake System Type	Air Brakes
Air Brakes Build Correct Pressure	Yes
Air Brake System Leaks	No
Comments	Air brakes passed 1 minute check, rear axle r/s possible wheel seal leak
Air Brake Hose Condition	3 - Normal Wear & Tear
Air Brake System Photos

<p>Wheel Seal Leaks</p>	<p>Yes</p>

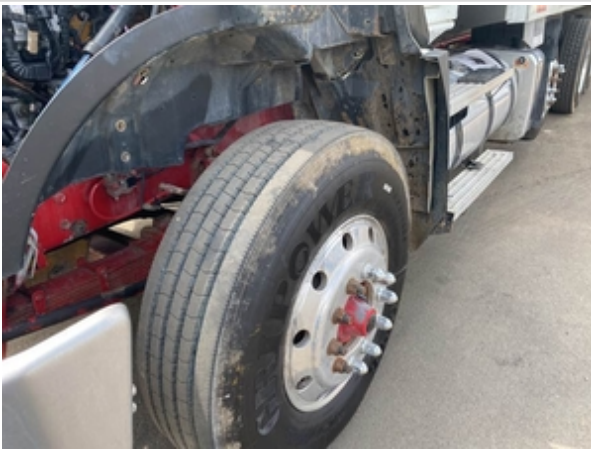
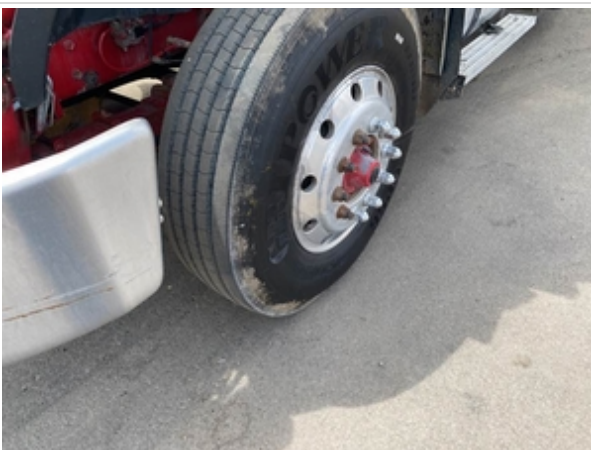
Tire Brand	Grip power (front) recaps (rear)
Tire Size	315/80r/22.5 & 11r/22.5
Front Left Tire - Ratio Remaining	90%
Front Left Tire Photos

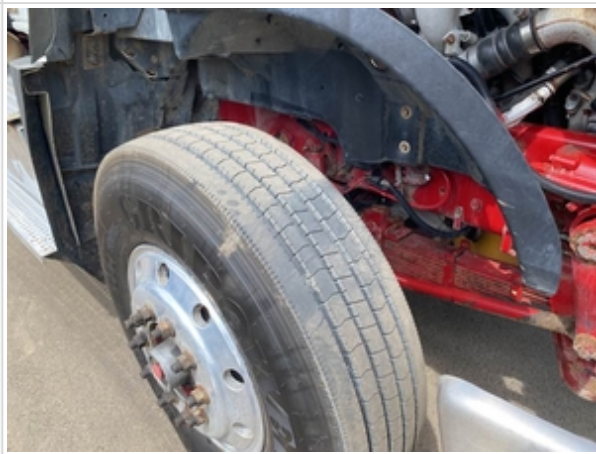
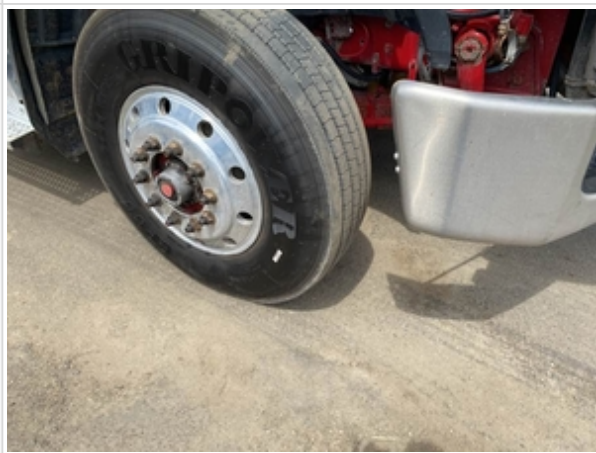
<p>Front Right Tire - Ratio Remaining</p>	<p>90%</p>	
<p>Front Right Tire Photos</p>

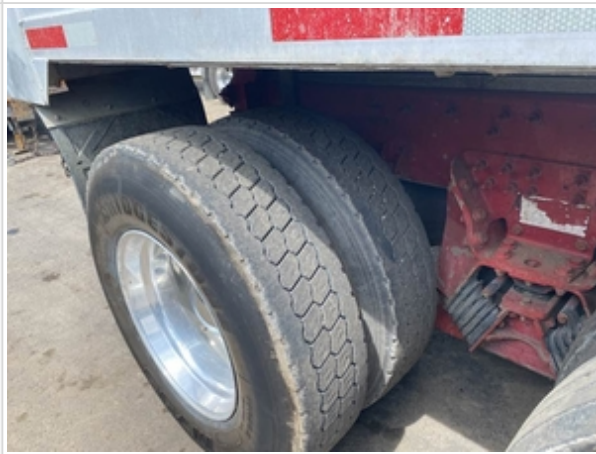
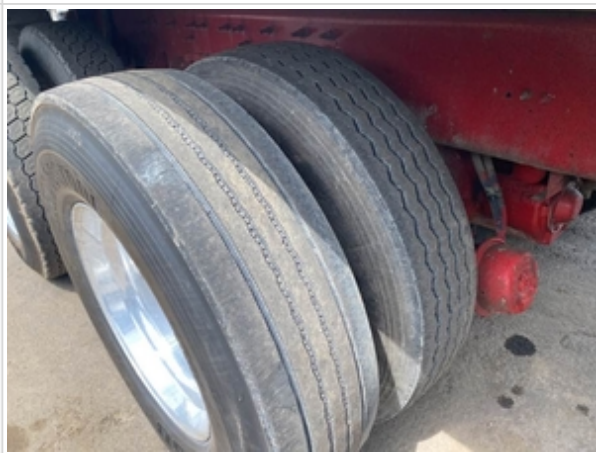
<p>Rear Right Tire - Ratio Remaining</p>	<p>50%</p>	
<p>Rear Right Tire Photos</p>

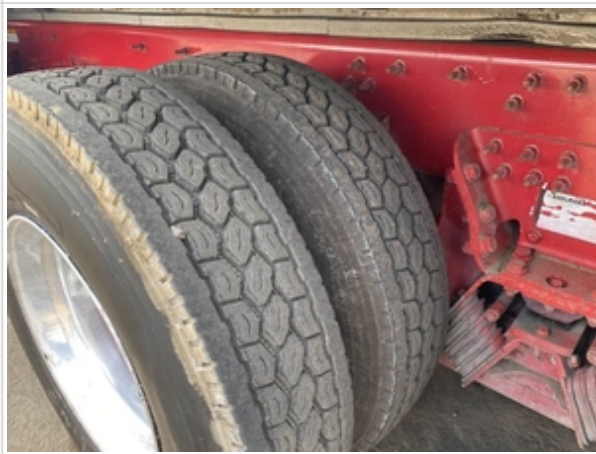
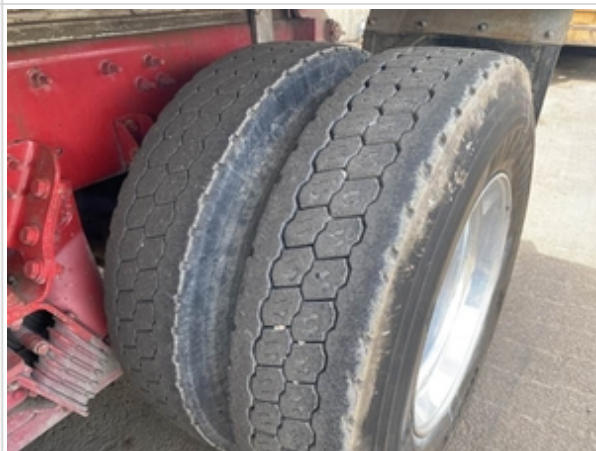
Rear Left Tire - Ratio Remaining	70%	
Rear Left Tire Photos

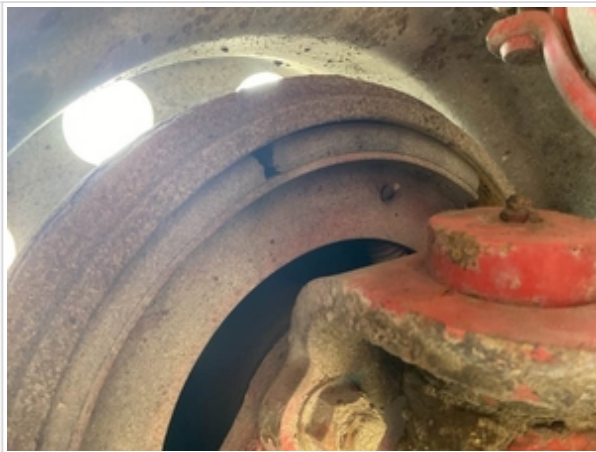
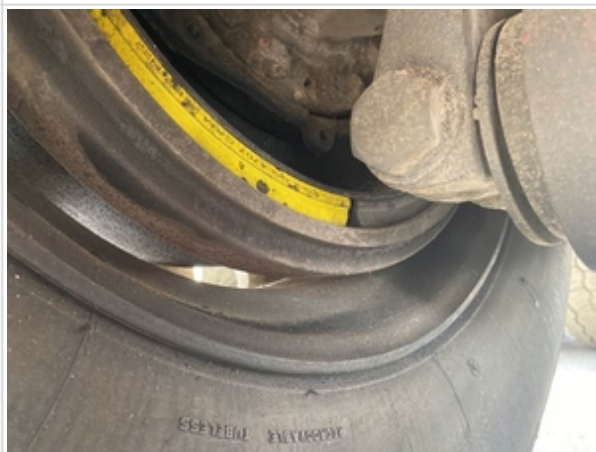
<p>Brake Shoe Photos</p>

Brake Shoe Thickness	70%
----------------------	-----

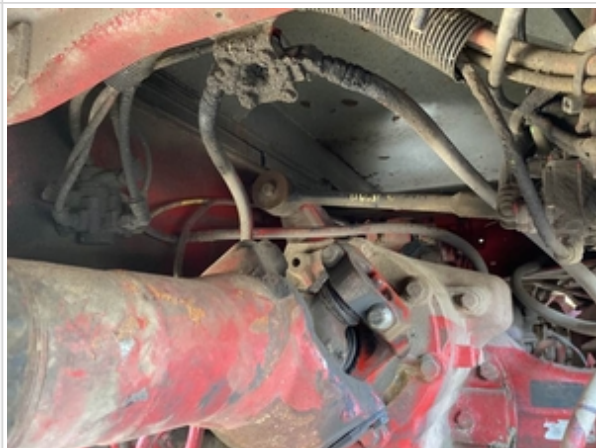
<p>Overall Chassis</p>	<p>3</p>
<p>Overall Chassis & Undercarriage Photos</p>

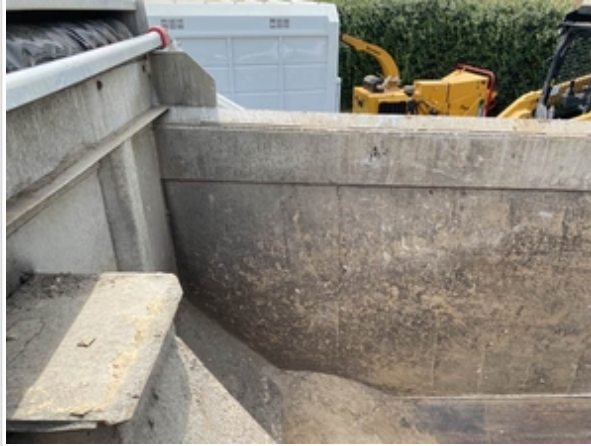
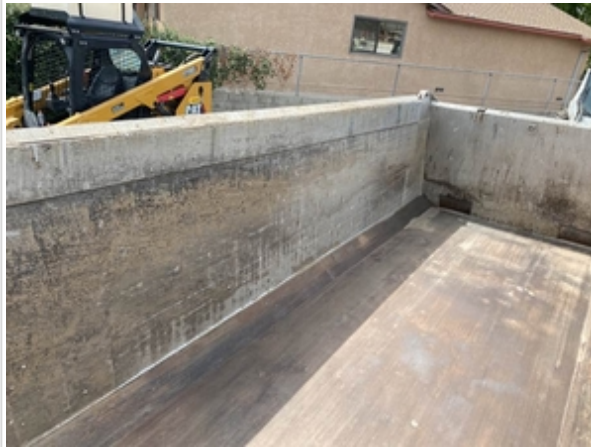
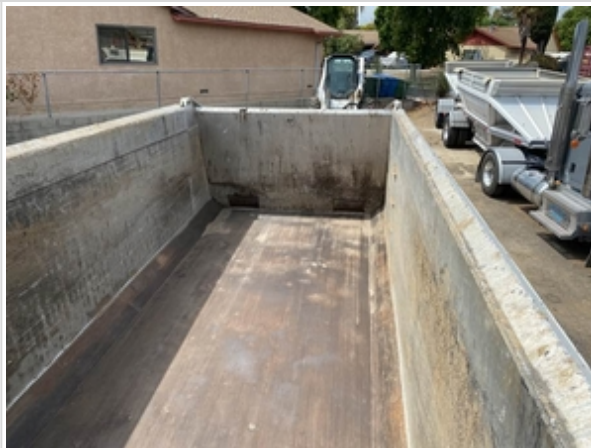
Bed Body Photos

Dump Body, Tailgate, Support & Trap	Check the condition of the dump body, tailgate, support & tarp. Note any damage or wear. Take photos.
Dump Body Make & Material	Tebco (TAG Series) Strong Aluminum Body
Dump Body Length (ft and inches)	21'
Dump Body Height (ft and inches)	72"
Bed Body	3
Comments	I'm good shape

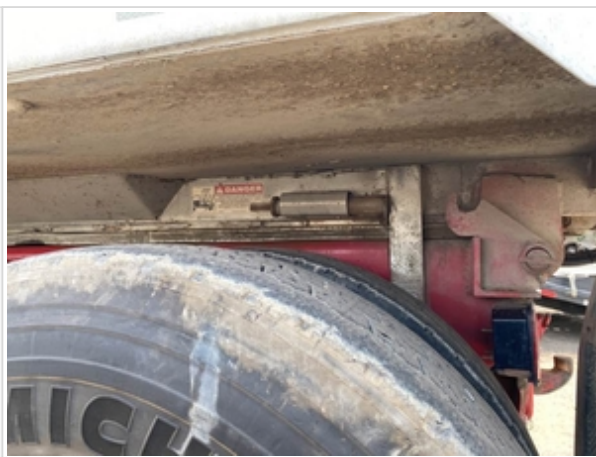
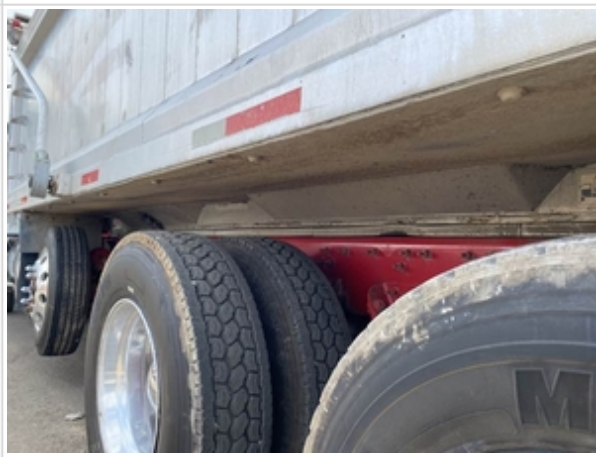
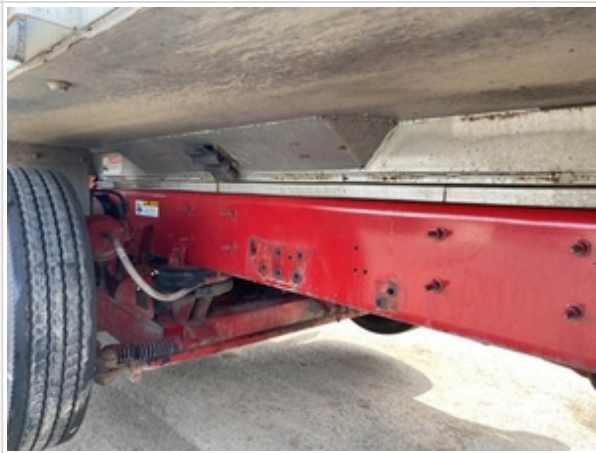
<p>Support Frame Photos</p>

Support Frame	3
