Inspection Report (On-Highway Service Truck)

Year	2015
Make	Ford
Model	F450
Serial Number	1FD0X4GTXFEB96166
Truck Odometer Reading	145,802
Current Inspection / State Cert / DOT	90 day inspection performed August 26th 2022 by in house mechanic
Previous Application (e.g., earth moving, mining, demolition, etc)	Grading General Construction Service Truck

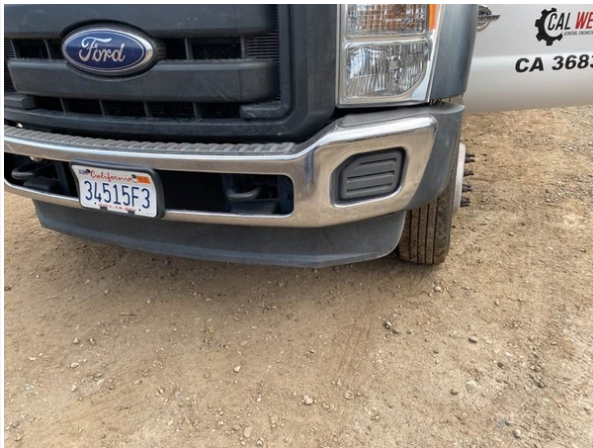
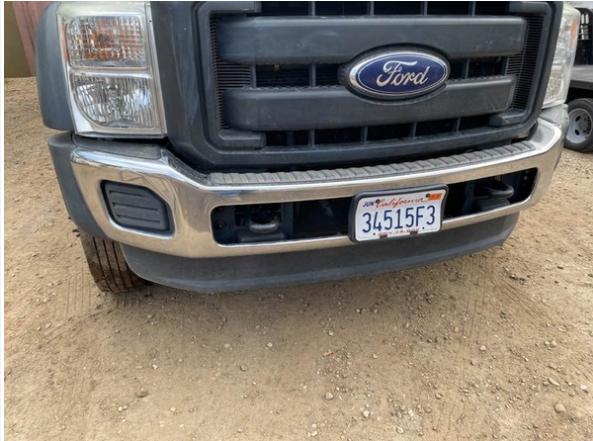
Front	3 - Normal Wear & Tear
Front Condition	No visible damage
Front Photos

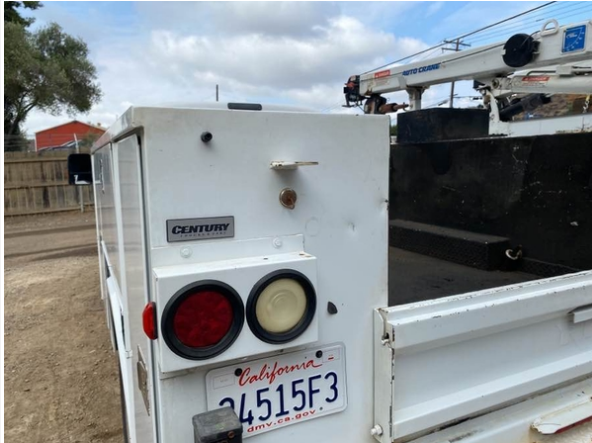
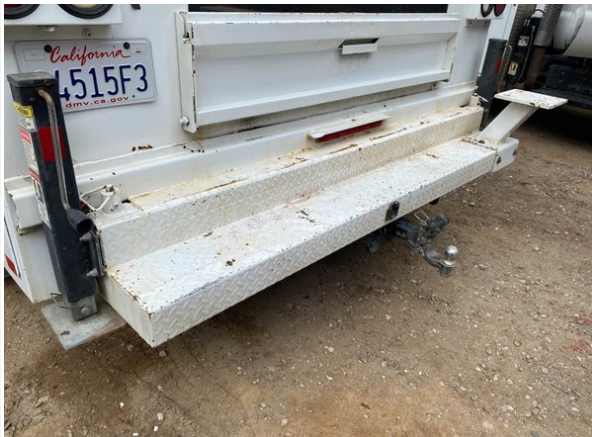
Rear	3 - Normal Wear & Tear	
Rear Condition	No visible damage, Visible chipped paint or dents	
Comments	Small dents on back of service body (both sides)	
Rear Photos

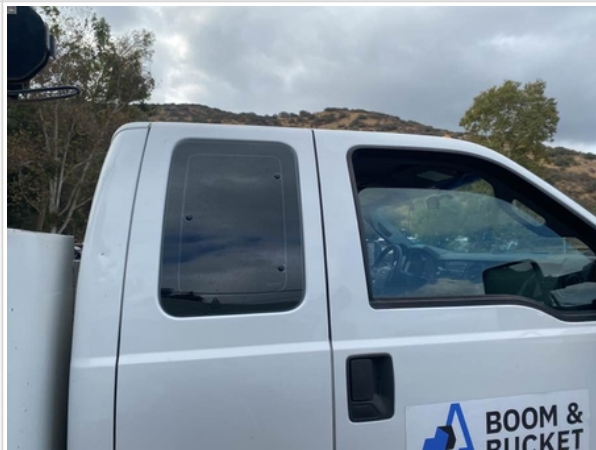
<p>Right</p>	<p>3 - Normal Wear & Tear</p>
<p>Right Condition</p>	<p>No visible damage</p>
<p>Right Photos</p>

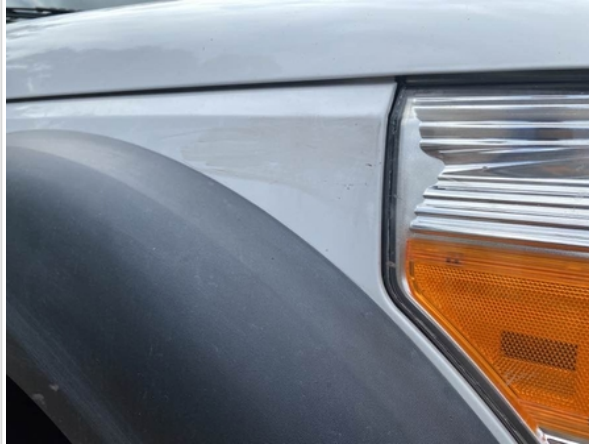
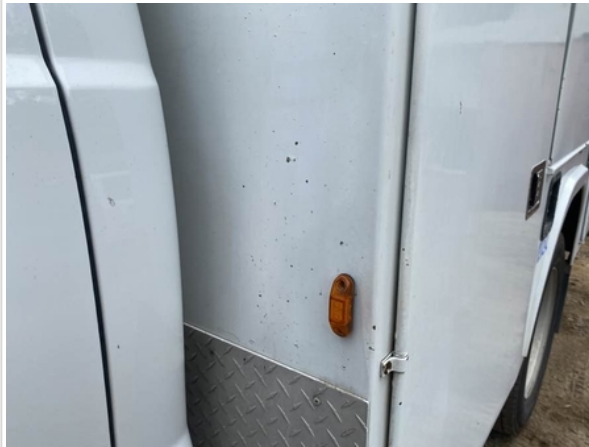
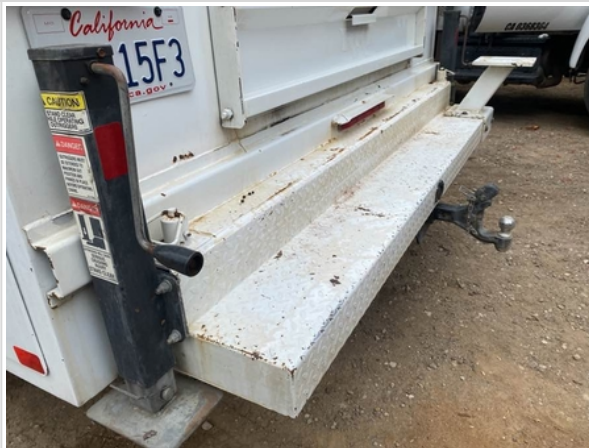
Body Panels Photos

Body Panels (Any Rust Damage?)	3 - Normal Wear & Tear
Body Panel Condition	No visible damage, good paint condition and panel fitment, Other (see comments)
Comments	Normal scuff marks and small dents and paint chips on rear of service body

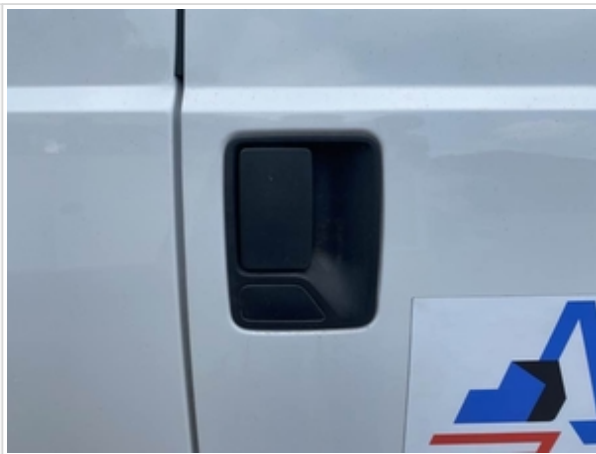
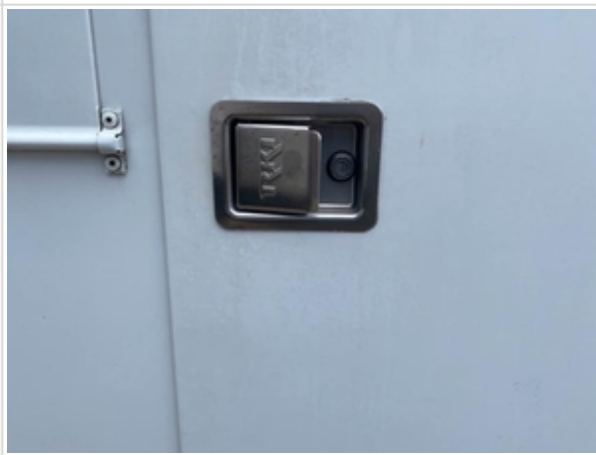
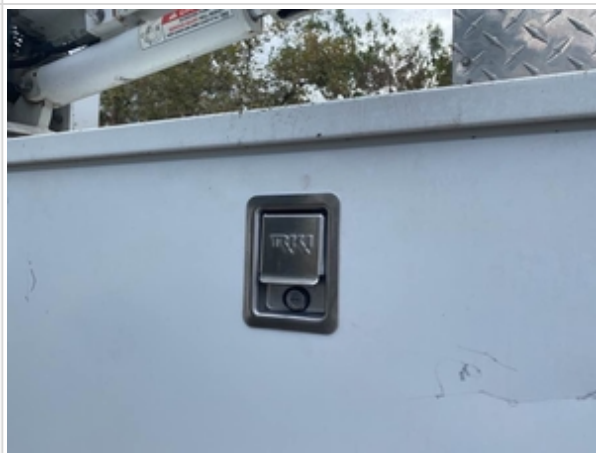
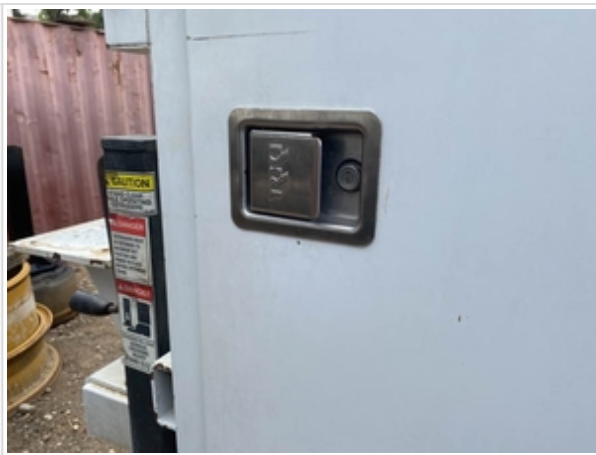
<p>Doors / Canopy Latches Photos</p>

Doors / Canopy Latches	3 - Normal Wear & Tear
Doors / Canopy Latches Condition	No visible damage

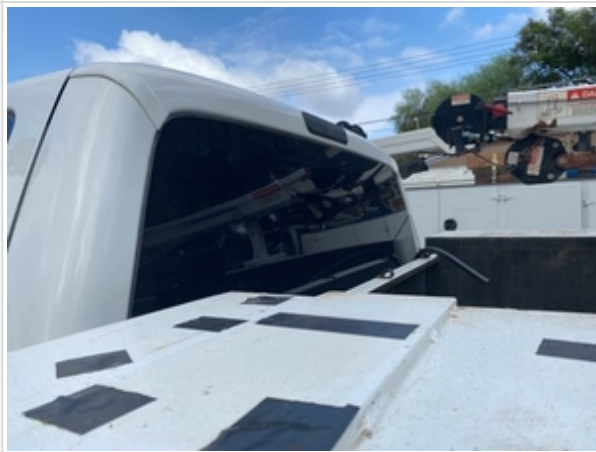
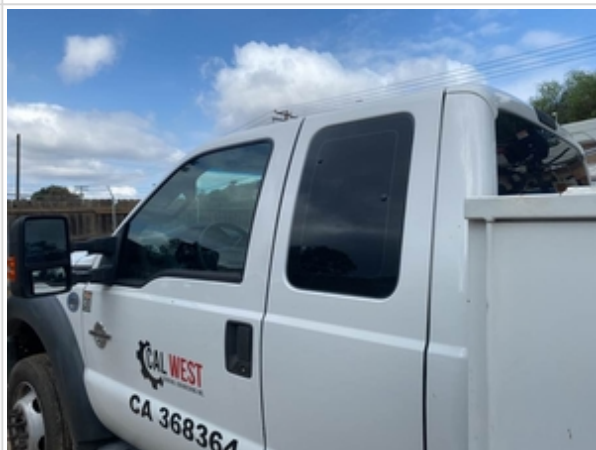
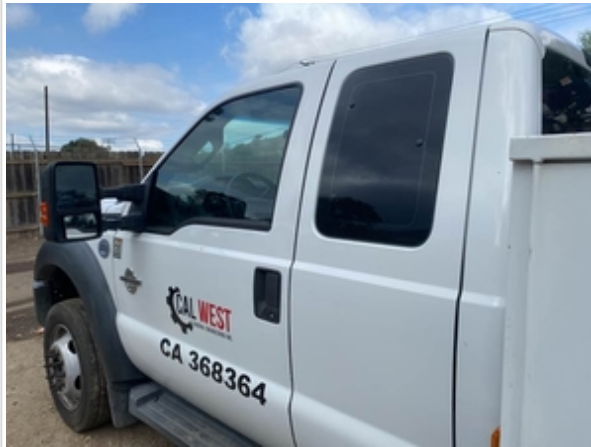
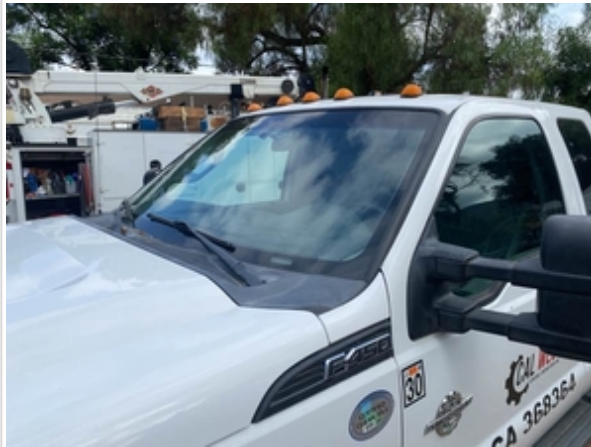
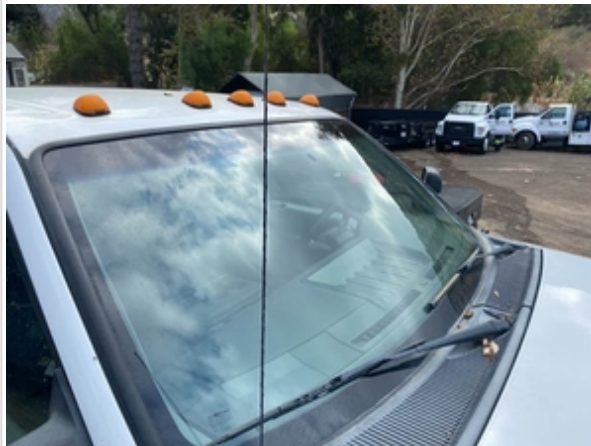
Glass Condition	3 - Normal Wear & Tear	
Glass Condition Notes	Glass intact, no visible damage	
Glass Condition Photos

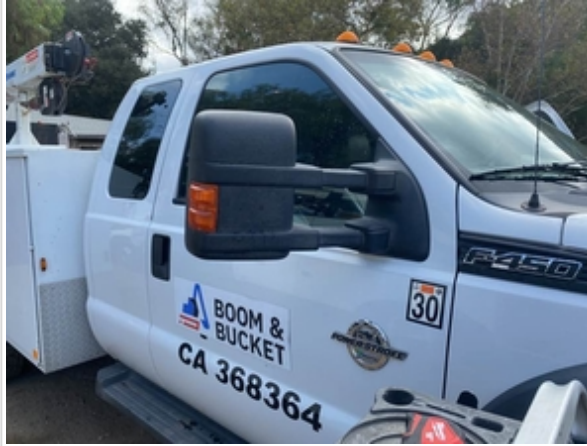
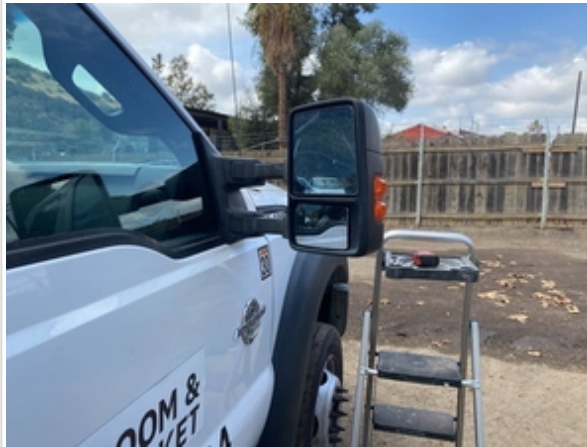
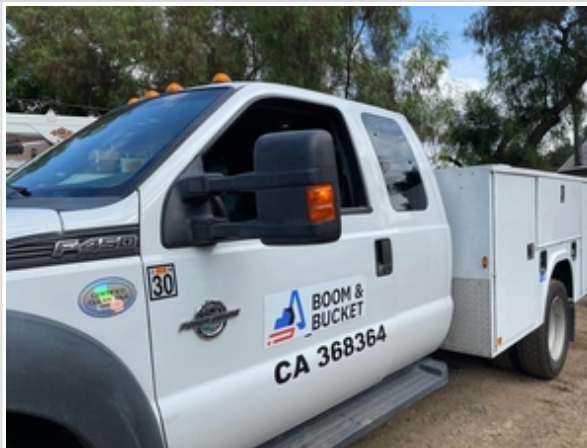
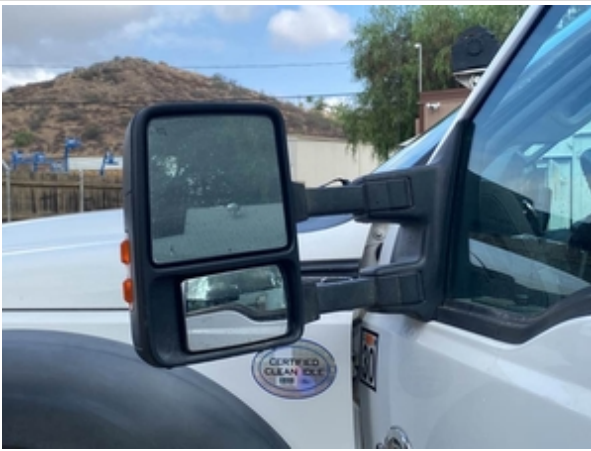
Mirrors Photos

Mirrors	3 - Normal Wear & Tear	
Mirror Condition Notes	Mirrors present and intact, no visible damage

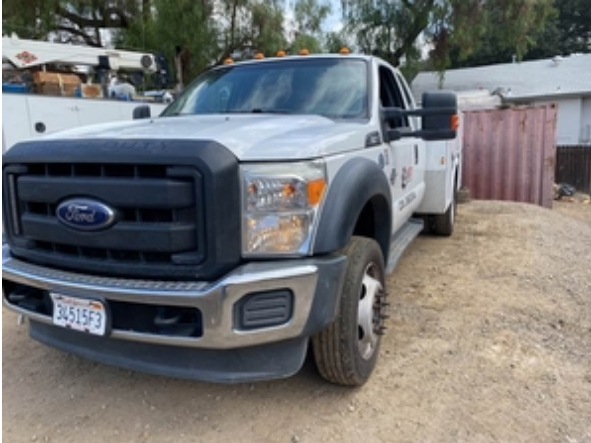
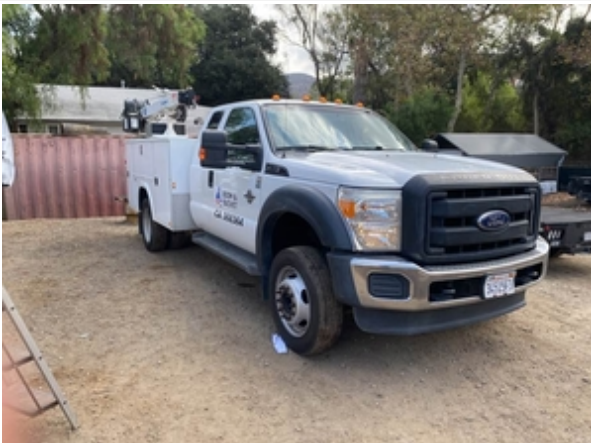
Lighting System	3 - Normal Wear & Tear	
Lighting System Condition	No visible damage, lighting system is operational	
Lighting System Photos

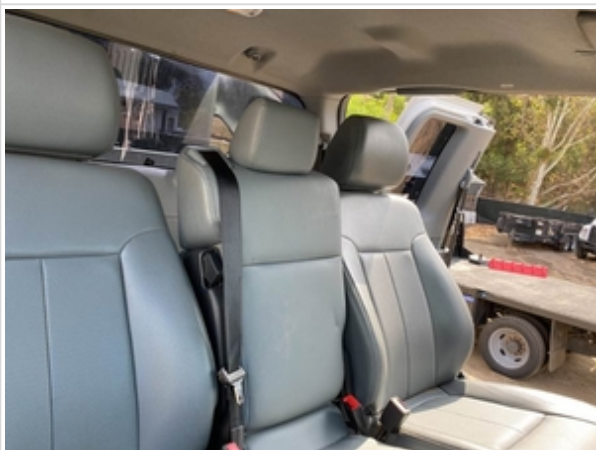
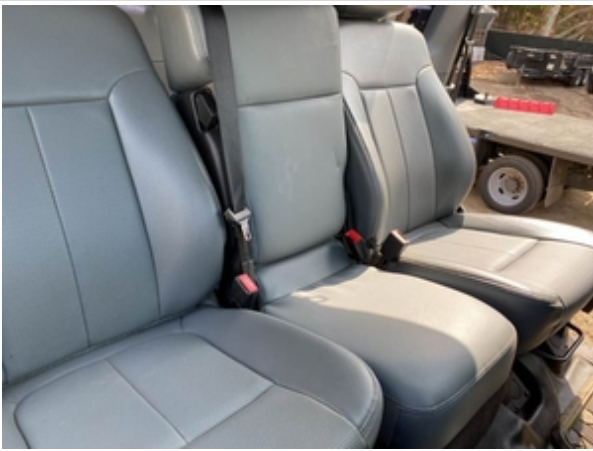
Operator's Seat & Arm Rests	4 - Like New, Recently Replaced	
Comments	Really good clean condition	
Operator's Seat & Arm Rests Photos

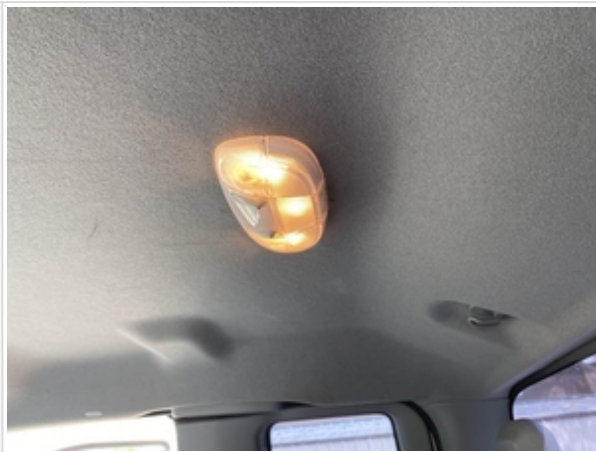
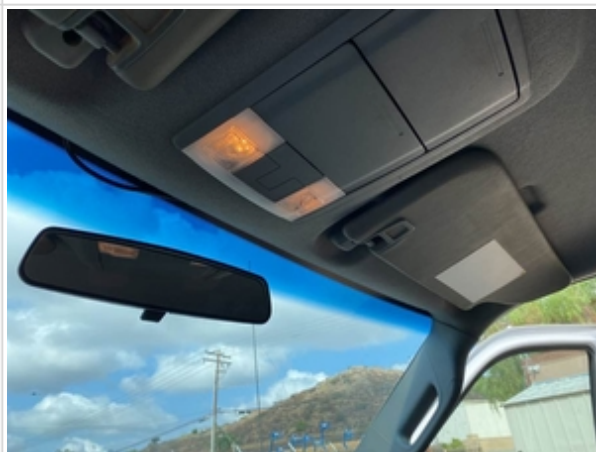
<p>Cabin Lights Photos</p>

Cabin Lights	3 - Normal Wear & Tear

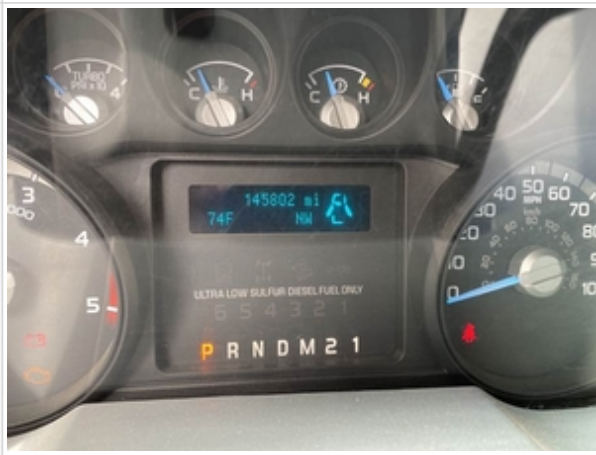
Odometer Activity	3 - Normal Wear & Tear	
Odometer Activity Photos

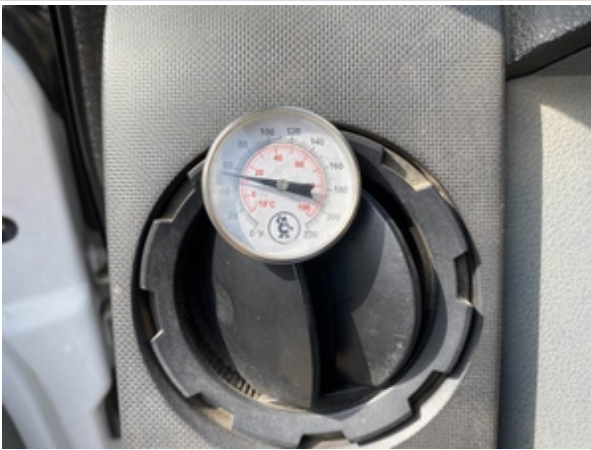
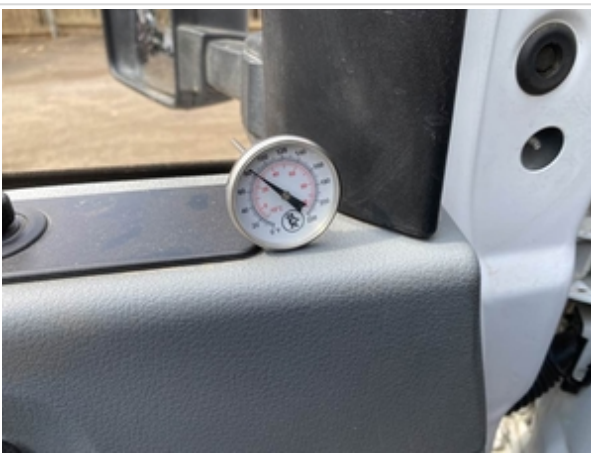
Heater & A/C	3 - Normal Wear & Tear
Comments	A/C exceeds 30 degree temp drop from ambient air tem
Heater & A/C Photos

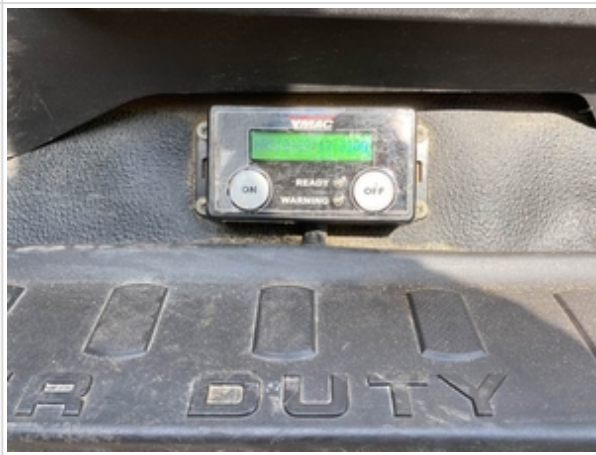
Horn	3 - Normal Wear & Tear	
Reverse Alarm / Backup Signal	0	
Comments	Either not available or disconnected	
Backup Camera	0	
Other Electronic Devices	6	
Comments	Electronic vmac air compressor controller functions normal	
Other Electronic Device Photos

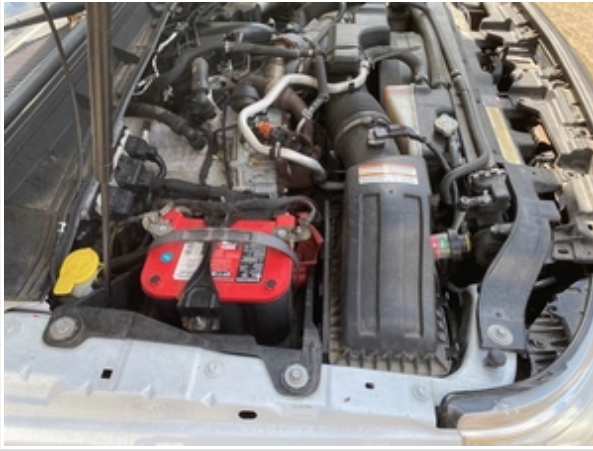
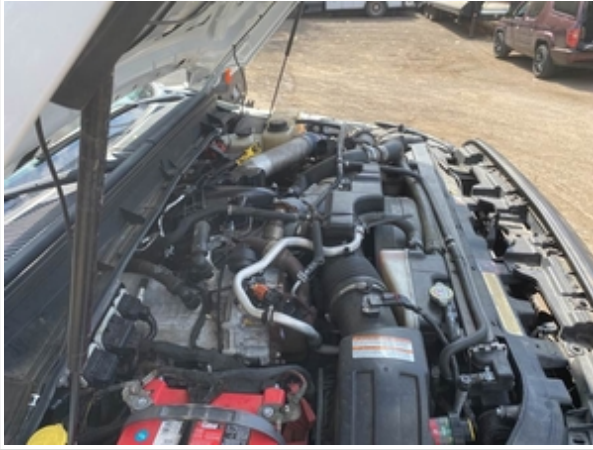
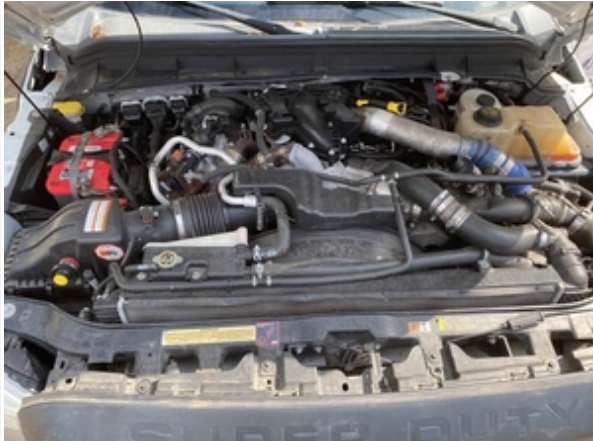
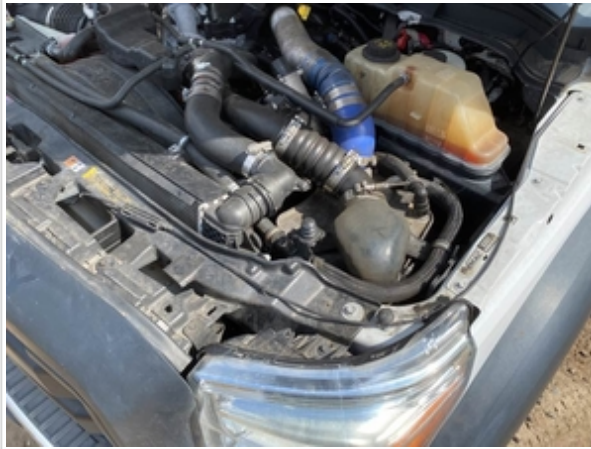
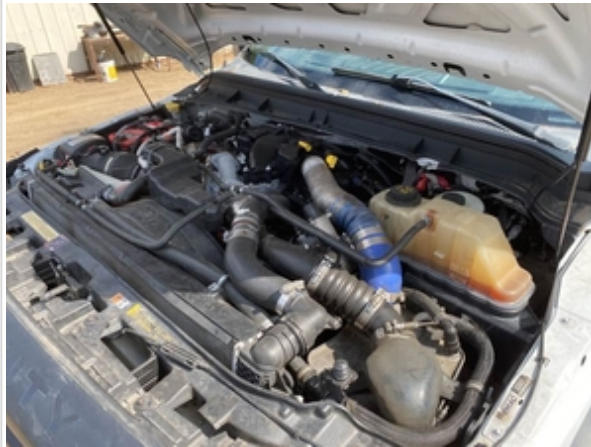
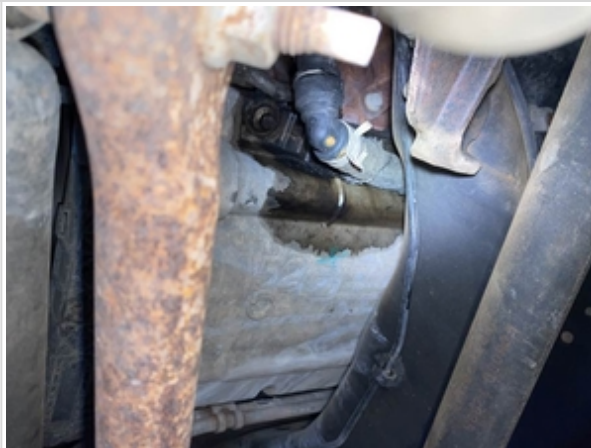
Engine Type (Make, Model, Cylinders, Hp)	Ford V8 - 6.7L - 400hp
Engine Serial Number	N/A
Engine Fuel Type	Diesel
Engine Photos

Blow-by (Visual Observation Check)	No
Unusual Noises (Upon Start-up, Idle, Shutdown)	Yes
Unusual Noise Notes	Other (see comments)
Comments	Engine noise may simply be a worn idler and/or tensioner pulley since noise sounds coming from front of engine
Engine Smoke (Upon Start-up, Idle, Shutdown)	No
Engine Smoke Notes	No engine smoke issues observed
Engine Exhaust Color	Clear
Battery	3 - Normal Wear & Tear
Battery Condition	Like new, recently replaced, Clean & dry appearance, tight connections
Battery Condition Photos

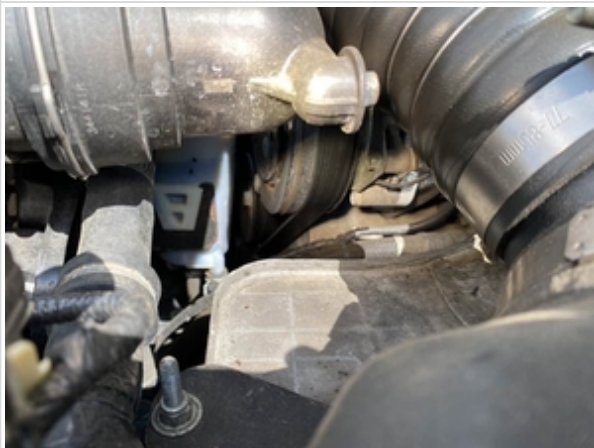
Belts	3 - Normal Wear & Tear
Belt Condition	Belts appear in good condition & alignment with proper tension, Other (see comments)
Comments	Auxiliary belt that drives air compressor may be misaligned with crank dampner
Belt Photos

Air Compressor Condition	3
Air Compressor Functionality	Operating as expected
Comments	However, hose reel not installed and air is leaking to atmosphere. Compressor belt alignment needs to be addressed. Compressor sounds strong and air tank mounted correctly under cab. Possible pulley worn or misaligned and serpentine belt needs adjustment

Overall Engine Appearance	Clean & dry
Overall Engine Comments	Minor oil leak could be coming from oil pan gasket left side. Mechanic also said that all 8 injectors were recently replaced. The engine harness was also recently replaced. Recently serviced. Serpentine belt for air compressor needs to be realigned and/or replaced.

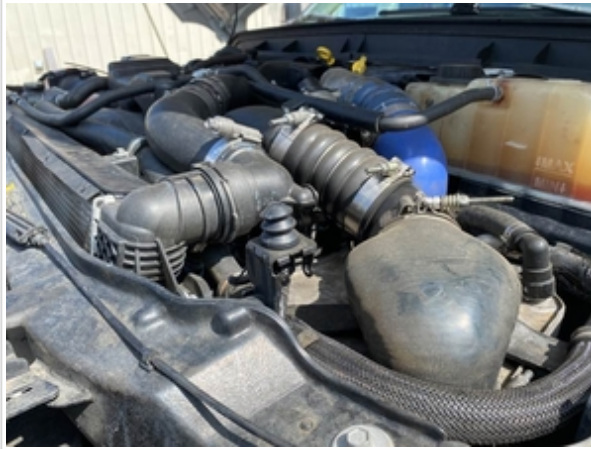
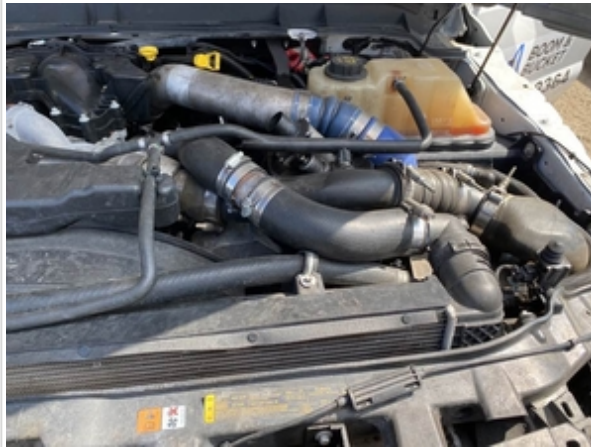
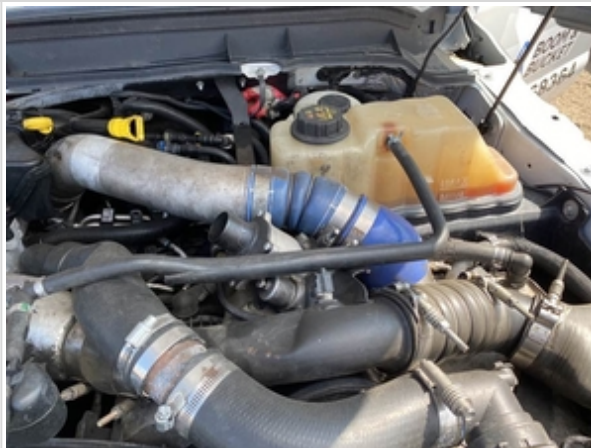
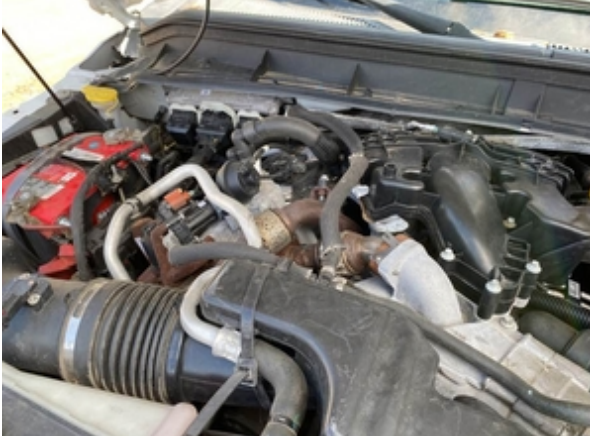
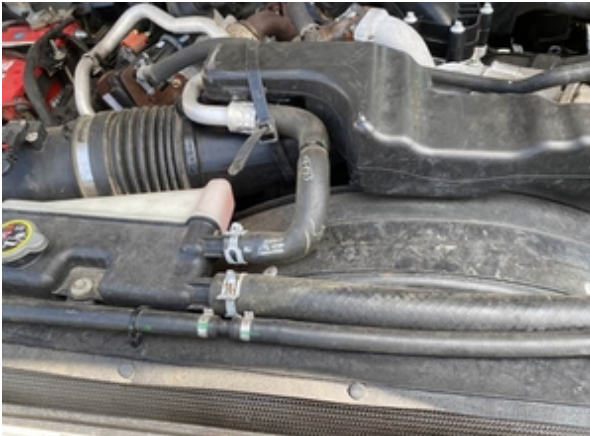
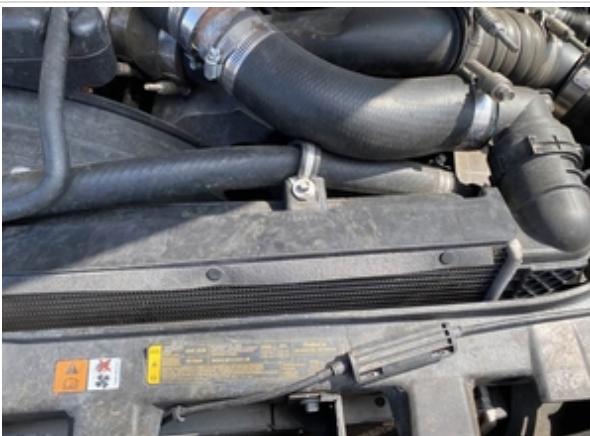
Hoses	3 - Normal Wear & Tear
Hose Condition	Firm, pliant hoses with no signs of wear or leaks

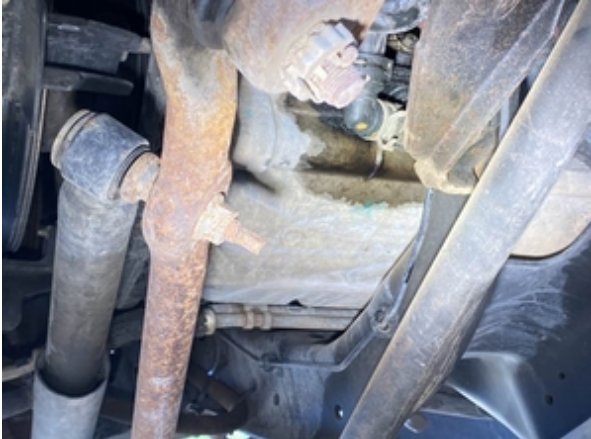
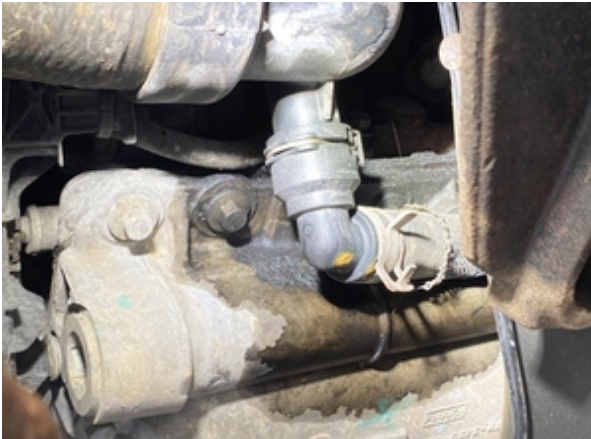
Water Pump	3 - Normal Wear & Tear	
Water Pump Condition	No unusual pump noises heard	
Cooling System Leaks	No	
Coolant Color / Appearance	3 - Normal Wear & Tear	
Coolant Color/Appearance Notes	Normal Translucent appearance, no visual signs of contamination	
Oil Leaks	Yes	
Oil Leak Notes	Wet areas with drops forming due to oil leakage, Other (see comments)

Comments	Very small leak possibly coming from bottom left side of oil pan gasket
Oil Leak Photos

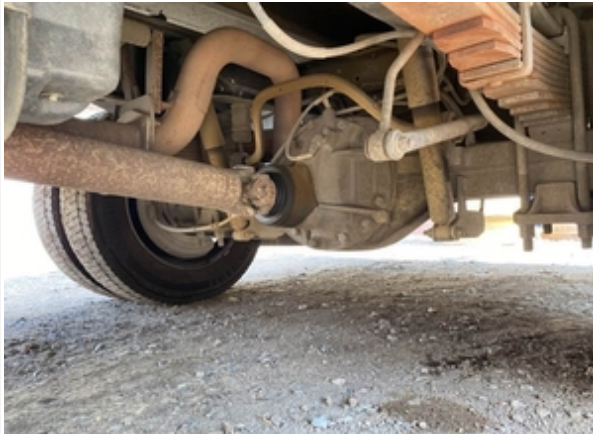
Differential	Check condition of the differential(s). Take photos and notes as relevant.	
Rear Differential	3 - Normal Wear & Tear	
Rear Differential Condition	Dry housing appearance, no unusual noises heard during operation	
Rear Differential Photos

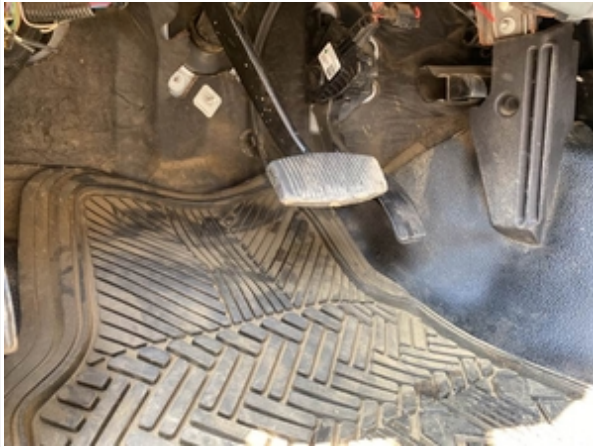
Front Differential	0
Brake System Type	Hydraulic
Air Brake Hose Condition	0
Foot Brake	3 - Normal Wear & Tear
Foot Brake Condition	Good brake function
Foot Brake Photos

Engine Brake Configuration	N/A
Parking Brake	2 - Above Average Wear
Parking Brake Condition	Other (see comments)
Comments	Parking brake barely holds at idle while in drive (needs adjustment)
Overall Drivetrain Comments	Overall drivetrain components look solid with no major obvious repairs needed. Parking brake should be adjusted. Rear driver side brake pads below 30 % should be replaced soon.

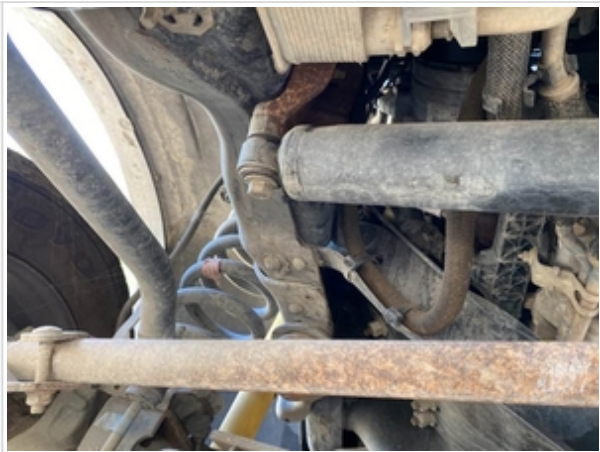
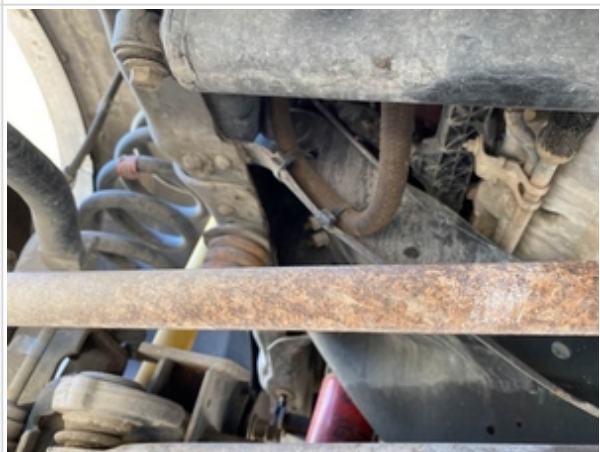
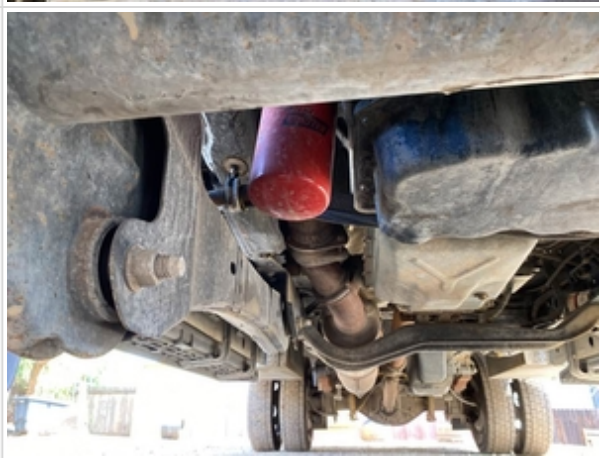
Frame Condition	3
Comments	As normal

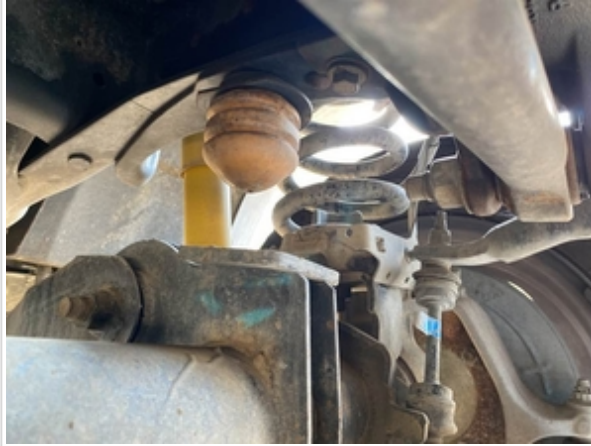
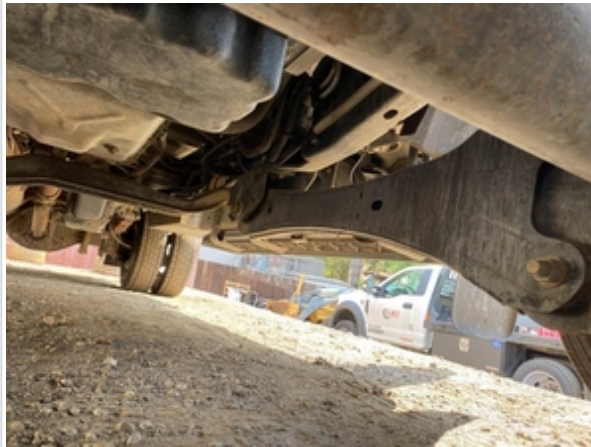
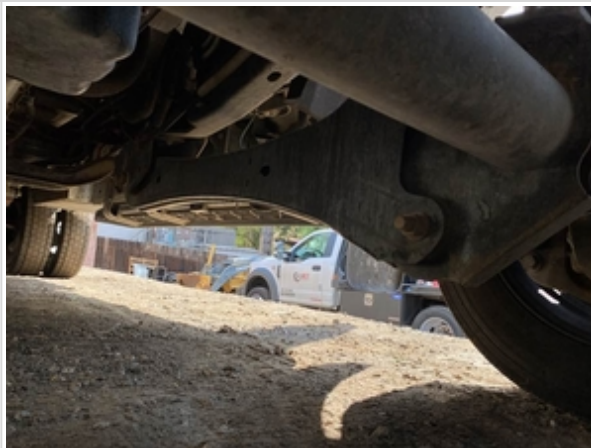
Suspension Photos

Suspension	3
Comments	Front shocks recently replaced, leaf spring assemblies look great

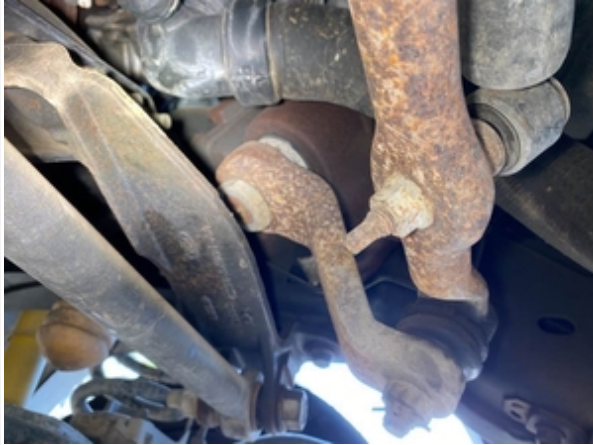
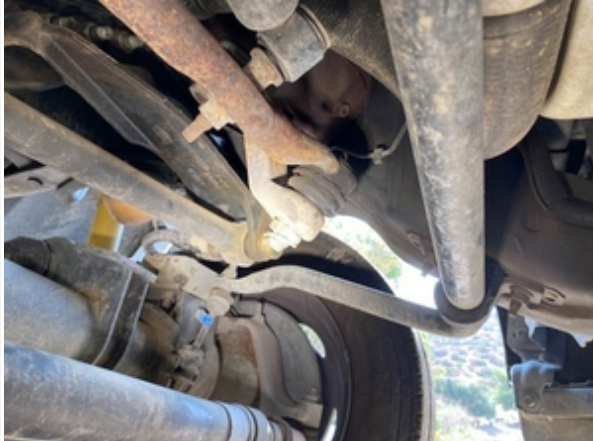
Steering Components	3
Comments	Looks good
Steering Components Photos

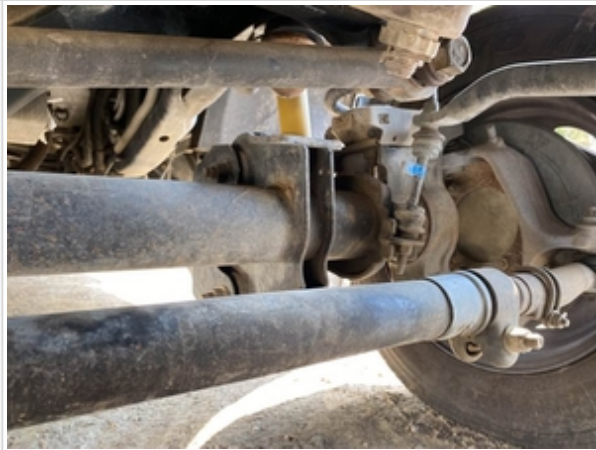
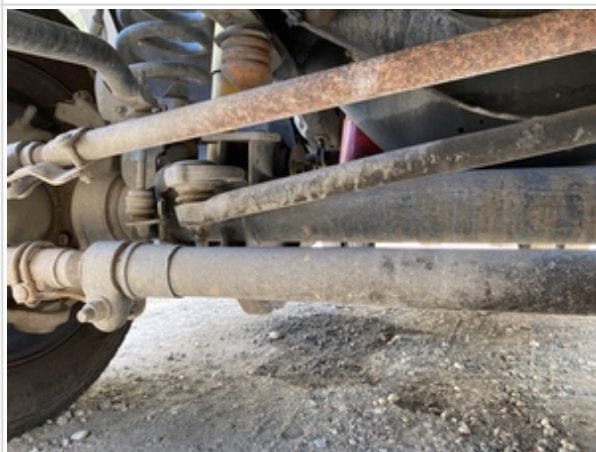
Steer Axle Photos

Steer Axle Condition	3

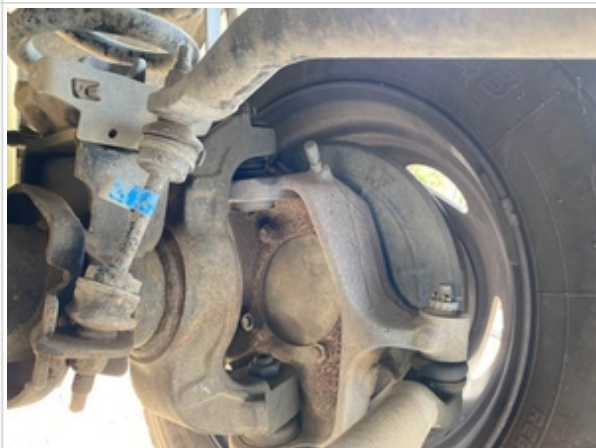
Wheels & Hub Condition	3	
Wheels & Hub Photos

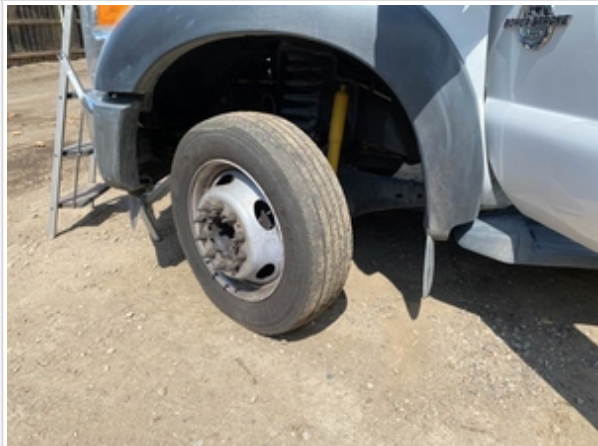
Wheel Seal Leaks	No	
Tire Brand	Toyo (front) Continental (rear)	
Tire Size	225/70R/19.5 (front and rear)	
Front Left Tire - Ratio Remaining	30%	
Front Left Tire Photos

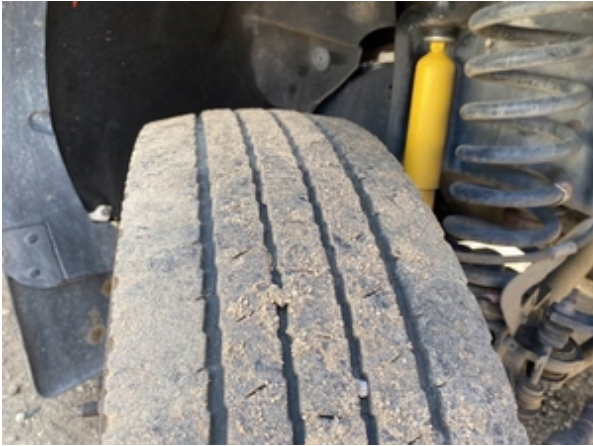
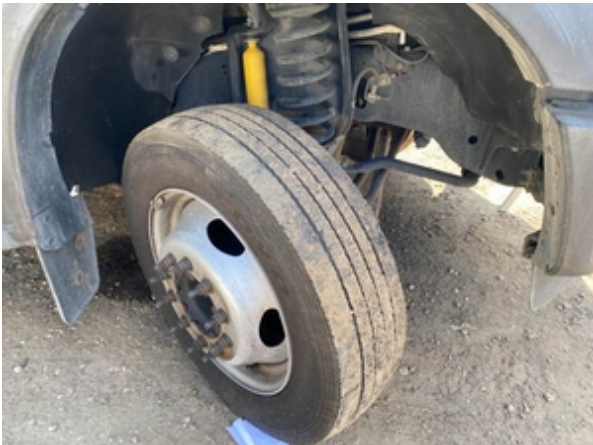
Front Right Tire - Ratio Remaining	30%	
Front Right Tire Photos

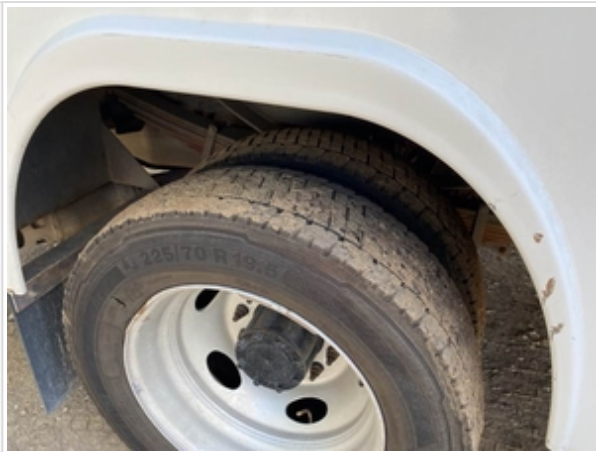
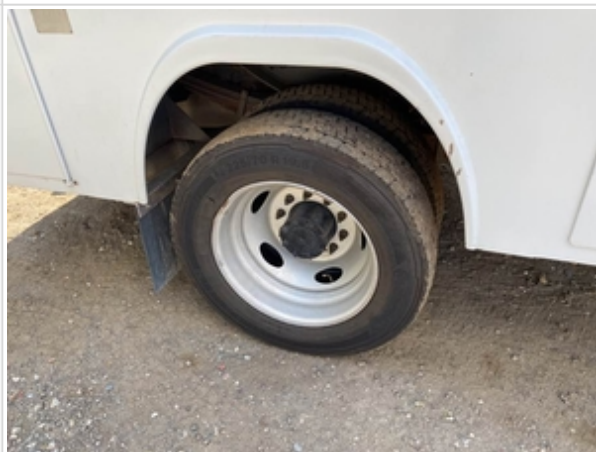
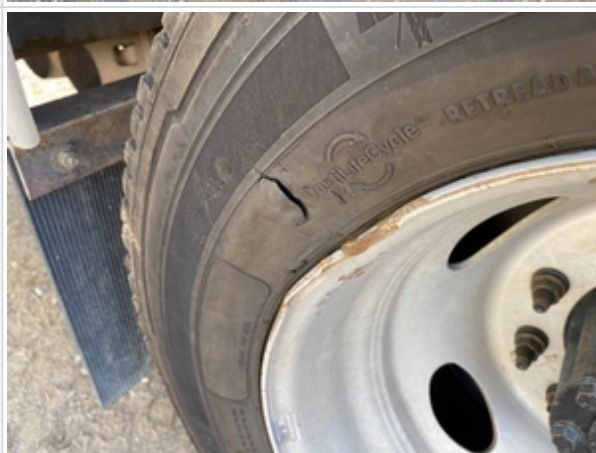
<p>Rear Right Tire Photos</p>

Rear Right Tire - Ratio Remaining	30%

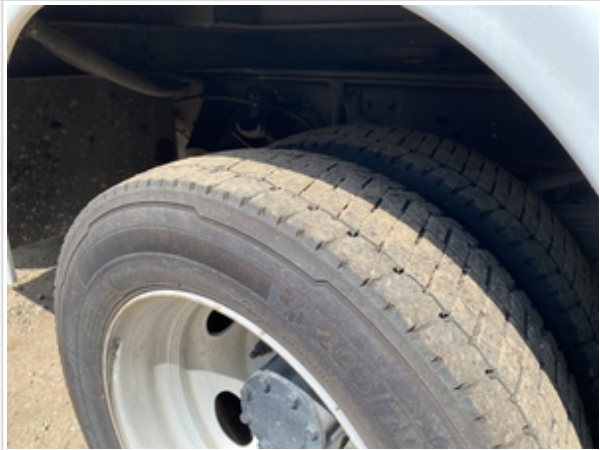
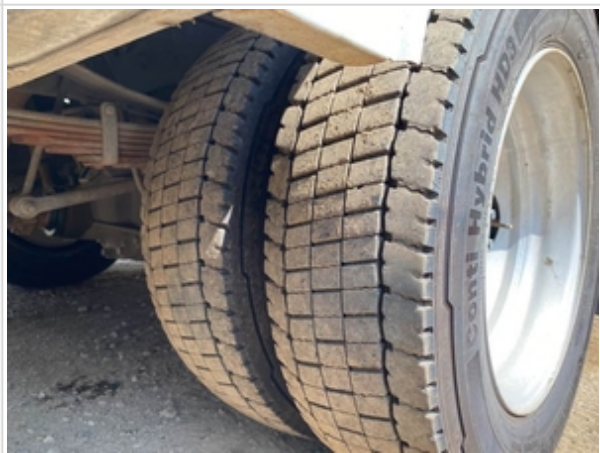
Rear Left Tire Photos

<p>Rear Left Tire - Ratio Remaining</p>	<p>50%</p>

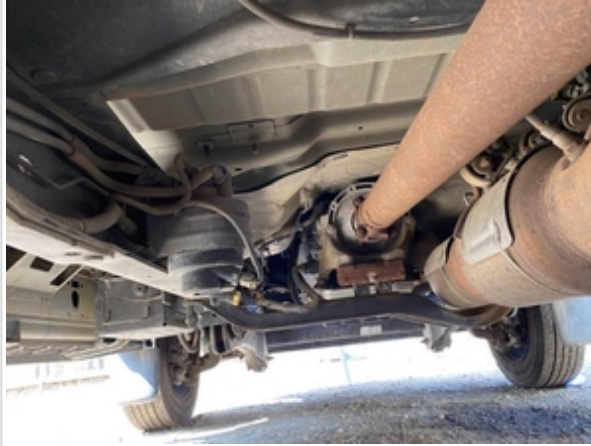
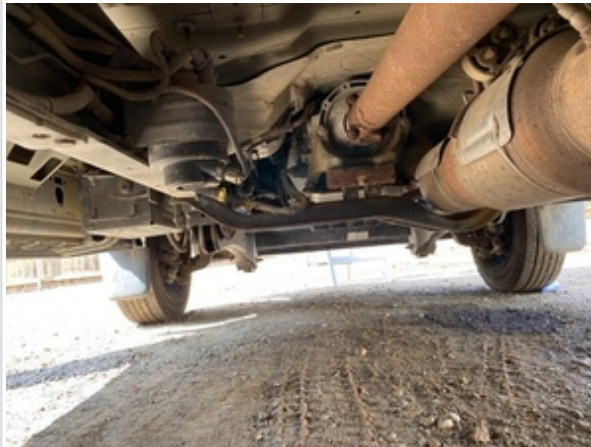
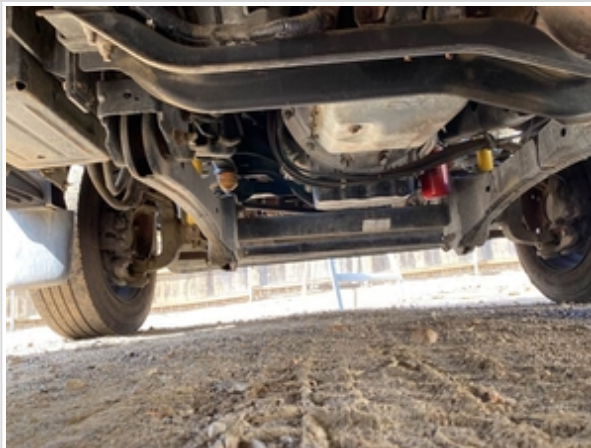
Overall Chassis & Undercarriage Photos

Overall Chassis	3
Overall Chassis Comments	Overall chasis in solid condition with no major obvious problems found.

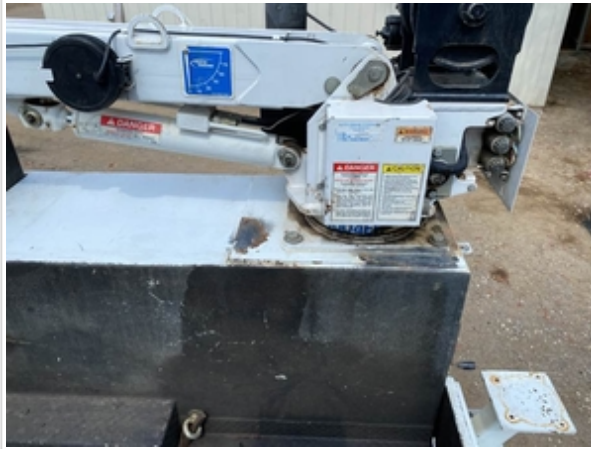
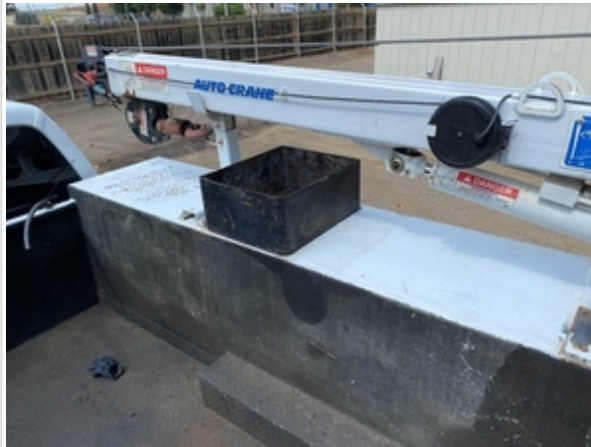
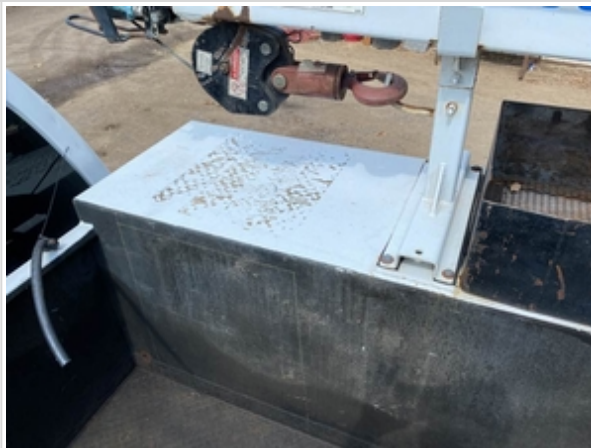
<p>Comments</p>	<p>RKI truck body 9' bed with Autocrane</p>
<p>Bed Body Photos</p>

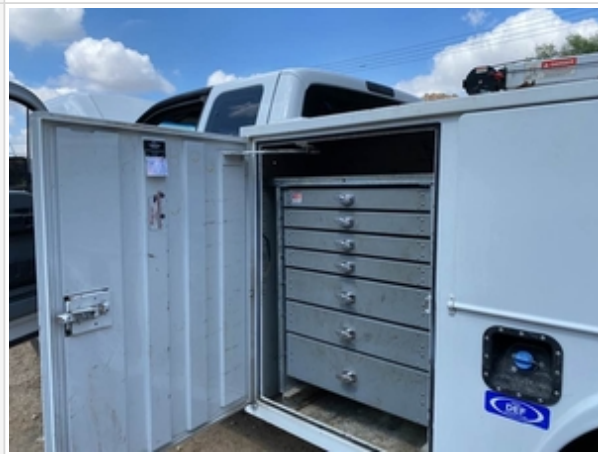
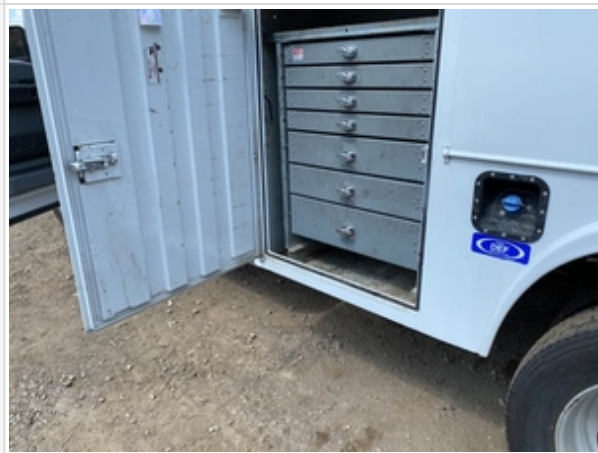
<p>Toolboxes</p>	<p>3</p>	
<p>Toolbox Photos</p>

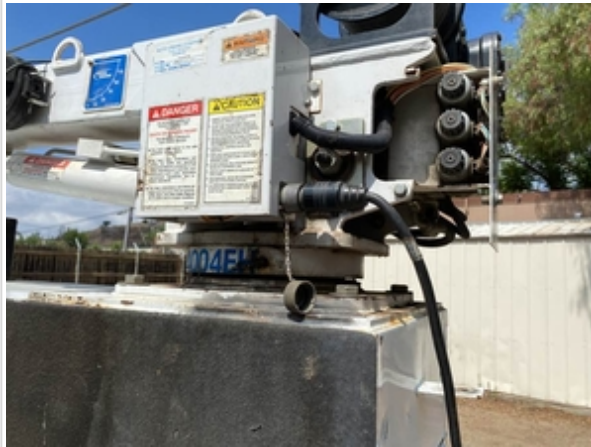
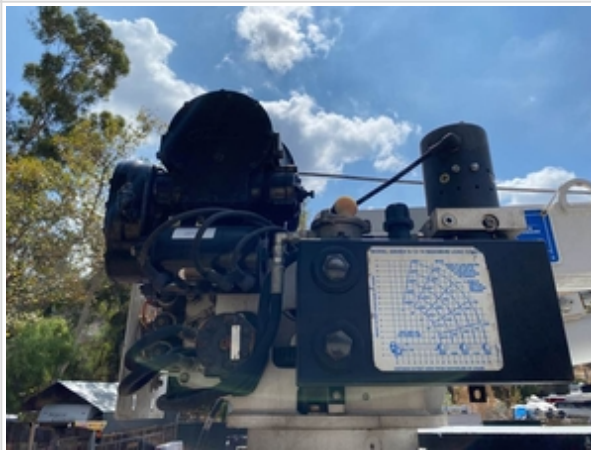
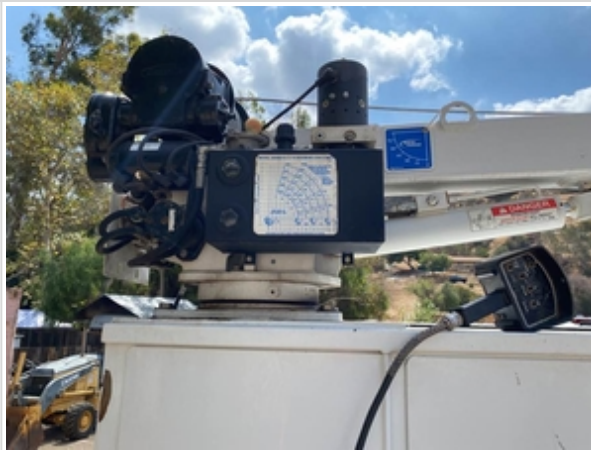
Crane Condition	3	
Crane Functionality	Operating as expected	
Comments	Crane in good shape	
Crane Photos
