Inspection Report (Generator)

Year	2016
Make	Multiquip
Model	Whisperwatt DCA - 70SSIU4F
Serial Number	7353197
Hour Meter Reading	15,272
Previous Application (e.g., earth moving, mining, demolition, etc)	General construction

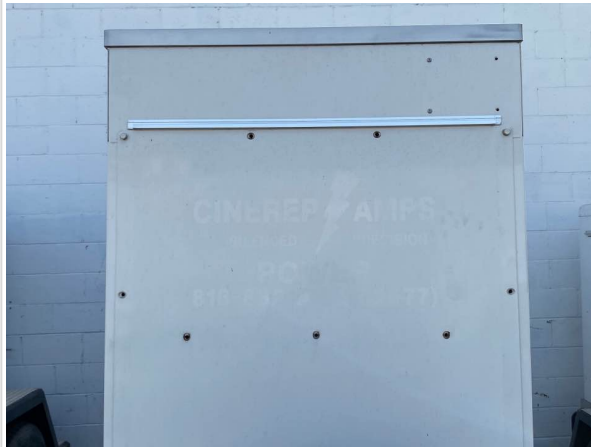
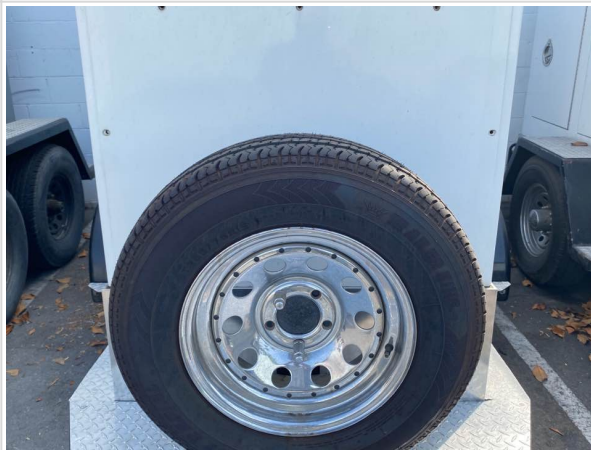
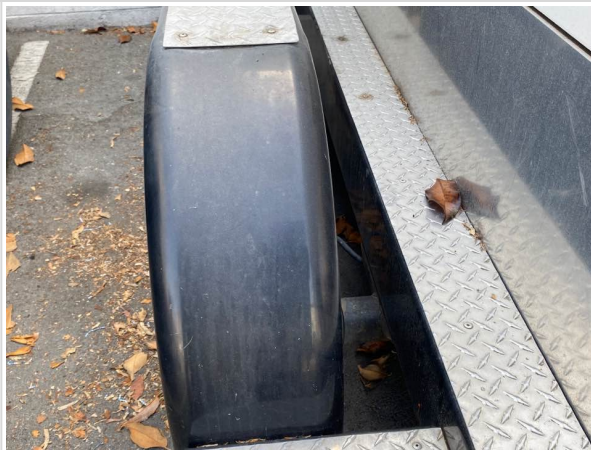
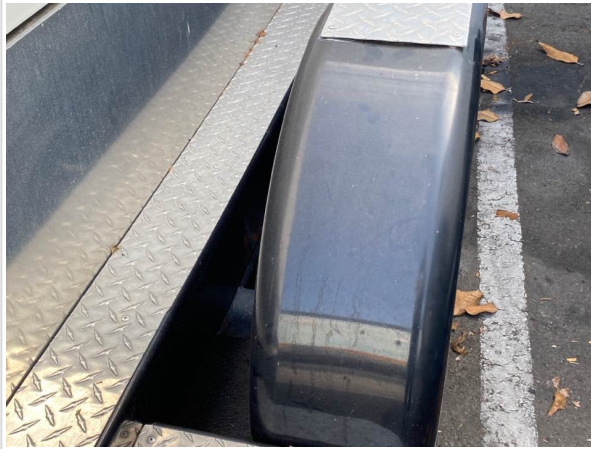
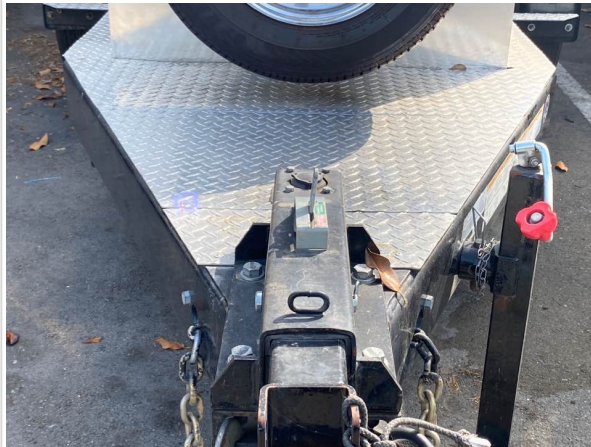
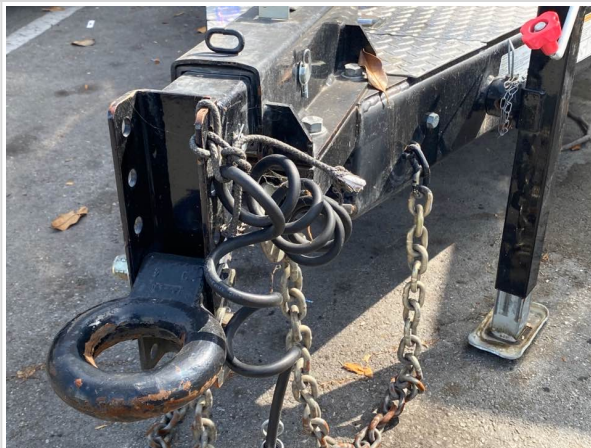
Front Photos

Front	3 - Normal Wear & Tear
Front Condition	No visible damage, Other (see comments)
Comments	Front panel hardware missing

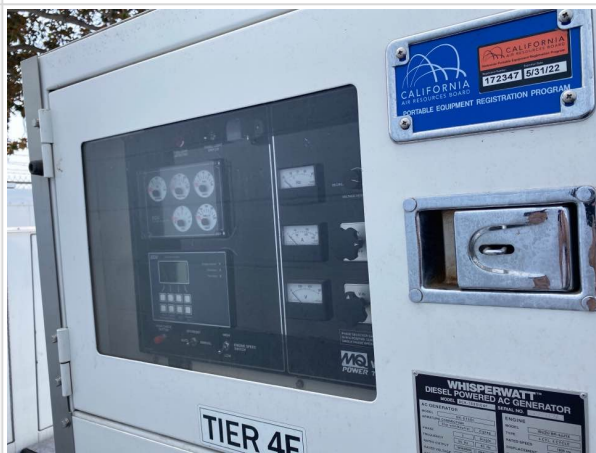
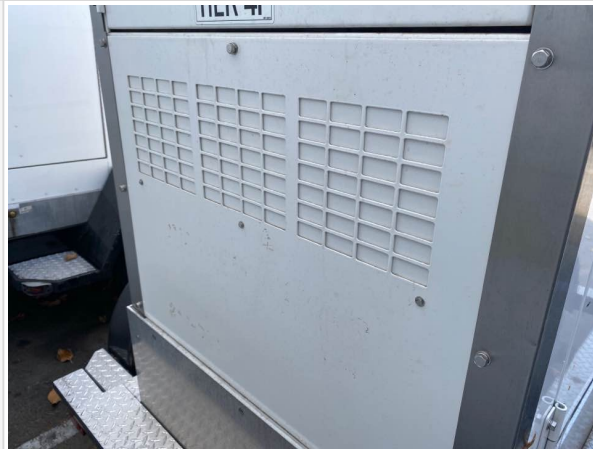
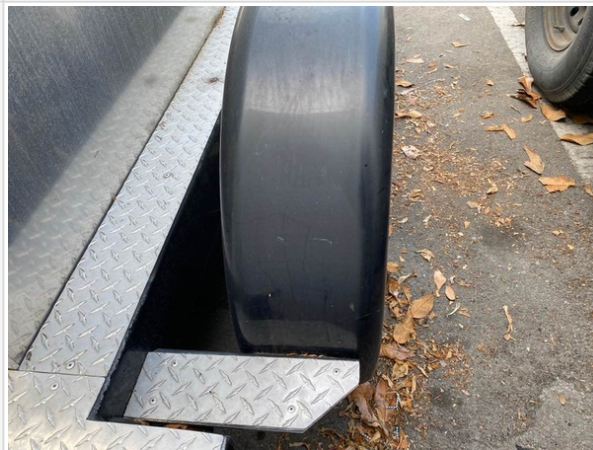
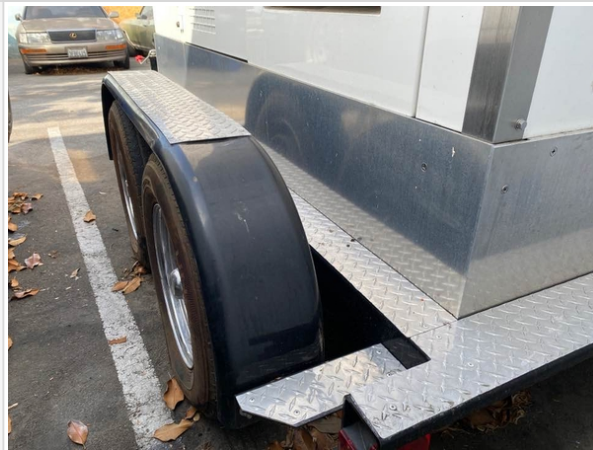
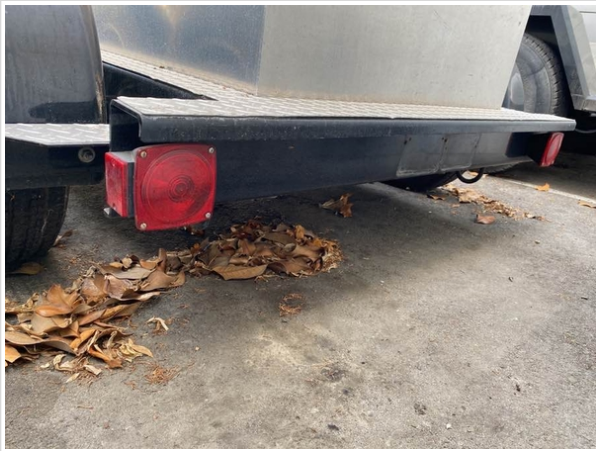
Rear	3 - Normal Wear & Tear
Rear Condition	No visible damage
Rear Photos

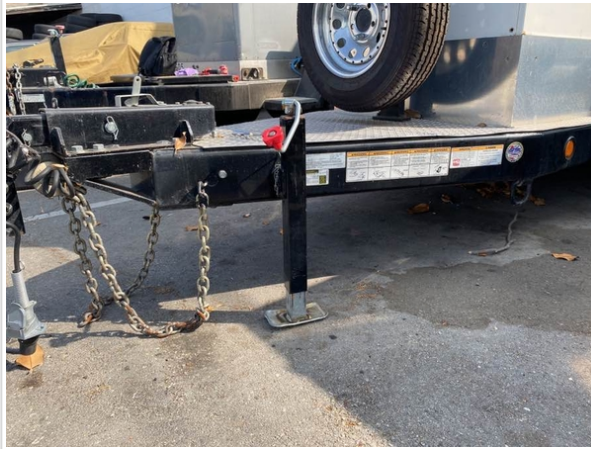
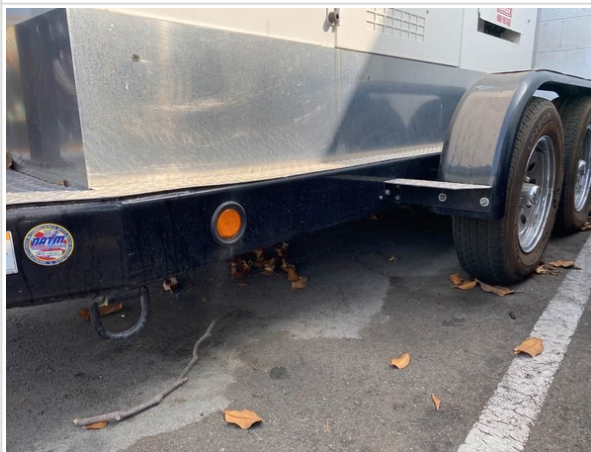
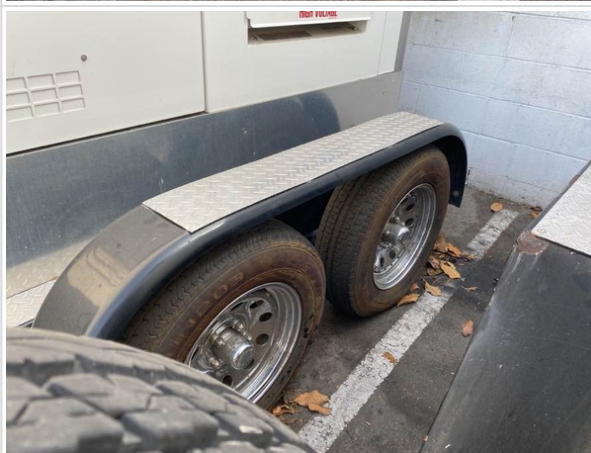
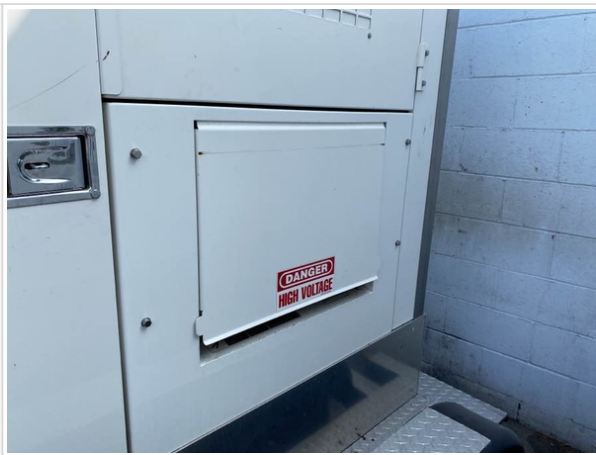
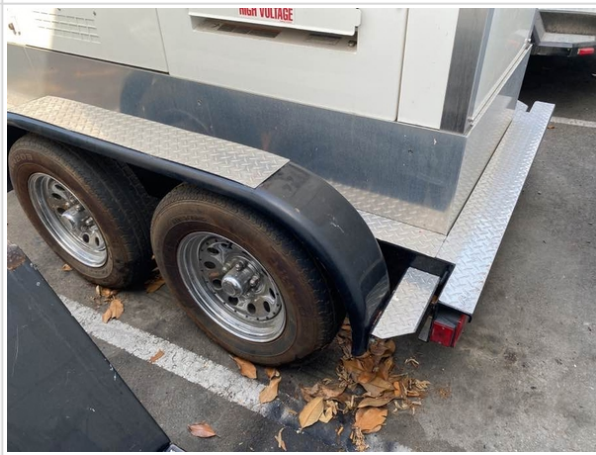
Left	3 - Normal Wear & Tear	
Left Condition	No visible damage, Other (see comments)	
Comments	No major damage just surface scratch on left side engine compartment door	
Left Photos

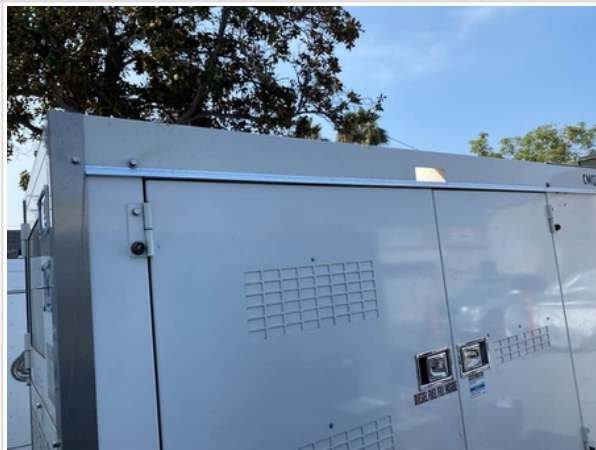
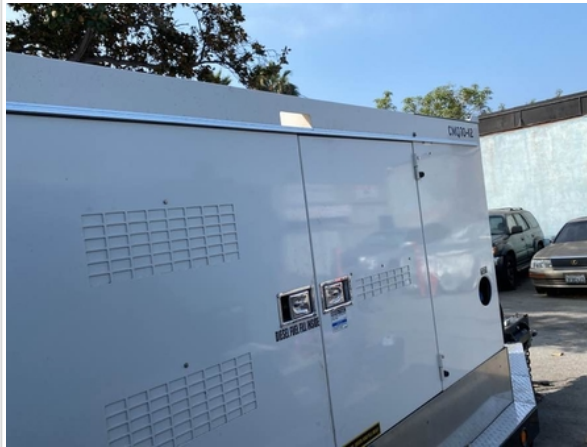
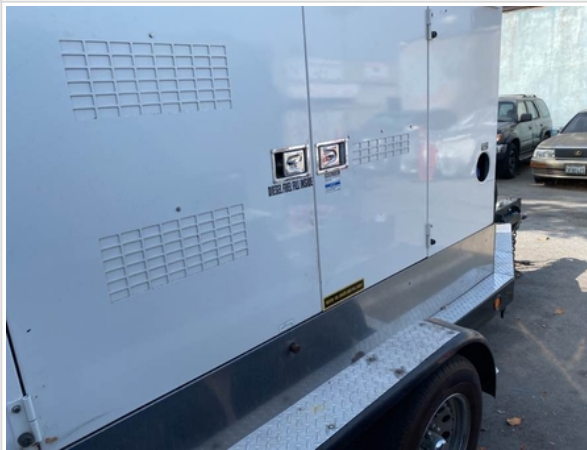
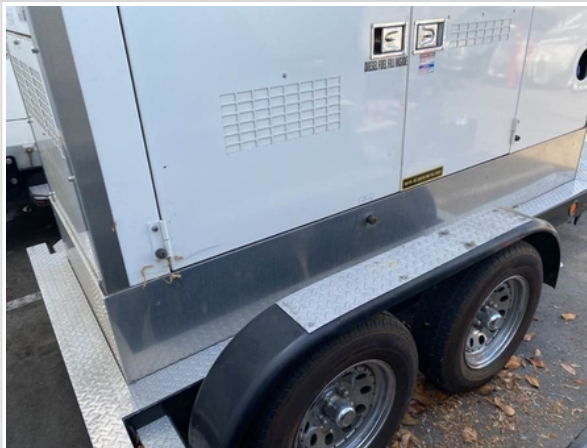
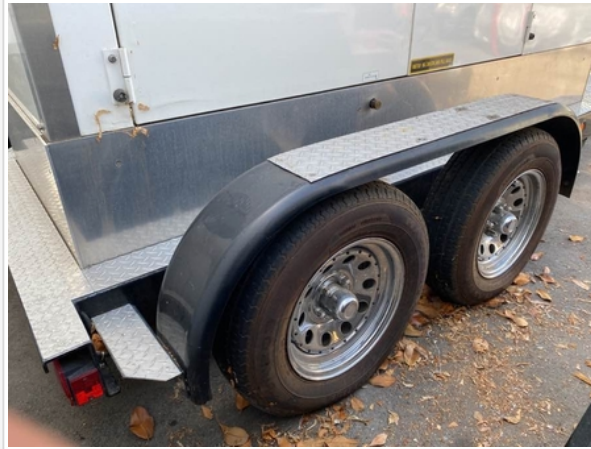
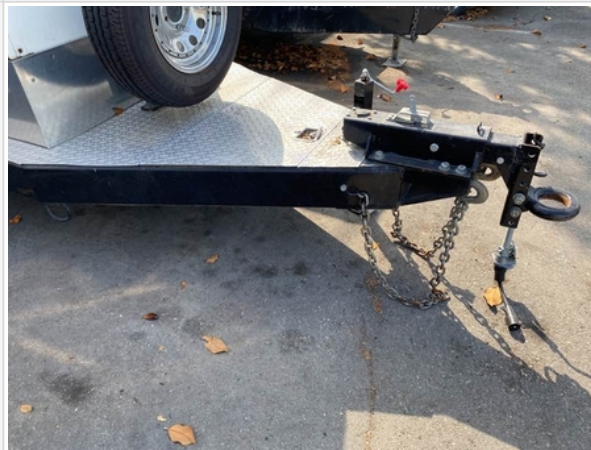
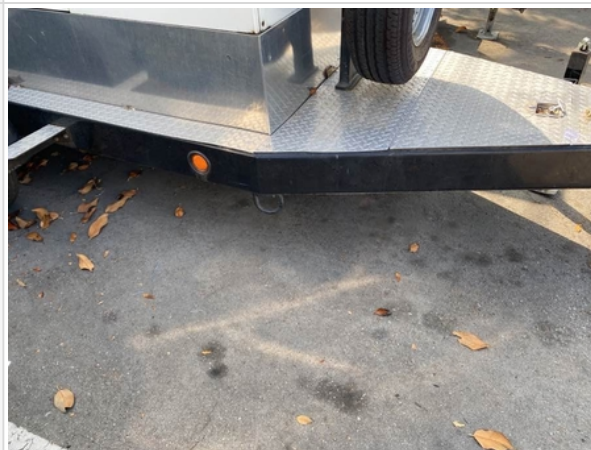
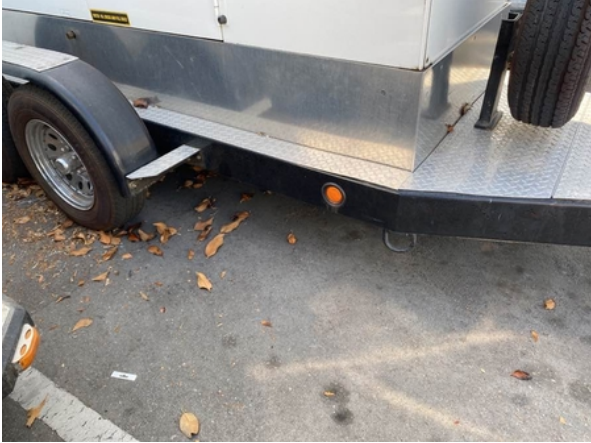
Right	3 - Normal Wear & Tear
Right Condition	No visible damage
Right Photos

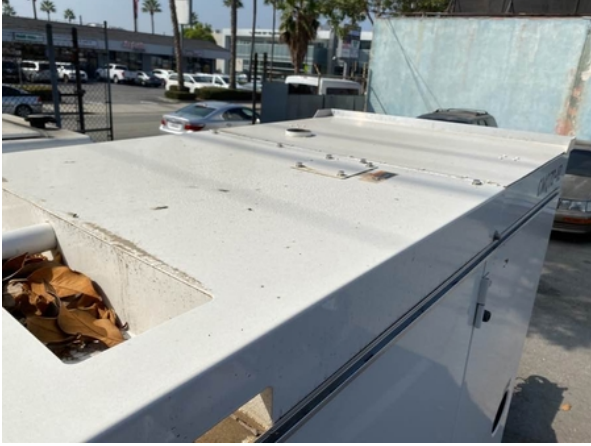
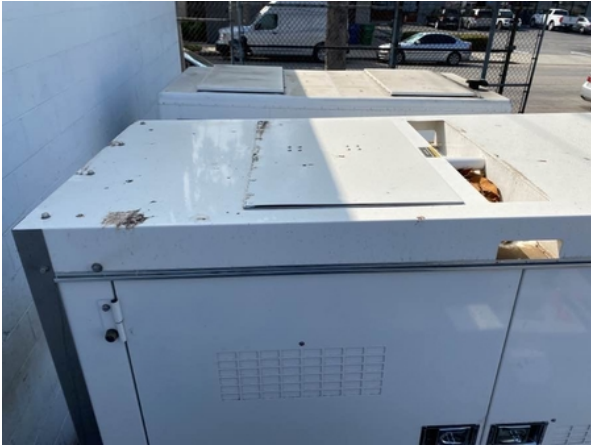
Upper	3 - Normal Wear & Tear
Upper Condition	No visible damage, Other (see comments)
Comments	Dusty
Upper Photos

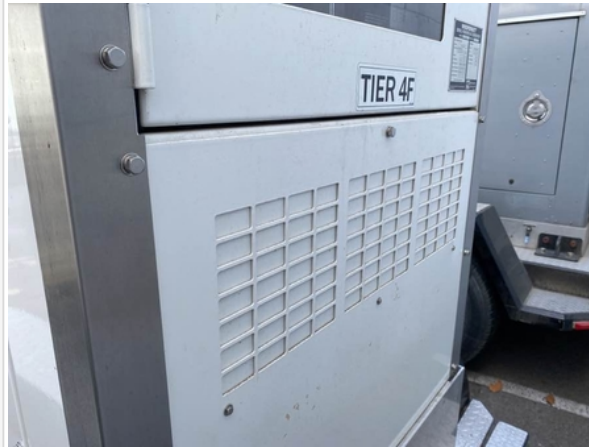
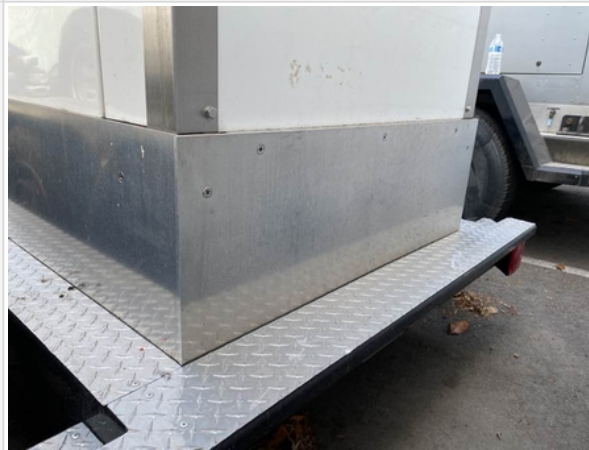
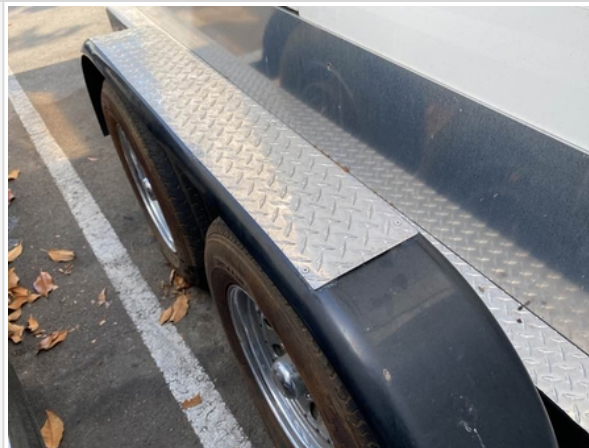
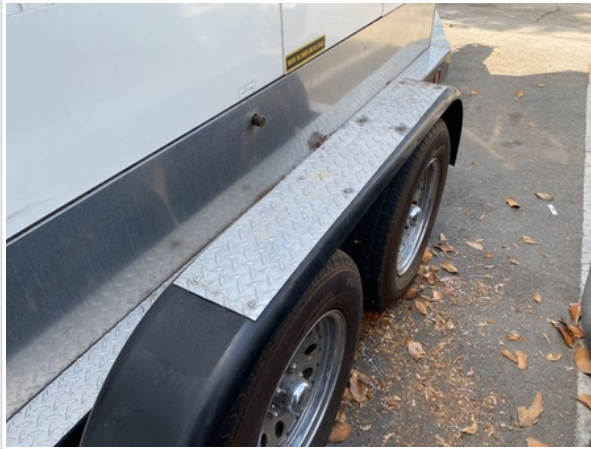
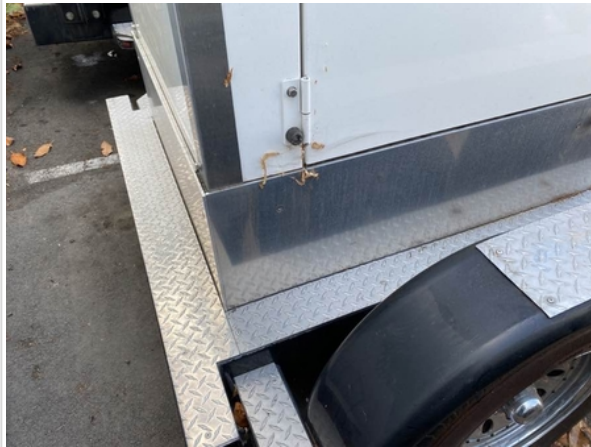
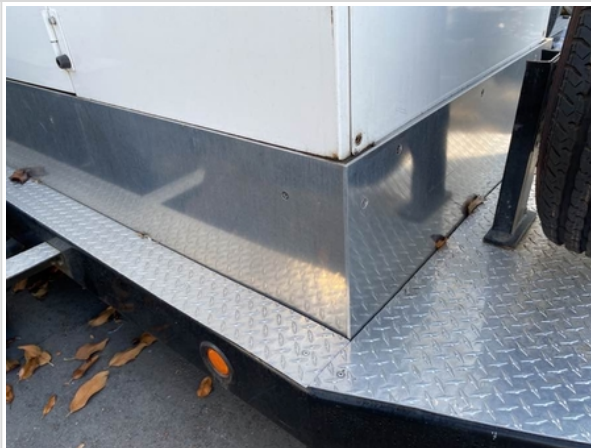
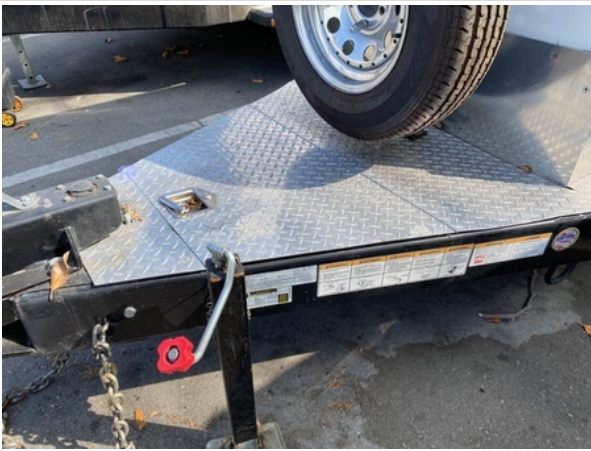
Body Panels Photos

Body Panels (Any Rust Damage?)	3 - Normal Wear & Tear
Body Panel Condition	No visible damage, good paint condition and panel fitment

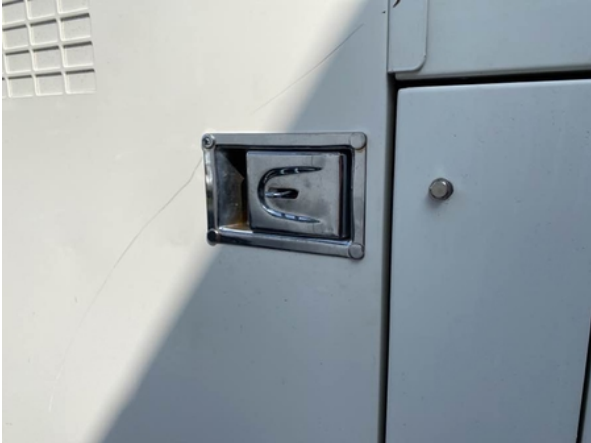
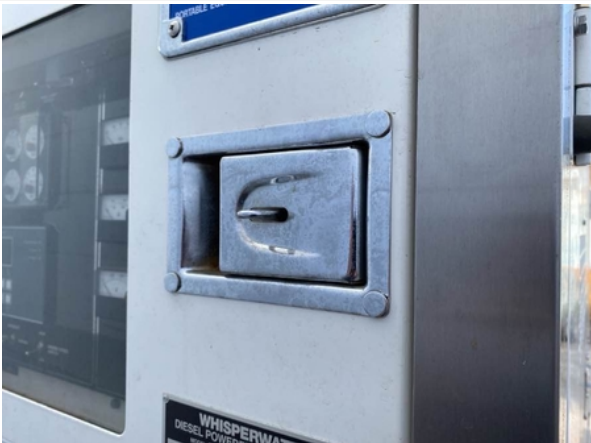
Doors / Canopy Latches	3 - Normal Wear & Tear	
Doors / Canopy Latches Condition	No visible damage	
Doors / Canopy Latches Photos

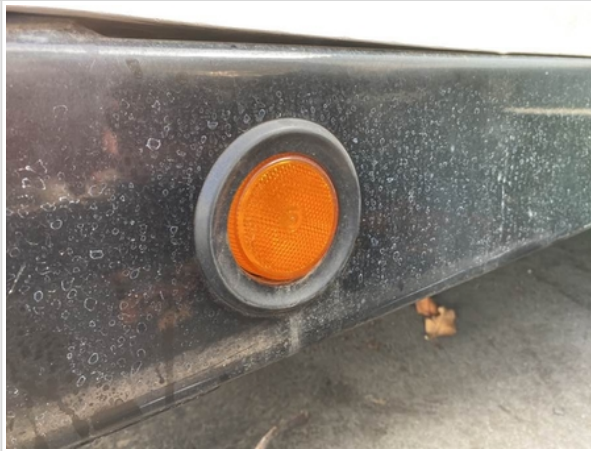
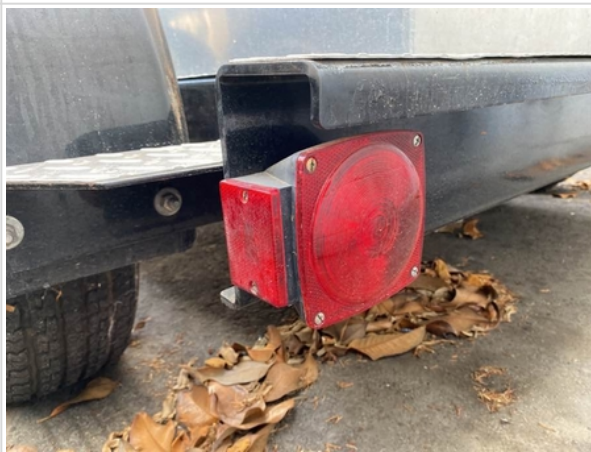
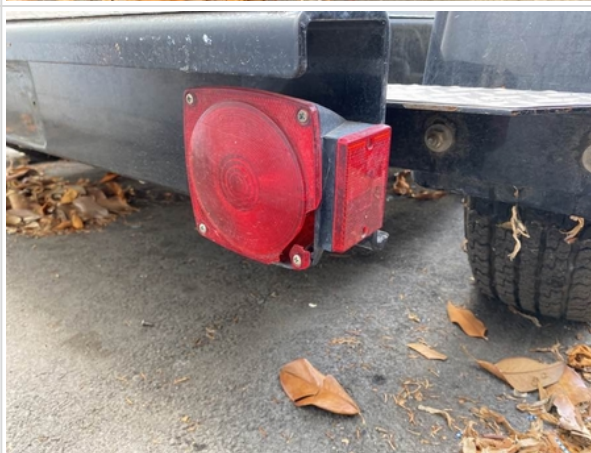
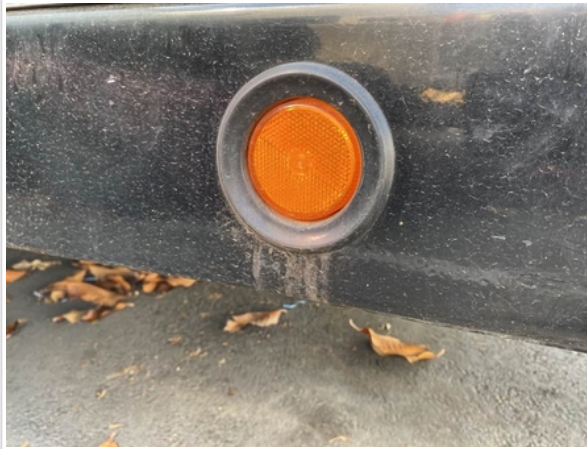
Glass Condition	0	
Mirrors	0	
Lighting System	3 - Normal Wear & Tear	
Lighting System Condition	Other (see comments)	
Comments	Exterior of lights and wire harness look to be good, unable to test	
Lighting System Photos

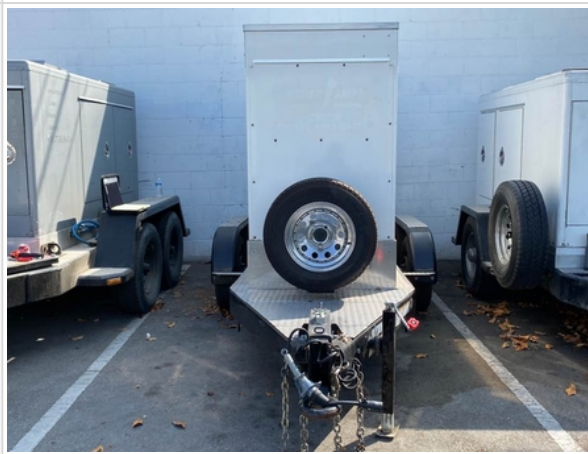
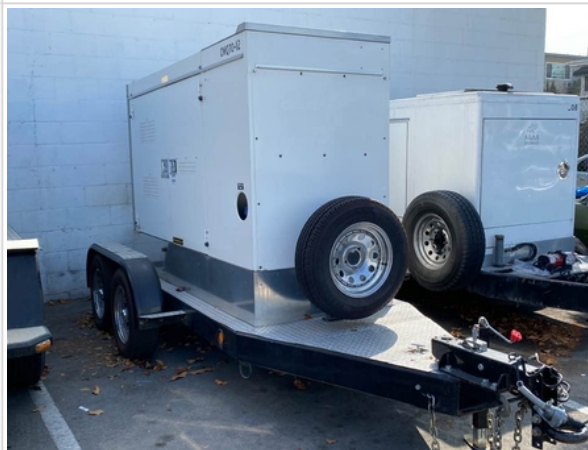
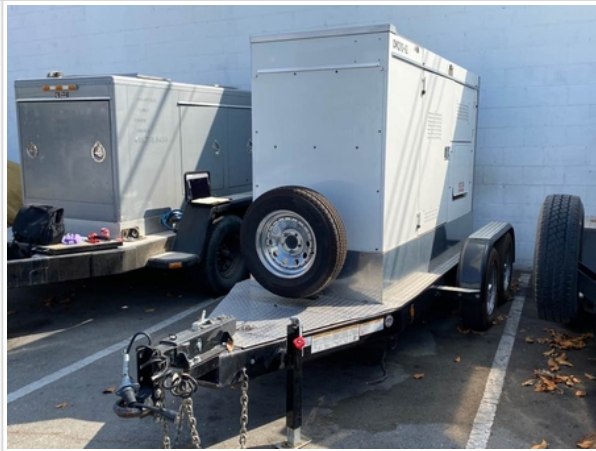
Front	3 - Normal Wear & Tear
Front Condition	No visible damage
Front Photos

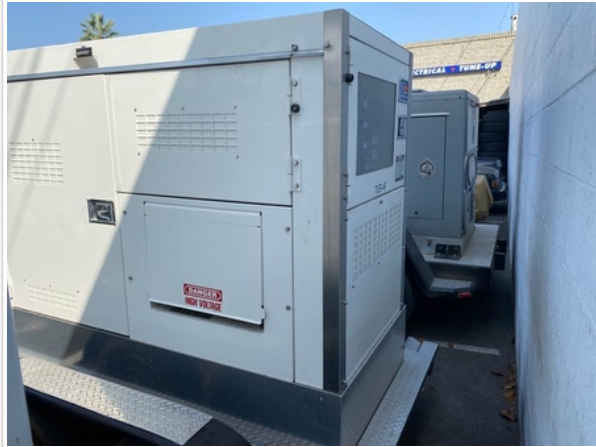
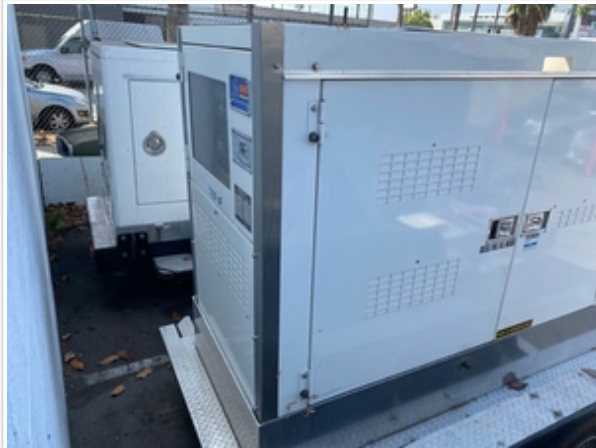
Rear	3 - Normal Wear & Tear
Rear Condition	No visible damage
Rear Photos

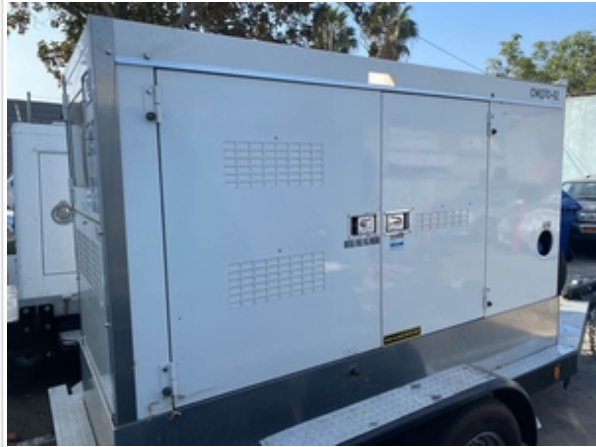
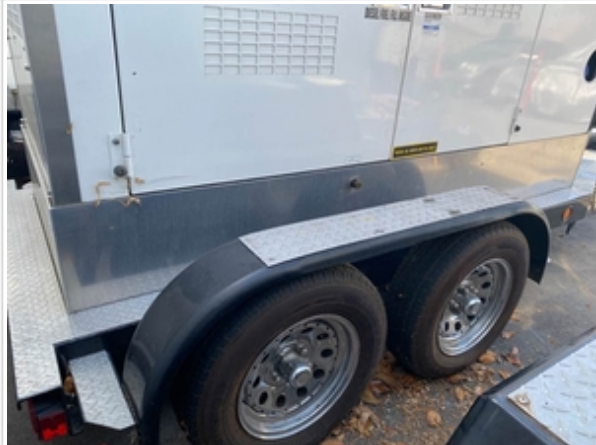
<p>Right</p>	<p>3 - Normal Wear & Tear</p>
<p>Right Condition</p>	<p>No visible damage</p>
<p>Right Photos</p>

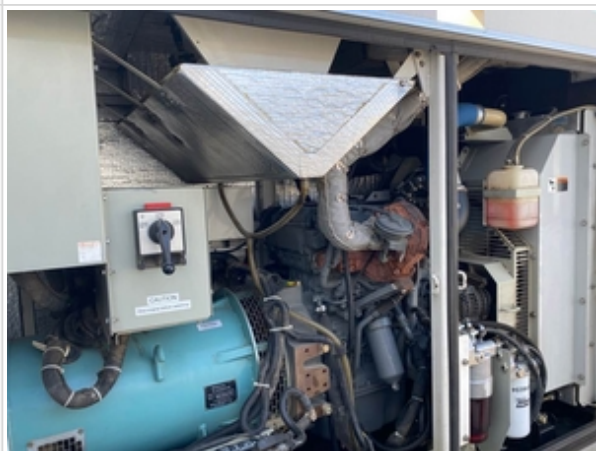
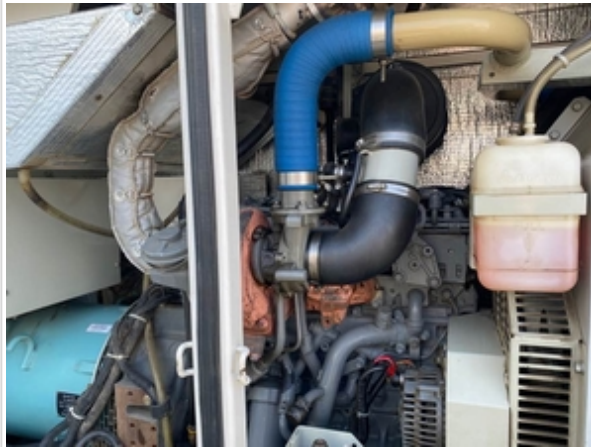
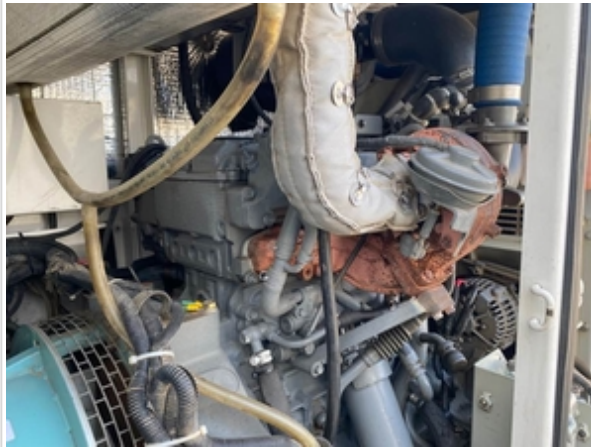
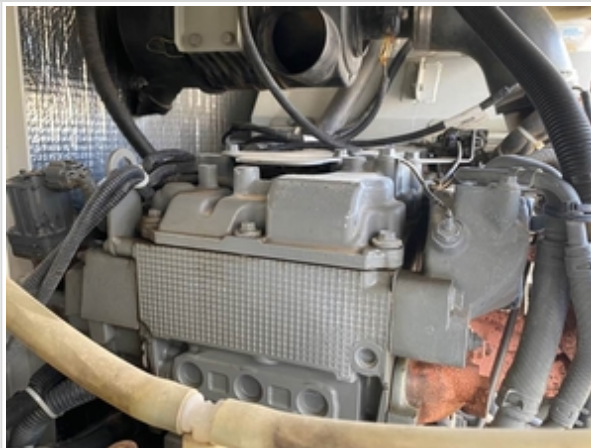
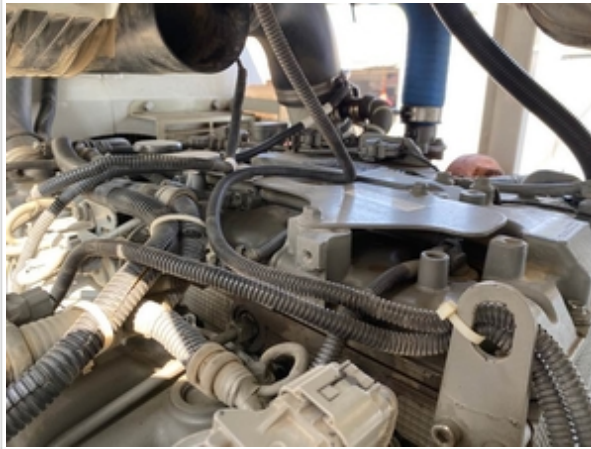
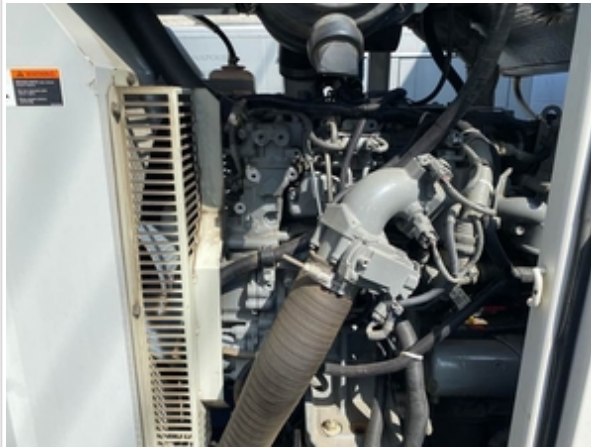
Engine Type (Make, Model, Cylinders, Hp)	Isuzu/BR - 4JJ1X - 6 Cyl. - 95HP
Emissions Tier	Tier 4F
Engine Serial Number	193097
Engine Fuel Type	Diesel
Engine Photos

Overall Engine Appearance	Clean & dry
Overall Engine Comments	Besides the small oil leak from turbo and seepage from valve cover, the rest of the engine looks well maintained. Engine oil buildup around intake and discharge hoses from turbo may be an indication of wet stacking.

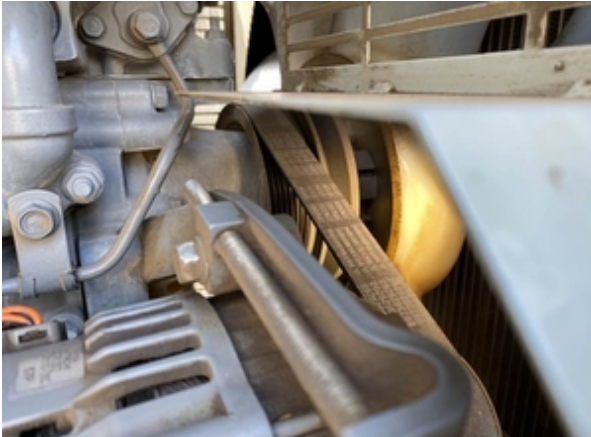
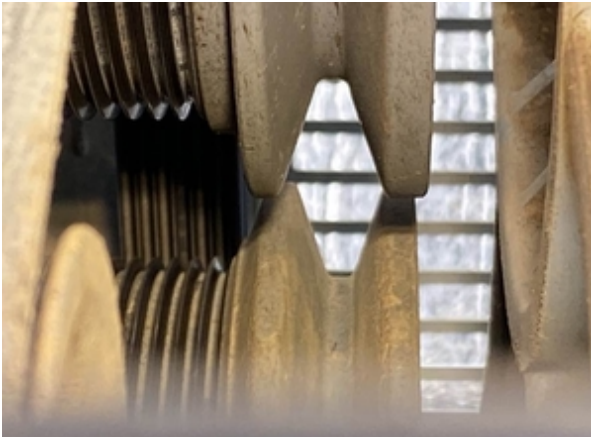
Belts	3 - Normal Wear & Tear
Belt Condition	Belts appear in good condition & alignment with proper tension
Belt Photos

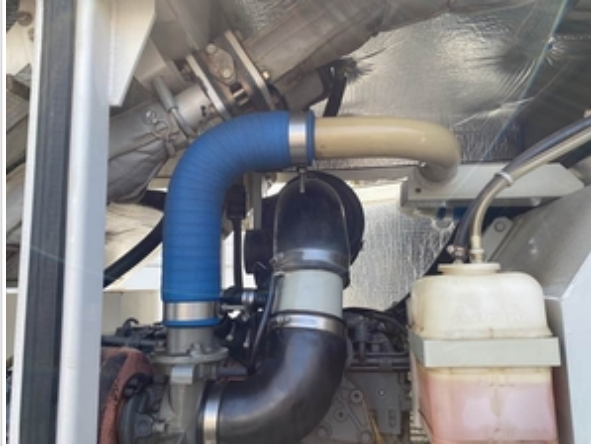
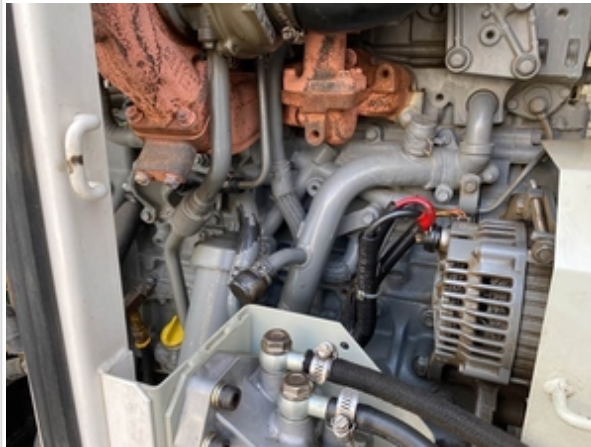
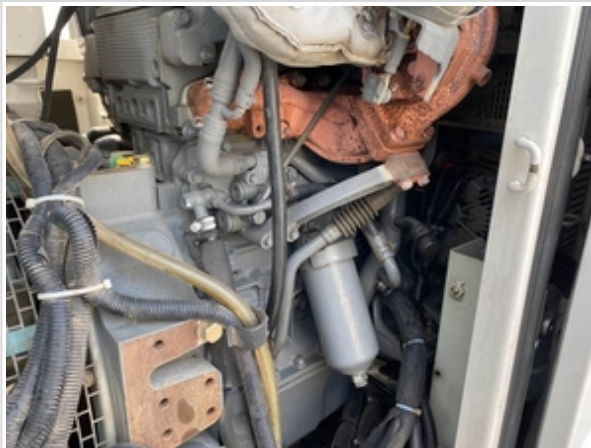
Hoses	3 - Normal Wear & Tear
Hose Condition	Firm, pliant hoses with no signs of wear or leaks

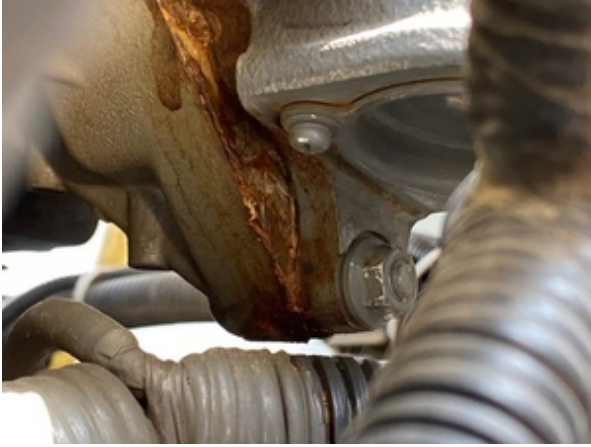
Water Pump	3 - Normal Wear & Tear
Water Pump Condition	No unusual pump noises heard
Cooling System Leaks	Yes
Cooling System Condition	Other (see comments, No indication of coolant leaks seen)
Comments	No active leaks seen just a sign of residual coolant from egr valve to manifold
Cooling System Leaks Photos

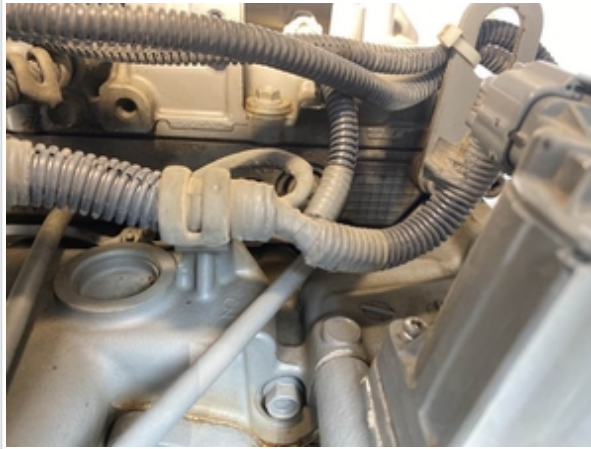
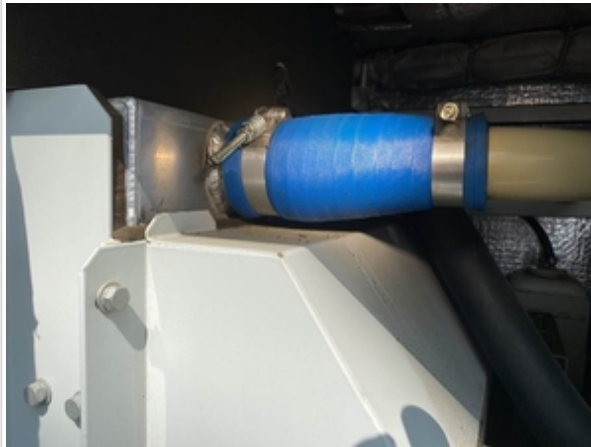
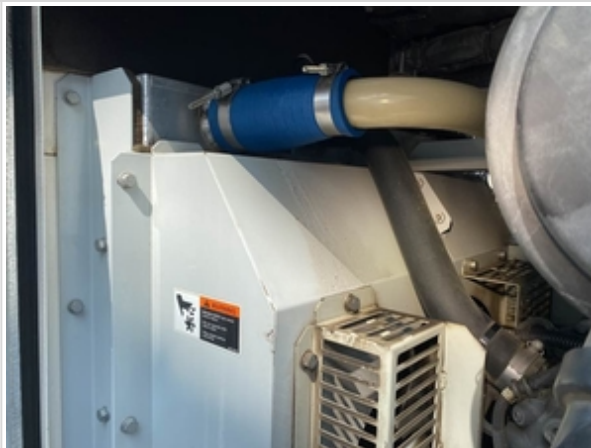
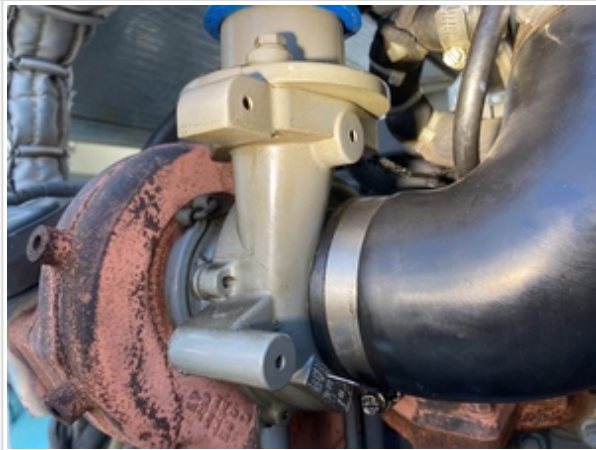
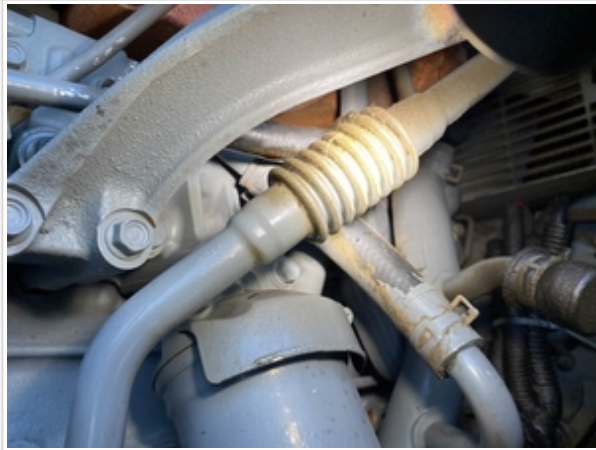
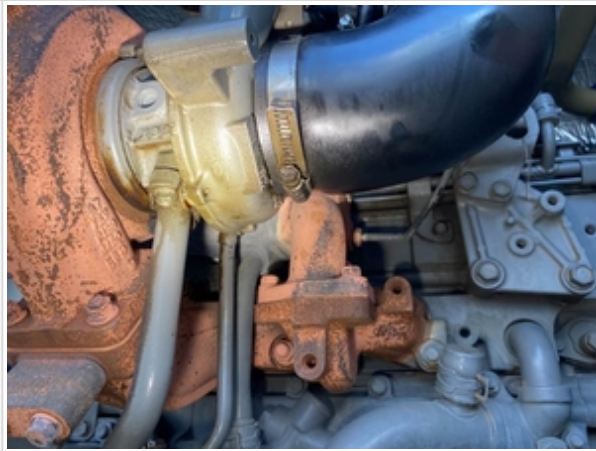
<p>Oil Leak Photos</p>

Coolant Color / Appearance	3 - Normal Wear & Tear
Coolant Color/Appearance Notes	Normal Translucent appearance, no visual signs of contamination
Oil Leaks	Yes
Oil Leak Notes	Dried oil seepages seen, Other (see comments)
Comments	Possible oil seepage coming from valve cover, oil coming out of cold side and charge side

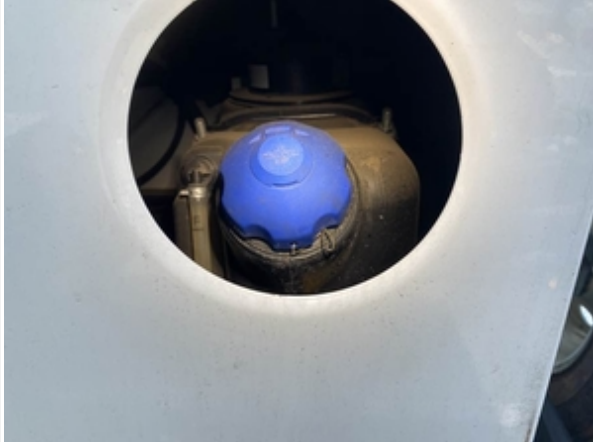
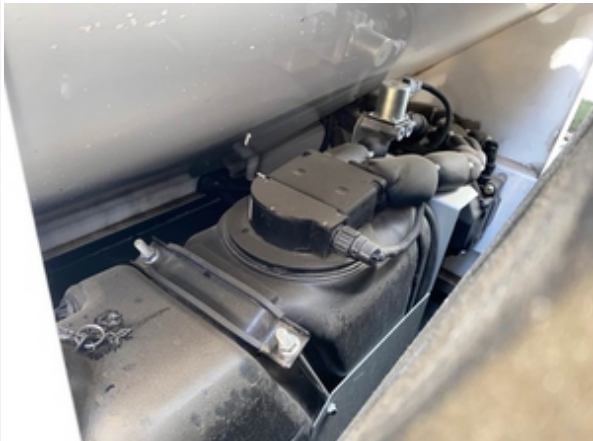
Requires DEF (Diesel Exhaust Fluid)	Yes
DEF Tank	3 - Normal Wear & Tear
DEF Tank Condition	Area around DEF tank cap is clean, fluid is clear & appears free of contaminants
DEF Tank Photos

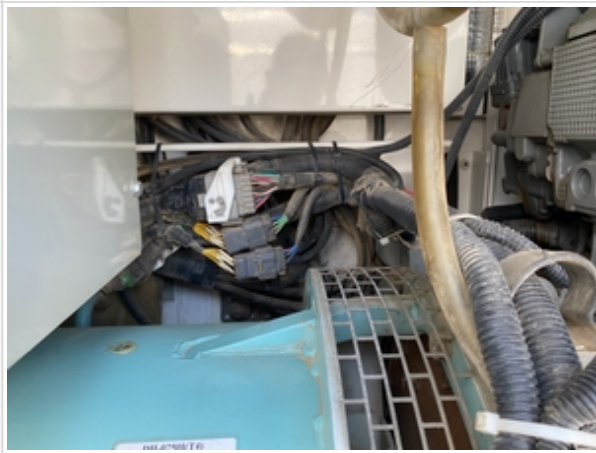
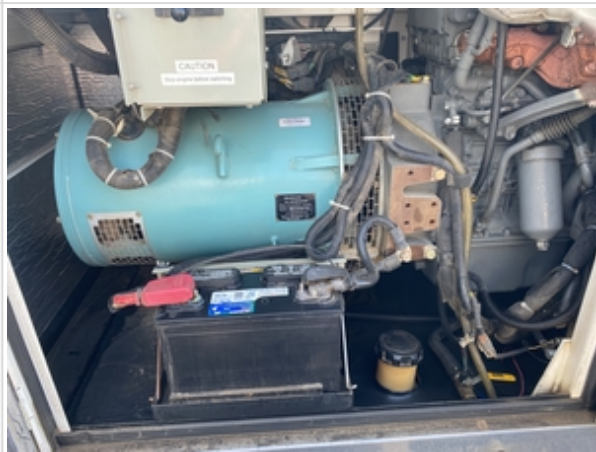
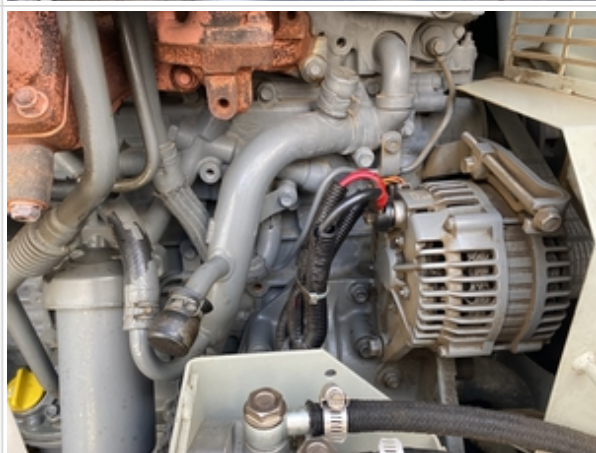
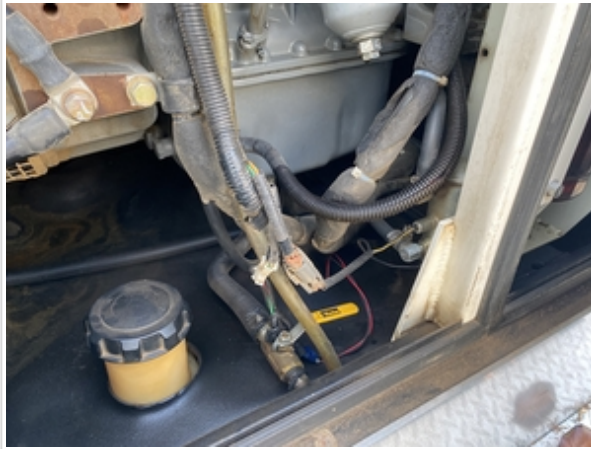
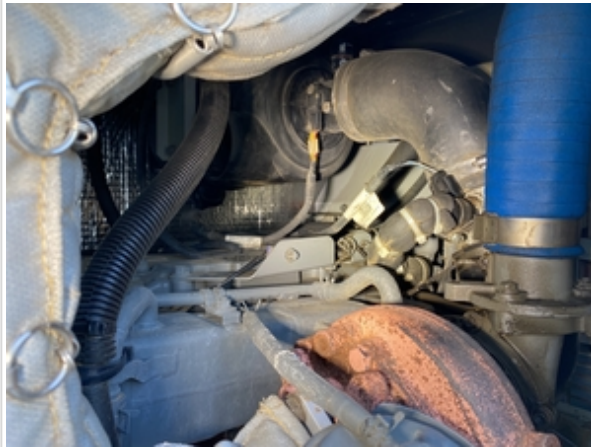
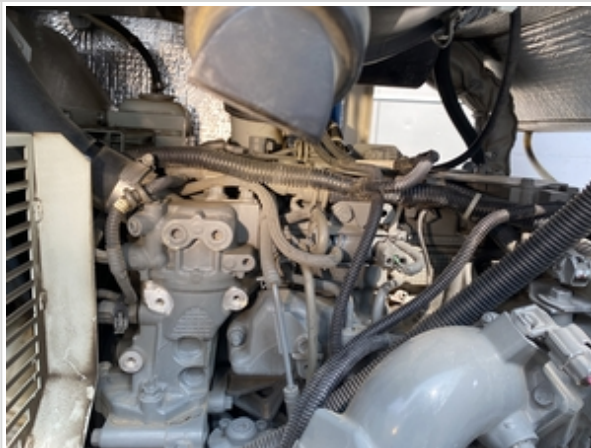
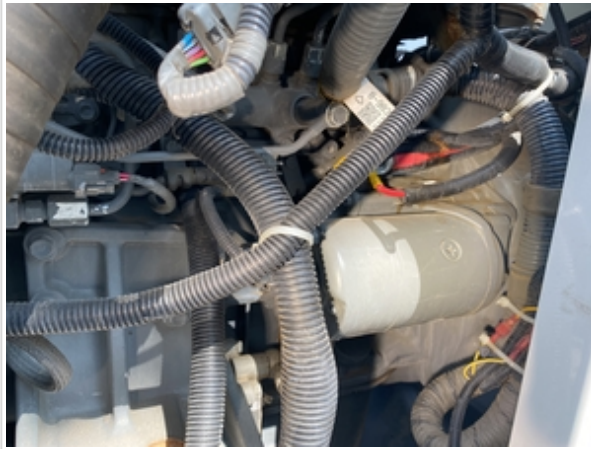
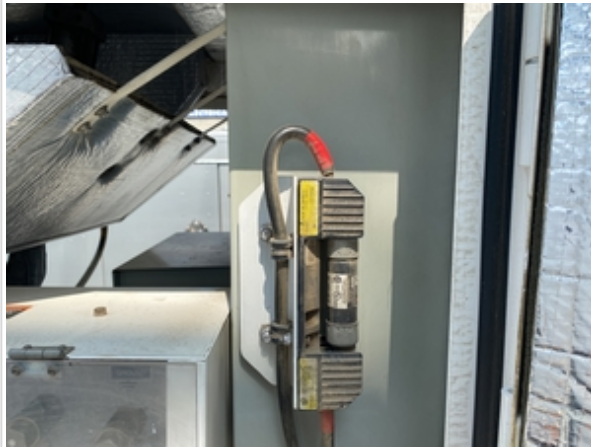
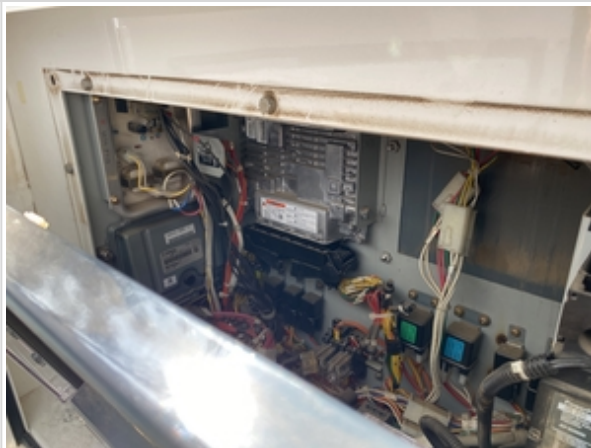
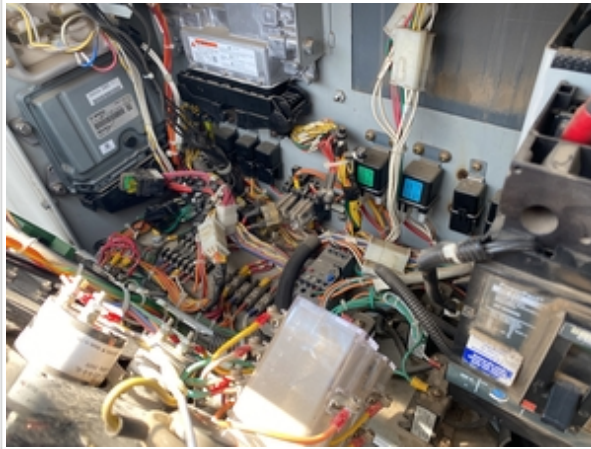
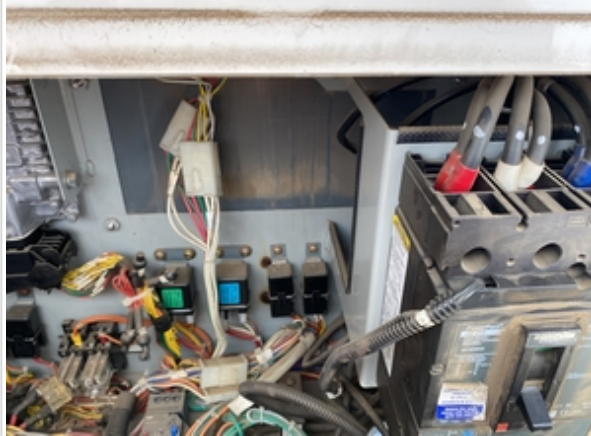
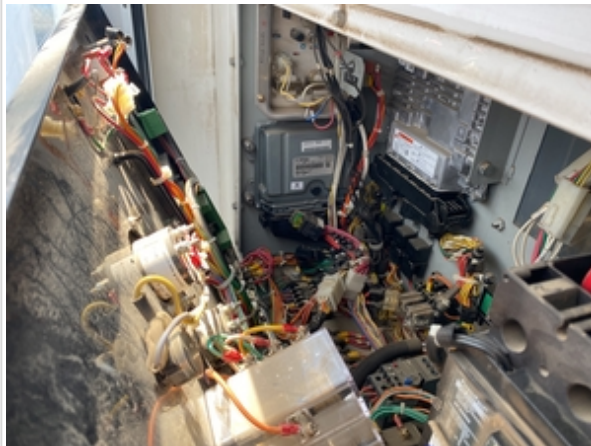
Wire Harness	3 - Normal Wear & Tear
Wire Harness Photos

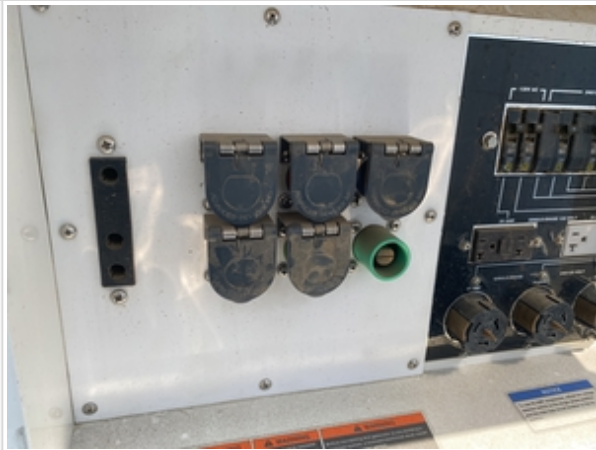
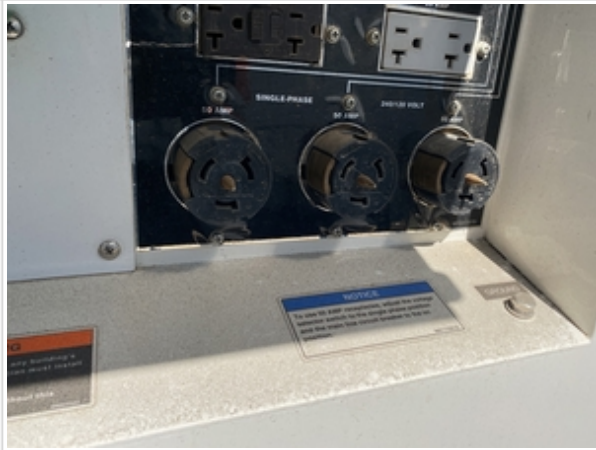
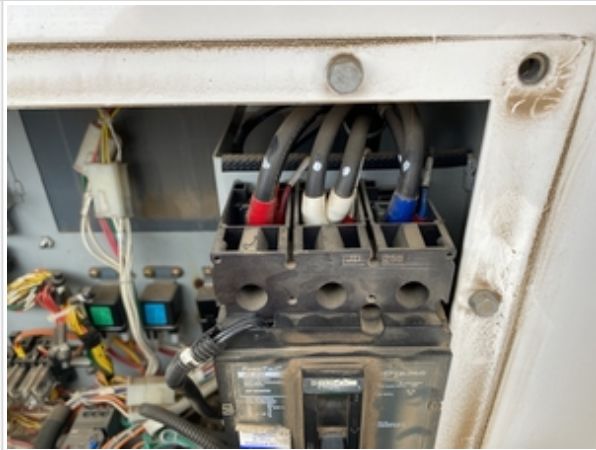
<p>Cables & Fittings Photos</p>

3 - Normal Wear & Tear

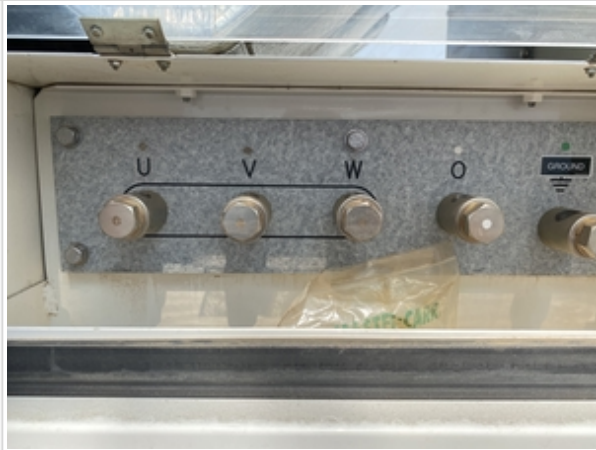
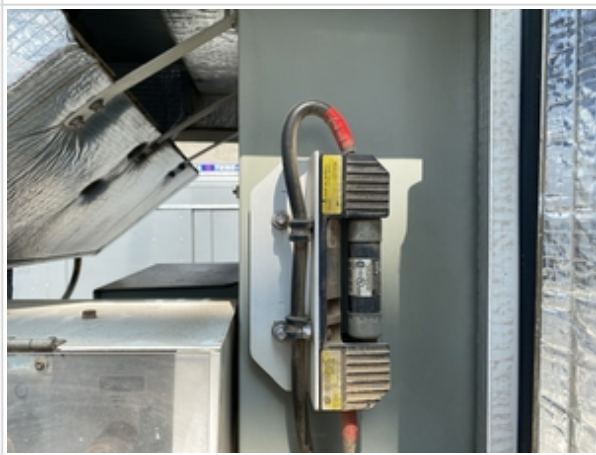
Electrical Connections Photos

<p>Electrical Connections</p>	<p>3 - Normal Wear & Tear</p>
