Inspection Report (Generator)

Year	2016
Make	Multiquip
Model	Whisperwatt DCA - 70SSIU4F
Serial Number	7353197
Hour Meter Reading	15,272
Previous Application (e.g., earth moving, mining, demolition, etc)	General construction

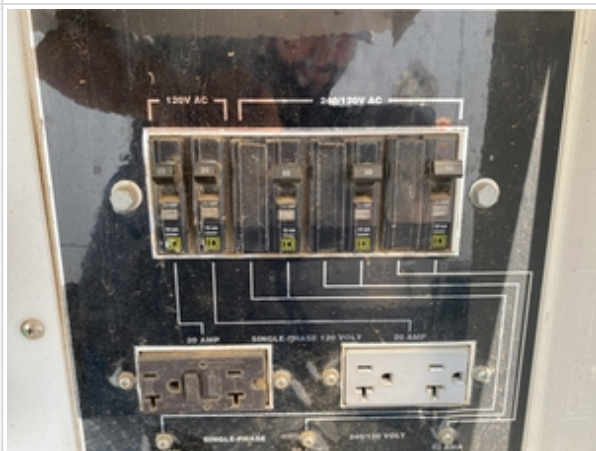
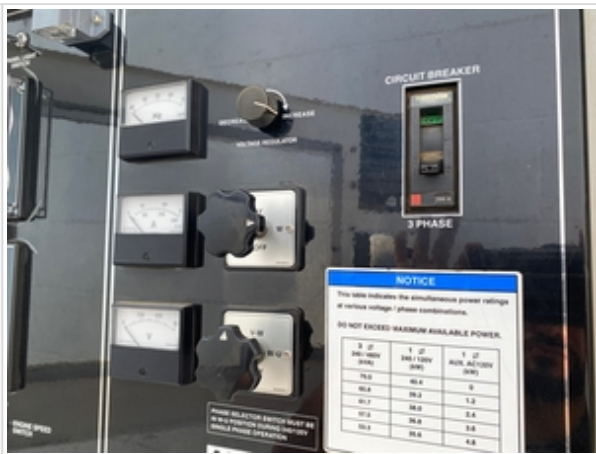
Controls & Switches	3 - Normal Wear & Tear
Controls & Switches Photos

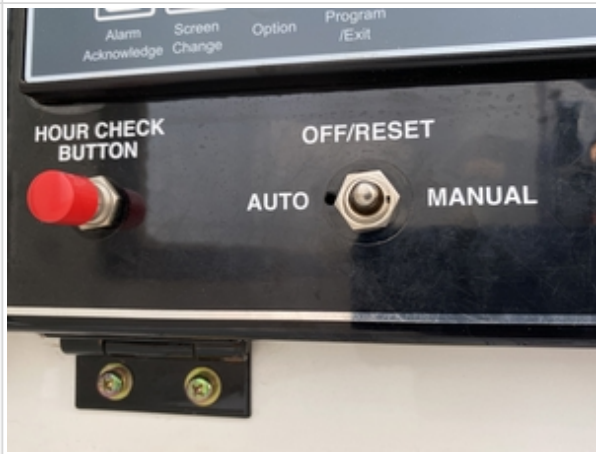
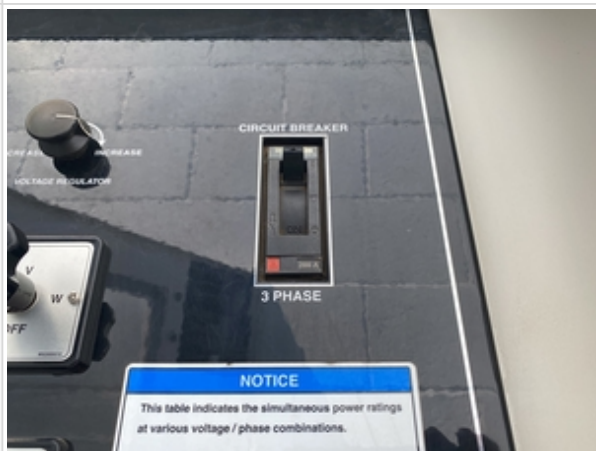
Disconnect Switch	3 - Normal Wear & Tear
Disconnect Switch Photos

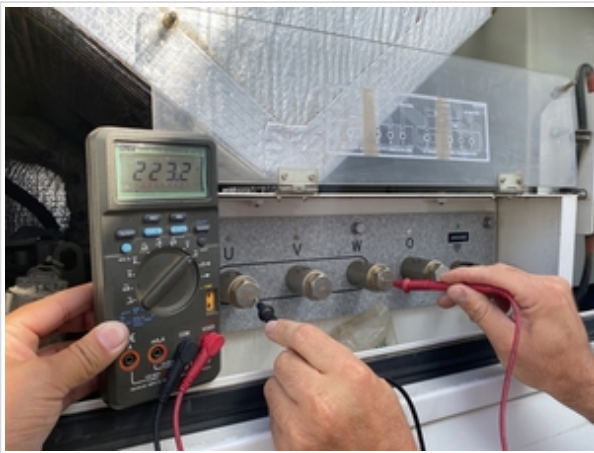
<p>240V Outlet Photos</p>

<p>240V</p>	<p>Yes</p>
<p>Number of Outlets</p>	<p>3</p>
<p>240V Outlet Condition</p>	<p>3 - Normal Wear & Tear</p>

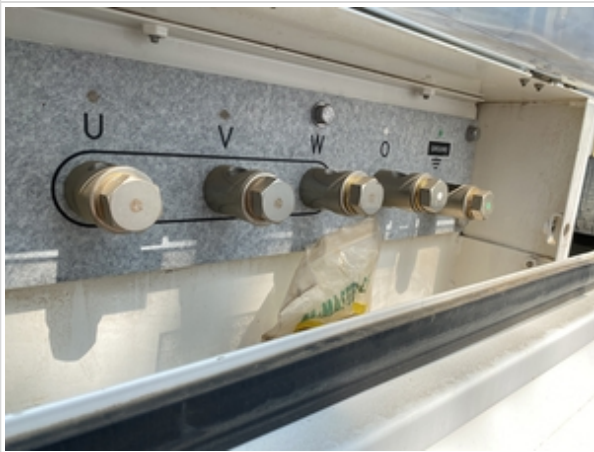
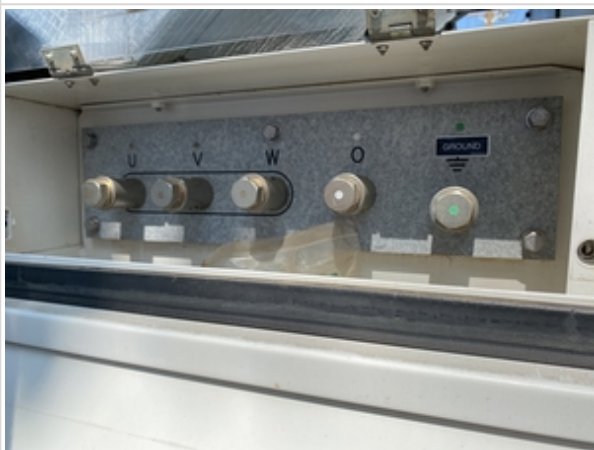
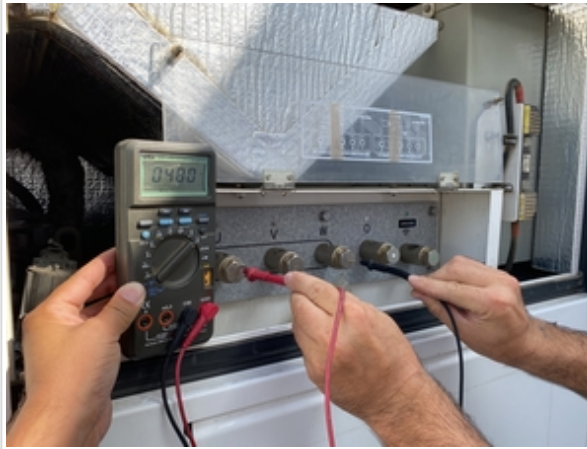
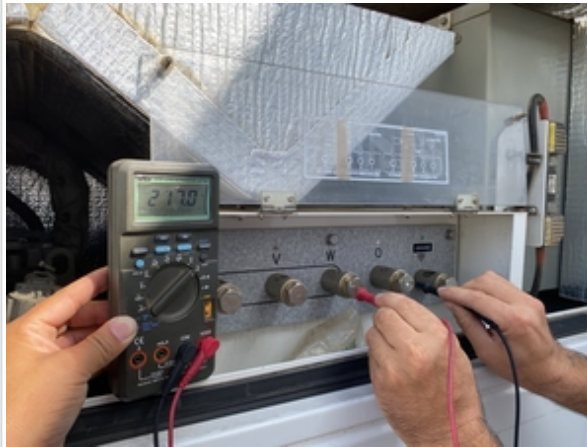
<p>480V</p>	<p>Yes</p>
<p>480V Outlet Condition</p>	<p>3 - Normal Wear & Tear</p>
<p>480V Outlet Photos</p>

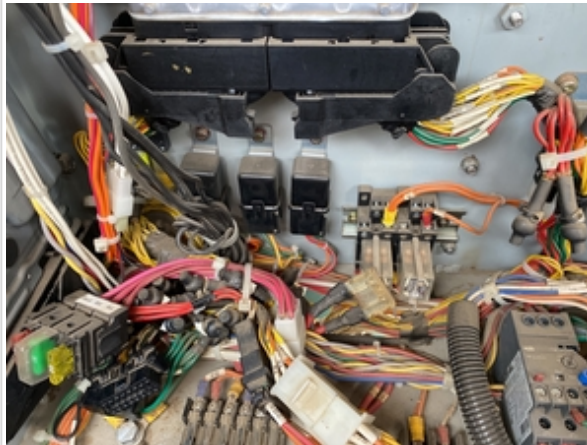
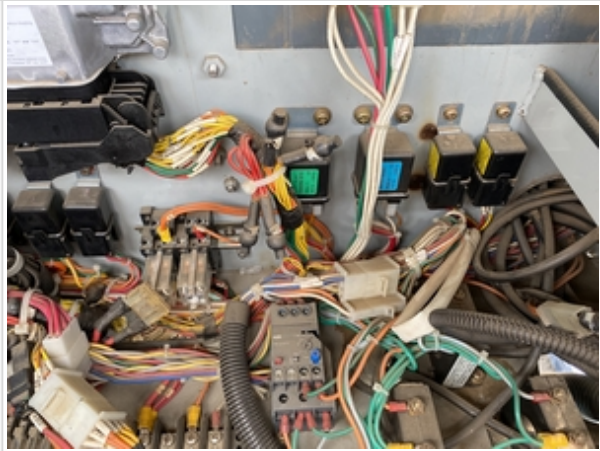
Relay Panel Photos

3 - Normal Wear & Tear

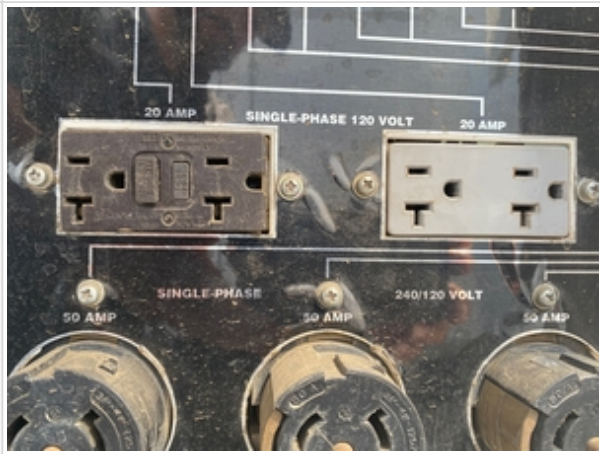
Receptacles	3 - Normal Wear & Tear	
Receptacles Photos

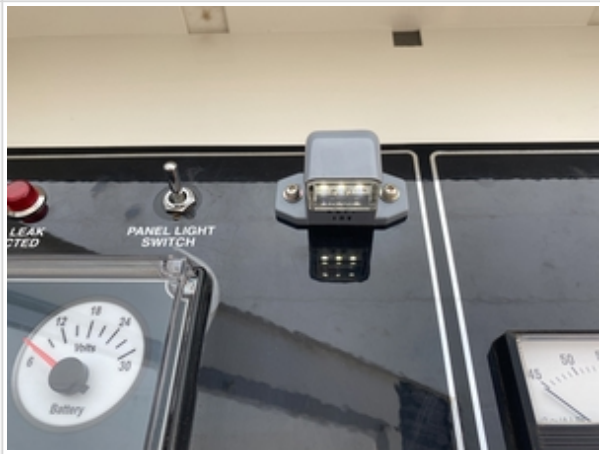
Panel Indicator Lights	3 - Normal Wear & Tear	
Panel Indicator Lights Photos

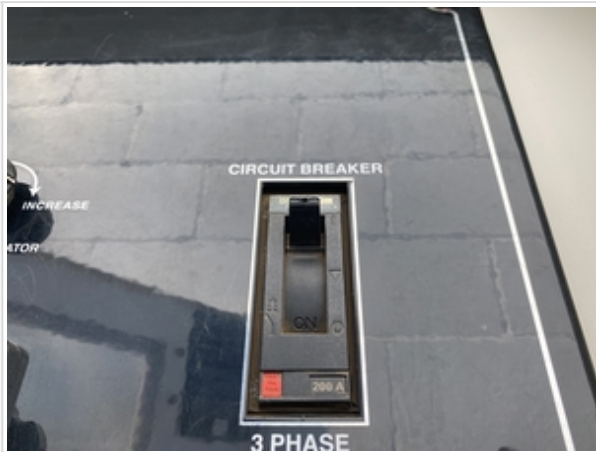
Disconnect Switch Photos

Disconnect Switch	3 - Normal Wear & Tear

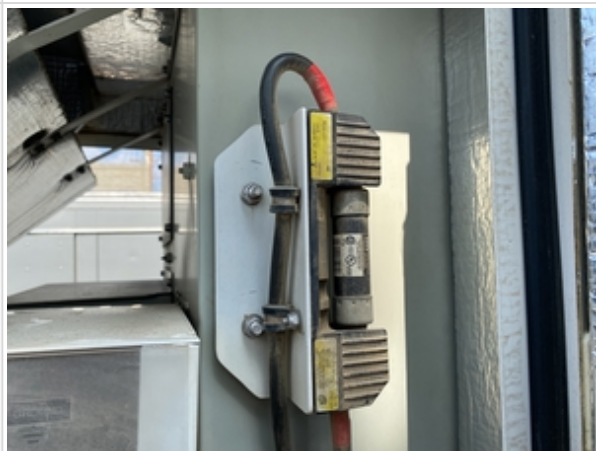
Emergency Shut Off Switch	0
Fuse Block	3 - Normal Wear & Tear
Fuse Block Photos

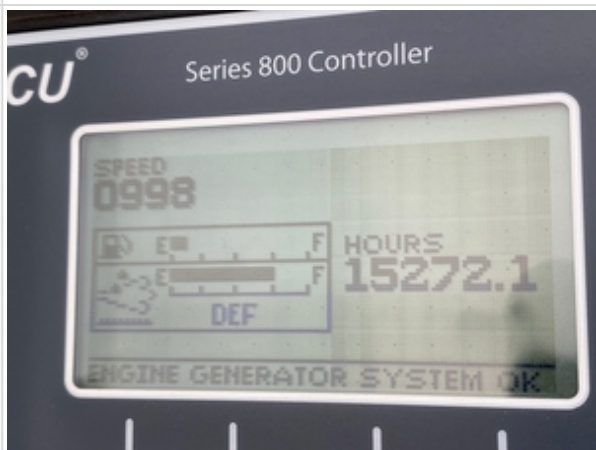
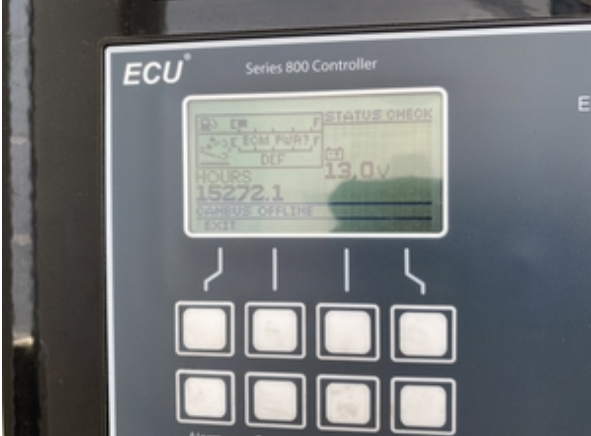
Hour Meter	3 - Normal Wear & Tear
Hour Meter Photos

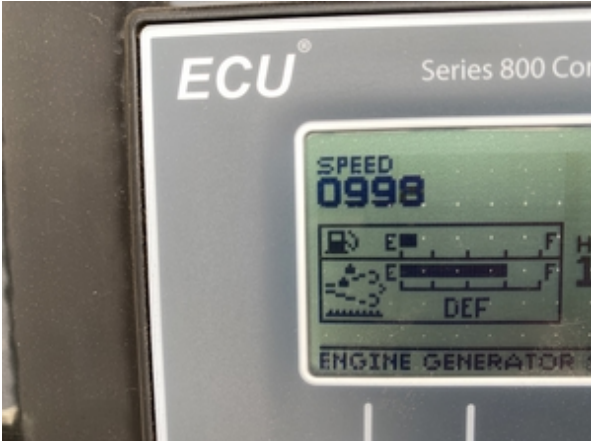
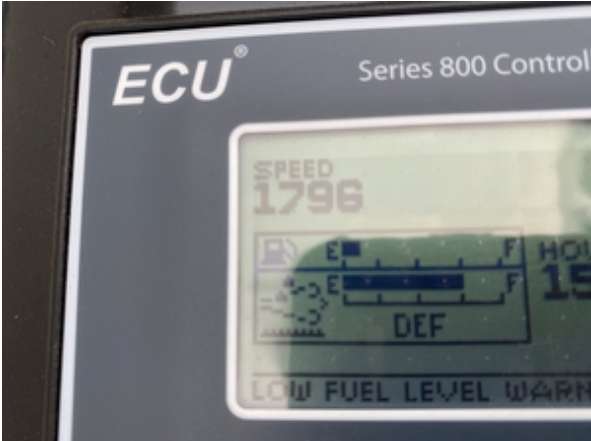
RPM Display	3 - Normal Wear & Tear
RPM Display Photos

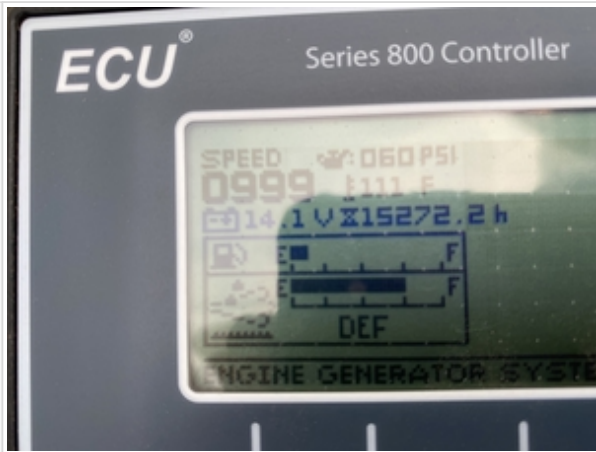
Volt Display Photos

Volt Display	3 - Normal Wear & Tear

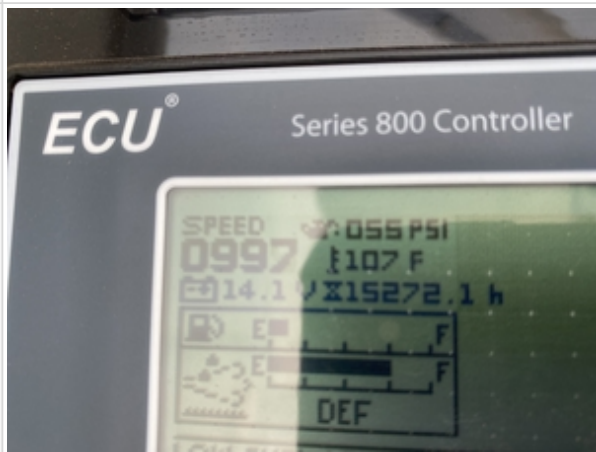
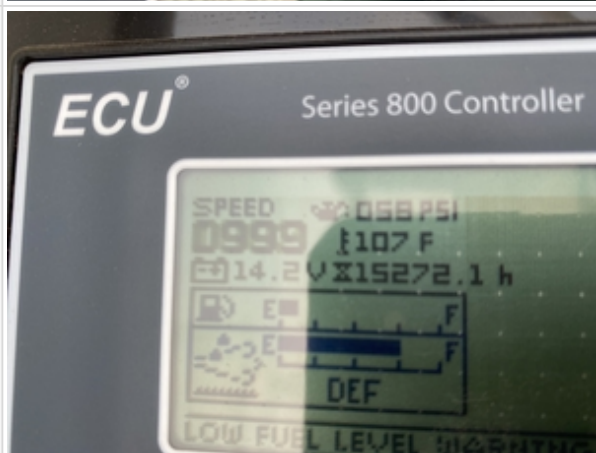
Pressure Display	3 - Normal Wear & Tear
Pressure Display Photos

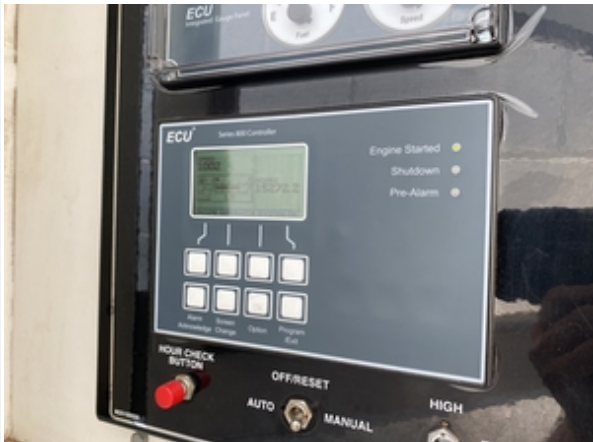
Menu Display	3 - Normal Wear & Tear
Menu Display Photos

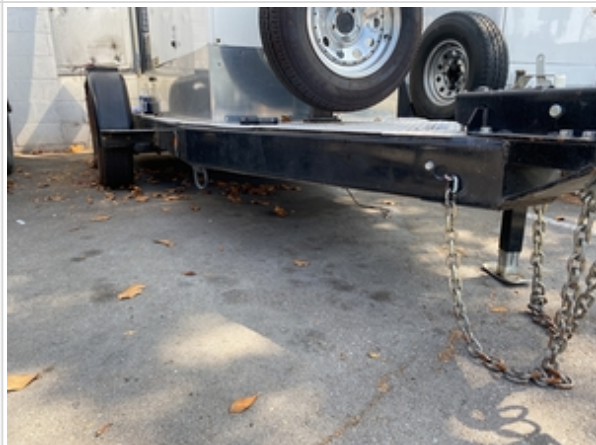
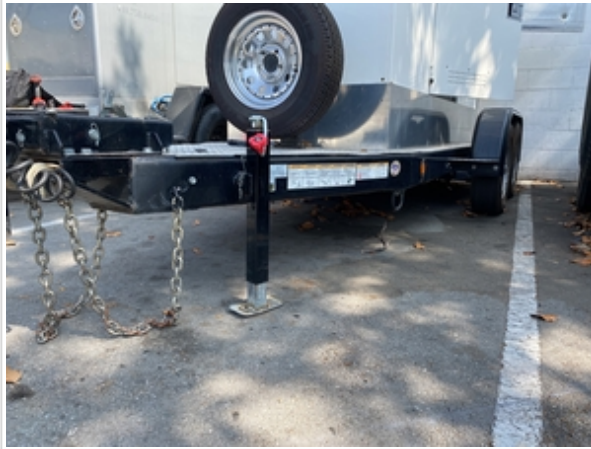
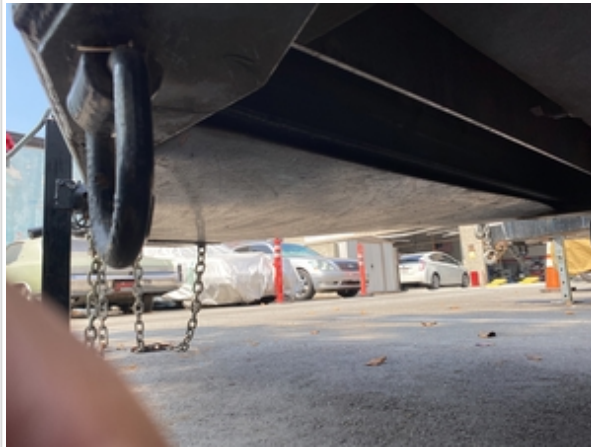
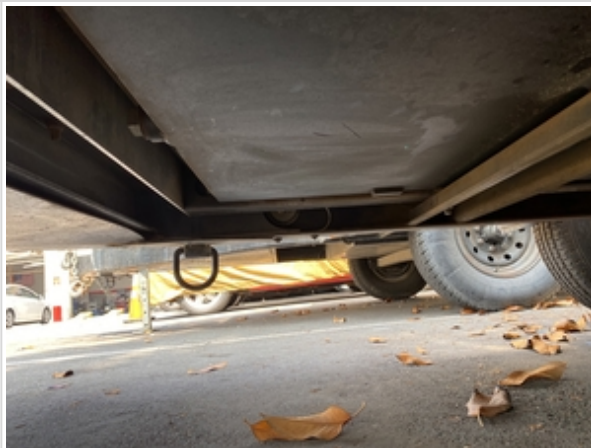
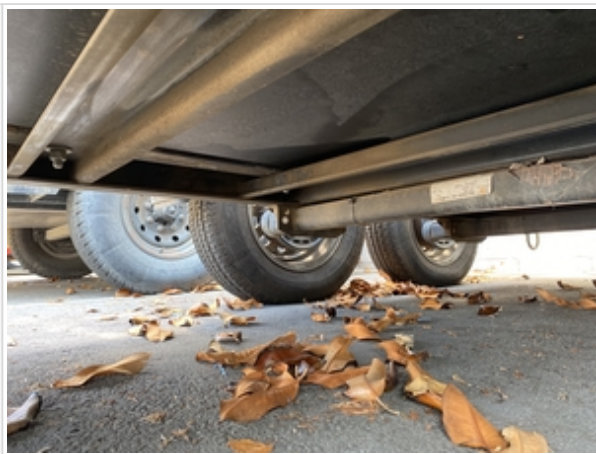
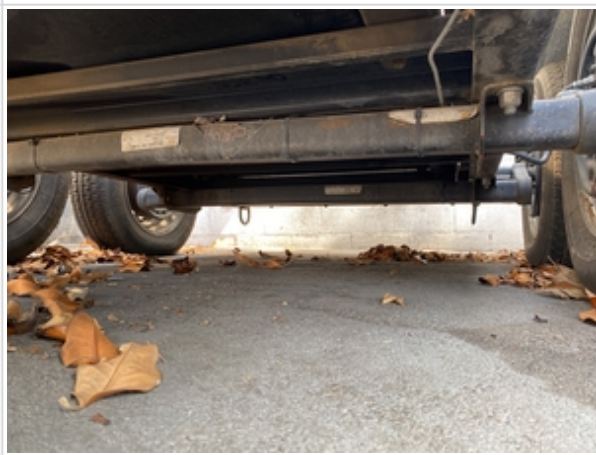
Frame Condition	3 - Normal Wear & Tear
Frame Photos

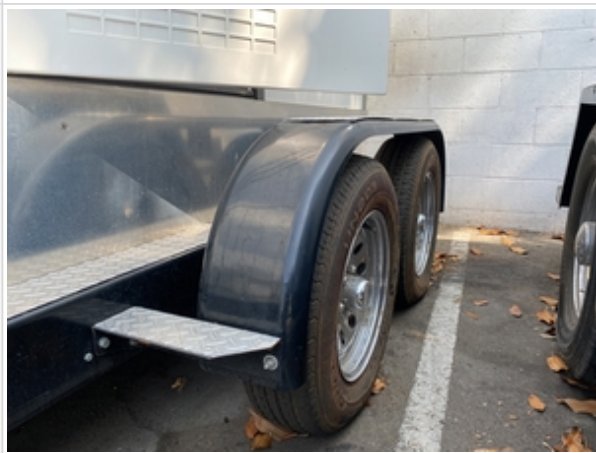
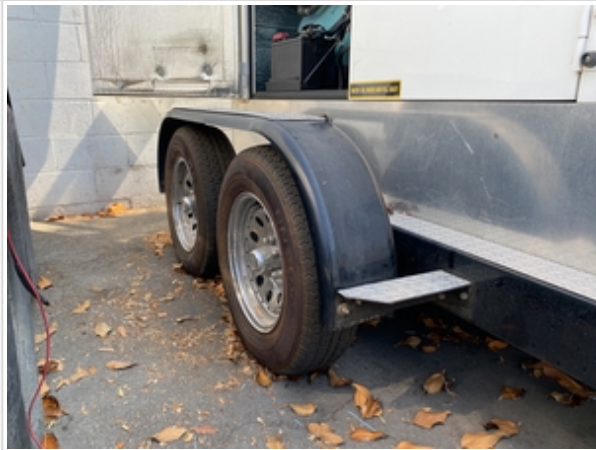
<p>Fenders</p>	<p>3 - Normal Wear & Tear</p>	
<p>Fender Photos</p>

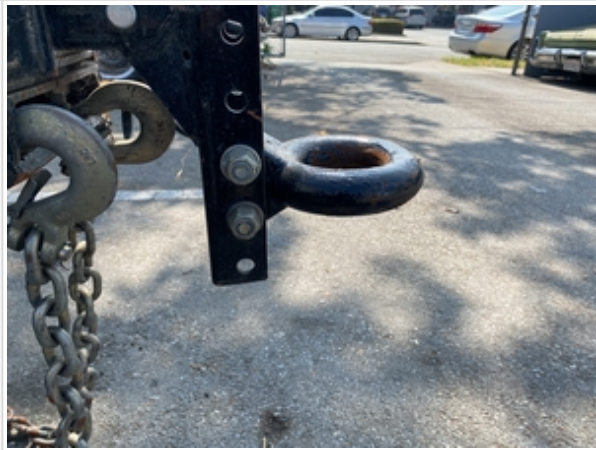
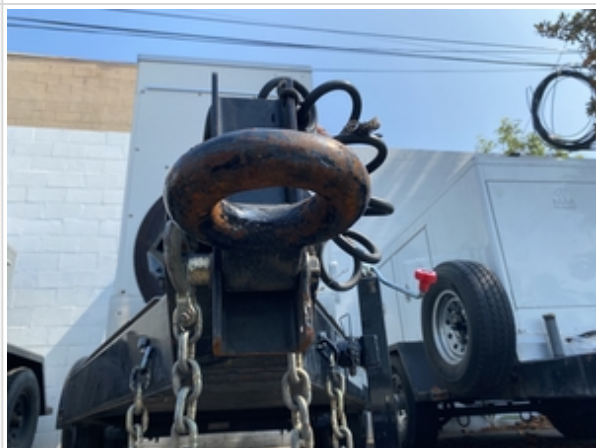
Hitch Type	Pintle
Hitch Condition	3 - Normal Wear & Tear
Hitch Photos

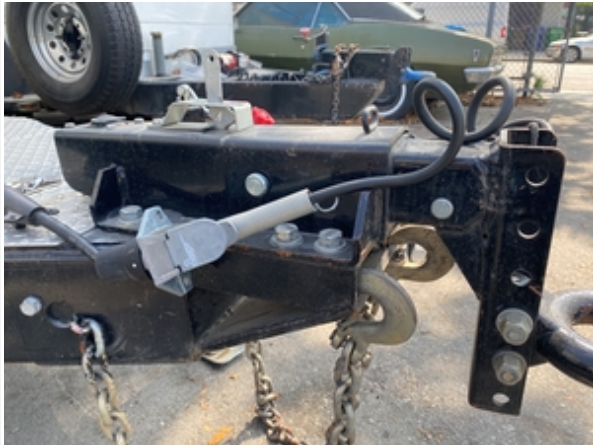
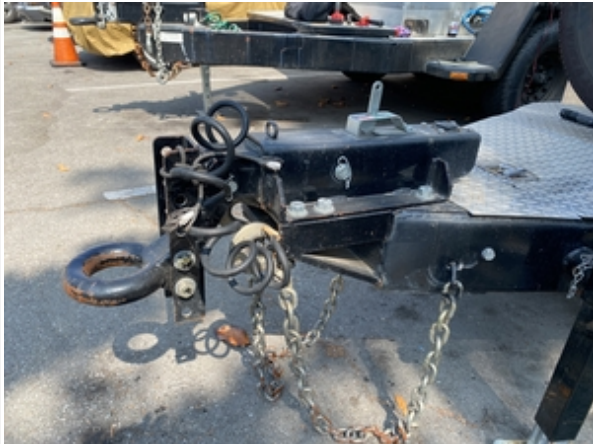
Drawbar	3 - Normal Wear & Tear
Strand Wear?	No
Comments	Safety breakaway cable missing
Drawbar Photos

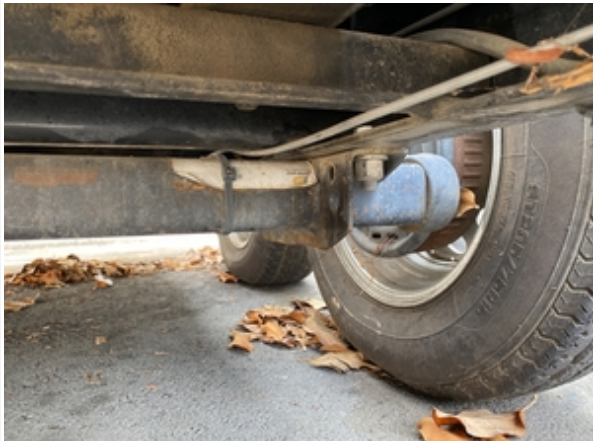
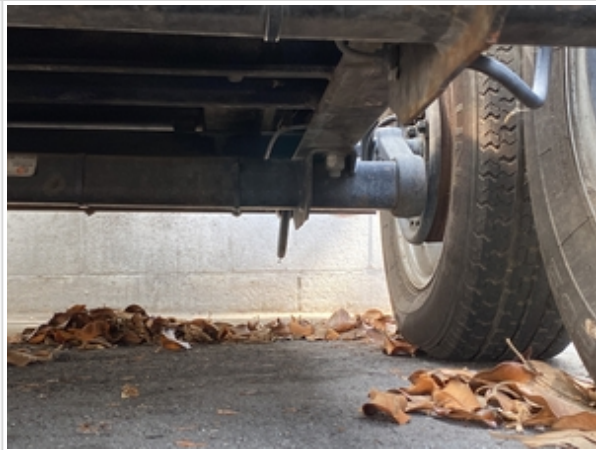
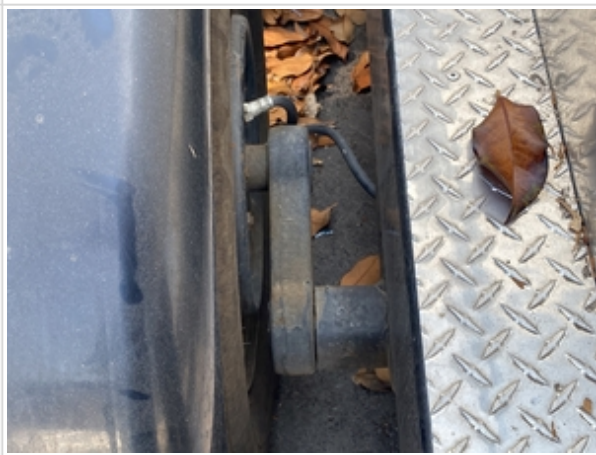
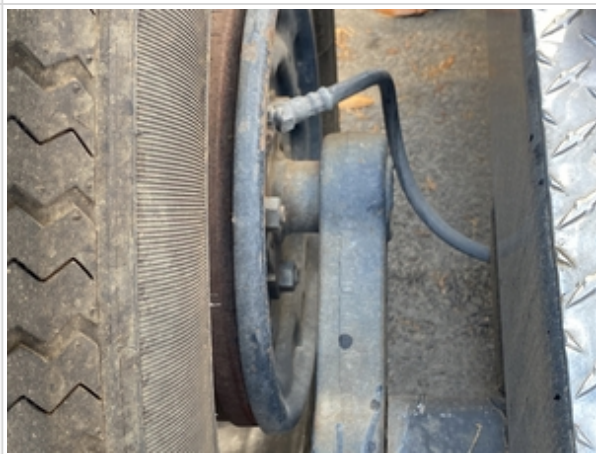
Springs	0
U-Bolts	0
Torque Arms	3
Torque Arms Photos

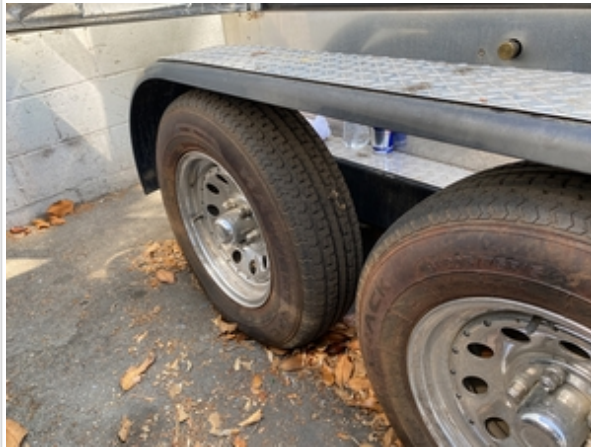
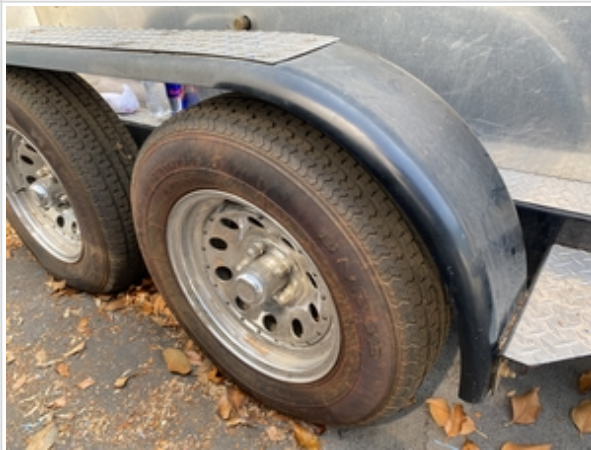
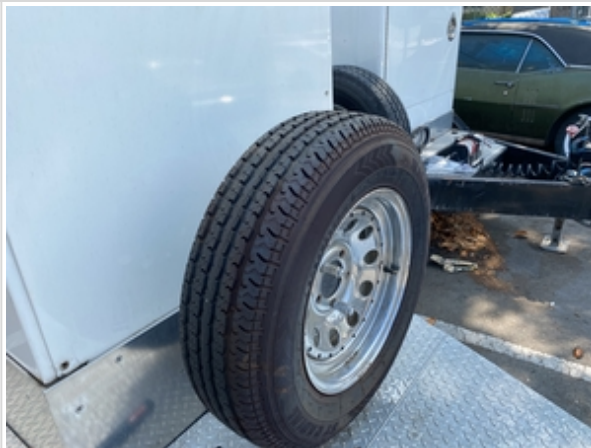
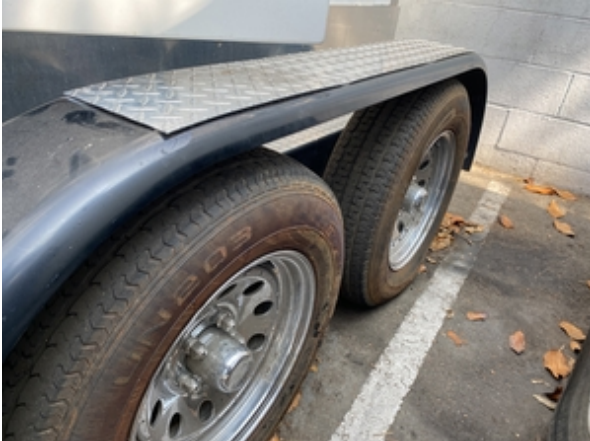
Wheels & Hub Condition	3 - Normal Wear & Tear
-----------------------------------	------------------------

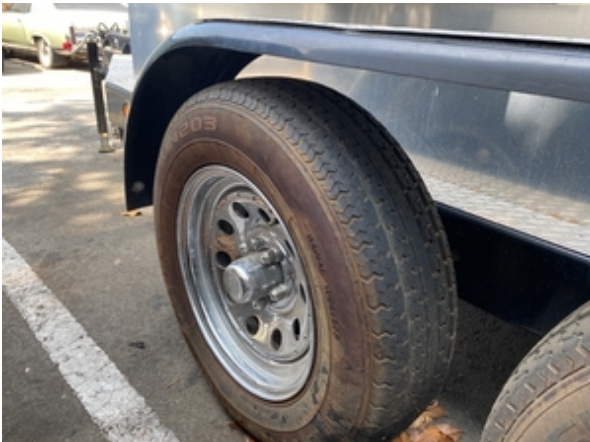
Loose Lugs	No	
Tire Brand	Mastertrack	
Tire Size	ST 205/75R15	
Front Left Tire - Ratio Remaining	50%	
Front Left Tire Photos

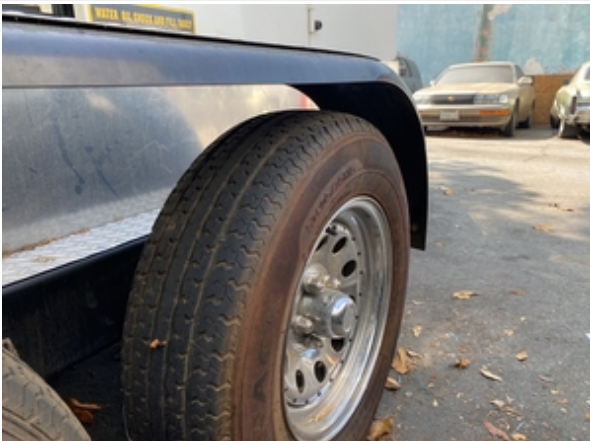
Front Right Tire - Ratio Remaining	50%	
Front Right Tire Photos

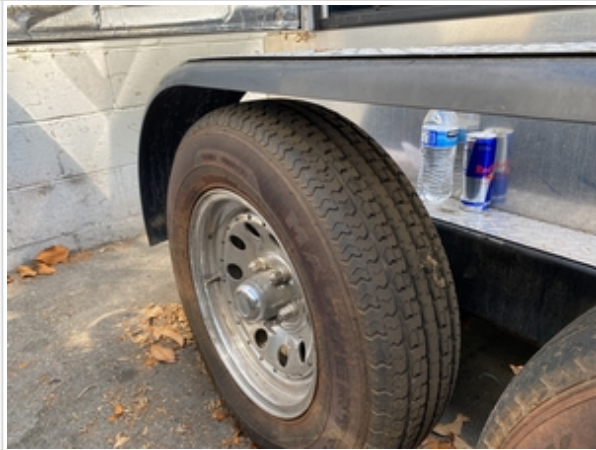
Rear Right Tire - Ratio Remaining	50%

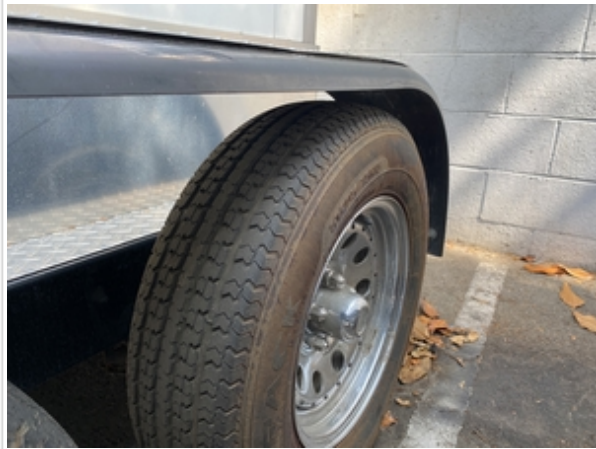
Rear Left Tire - Ratio Remaining	50%
Rear Left Tire Photos

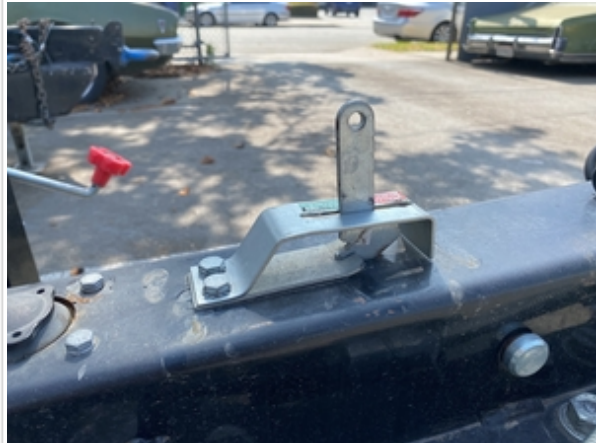
Brake Type	Surge Brakes
Brake Controller	No
Emergency Brake/Break-Away	1 - Service Required
Comments	Missing break away pull cable (did not test)
Emergency Brake/Break-Away Photos

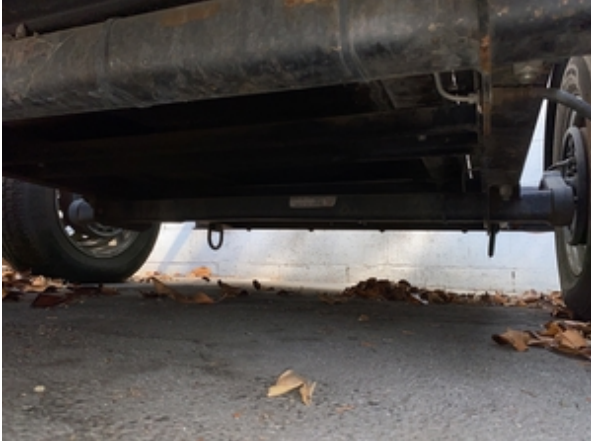
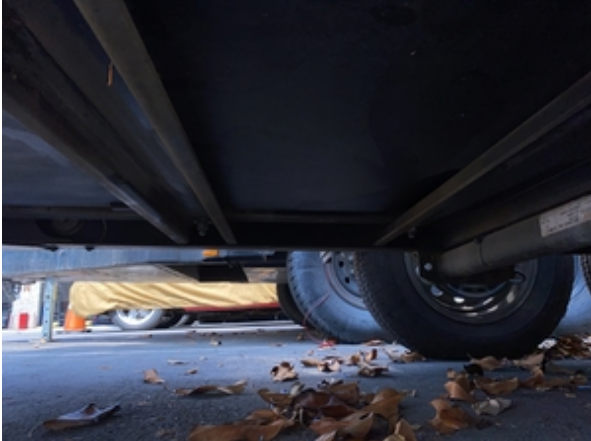
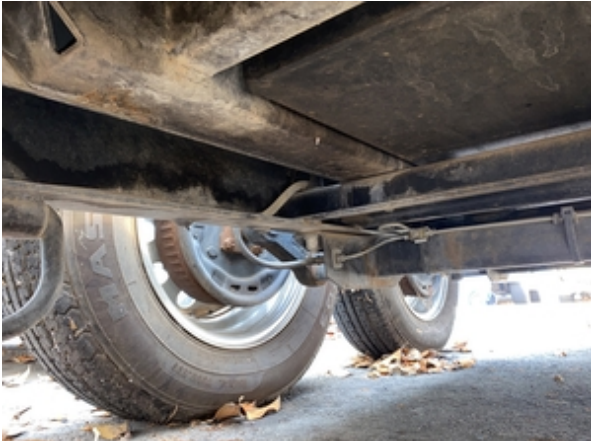
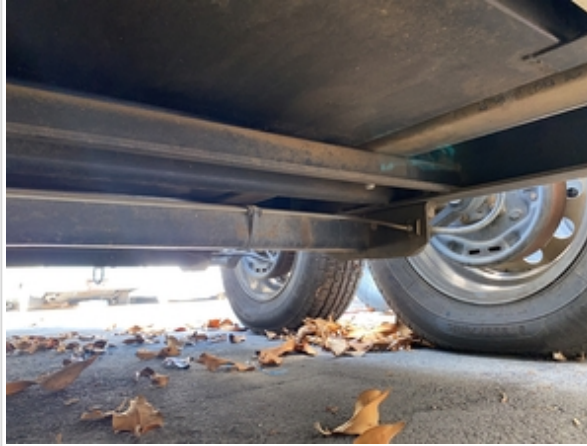
Overall Trailer	3 - Normal Wear & Tear
Overall Trailer Comments	Overall trailer in good shape with no major repairs needed. Unable to test brake, trailer light functions.
Overall Trailer & Undercarriage Photos

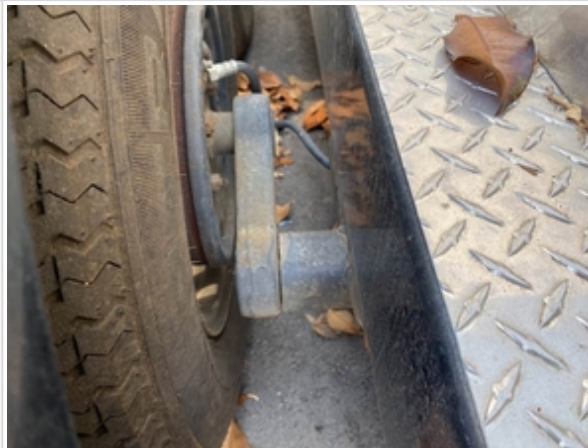
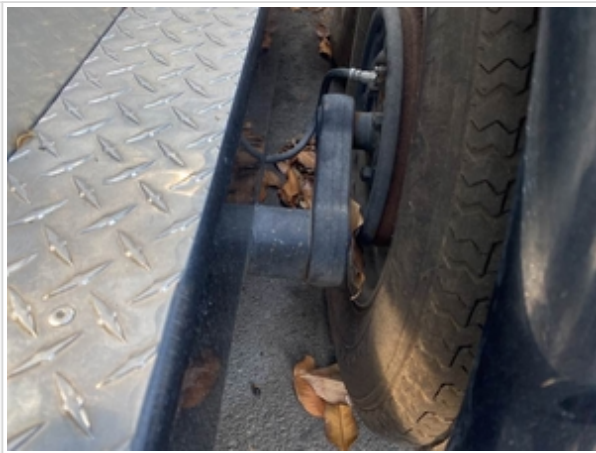
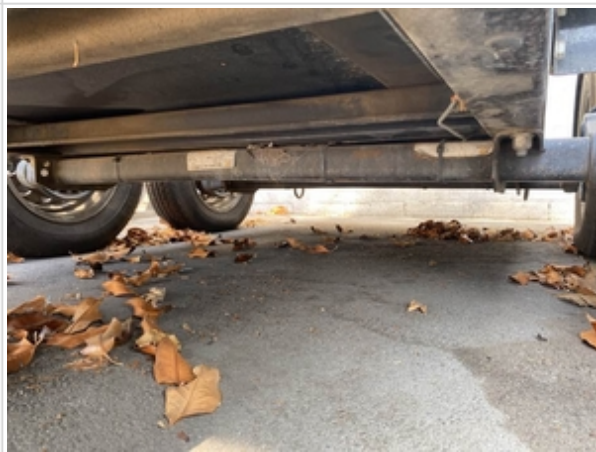
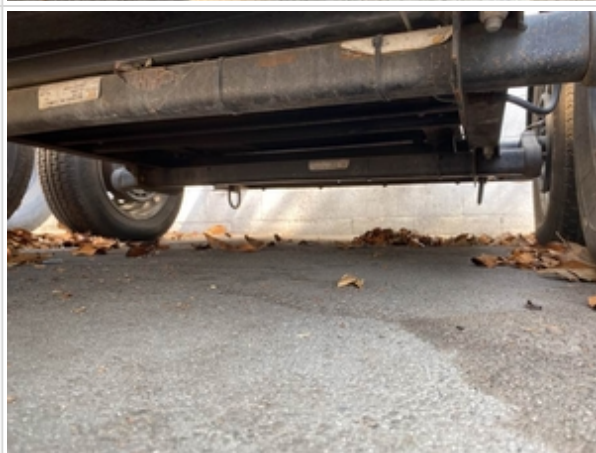
Instructions	Check the condition of additional axle(s), wheels & tires. Note any damage or wear. Take photos.
Axle Description & Position	2 solid bolt to frame axles
Steerable?	No
Drop Axle?	No
Super Dump?	No
Weight Rating	3,750lbs.
Axle Condition	3 - Normal Wear & Tear
Axle Condition Photos

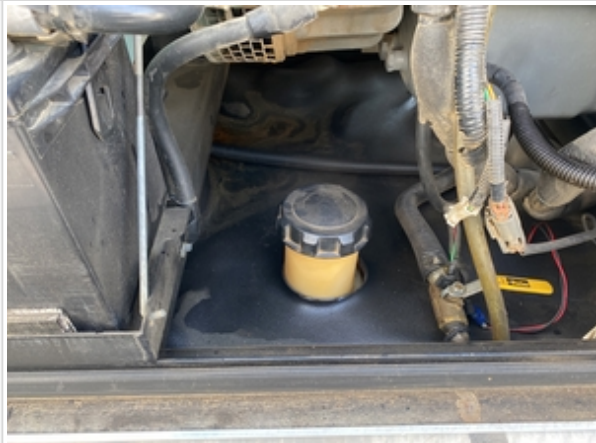
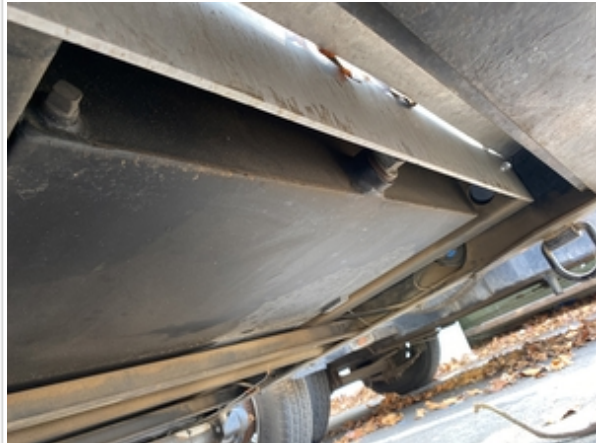
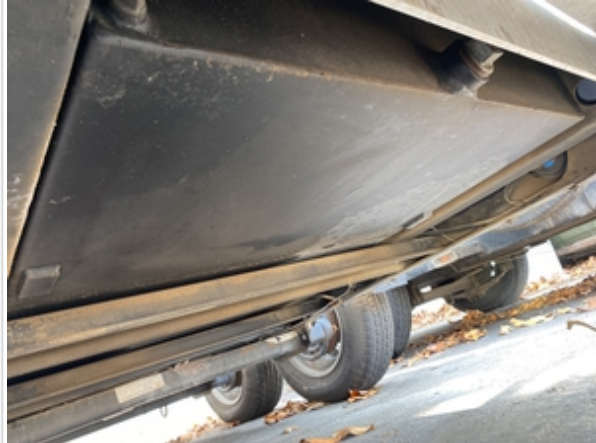
<p>Fuel Tank Photos</p>

Wheels & Tires	3 - Normal Wear & Tear
Fuel Tank Condition	3 - Normal Wear & Tear

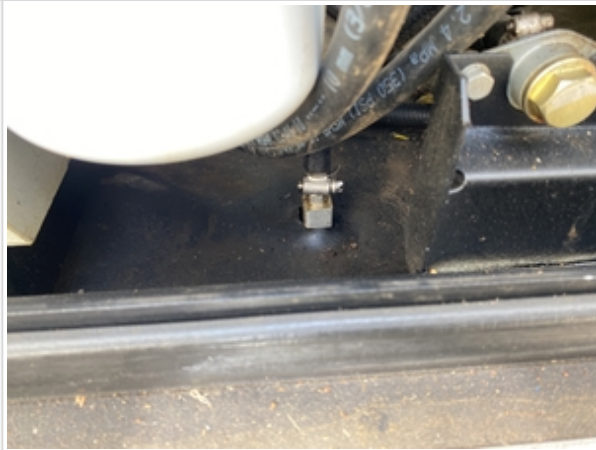
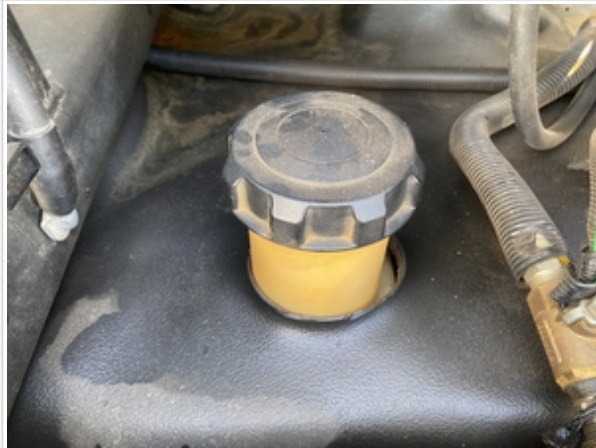
Fuel Lines & Hoses Photos

<p>Fuel Lines & Hoses</p>	<p>3 - Normal Wear & Tear</p>
