Inspection Report (Wheel Loader)

Year	1981
Make	CAT
Model	930B - unit 15-101
Serial Number	41K10862
Hour Meter Reading	4,018
Previous Application (e.g., earth moving, mining, demolition, etc)	General Construction excavation

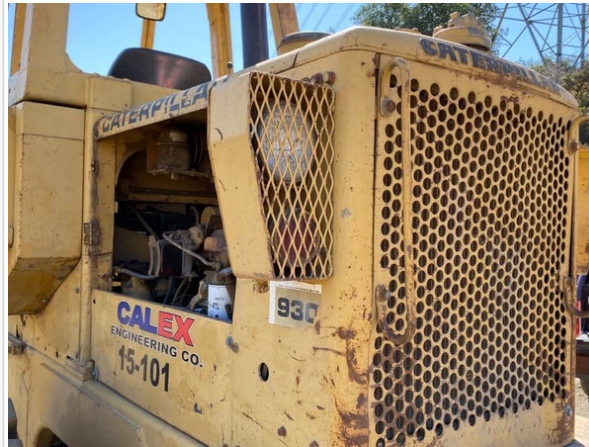
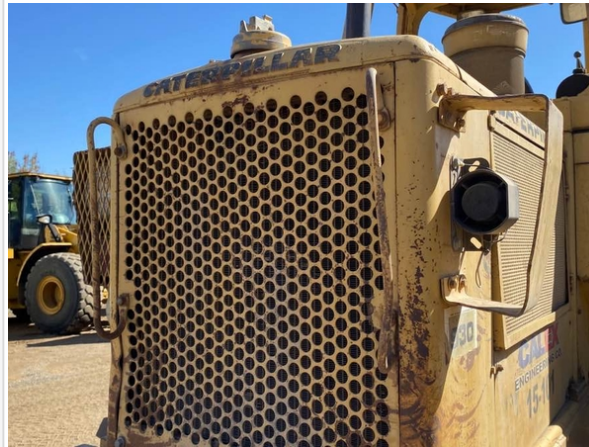
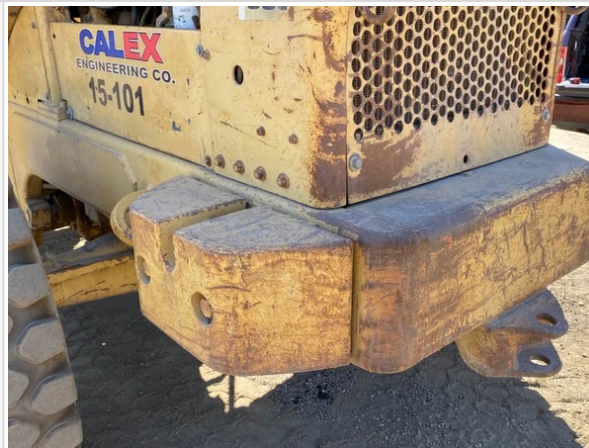
Rear Photos

<p>Rear</p>	<p>3 - Normal Wear & Tear</p>
<p>Rear Condition</p>	<p>No visible damage</p>

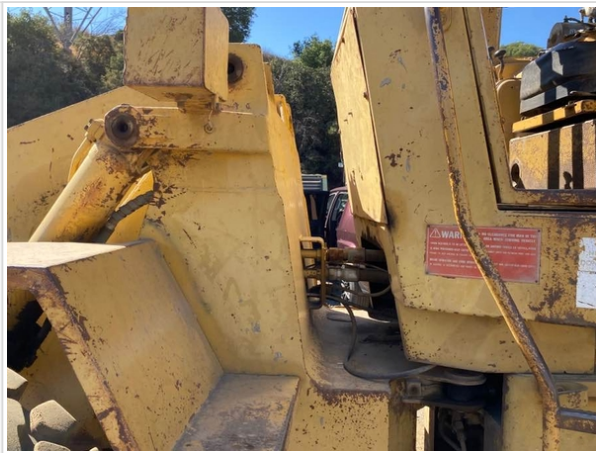
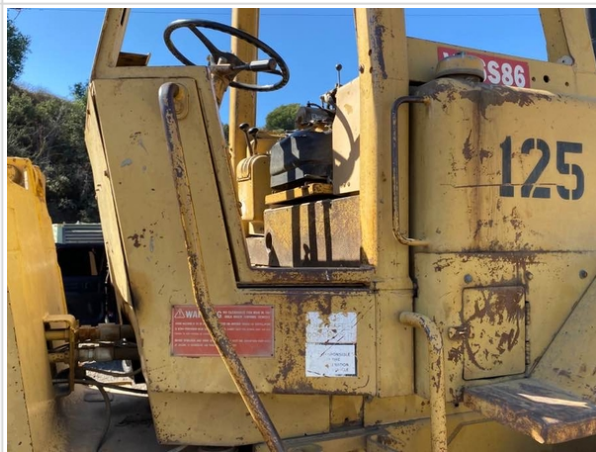
Left	3 - Normal Wear & Tear	
Left Condition	No visible damage	
Left Photos

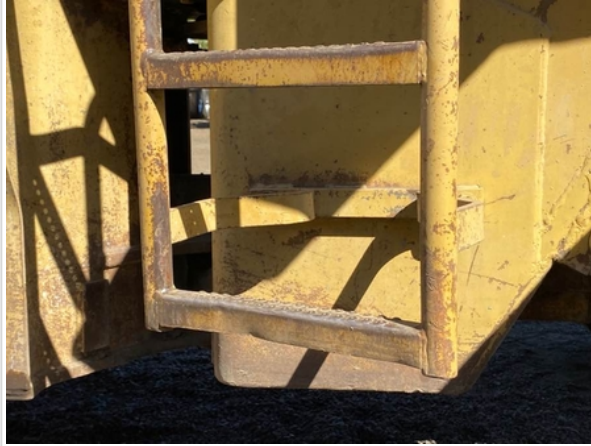
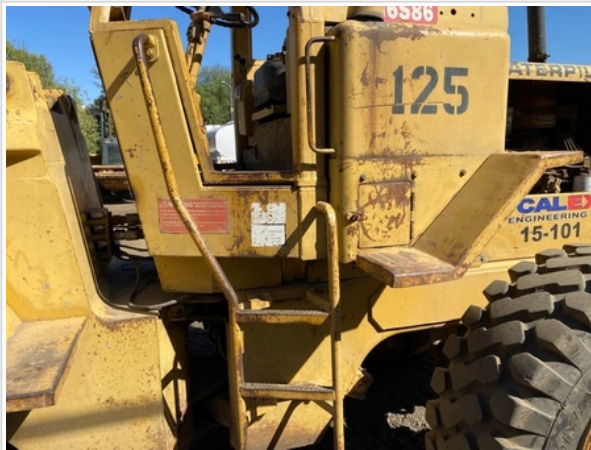
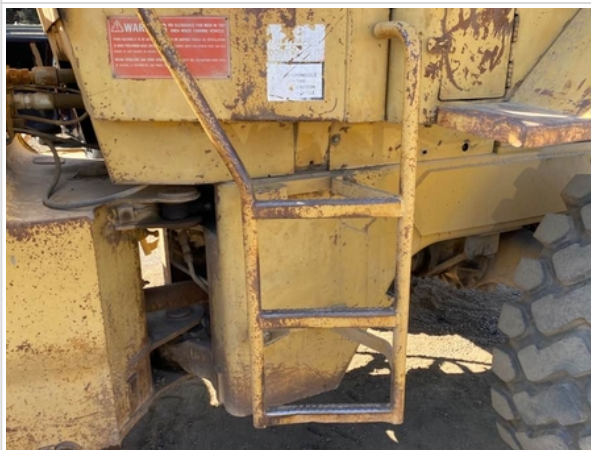
Steps / Ladders Photos

Body Panels (Any Rust Damage?)	3 - Normal Wear & Tear
Body Panel Condition	No visible damage, good paint condition and panel fitment
Doors / Canopy Latches	3 - Normal Wear & Tear
Doors / Canopy Latches Condition	No visible damage
Steps / Ladders	3 - Normal Wear & Tear
Steps / Ladders Condition	Steps/ladders are fully intact and appear structurally sound

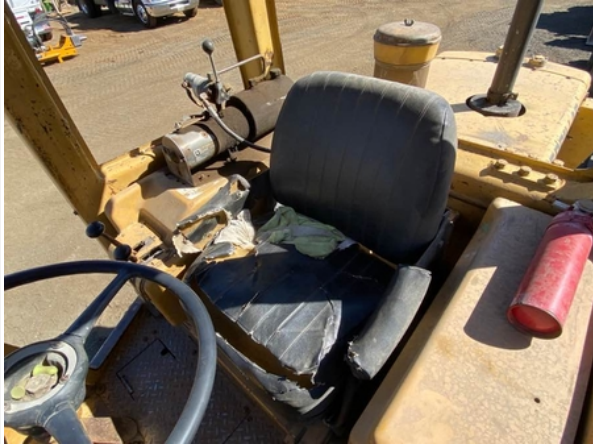
Operator's Seat & Arm Rests	2 - Above Average Wear
Operator's Seat & Arm Rests Condition	Seat(s) is damaged due to sun exposure; fading, cracking observed
Operator's Seat & Arm Rests Photos

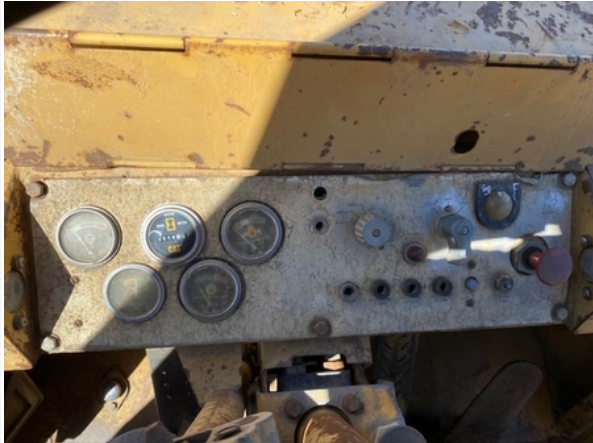
Seat Belt	2 - Above Average Wear
Seat Belt Condition	Seat belt secures properly. Nicks, cuts, holes, or fraying observed on belt webbing, Other (see comments)
Comments	Seat belt difficult to lock in place
Cabin Lights	0
Safety Lock Out / Stop	0
Controls & Switches	2 - Above Average Wear
Controls & Switches Condition	All switches are installed and functional
Controls & Switches Photos

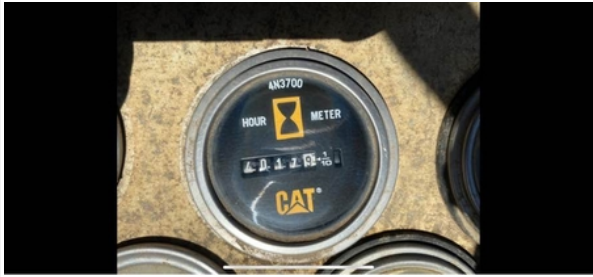
Hour Meter Condition	Hour meter is functional and in good condition
Hour Meter Activity Photos

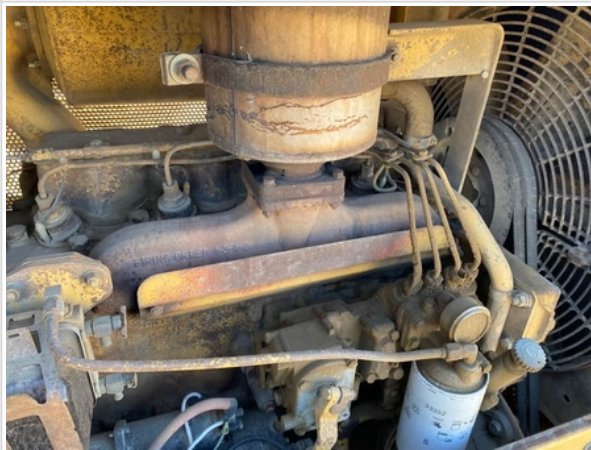
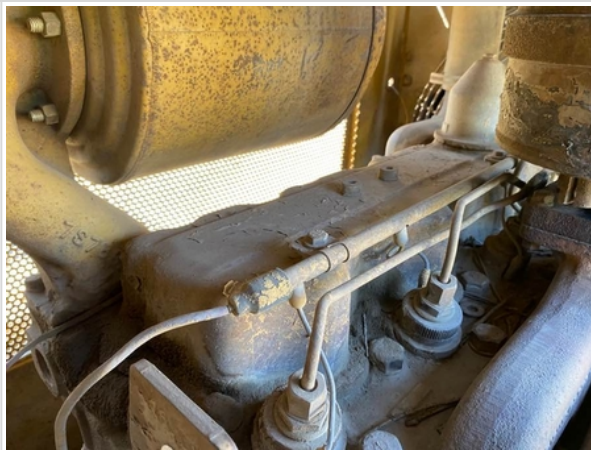
Engine Photos

Oil Color / Appearance	3 - Normal Wear & Tear
Oil Color / Appearance Notes	Clean oil appearance, no signs of cross contamination, Appropriate oil level, Other (see comments)
Fuel Leaks	No
Equipped with DPF (Diesel Particulate Filter)	No
Requires DEF (Diesel Exhaust Fluid)	No
Overall Engine Appearance	Active leaks/pooling observed in & around engine compartment, Areas of dried seepage seen on engine hoses & components
Overall Engine Comments	Overall engine sounds okay. Engine oil leaks exist.

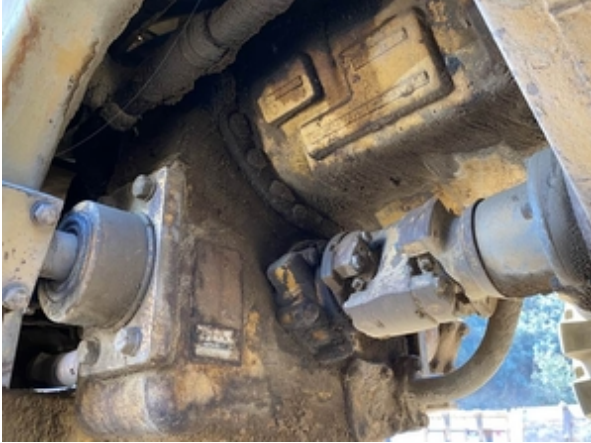
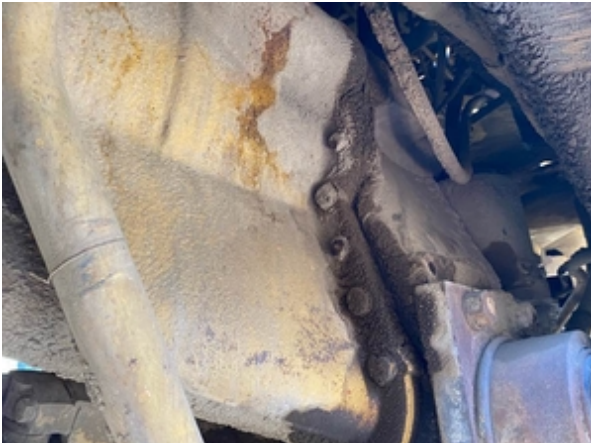
Transmission Photos

Hydrostatic Transmission?	No
Transmission Info (Make/Model/Speeds)	4 Speed Powershift Transmission
Transmission	2 - Above Average Wear
Transmission Condition	Other (see comments), Leaking transmission fluid observed, Grinding, clunking, or whining sounds heard
Comments	Transmission hesitates to move immediately under low throttle and knocking is felt/heard in higher gears shifting

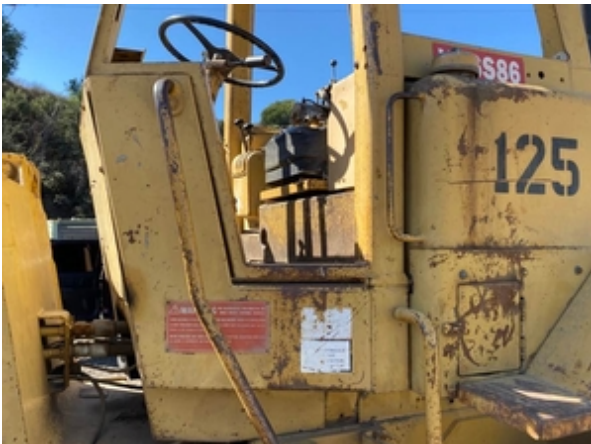
Clutch	0
Shift Lever	3 - Normal Wear & Tear
Shift Lever Condition	Good forward and reverse function
Shift Level Photos

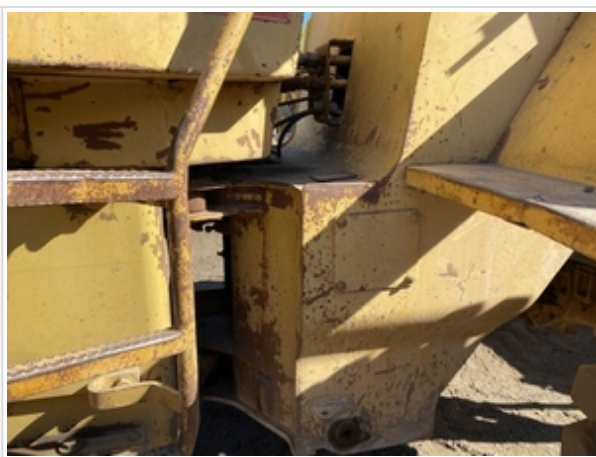
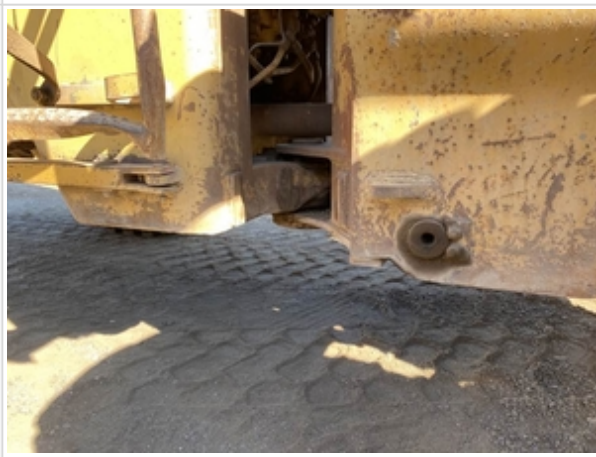
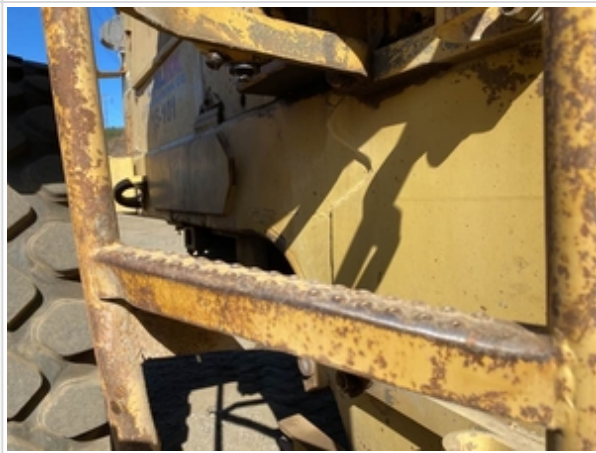
<p>Frame Photos</p>

Frame	3 - Normal Wear & Tear
-------	------------------------

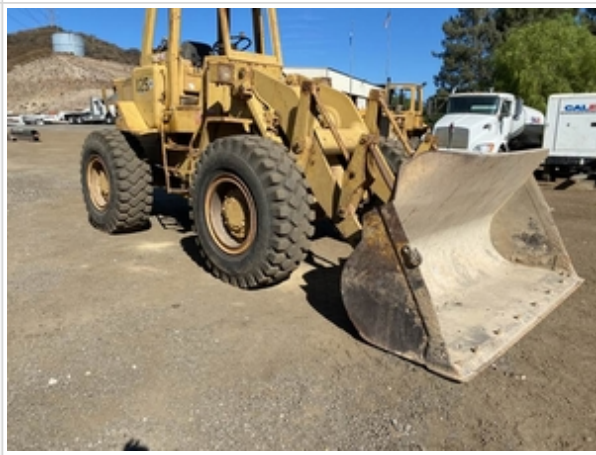
<p>Stance</p>	<p>3 - Normal Wear & Tear</p>
<p>Stance Photos</p>

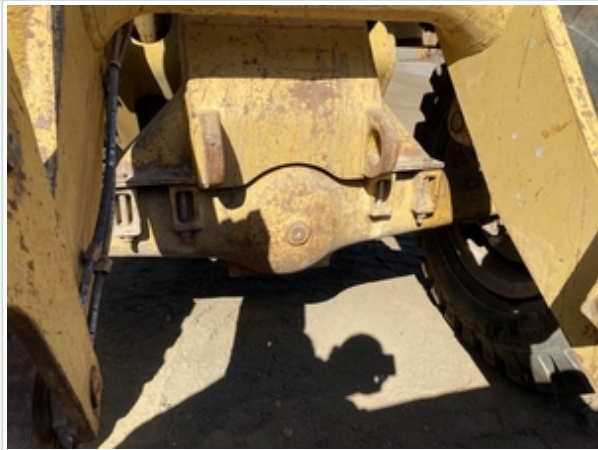
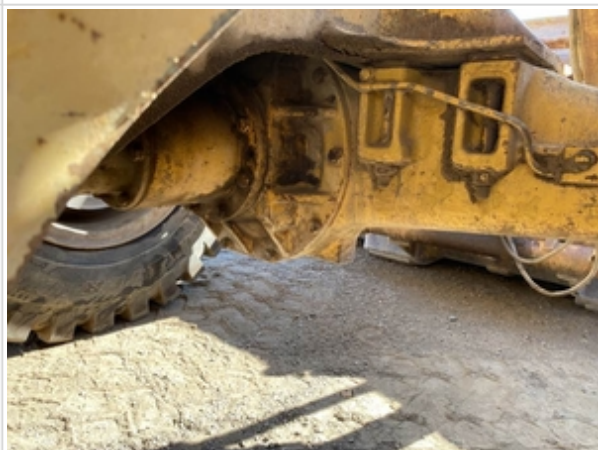
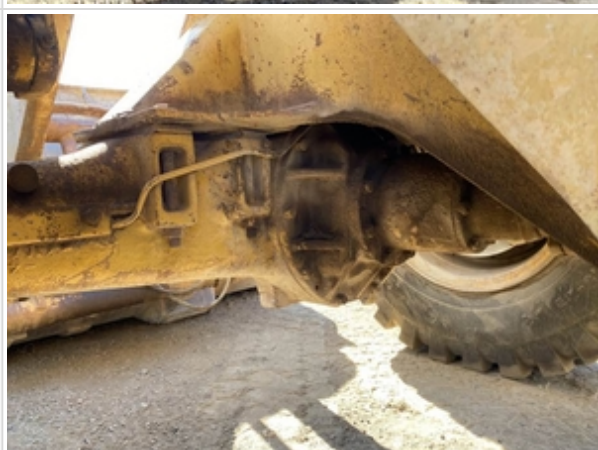
Front Axle Appearance Photos

<p>Front Axle Appearance</p>	<p>3 - Normal Wear & Tear</p>

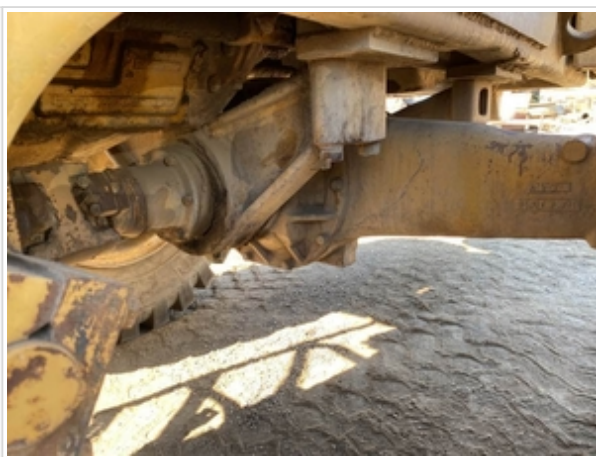
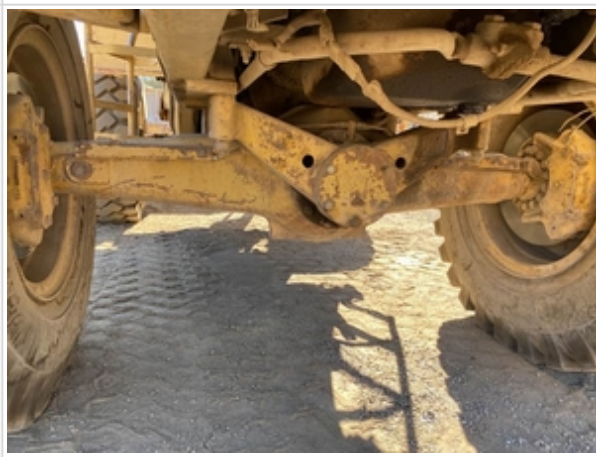
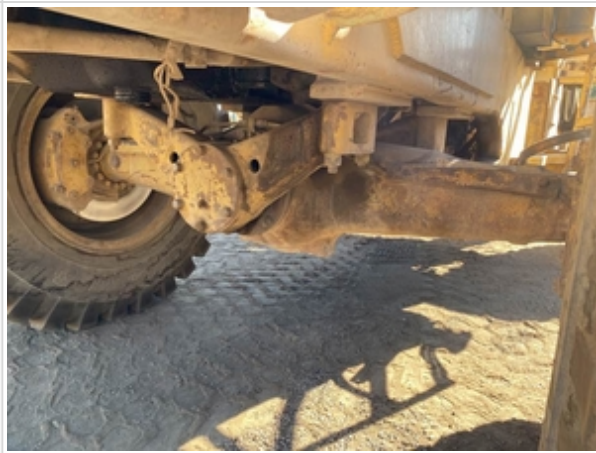
<p>Rear Axle Appearance Photos</p>

Rear Axle Appearance	3 - Normal Wear & Tear

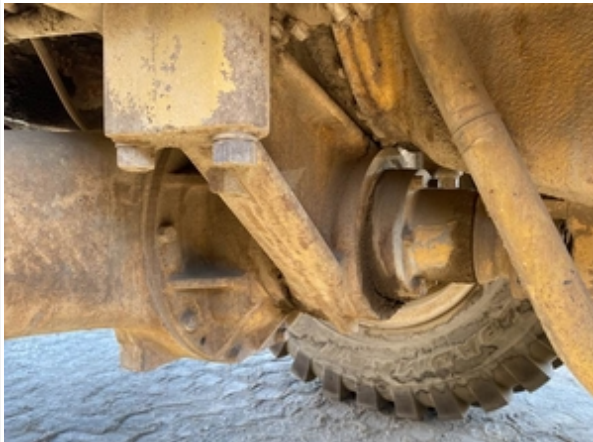
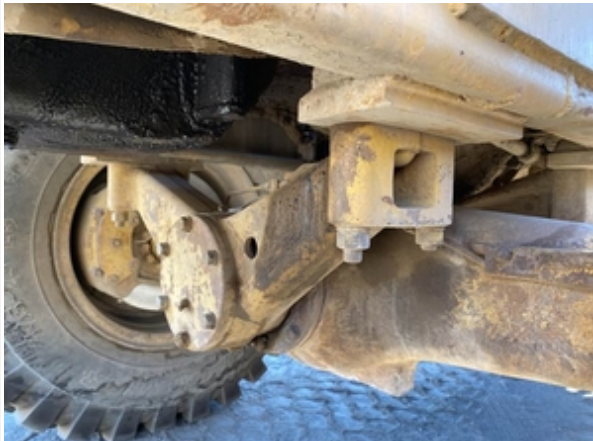
Articulating Center Pin Appearance	3 - Normal Wear & Tear	
Articulating Center Pin Appearance Photos

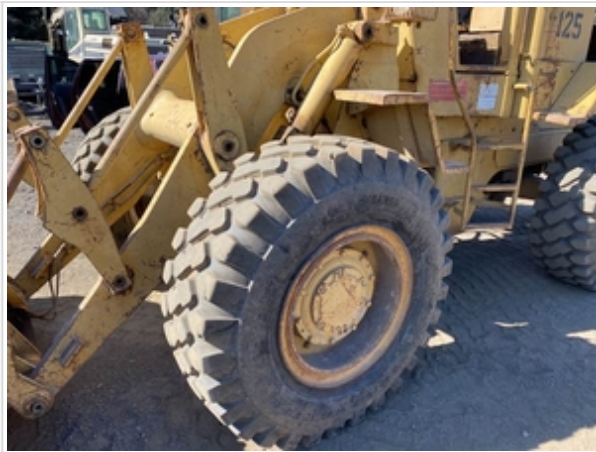
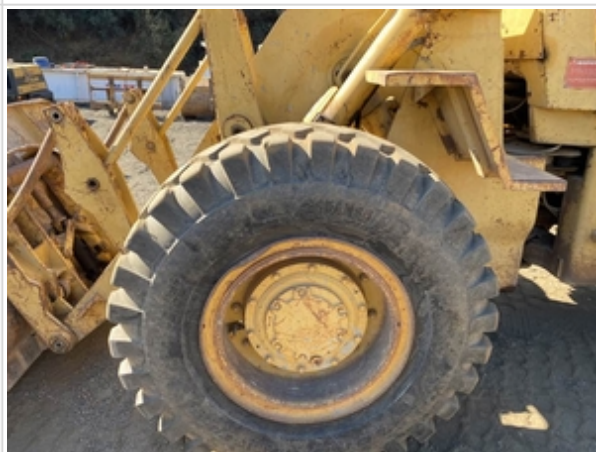
<p>Front Left Tire Photos</p>

Tire Brand	Loadmaster	
Tire Size	17.5-25	
Front Left Tire - Ratio Remaining	90%

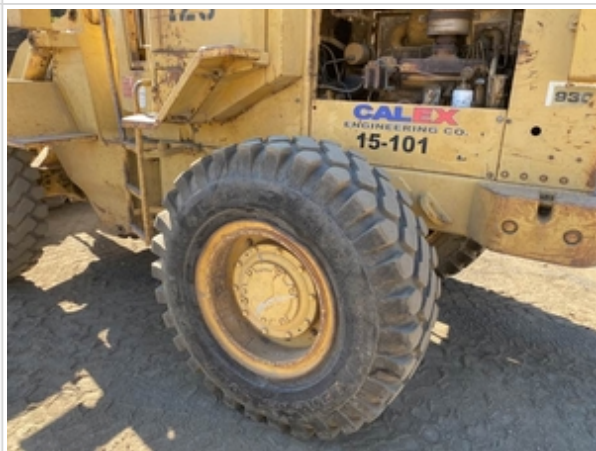
<p>Rear Left Tire - Ratio Remaining</p>	<p>90%</p>
<p>Rear Left Tire Photos</p>

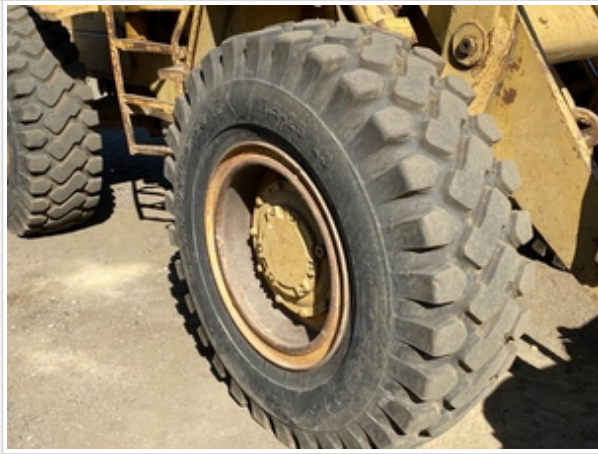
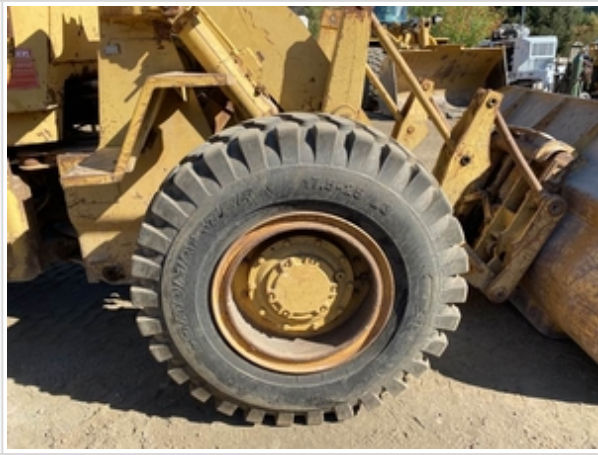
<p>Front Right Tire - Ratio Remaining</p>	<p>90%</p>	
<p>Front Right Tire Photos</p>

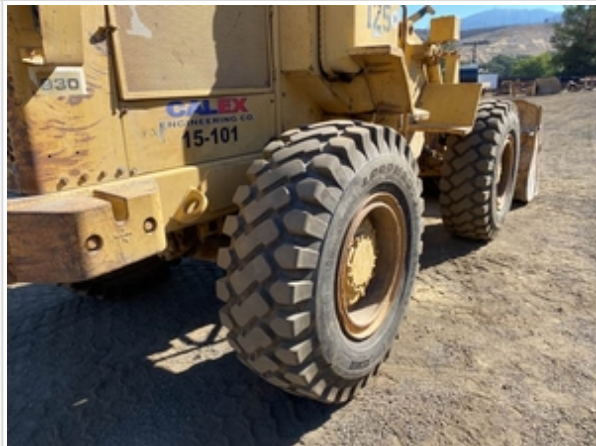
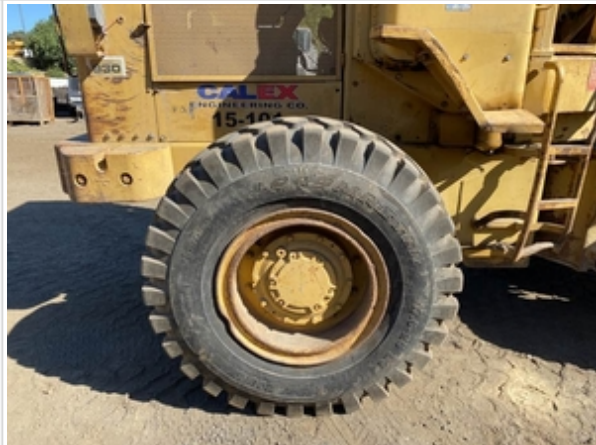
Rear Right Tire Photos

<p>Rear Right Tire - Ratio Remaining</p>	<p>90%</p>

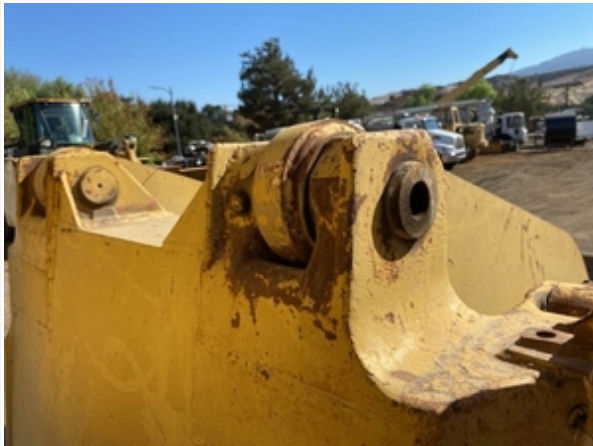
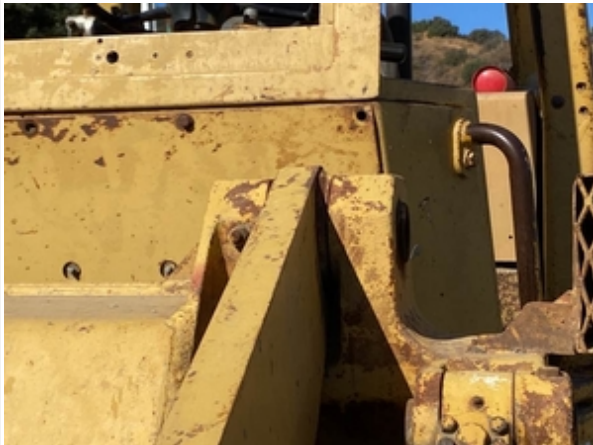
Chassis to Arm Pins	3 - Normal Wear & Tear	
Chassis to Arm Pins Photos

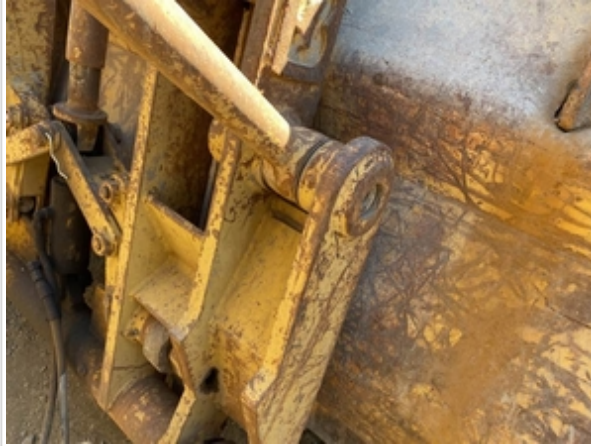
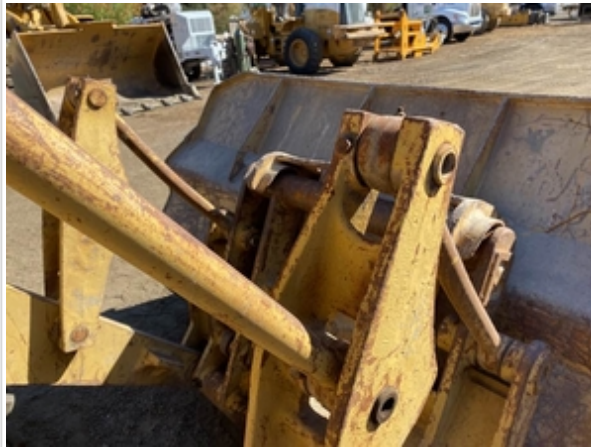
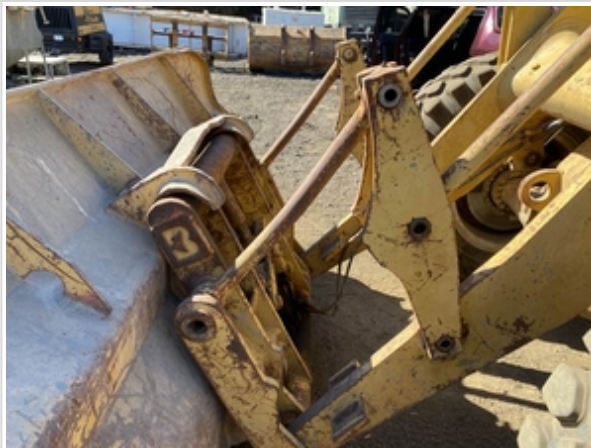
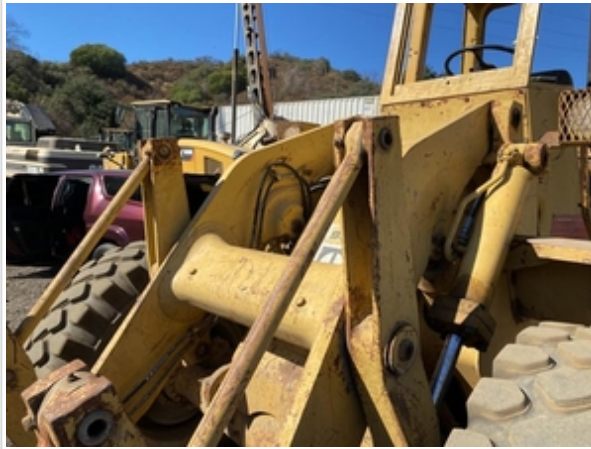
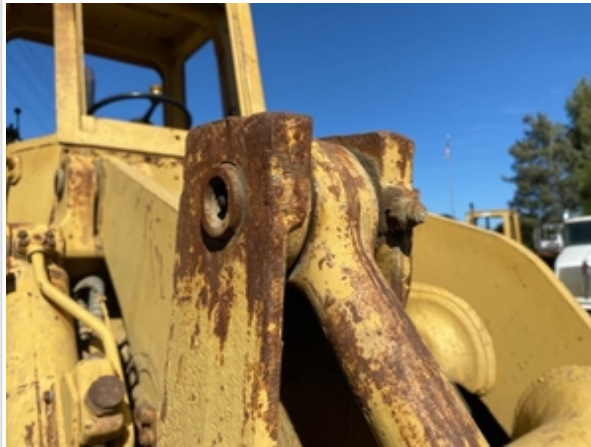
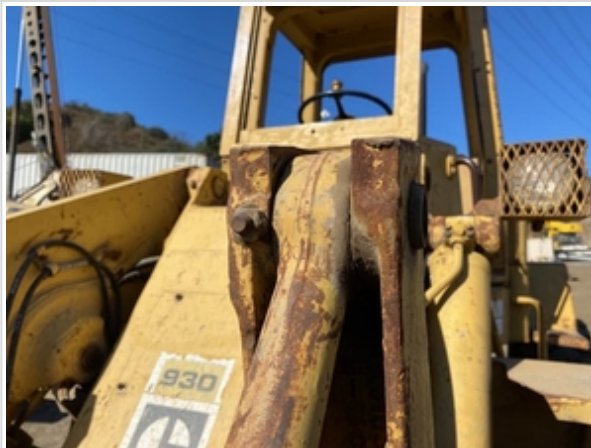
Tilt Linkage Pins and Bushings
Photos

<p>Tilt Linkage Pins and Bushings</p>	<p>3 - Normal Wear & Tear</p>

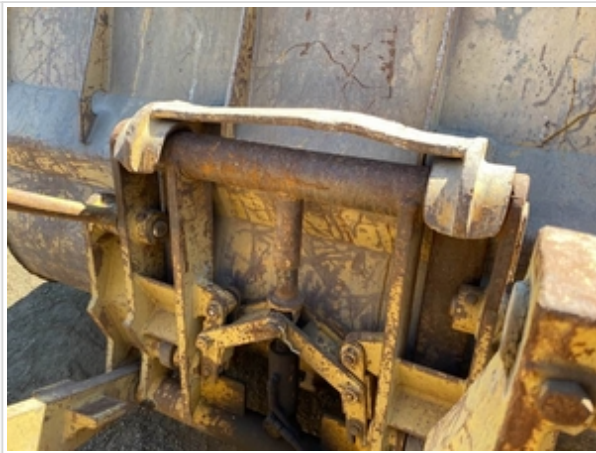
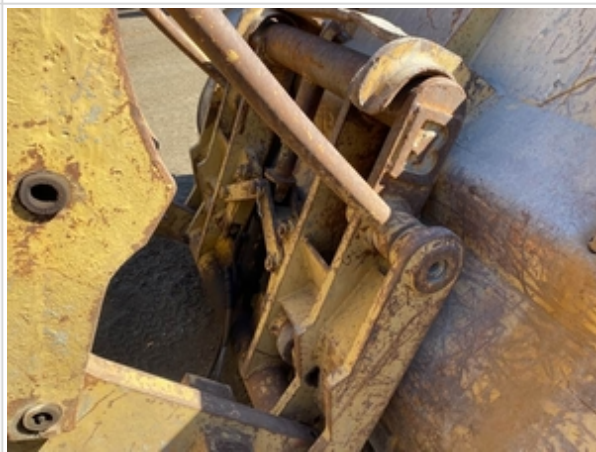
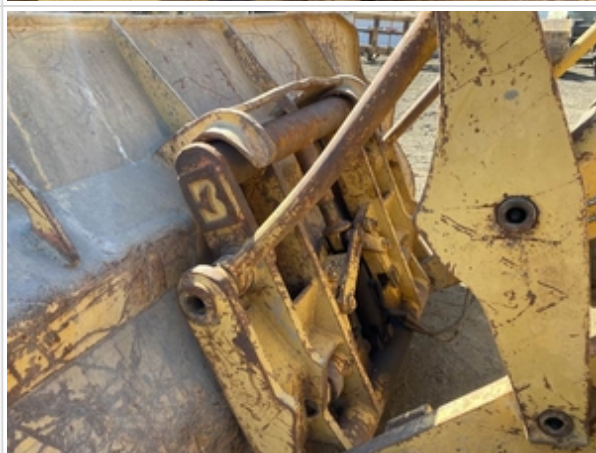
<p>Quick Coupler Photos</p>

3 - Normal Wear & Tear

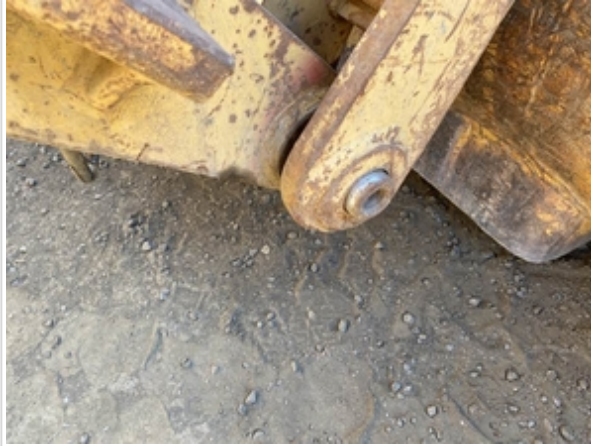
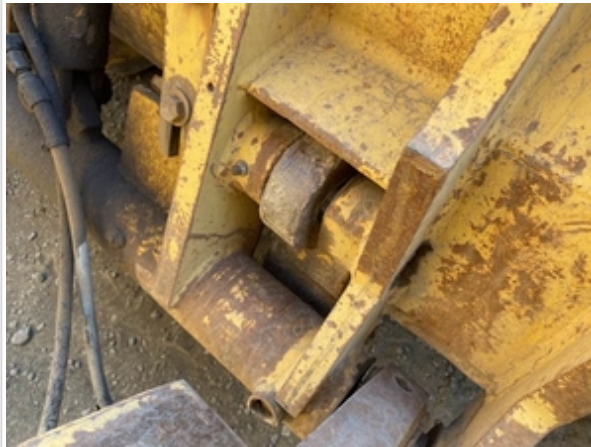
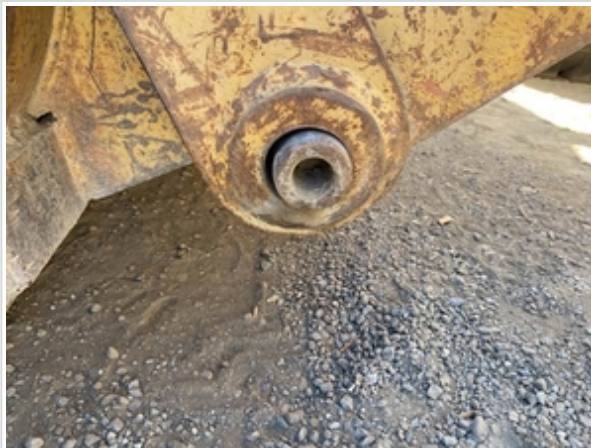
Quick Coupler to Arms Pins
Photos

<p>Quick Coupler to Arms Pins</p>	<p>3 - Normal Wear & Tear</p>
<p>Comments</p>	<p>Quick coupler to loader arms bores have excessive play</p>

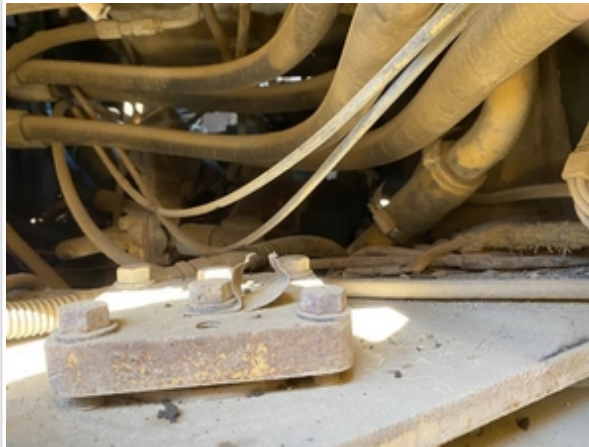
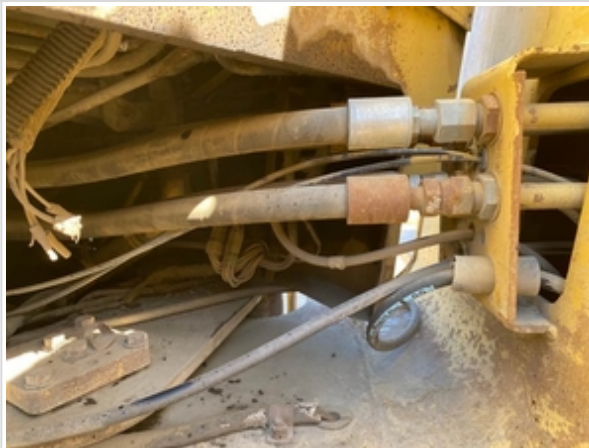
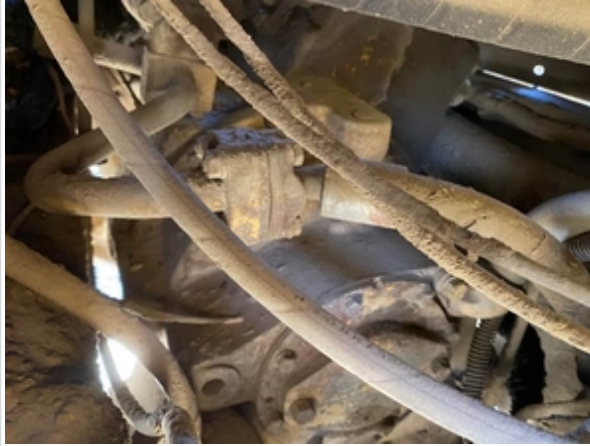
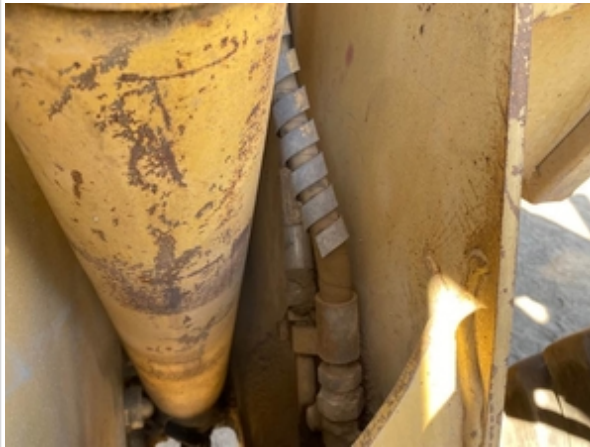
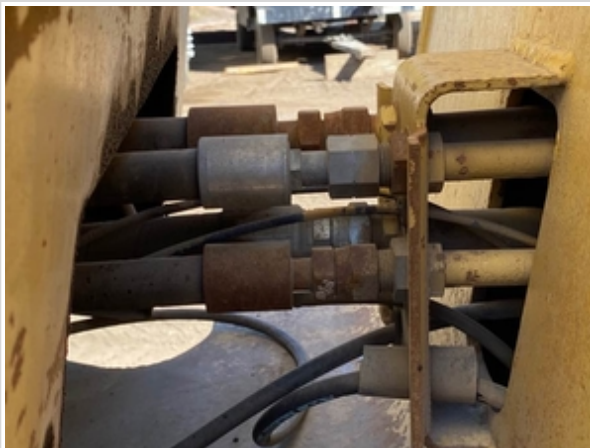
Appearance of Hydraulic Lines /
Fittings Photos

Hydraulics Overall	
Wet or Damp Hydraulic Lines / Fittings	Yes
Appearance of Hydraulic Lines / Fittings	3
Hydraulic Lines / Fittings Condition	Active leaks in hoses or fittings observed, Hydraulic lines & fittings are clean and in good condition, Other (see comments)
Comments	Some hoses showing signs of active leaks

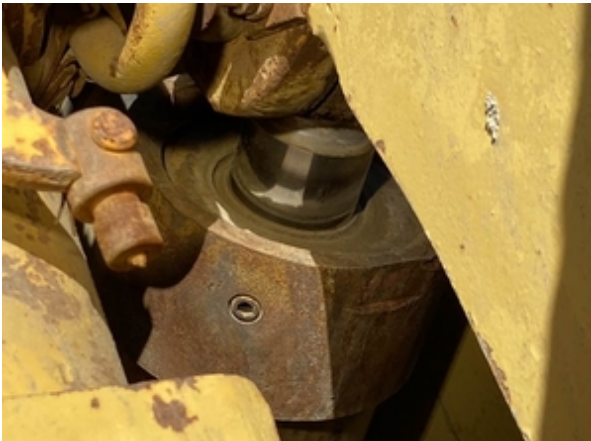
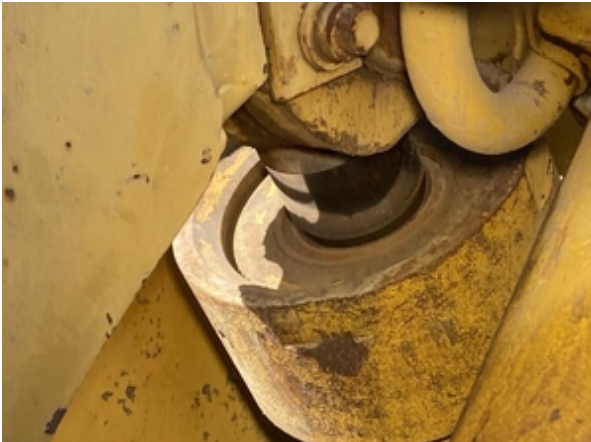
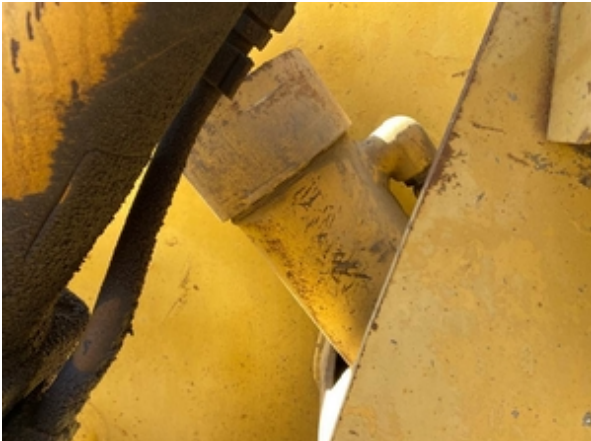
Lift Cylinder	Check the lift cylinder. Note any wear, pitting, discoloration, etc. Take photos.
Lift Cylinder: Mounting Pin	3
Lift Cylinder: Oil Leaks	No
Lift Cylinder Photos

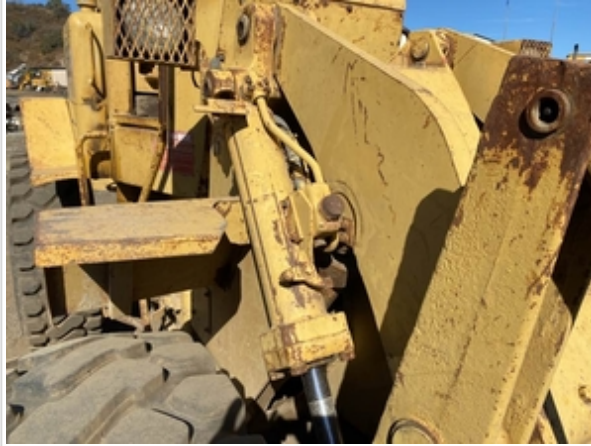
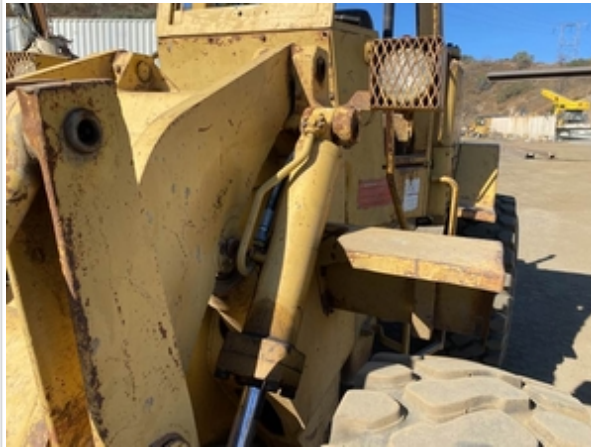
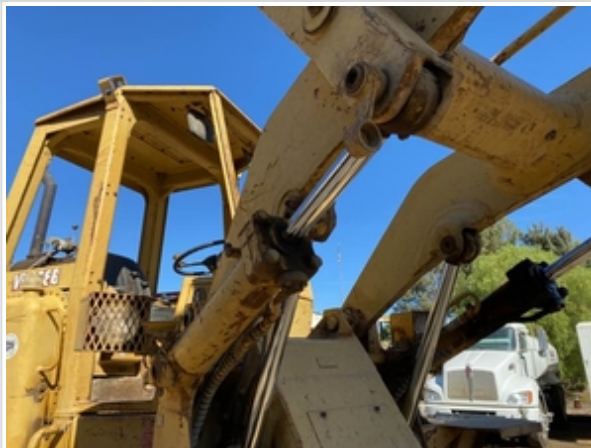
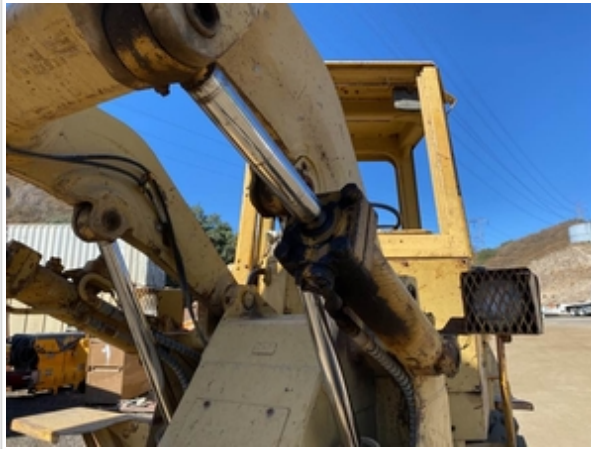
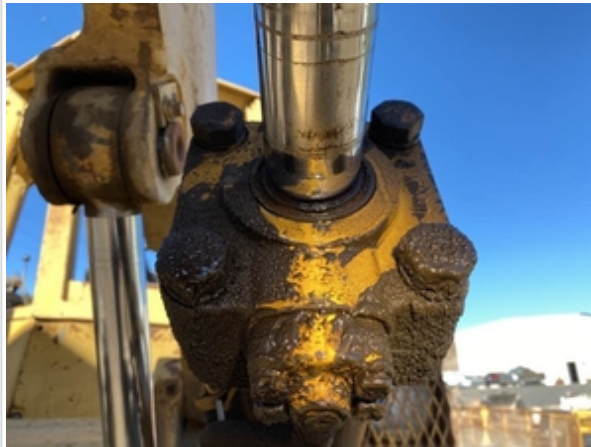
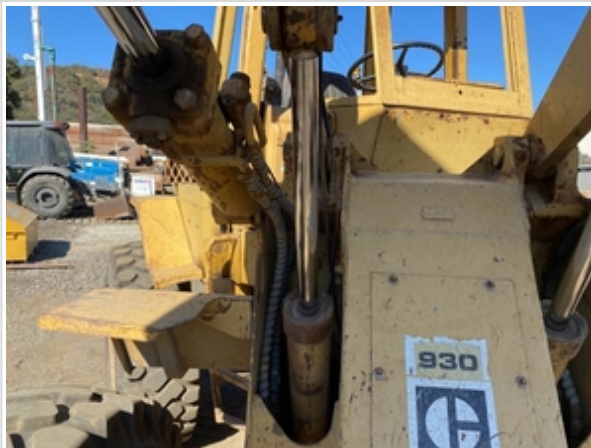
Bucket Cylinder Photos

Bucket Cylinder	Check the bucket cylinder. Note any wear, pitting, discoloration, etc. Take photos.
Bucket Cylinder: Mounting Pin	3
Bucket Cylinder: Oil Leaks	Yes
Comments	L/S Bucket Cylinder leaking

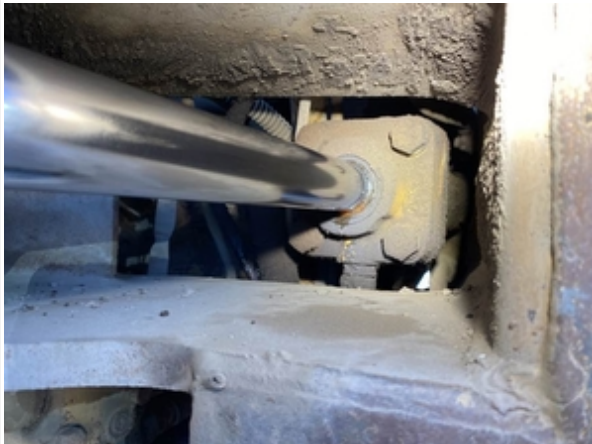
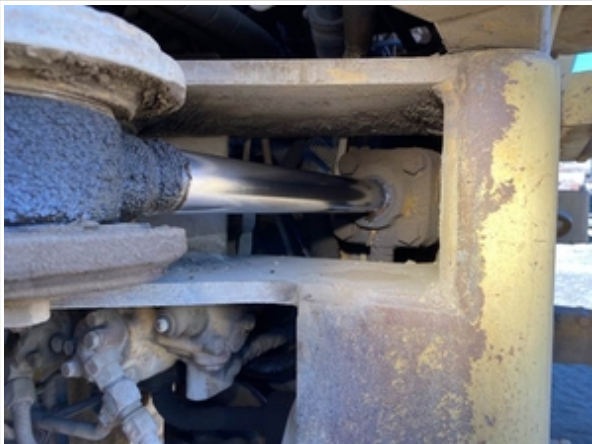
Steering Cylinder	Check the steering cylinder. Note any wear, pitting, discoloration, etc. Take photos.	
Steering Cylinder: Mounting Pin	3	
Steering Cylinder: Oil Leaks	Yes	
Comments	L/S Steer Cylinder seeping oil	
Steering Cylinder Photos

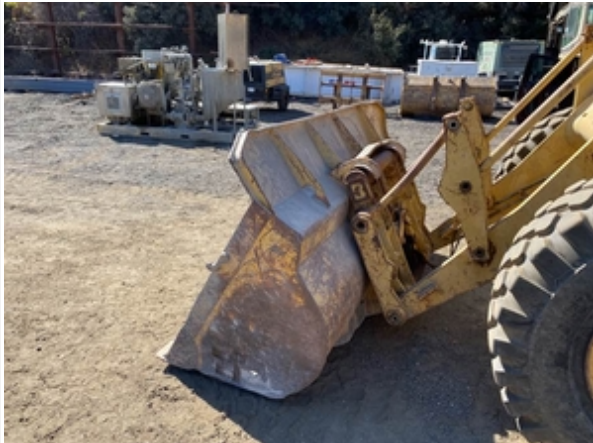
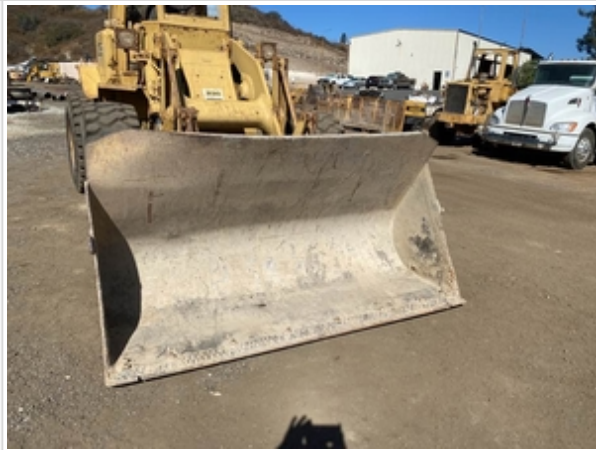
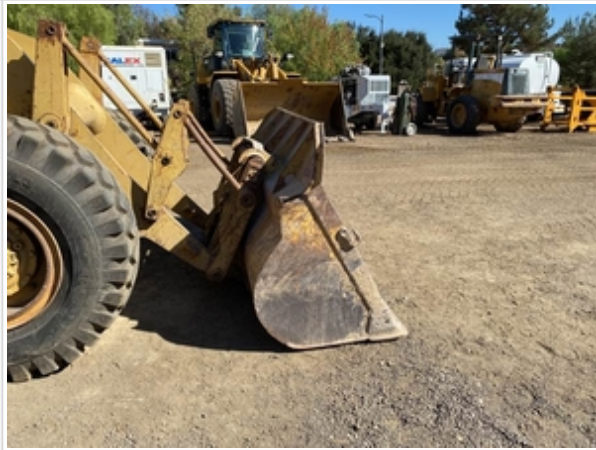
Bucket	3 - Normal Wear & Tear
Comments	8' wide r/s top of bucket bent back
Bucket Photos
