Inspection Report (Generator)

Year	2006
Make	CAT Generator
Model	XQ300
Serial Number	X3R00217 - Enclosure SN# - E33 BXFGS
Hour Meter Reading	6,787
Previous Application (e.g., earth moving, mining, demolition, etc)	General Construction

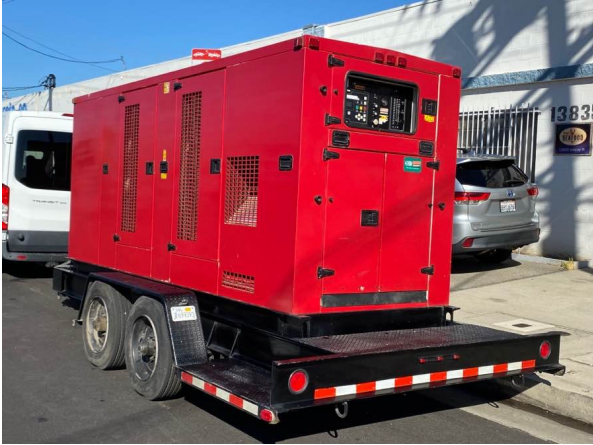
Rear	3 - Normal Wear & Tear
Rear Condition	No visible damage
Rear Photos

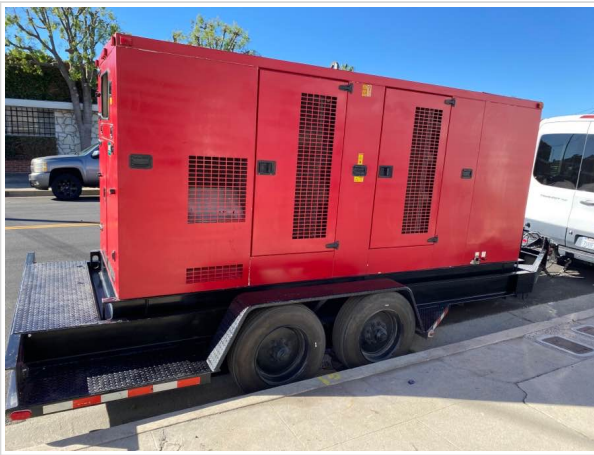
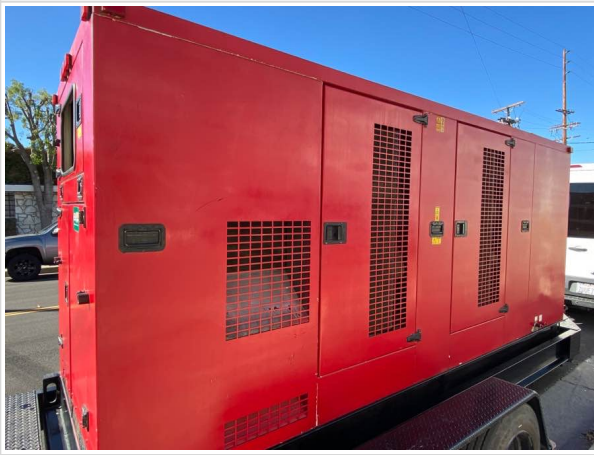
Right Photos

Right	3 - Normal Wear & Tear
Right Condition	No visible damage

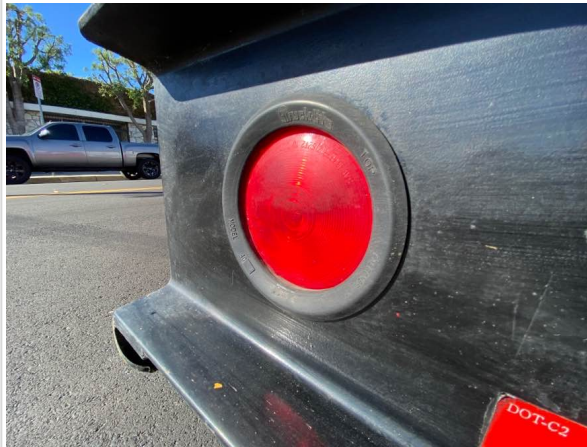
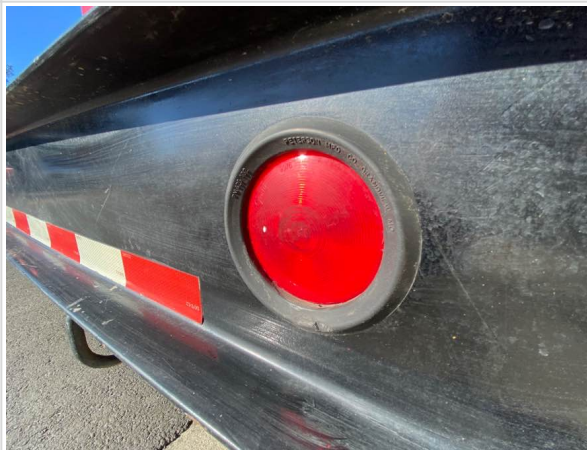
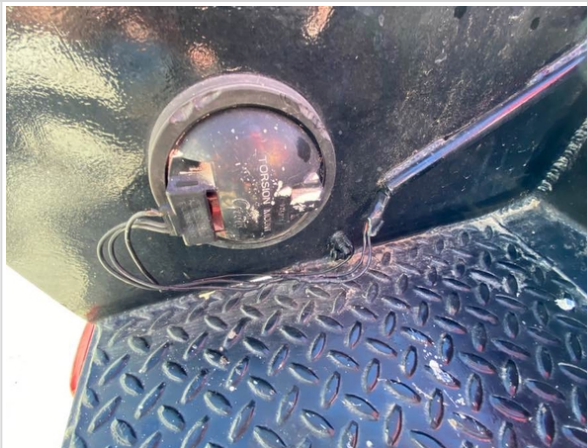
Lighting System Photos

Upper	3 - Normal Wear & Tear
Upper Condition	No visible damage
Body Panels (Any Rust Damage?)	3 - Normal Wear & Tear
Body Panel Condition	No visible damage, good paint condition and panel fitment
Doors / Canopy Latches	3 - Normal Wear & Tear
Doors / Canopy Latches Condition	No visible damage
Glass Condition	0
Mirrors	0
Lighting System	3 - Normal Wear & Tear
Lighting System Condition	No visible damage, lighting system is operational, Other (see comments)
Comments	Unable to test light system on trailer. Light fixtures intact looked okay.

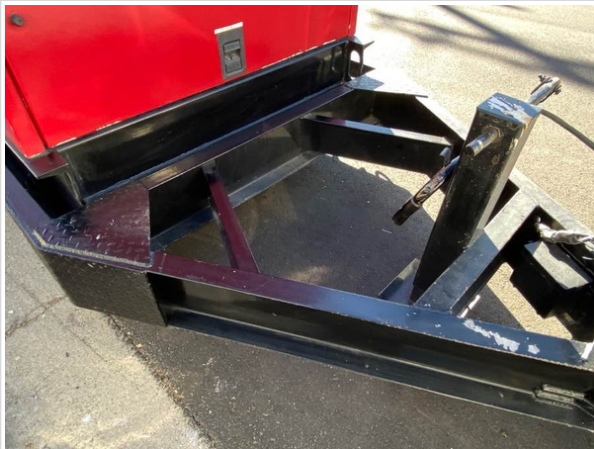
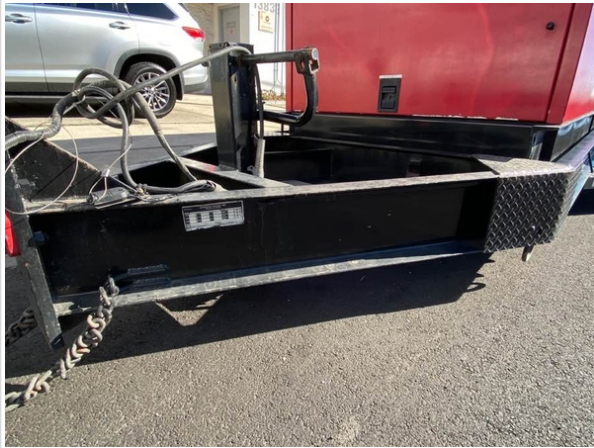
Front	3 - Normal Wear & Tear
Front Condition	No visible damage
Front Photos

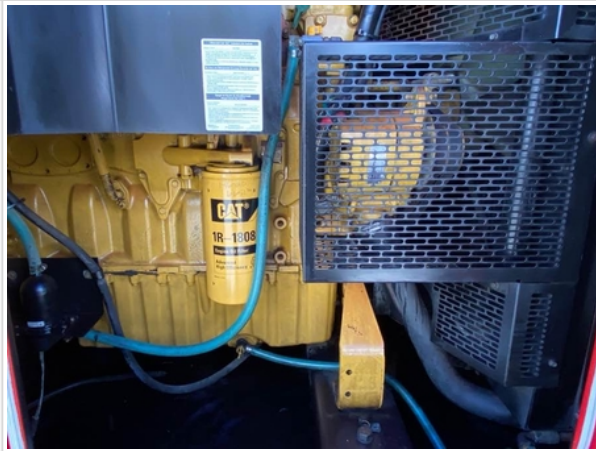
Belt Photos

Belts	3 - Normal Wear & Tear
Belt Condition	Belts appear in good condition & alignment with proper tension

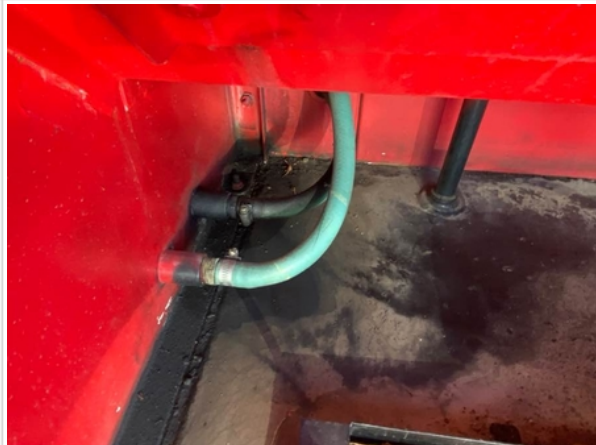
Hoses	3 - Normal Wear & Tear
Hose Condition	Firm, pliant hoses with no signs of wear or leaks
Hose Photos

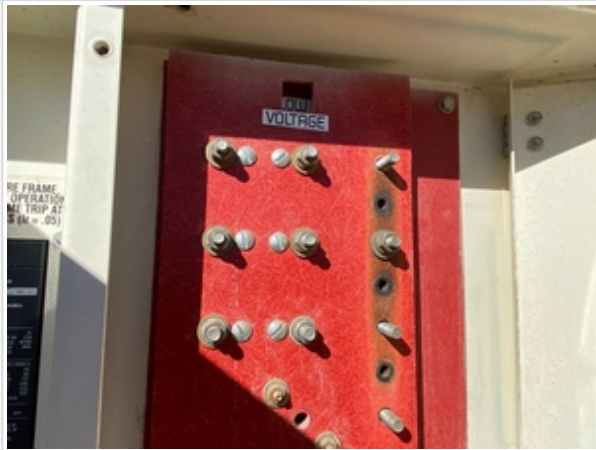
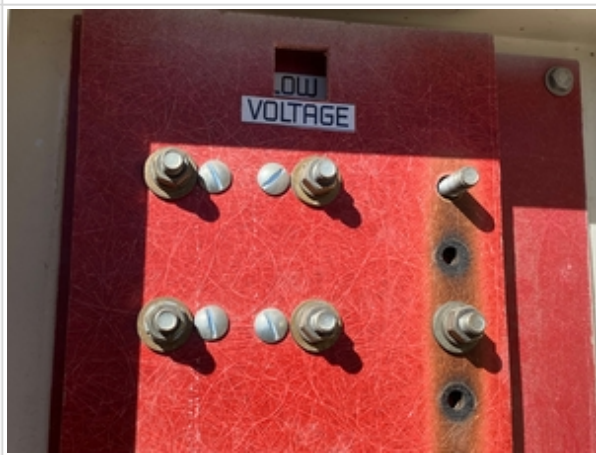
<p>Electrical Connections Photos</p>

3 - Normal Wear & Tear

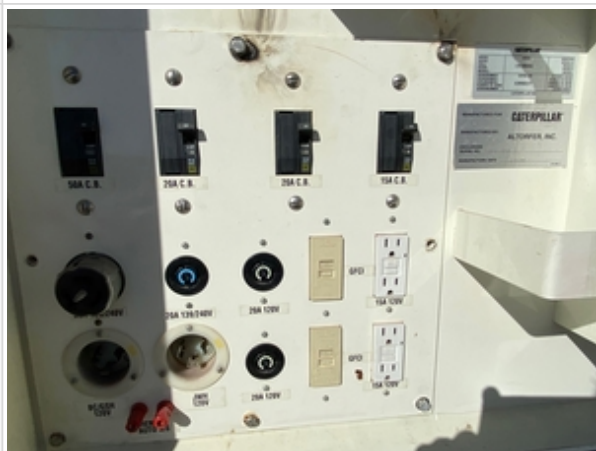
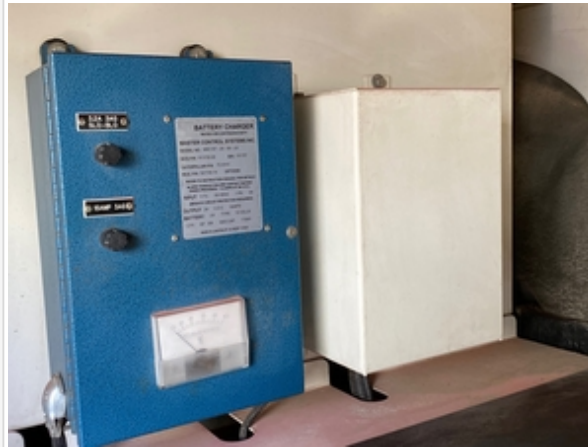
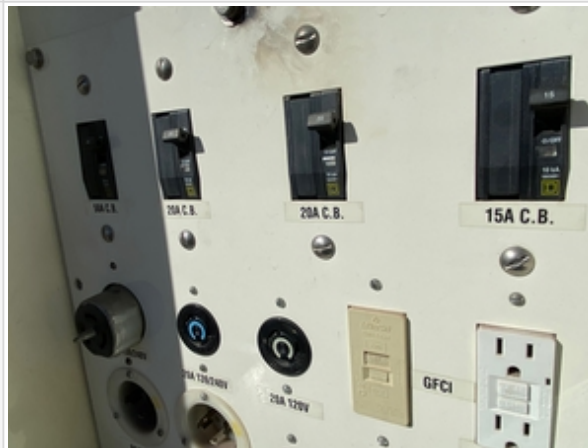
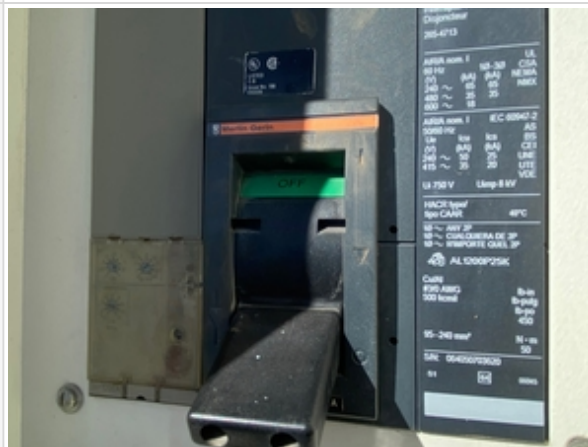
<p>Controls & Switches</p>	<p>3 - Normal Wear & Tear</p>
<p>Controls & Switches Photos</p>

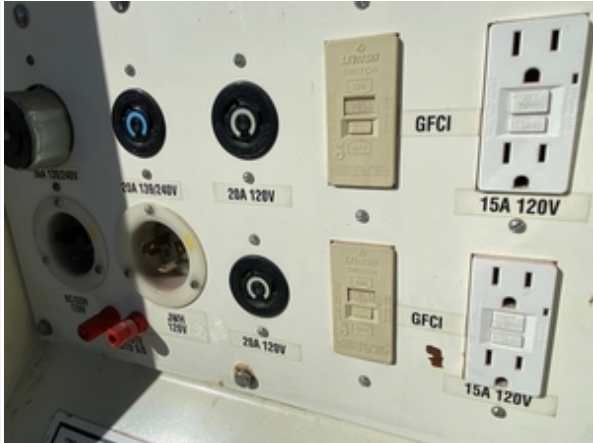
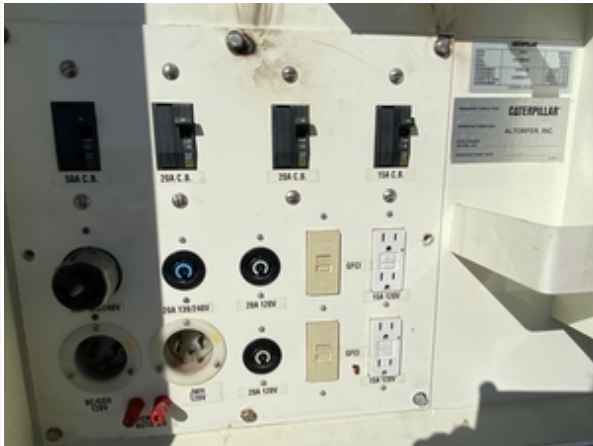
Receptacles	3 - Normal Wear & Tear
Receptacles Photos

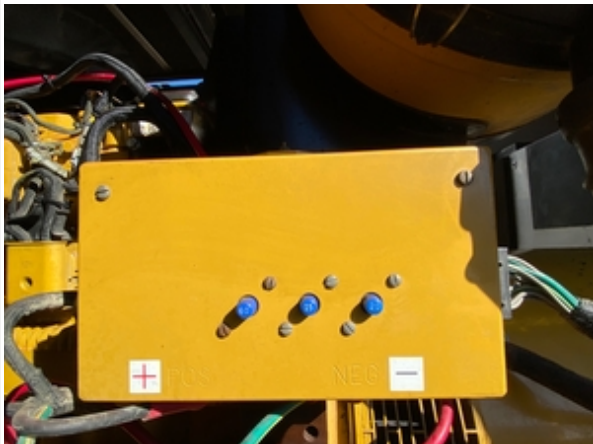
Panel Indicator Lights	3 - Normal Wear & Tear
Fuse Block	3 - Normal Wear & Tear
Fuse Block Photos

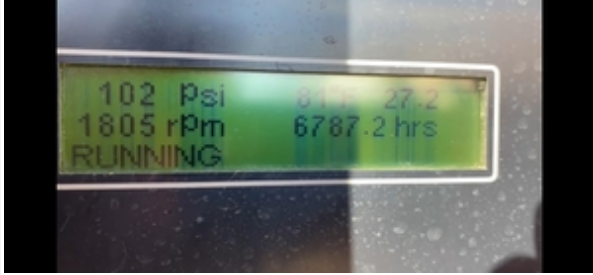
Hour Meter Photos

Hour Meter	3 - Normal Wear & Tear
------------	------------------------

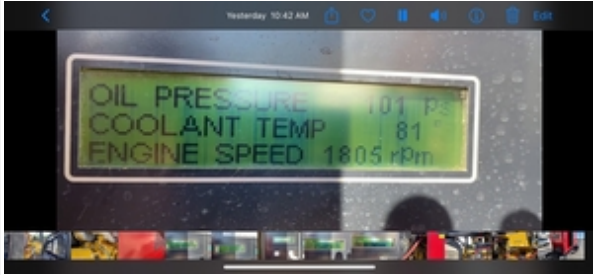
RPM Display	3 - Normal Wear & Tear
RPM Display Photos

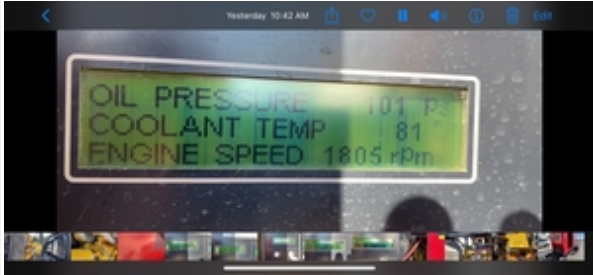
Volt Display	3 - Normal Wear & Tear
Pressure Display	3 - Normal Wear & Tear
Pressure Display Photos

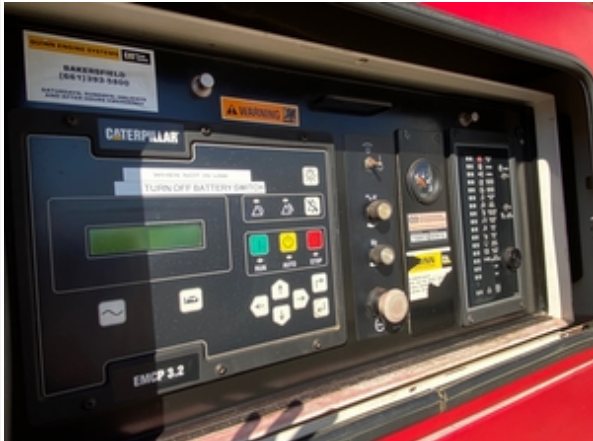
Menu Display	3 - Normal Wear & Tear
Menu Display Photos

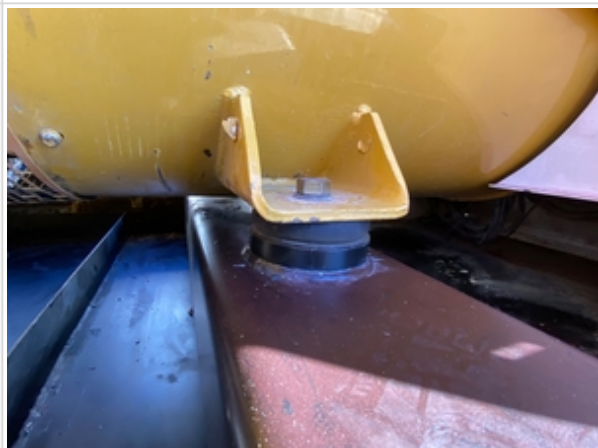
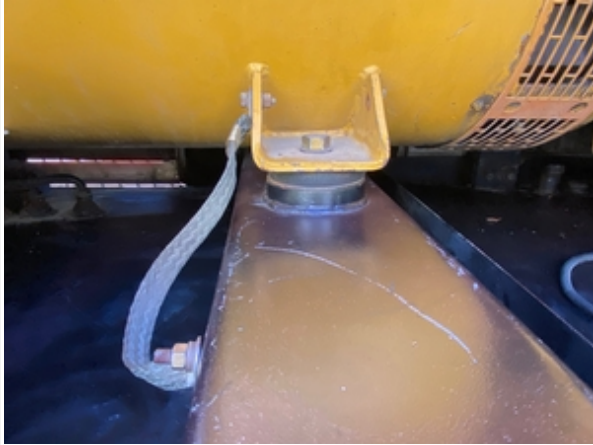
Overall Mounting Plate Appearance	3 - Normal Wear & Tear	
Mounting Plate Photos

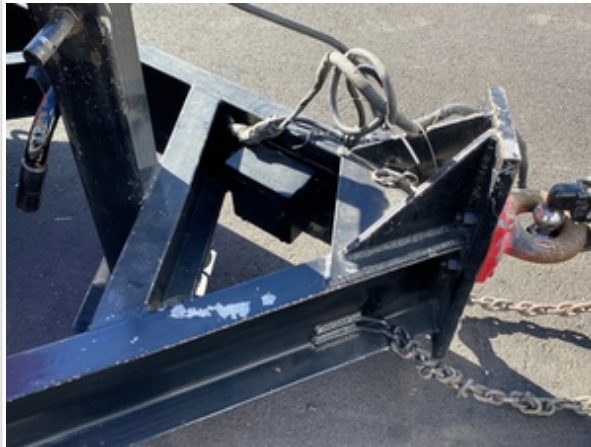
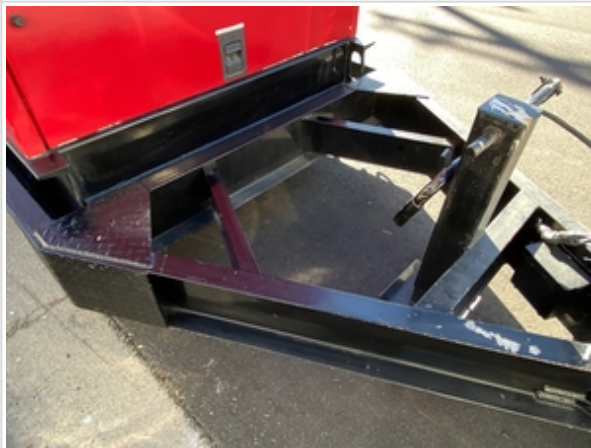
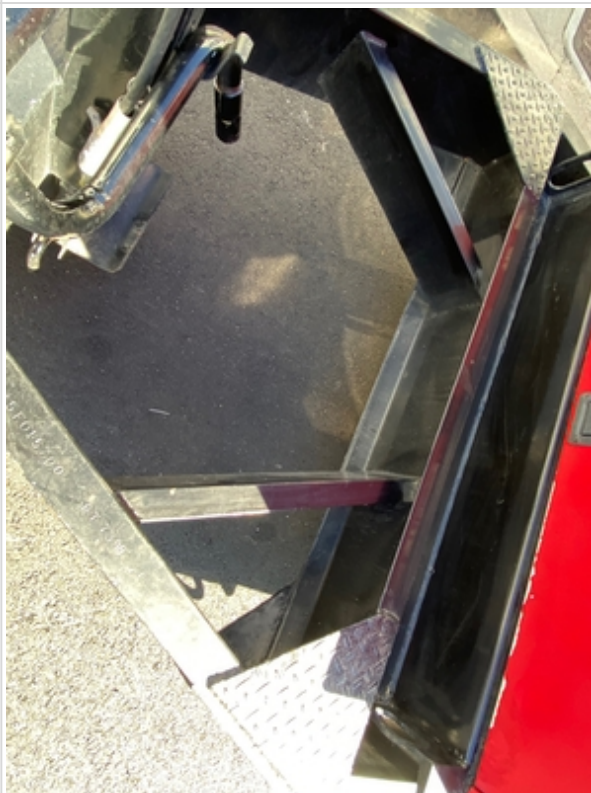
Frame Photos

Frame Condition	3 - Normal Wear & Tear
-----------------	------------------------

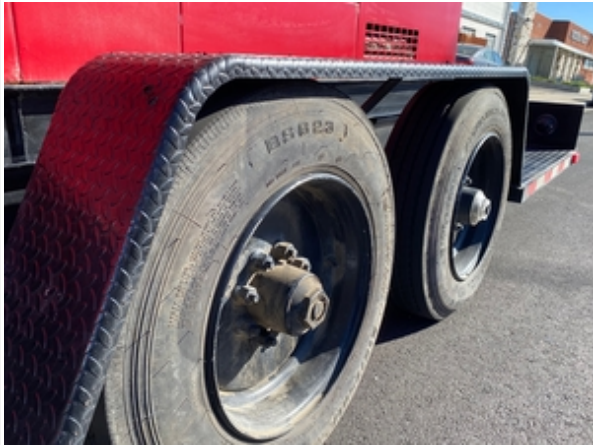
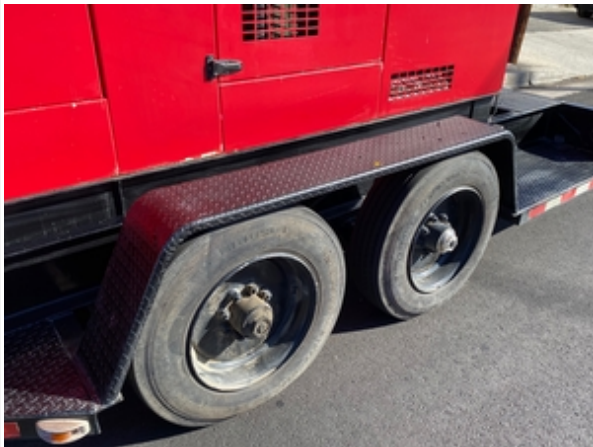
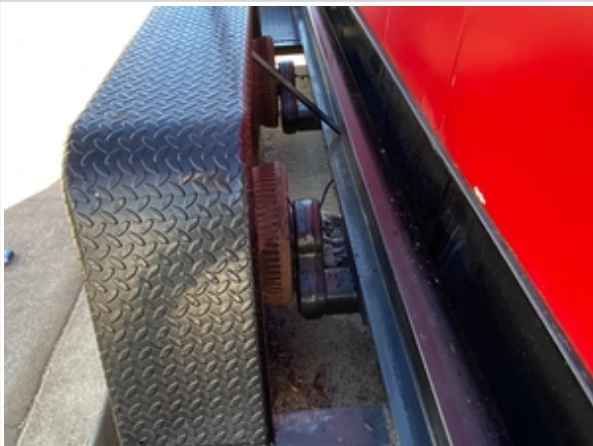
Fenders	3 - Normal Wear & Tear
Fender Photos

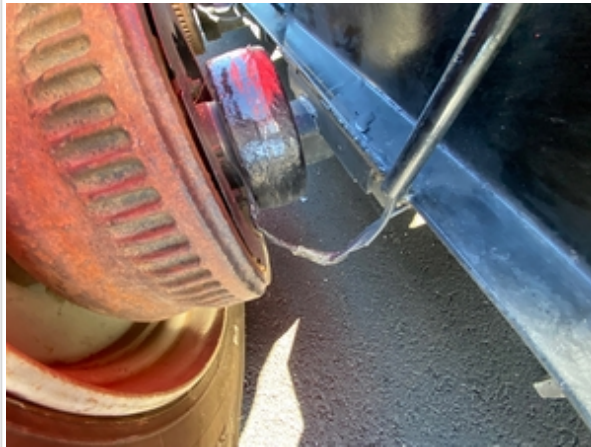
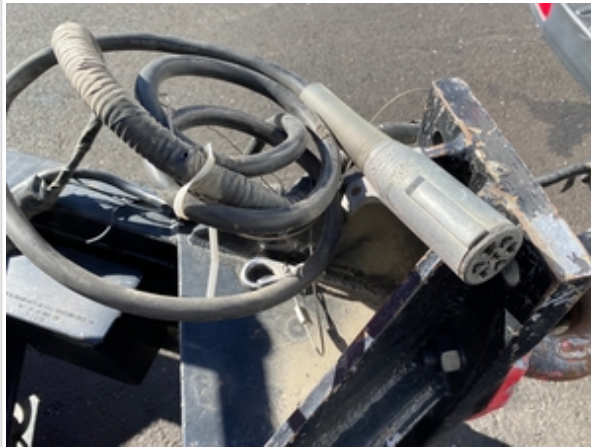
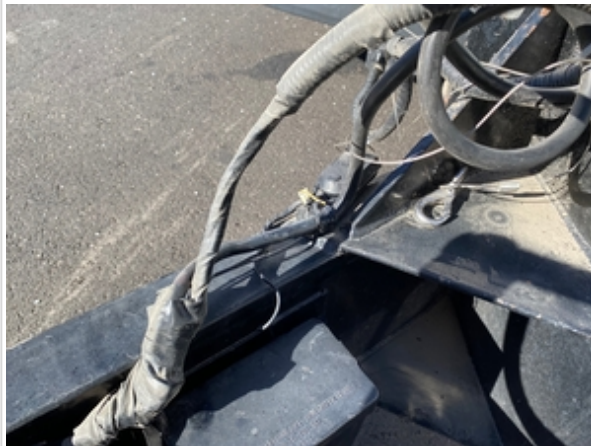
Trailer Lights Photos

Mud Flaps	0
Trailer Lights/Wiring (Stop, Tail, Turn)	2 - Above Average Wear

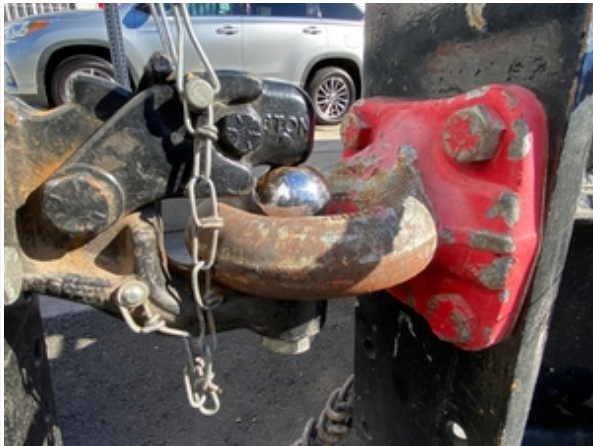
Hitch Type	Pintle
Hitch Condition	3 - Normal Wear & Tear
Hitch Photos

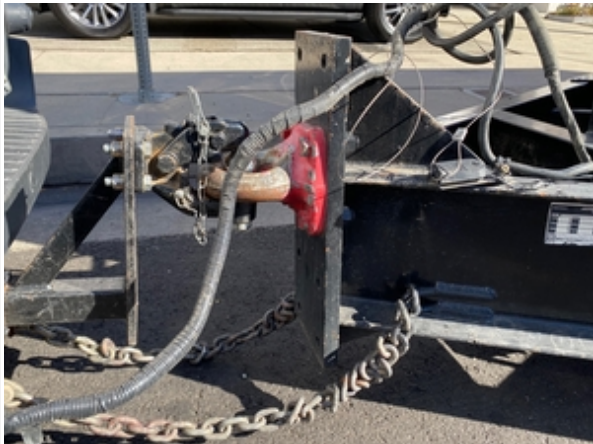
Drawbar	3 - Normal Wear & Tear
Strand Wear?	No
Drawbar Photos

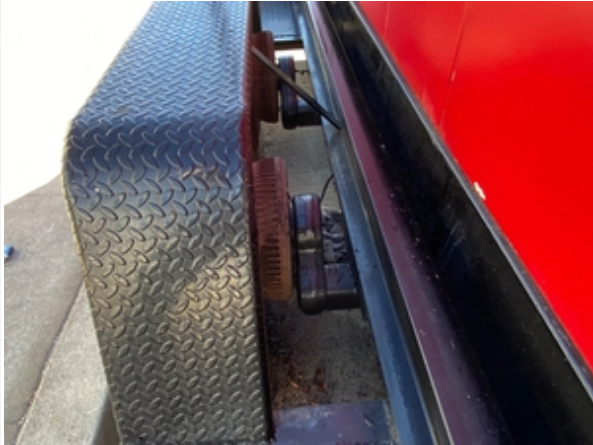
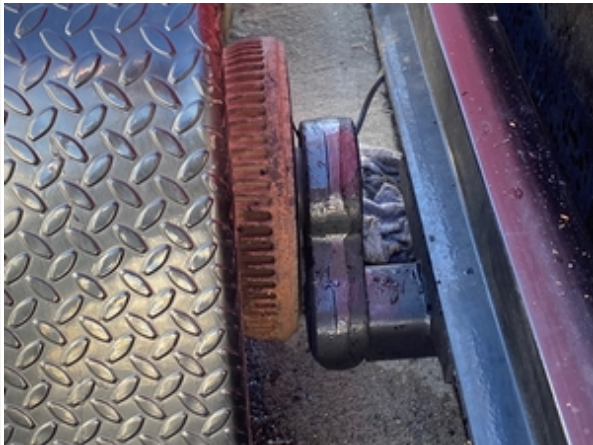
Springs	0
U-Bolts	0
Torque Arms	3
Torque Arms Photos

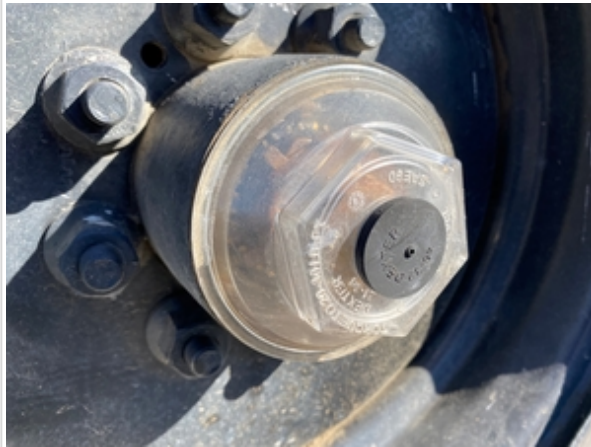
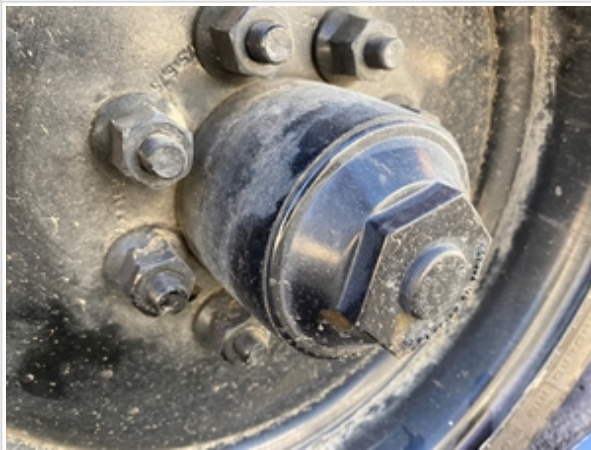
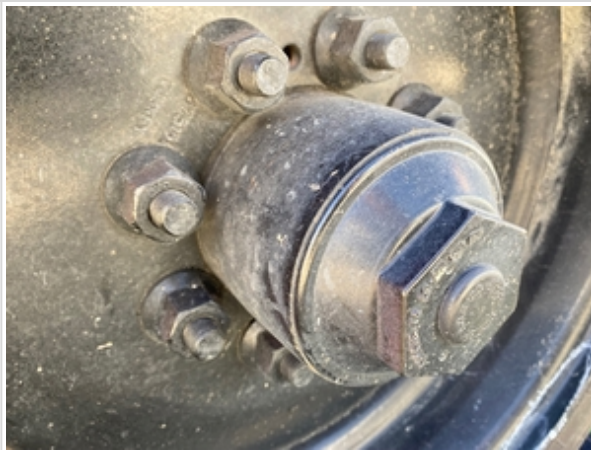
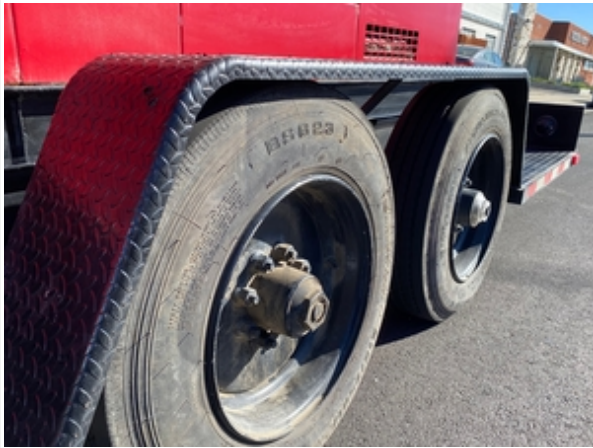
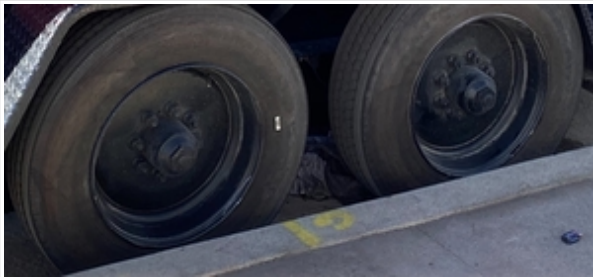
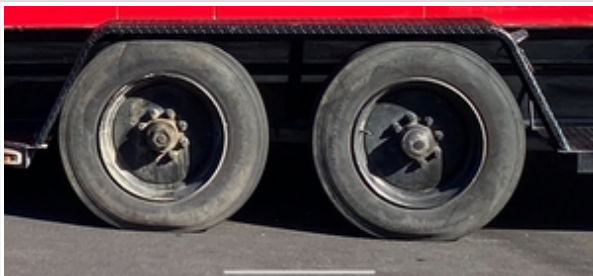
Wheels & Hub Condition	3 - Normal Wear & Tear
Comments	Tires rated at 50% due to sidewalls starting to crack
Wheels & Hub Photos

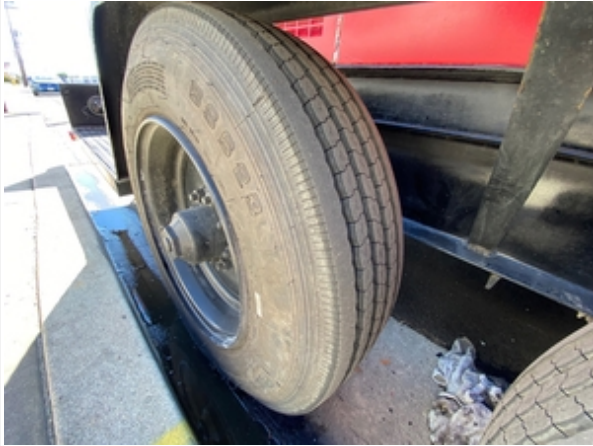
Rear Right Tire - Ratio Remaining	50%
Rear Right Tire Photos

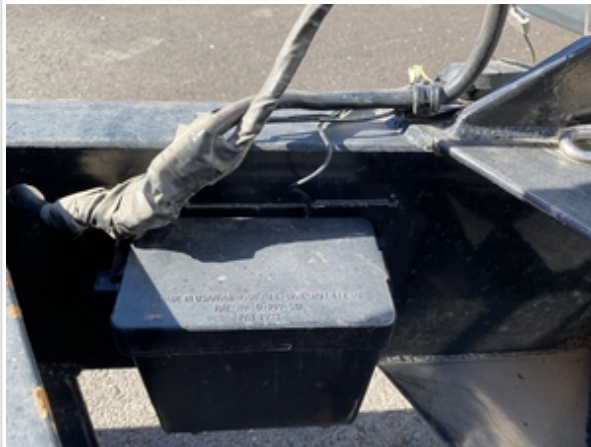
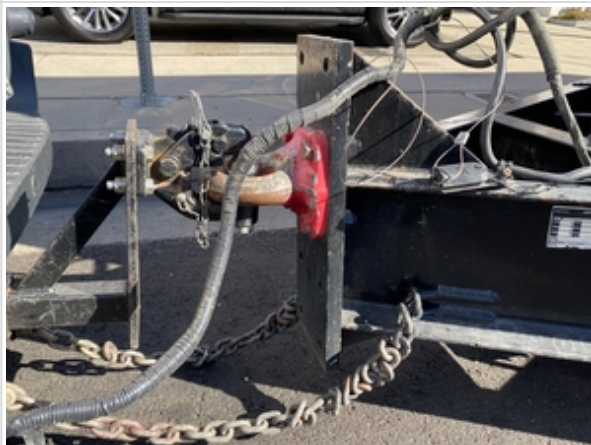
Emergency Brake/Break-Away
Photos

Brake Shoe Thickness	50%
Comments	Unable to access brake shoes
Emergency Brake/Break-Away	3 - Normal Wear & Tear
Comments	Electric breakaway device intact but unable to test
