Inspection Report (On-Highway Dump Truck)

Year	2011
Make	Peterbilt
Model	367
Serial Number	1NP - TLUOX - 8 - BD127978
Truck Odometer Reading	400,445 Mi.
Previous Application (e.g., earth moving, mining, demolition, etc)	Asphalt Construction

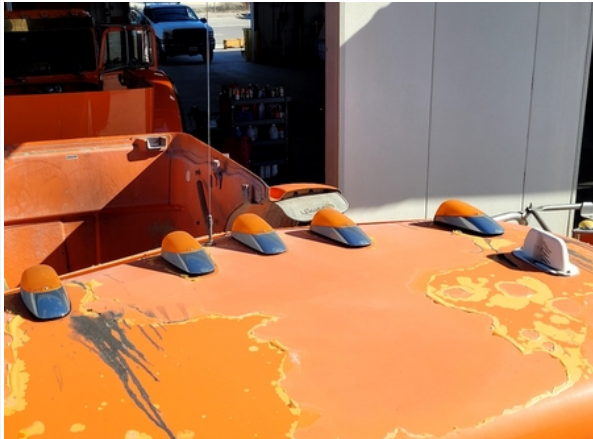
Upper	3 - Normal Wear & Tear	
Upper Condition	No visible damage	
Upper Photos

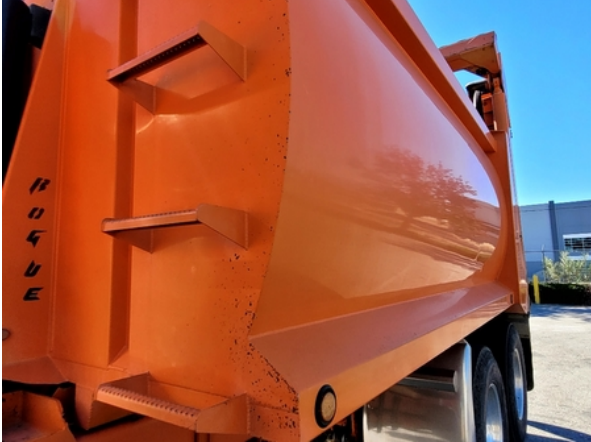
Body Panels (Any Rust Damage?)	3 - Normal Wear & Tear	
Body Panel Condition	No visible damage, good paint condition and panel fitment, Other (see comments)	
Doors / Canopy Latches	3 - Normal Wear & Tear	
Doors / Canopy Latches Condition	No visible damage	
Steps / Ladders	3 - Normal Wear & Tear	
Steps / Ladders Photos

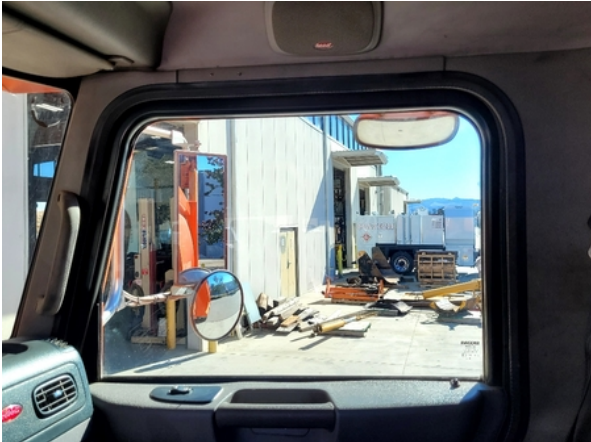
Glass Condition	3 - Normal Wear & Tear	
Glass Condition Notes	Glass intact, no visible damage	
Glass Condition Photos

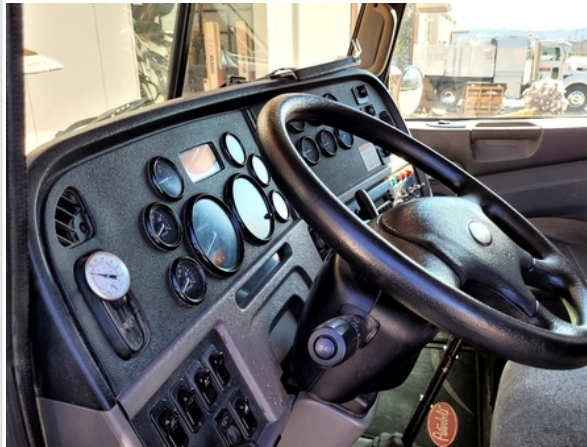
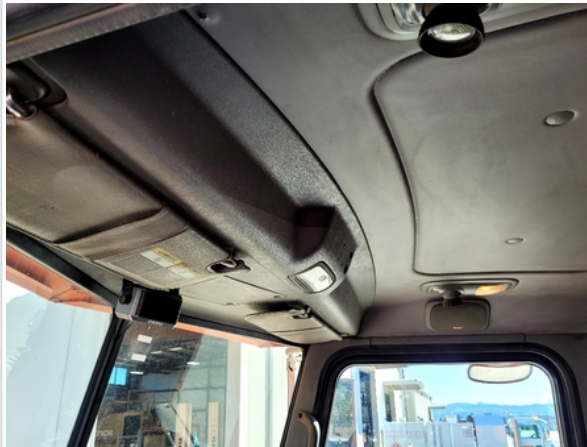
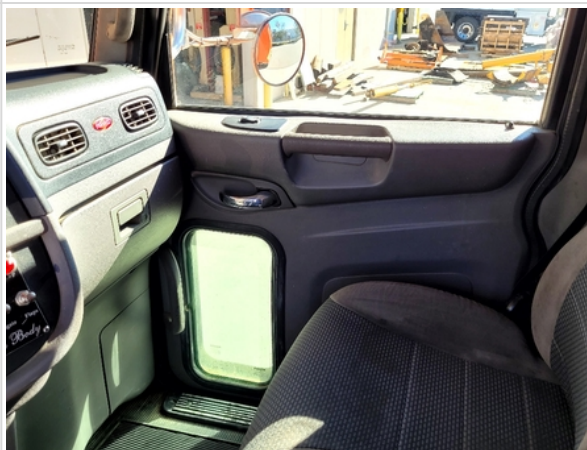
Operator Cabin Photos

3 - Normal Wear & Tear

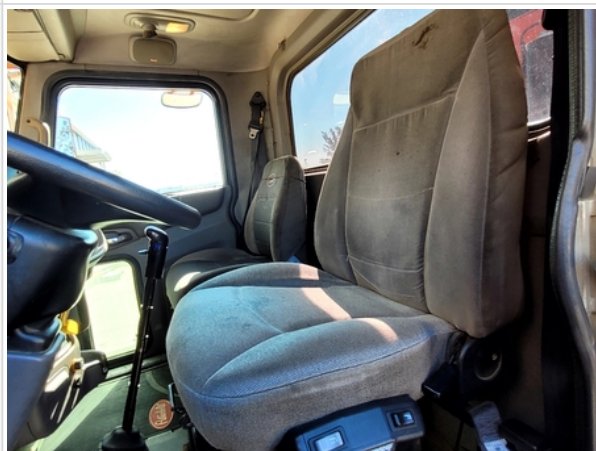
<p>Operator's Seat & Arm Rests</p>	<p>3 - Normal Wear & Tear</p>
<p>Operator's Seat & Arm Rests Photos</p>

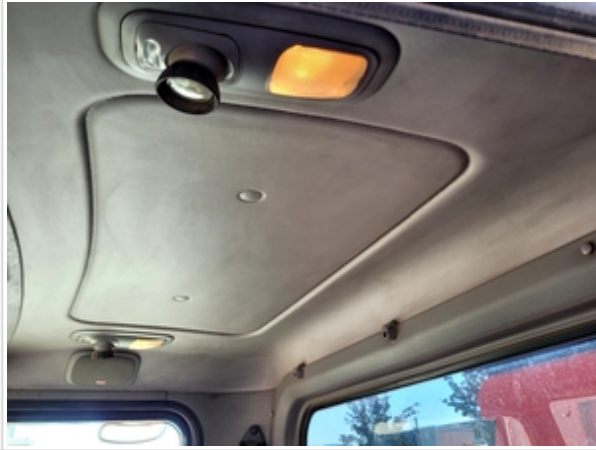
Seat Belt	3 - Normal Wear & Tear	
Cabin Lights	3 - Normal Wear & Tear	
Cabin Lights Photos

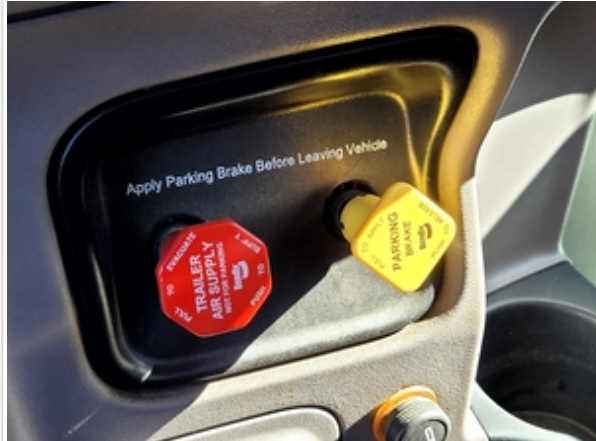
Controls & Switches	3 - Normal Wear & Tear	
Controls & Switches Photos

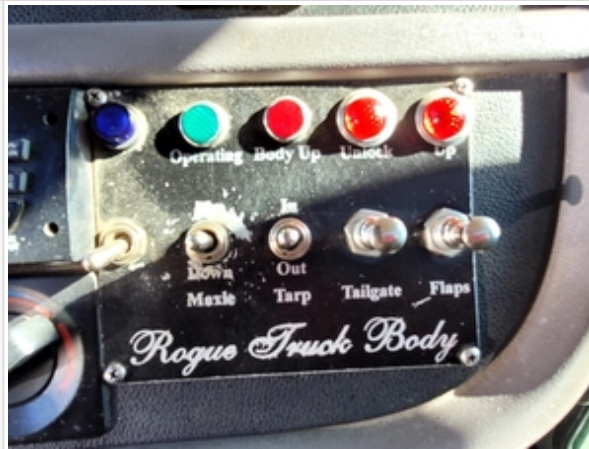
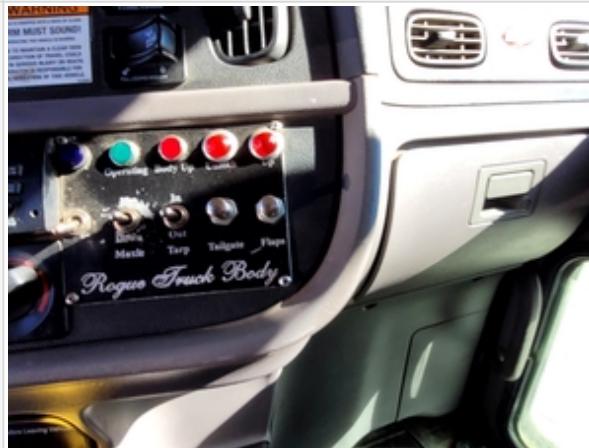
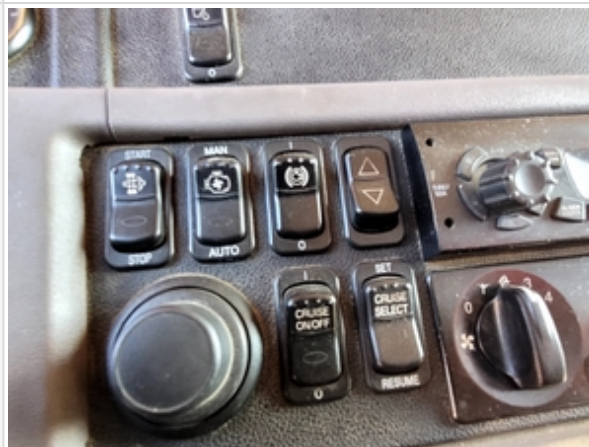
Odometer Activity	3 - Normal Wear & Tear
Odometer Activity Photos	 
Other Gauge Activity	3 - Normal Wear & Tear
Other Gauge Activity Photos

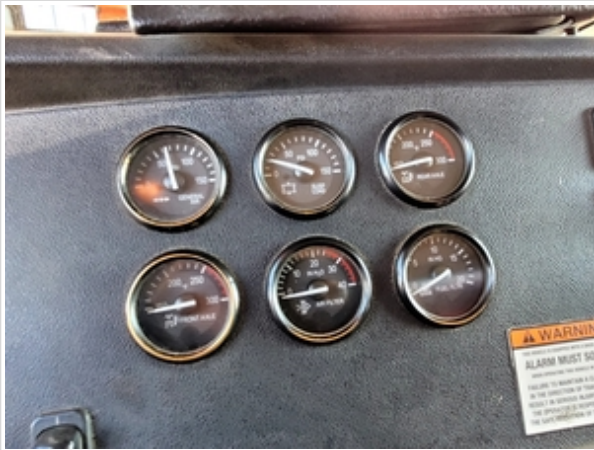
Heater & A/C	3 - Normal Wear & Tear
Heater & A/C Photos

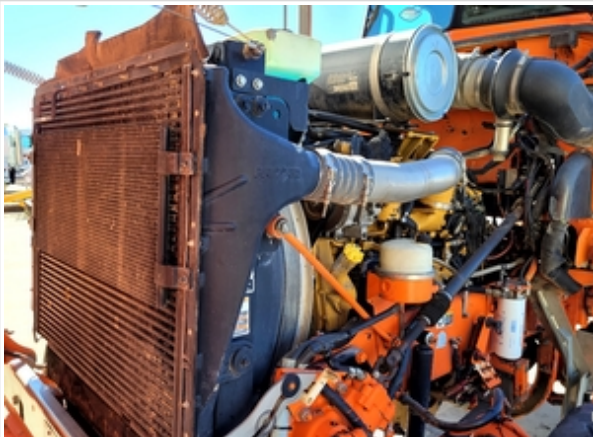
Blow-by (Visual Observation Check)	No	
Unusual Noises (Upon Start-up, Idle, Shutdown)	No	
Unusual Noise Notes	No unusual noises heard	
Engine Smoke (Upon Start-up, Idle, Shutdown)	No	
Engine Smoke Notes	No engine smoke issues observed	
Engine Exhaust Color	Clear	
Battery	3 - Normal Wear & Tear	
Battery Condition	Clean & dry appearance, tight connections	
Radiator	3 - Normal Wear & Tear	
Radiator Condition	Radiator fins & components appear to be in good working order, no signs of damage or leaks	
Radiator Photos

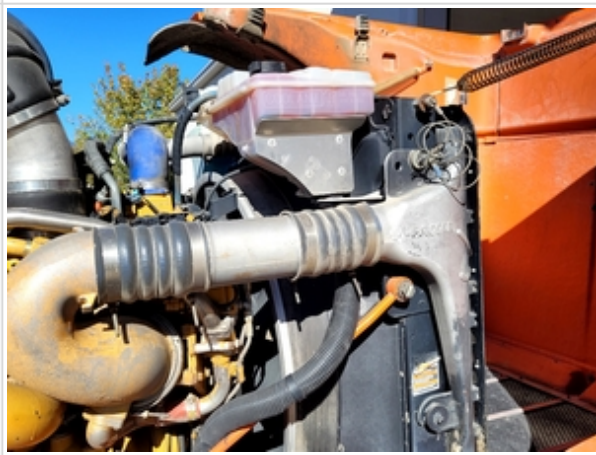
Belts	3 - Normal Wear & Tear	
Belt Condition	Belts appear in good condition & alignment with proper tension	
Belt Photos

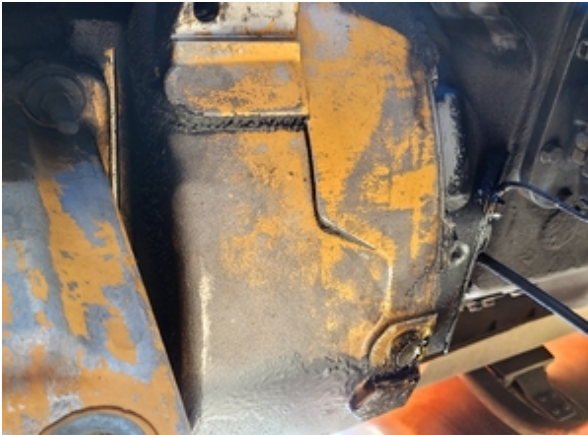
Water Pump	3 - Normal Wear & Tear	
Cooling System Leaks	No	
Coolant Color / Appearance	3 - Normal Wear & Tear	
Coolant Color/Appearance Notes	Normal Translucent appearance, no visual signs of contamination	
Oil Leaks	Yes	
Oil Leak Notes	Wetness & discoloration observed, Other (see comments)	
Comments	small oil leak observed at rear, right side of oil pan to back cover & engine block area	
Oil Leak Photos

Requires DEF (Diesel Exhaust Fluid)	No
Overall Engine Appearance	Clean & dry
Overall Engine Comments	Minor leak at top r/s of engine oil pan to block and back cover

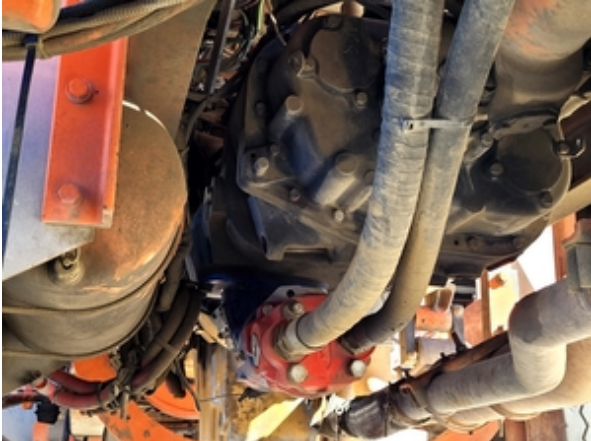
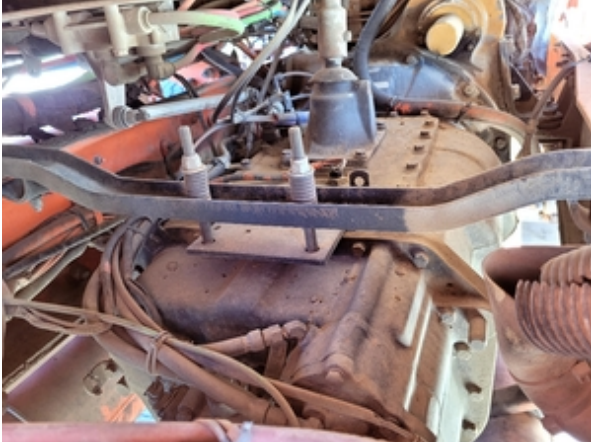
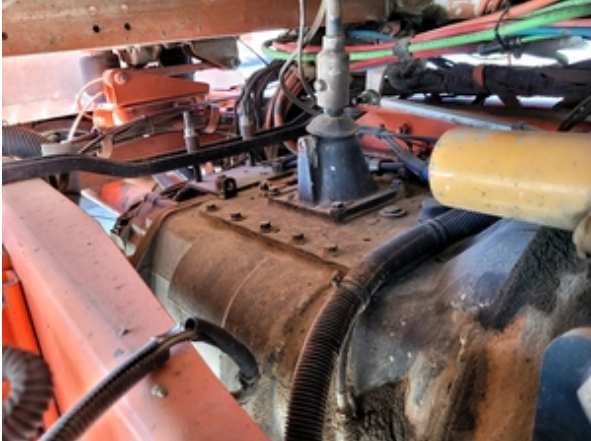
Transmission Condition	No unusual noises or vibrations
Transmission Condition Photos

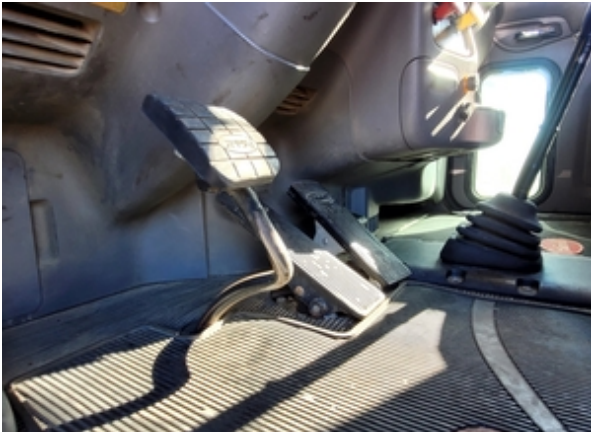
Foot Brake	3 - Normal Wear & Tear
Foot Brake Condition	Good brake function
Foot Brake Photos

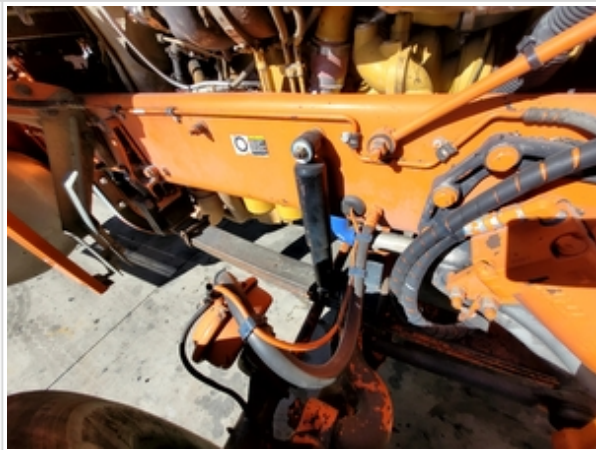
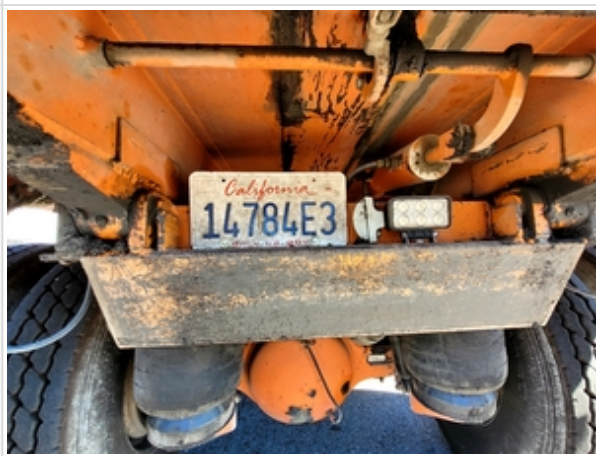
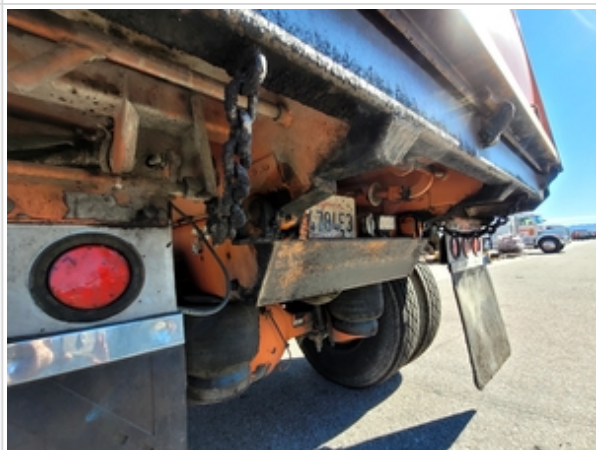
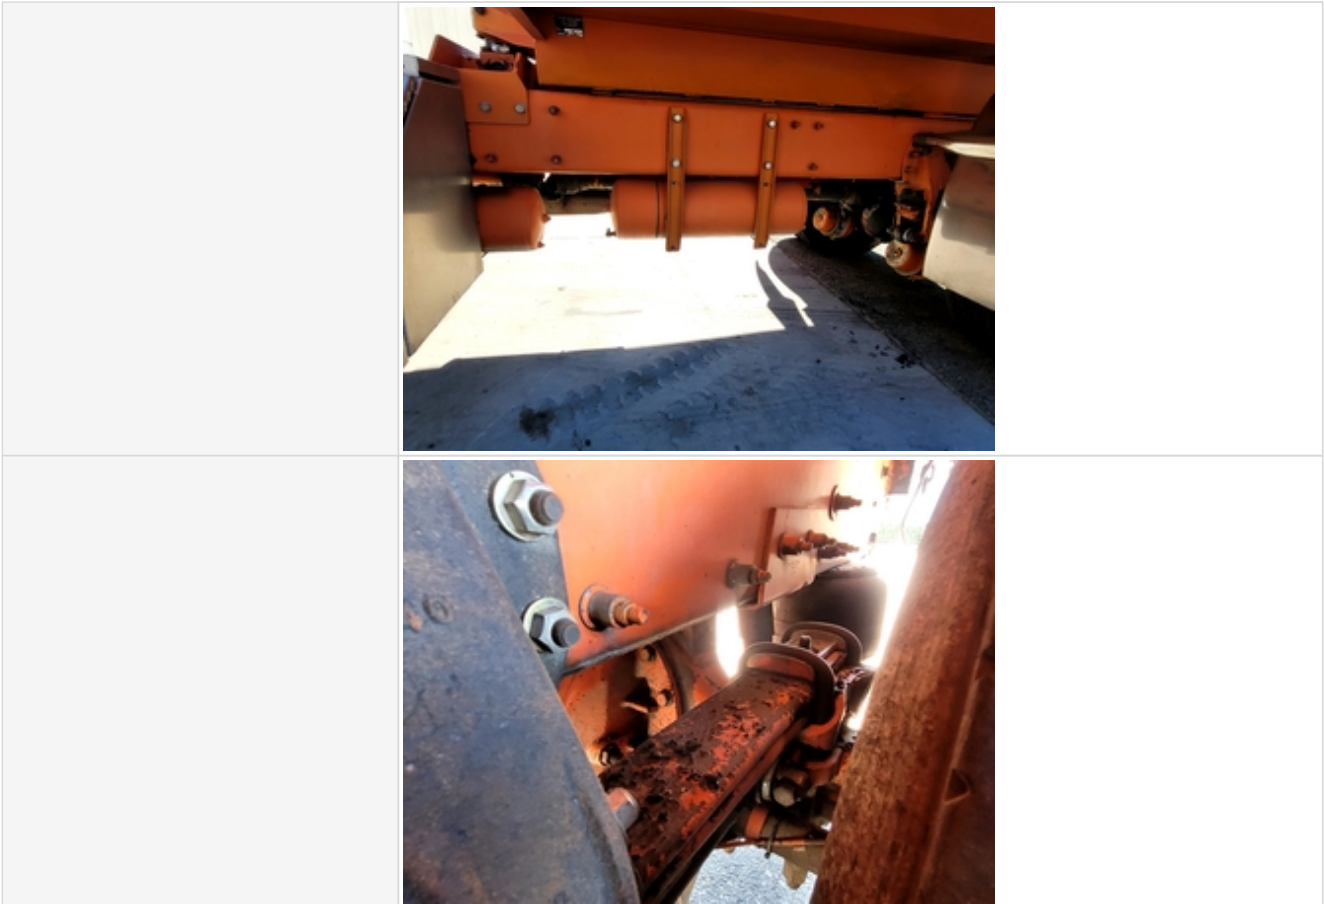
Frame Condition	3
Frame Photos

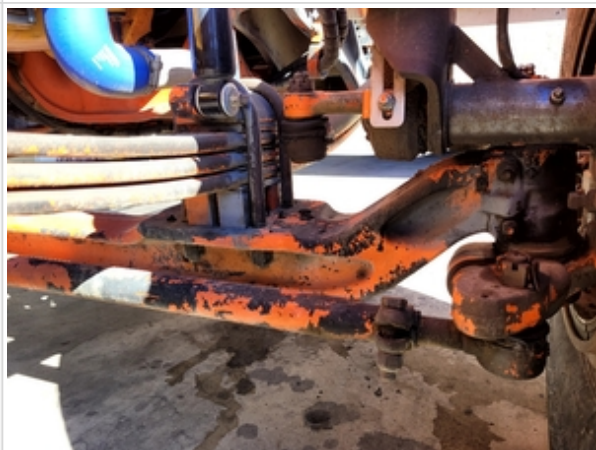
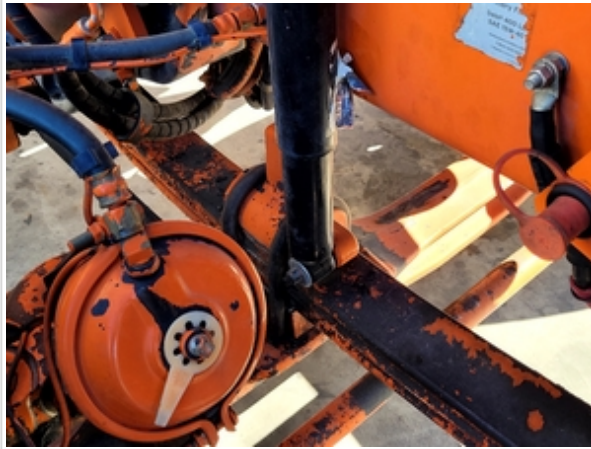
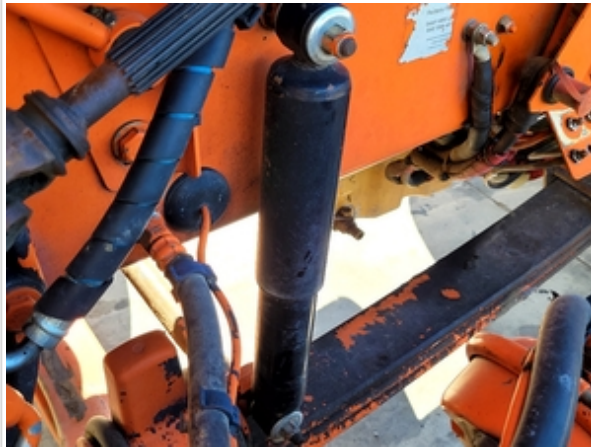
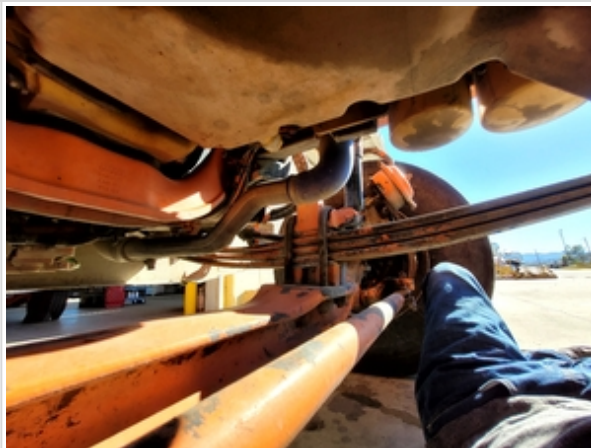
<p>Suspension</p>	<p>3</p>
<p>Suspension Photos</p>

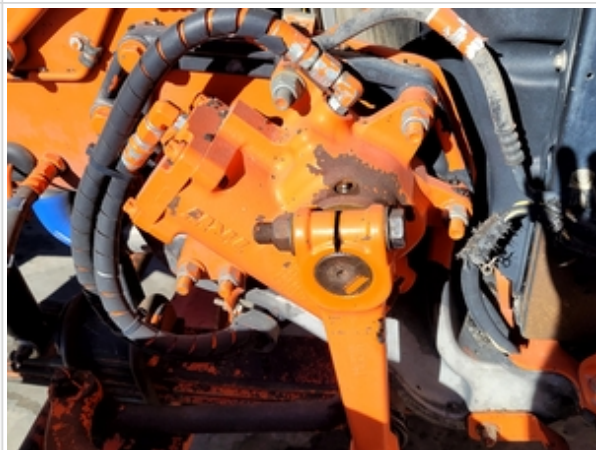
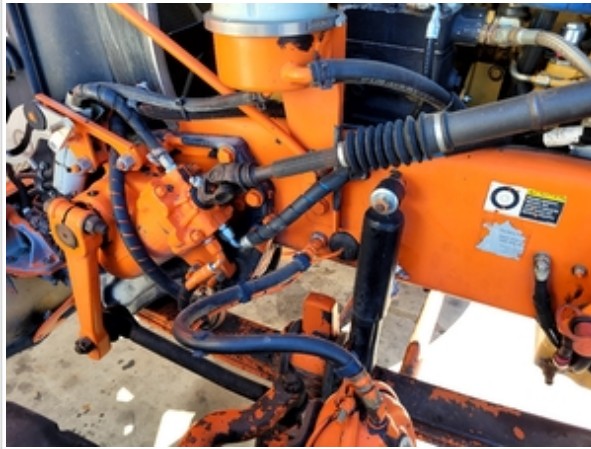
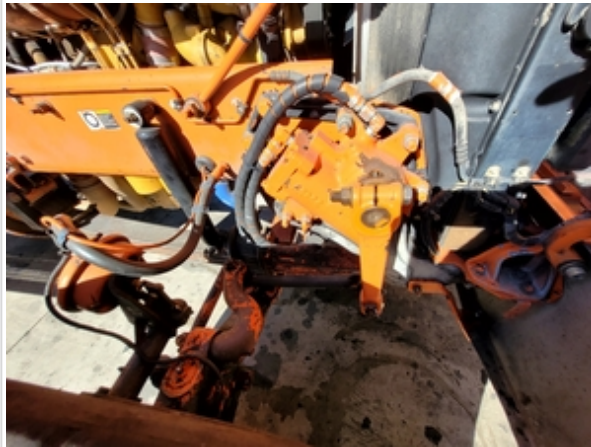
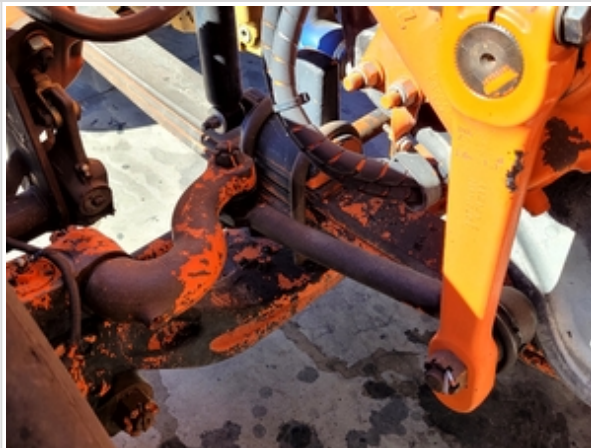
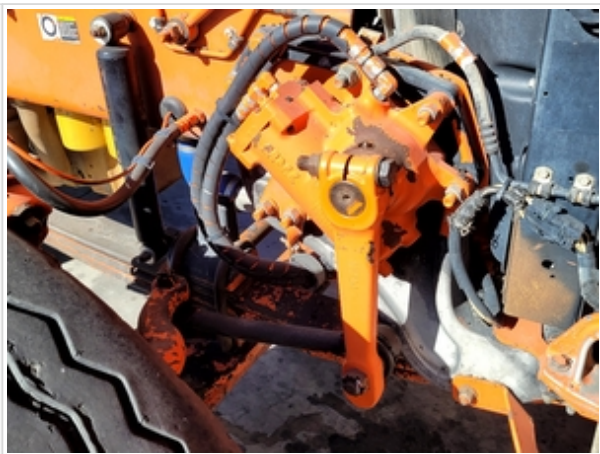
Steering Components	3
Steering Components Photos

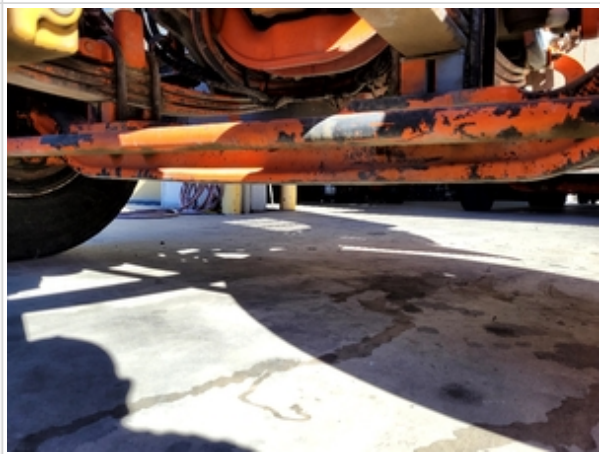
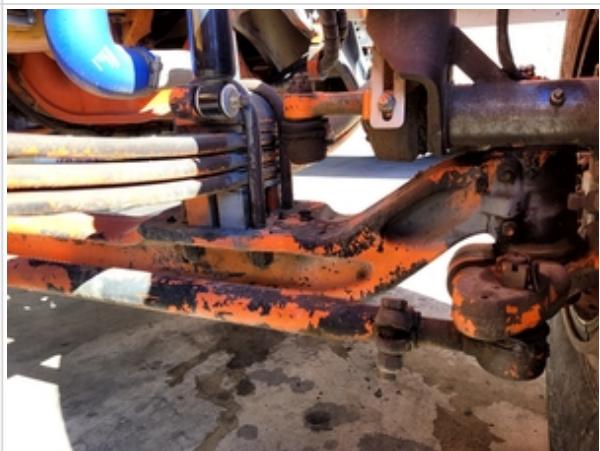
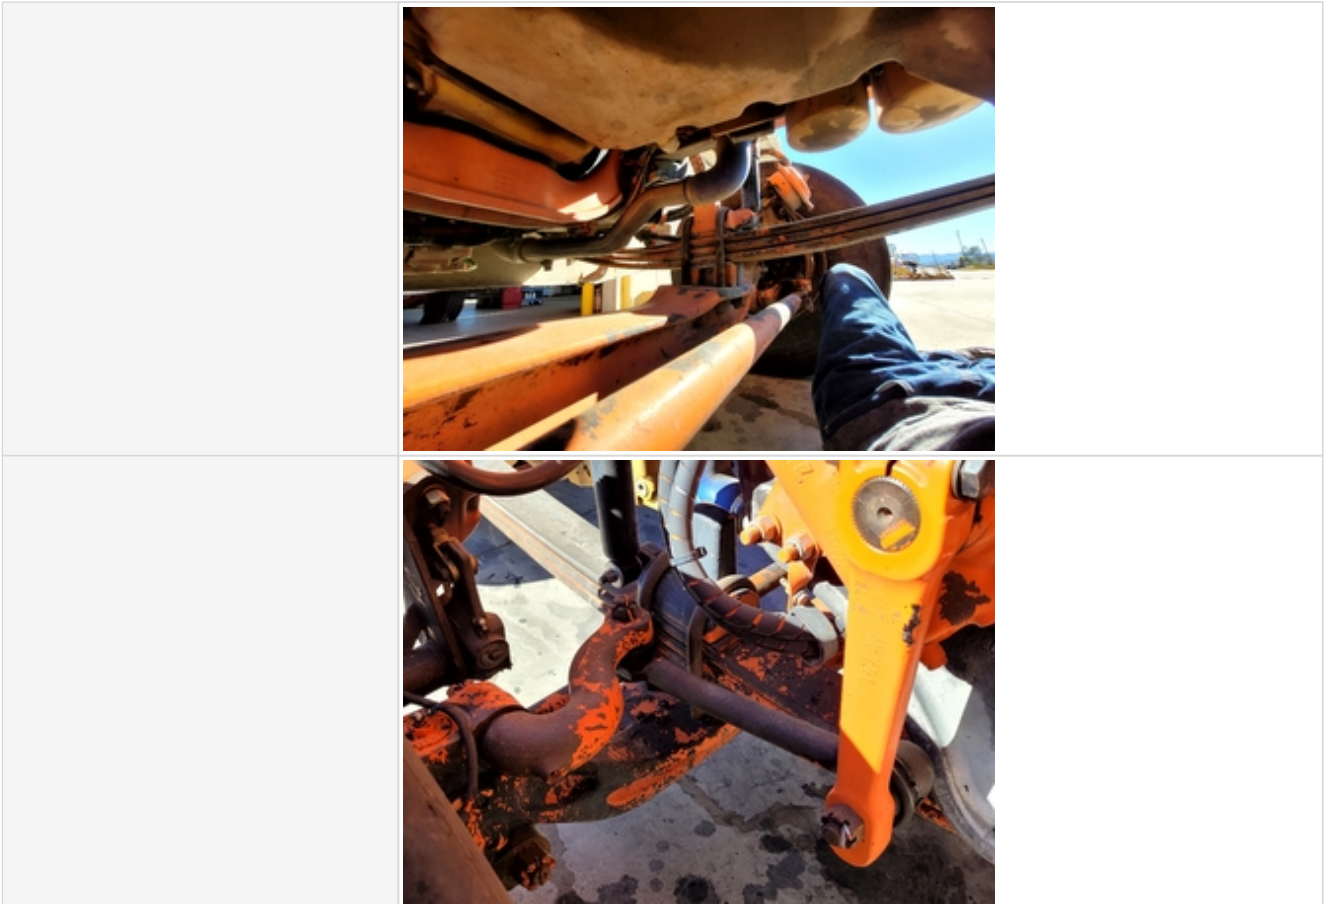
Steer Axle Condition	3	
Steer Axle Photos

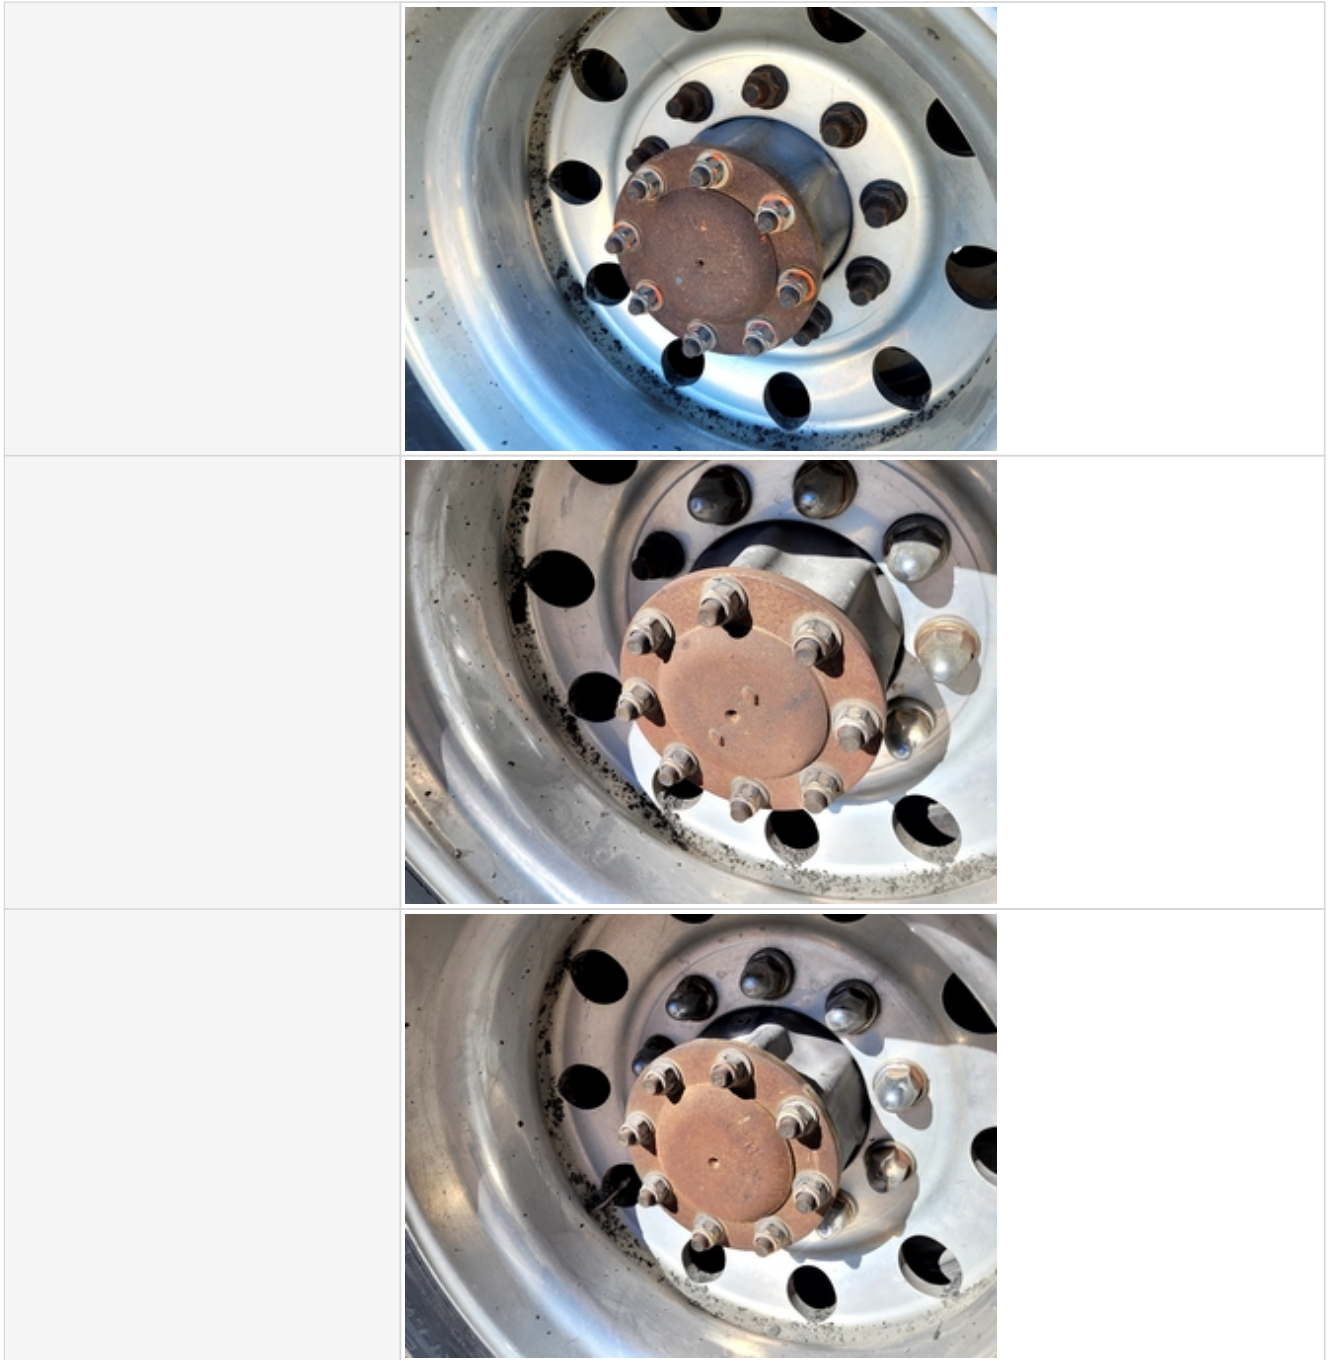
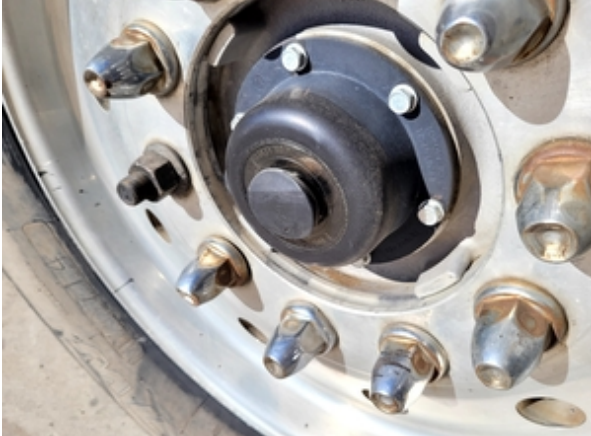
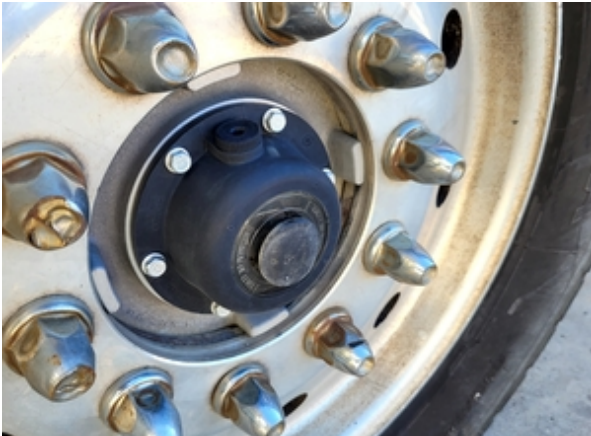
Wheels & Hub Condition	3
Wheels & Hub Photos

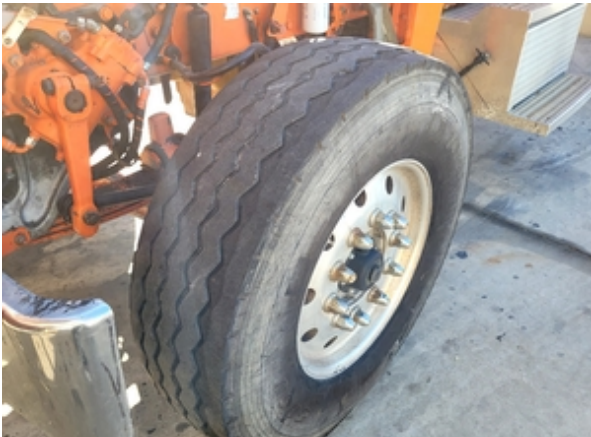
Wheel Seal Leaks	No
Tire Brand	(Front) Yokohama (Rear) Generic Recaps
Tire Size	(Front) 315/80R/22.5 (Rear) 11R22.5
Front Left Tire - Ratio Remaining	10%
Front Left Tire Photos

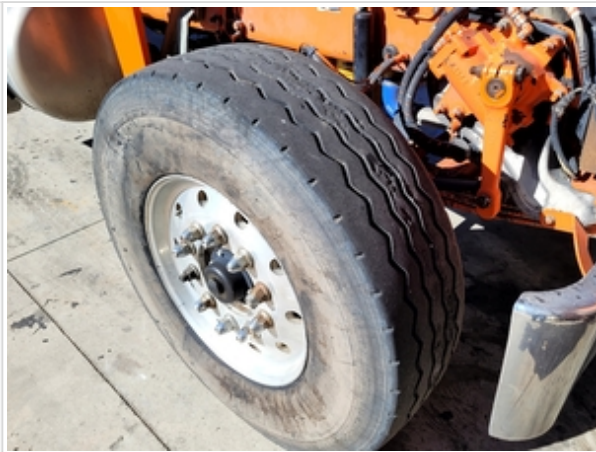
Front Right Tire - Ratio Remaining	30%

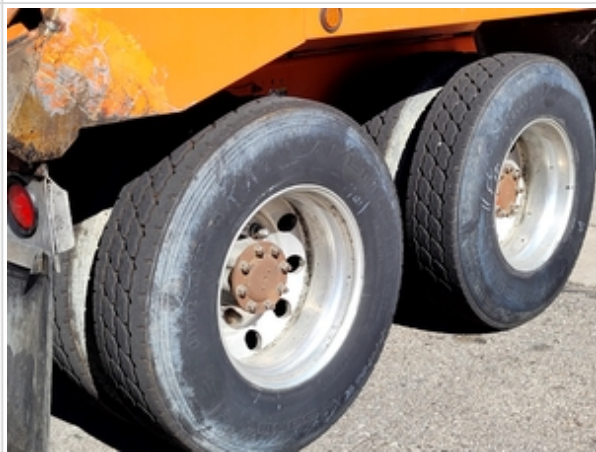
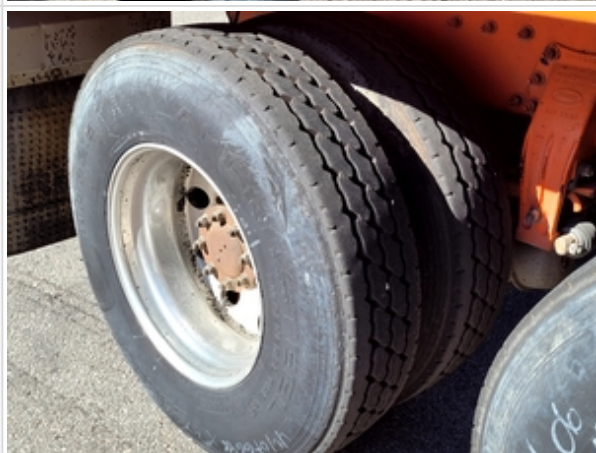
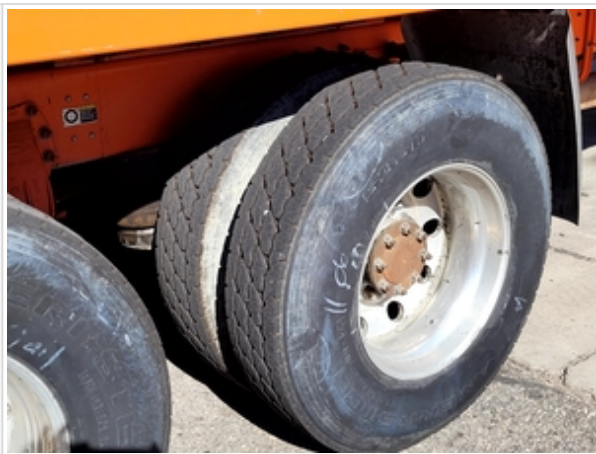
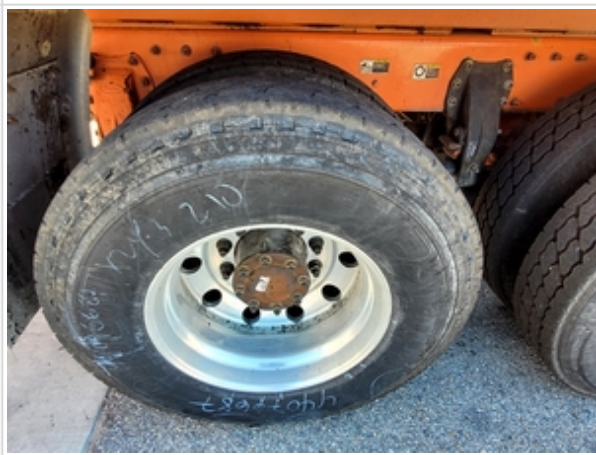
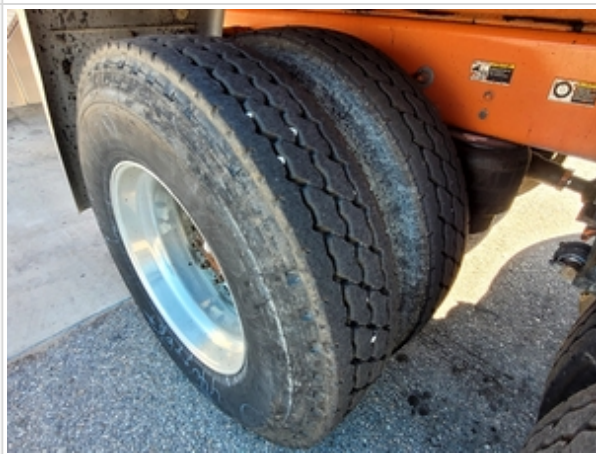
Rear Right Tire - Ratio Remaining	50%
Rear Right Tire Photos

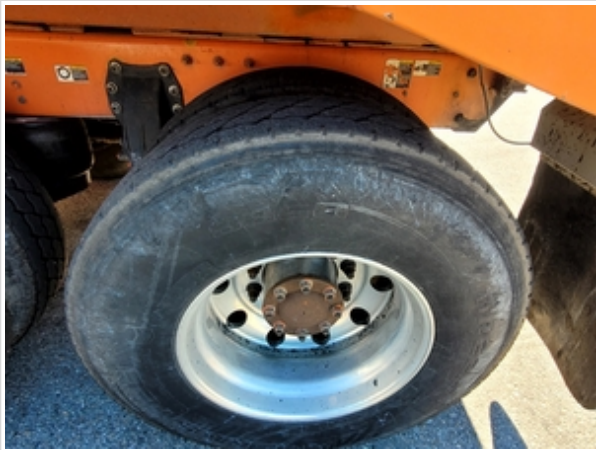
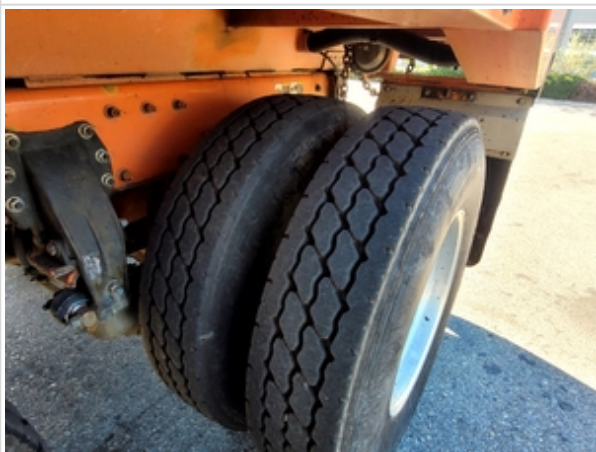
<p>Rear Left Tire - Ratio Remaining</p>	<p>50%</p>

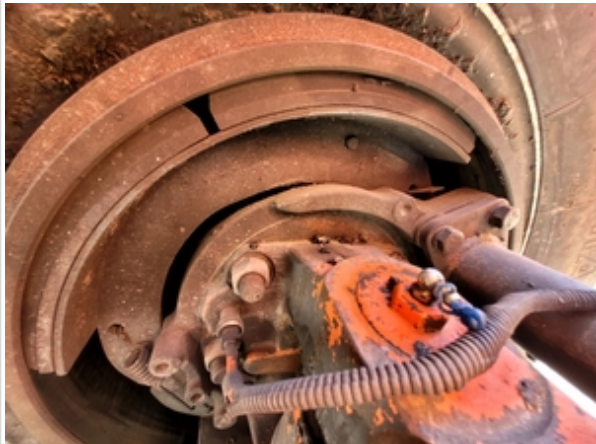
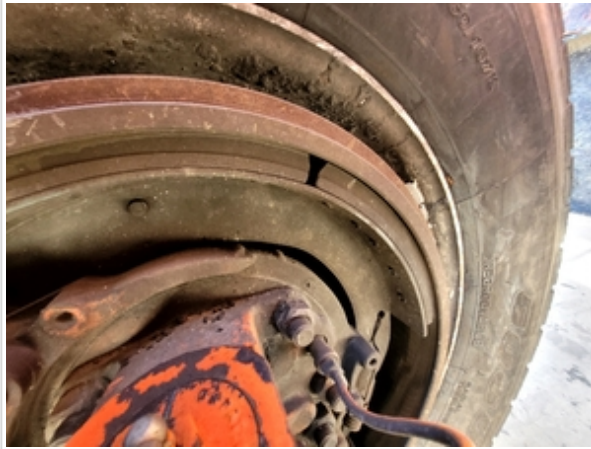
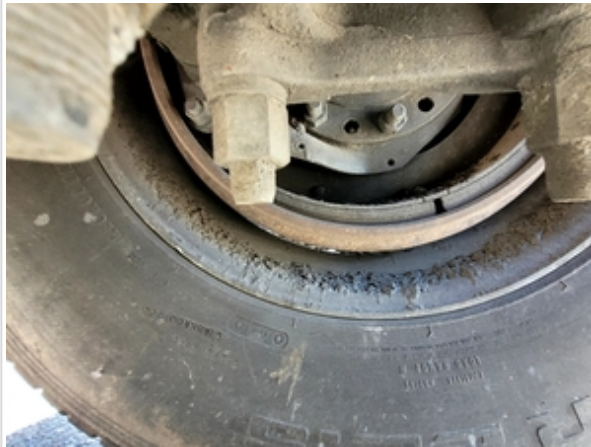
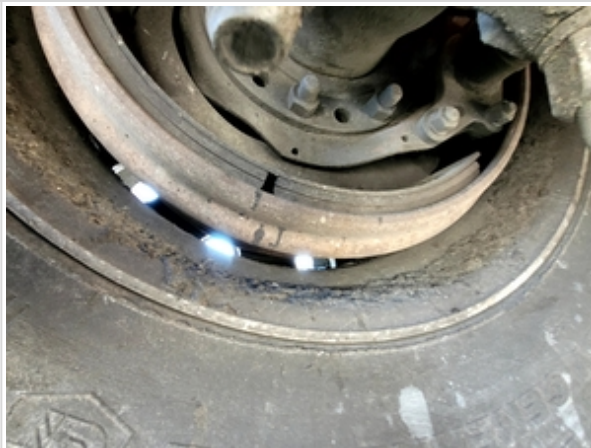
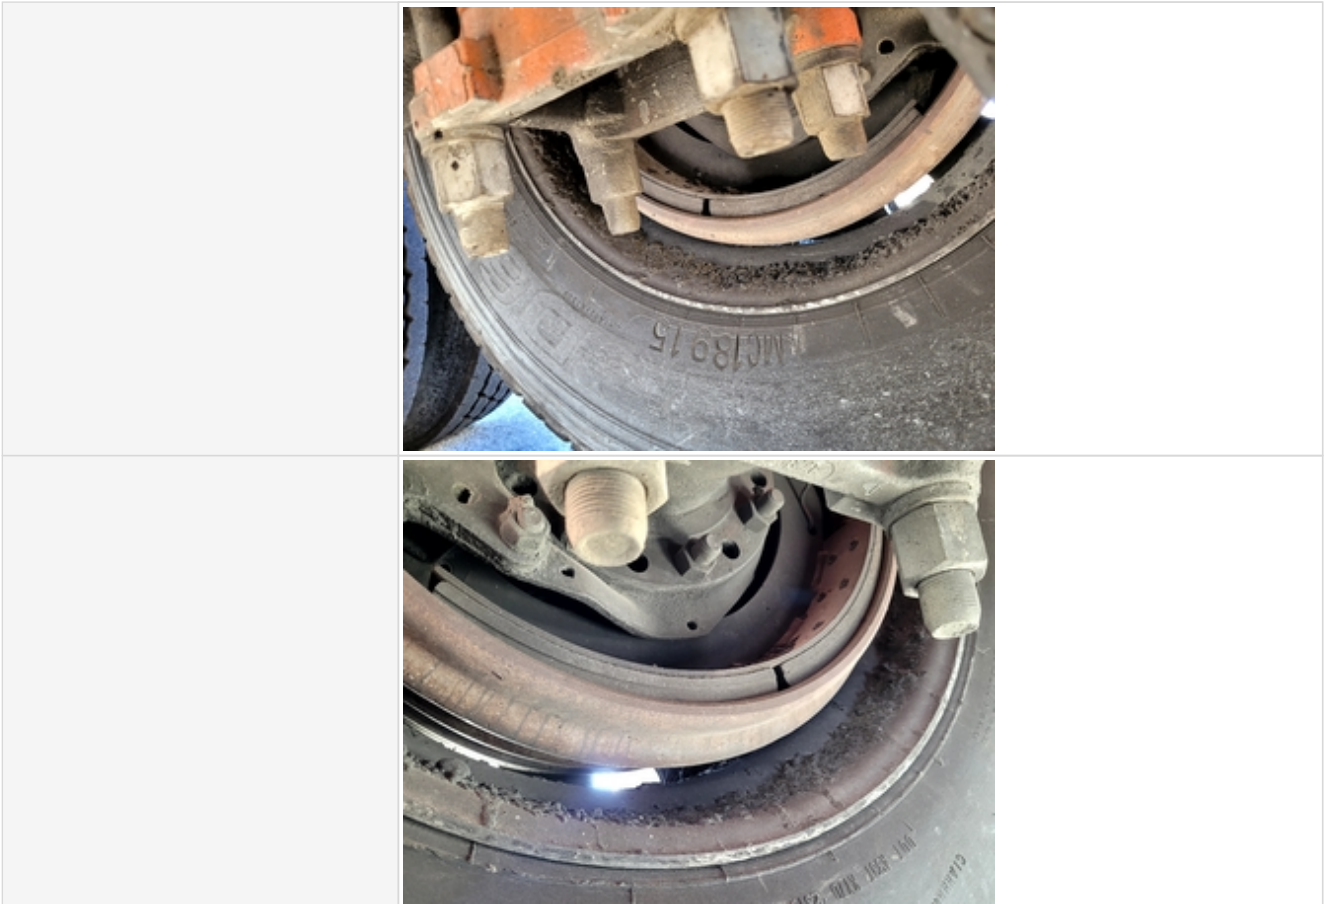
Brake Shoe Thickness	50%
Comments	Most brake shoes above 50% of brake shoe material left
Brake Shoe Photos

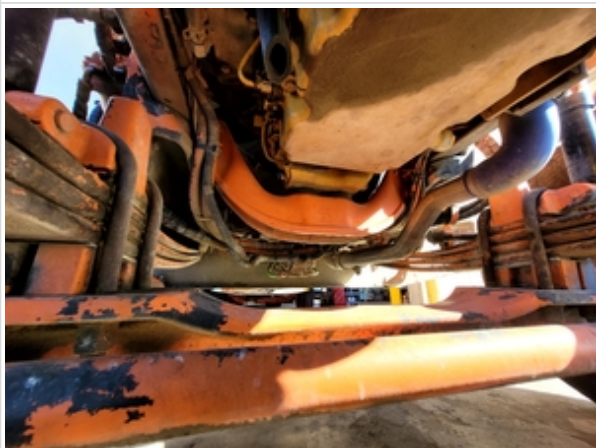
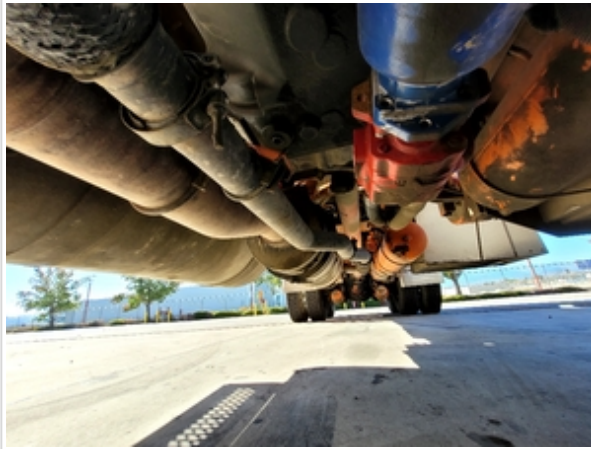
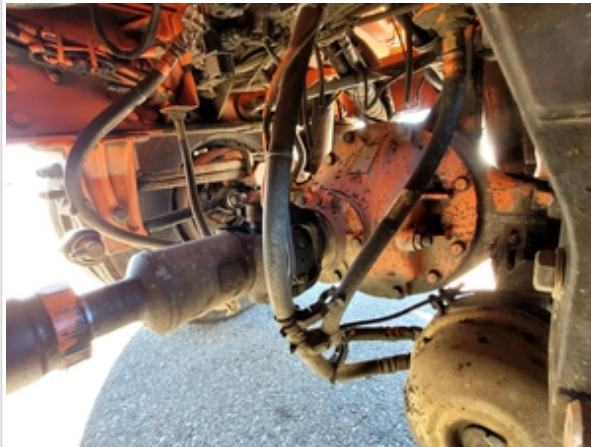
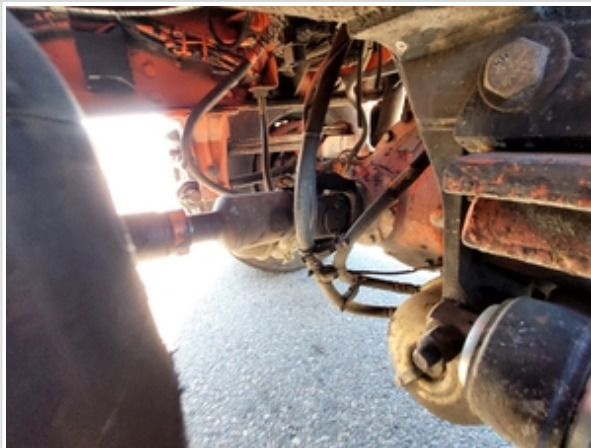
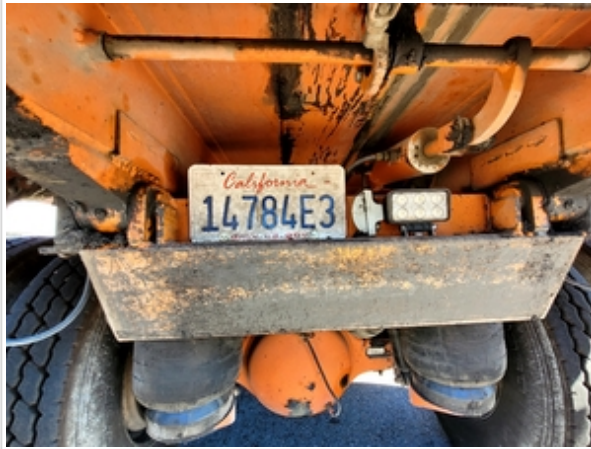
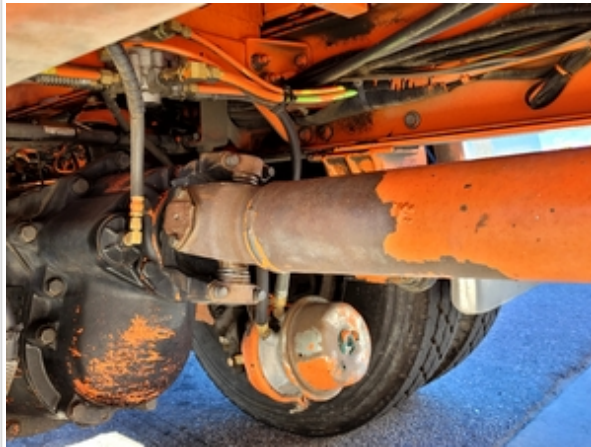
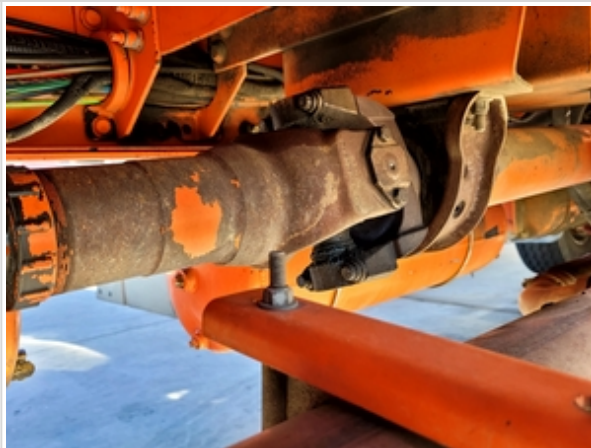
Overall Chassis	3
Overall Chassis & Undercarriage Photos
