Inspection Report (On-Highway Dump Truck)

Year	2011
Make	Peterbilt
Model	367
Serial Number	1NP - TLUOX - 8 - BD127978
Truck Odometer Reading	400,445 Mi.
Previous Application (e.g., earth moving, mining, demolition, etc)	Asphalt Construction

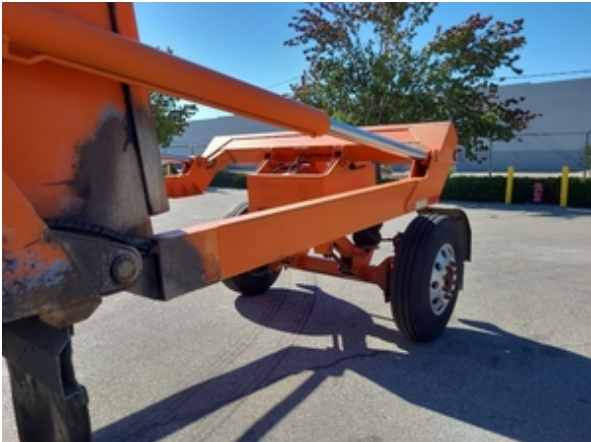
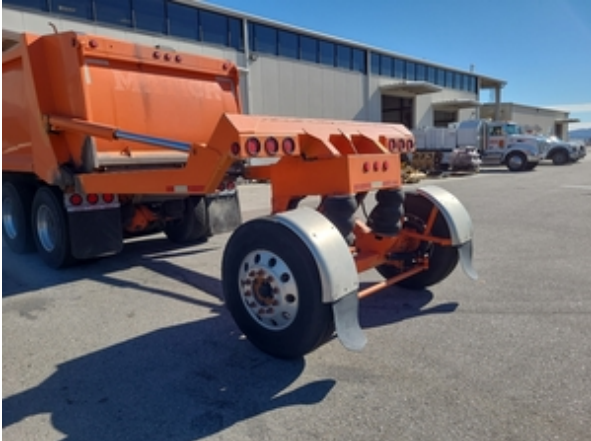
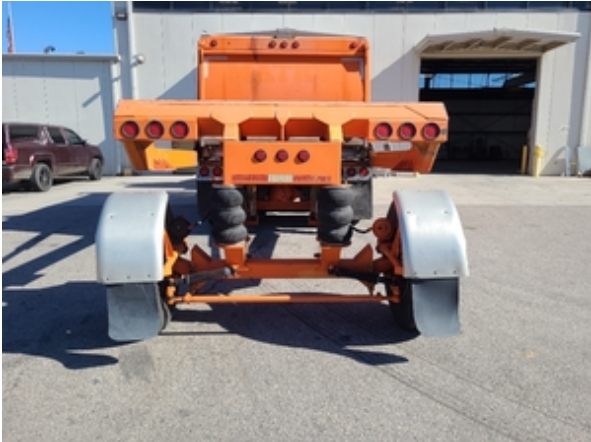
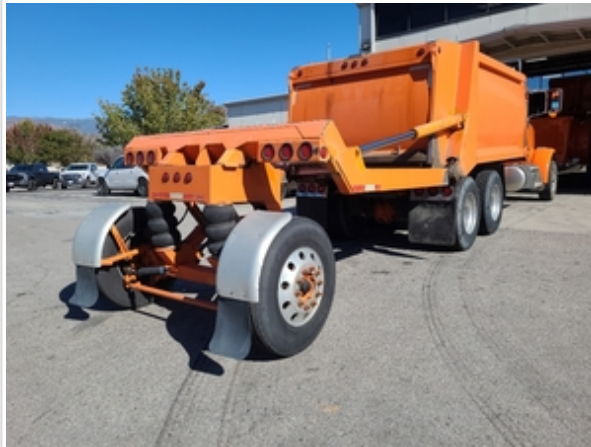
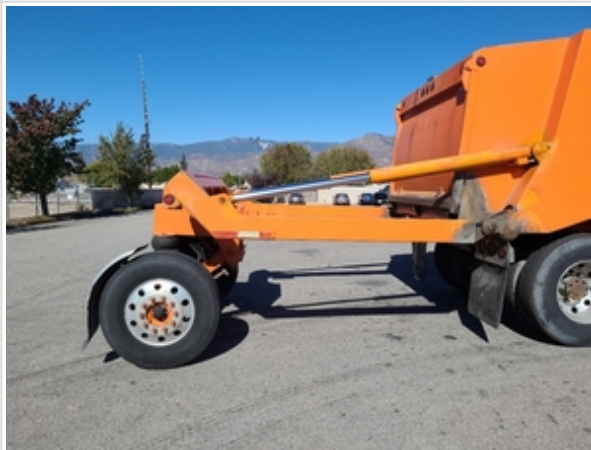
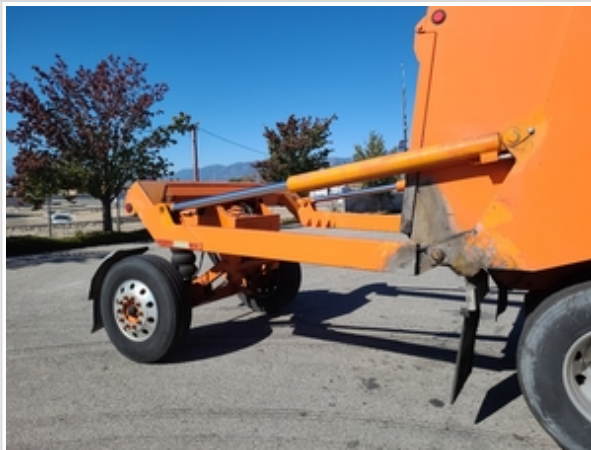
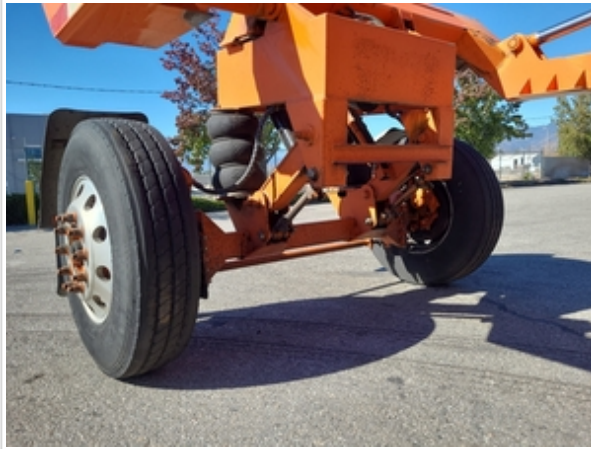
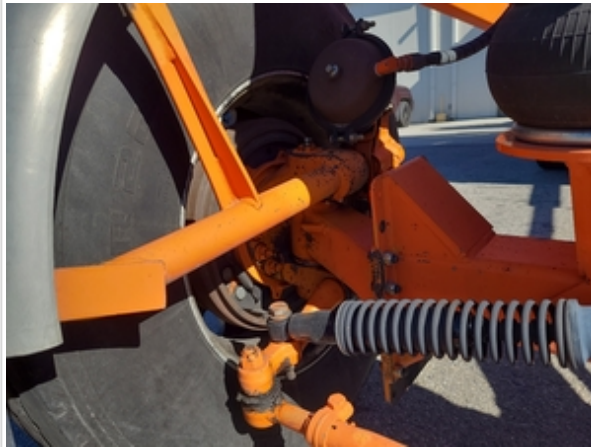
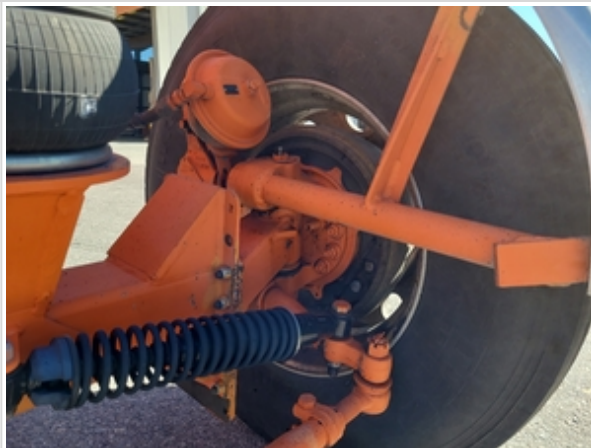
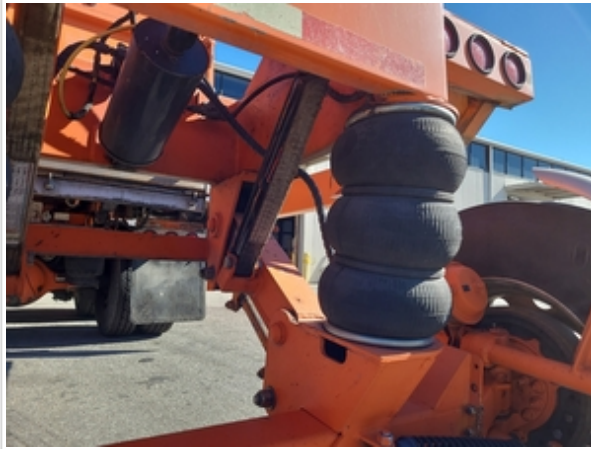
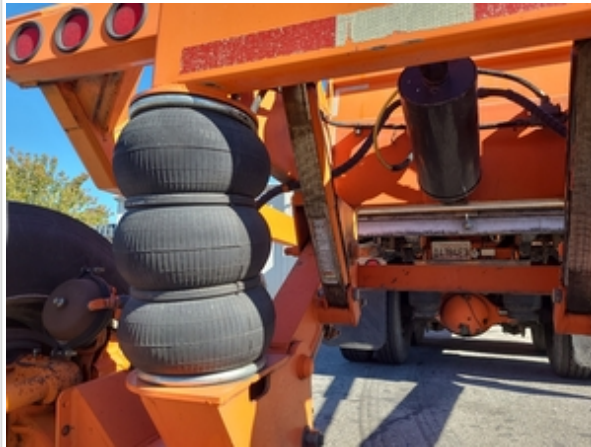
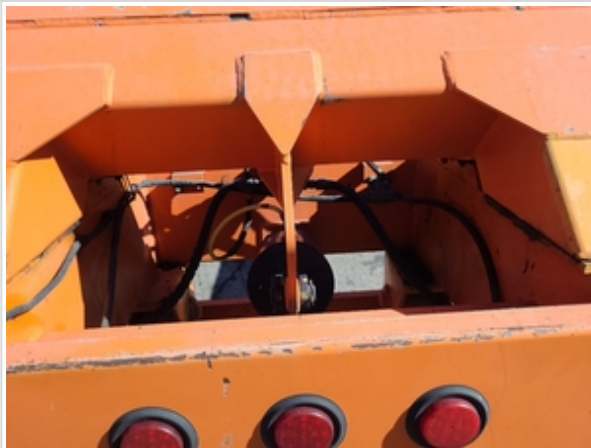
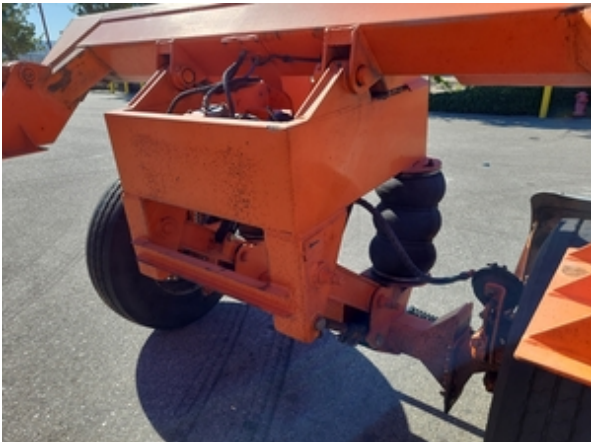
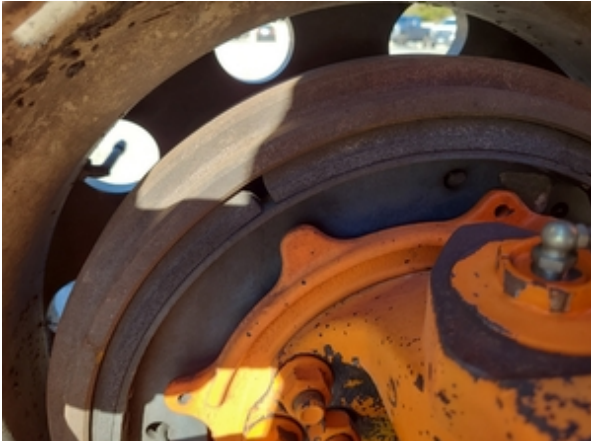
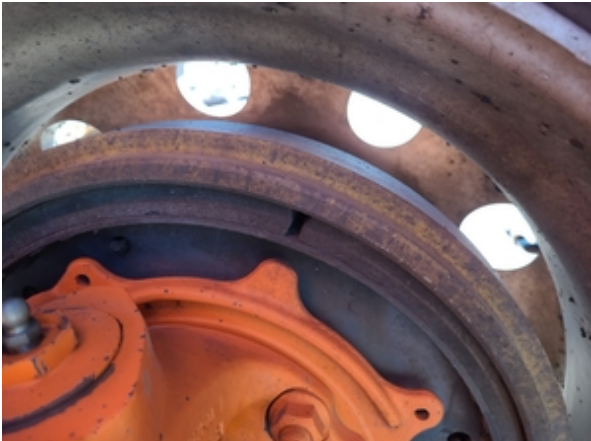
Drop Axle?	Yes
Super Dump?	Yes
Weight Rating	12,000
Axle Condition	3 - Normal Wear & Tear
Axle Condition Photos

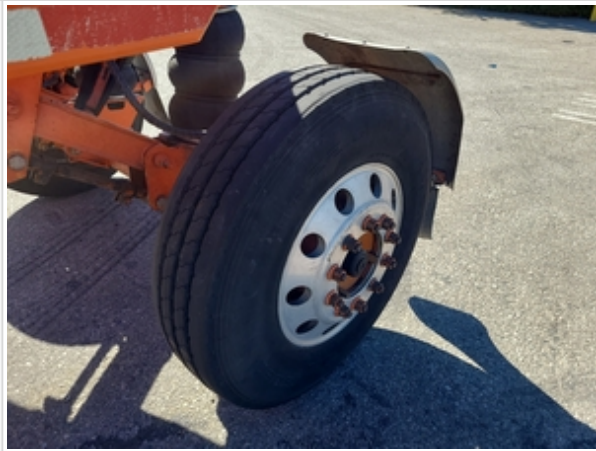
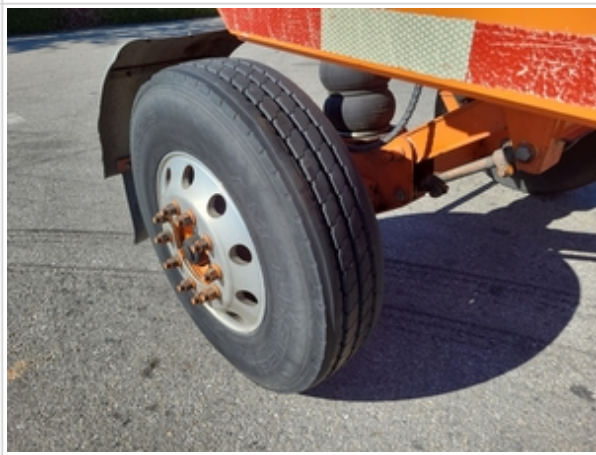
Wheels & Tires Photos

Wheels & Tires	3 - Normal Wear & Tear
Comments	tread life left above 70%

Tire Brand	Ameristeel	
Tire Size	11R22.5	
Left Tire(s) Ratio Remaining	70%	
Right Tire(s) Ratio Remaining	70%

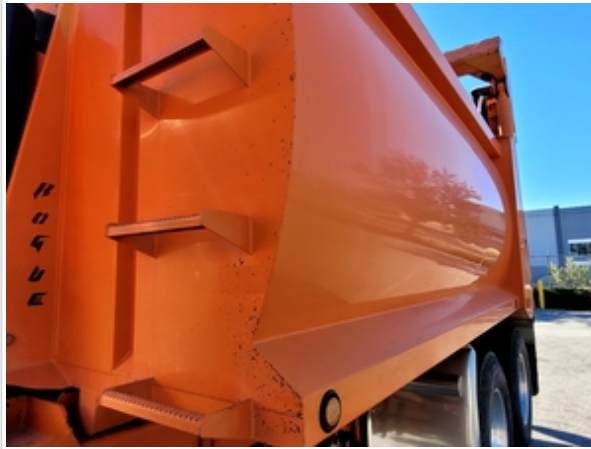
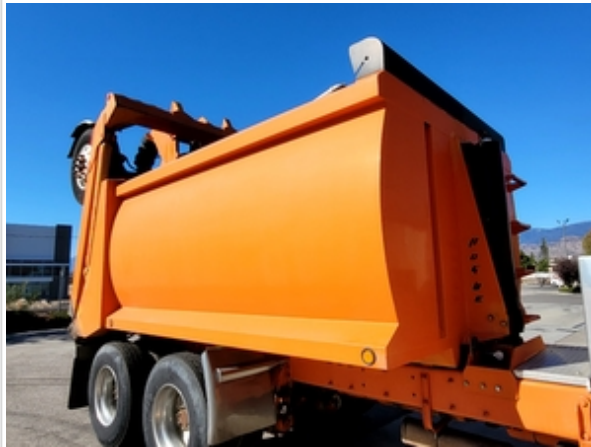
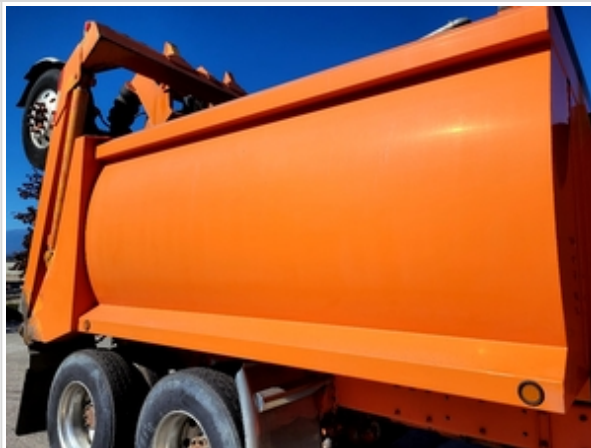
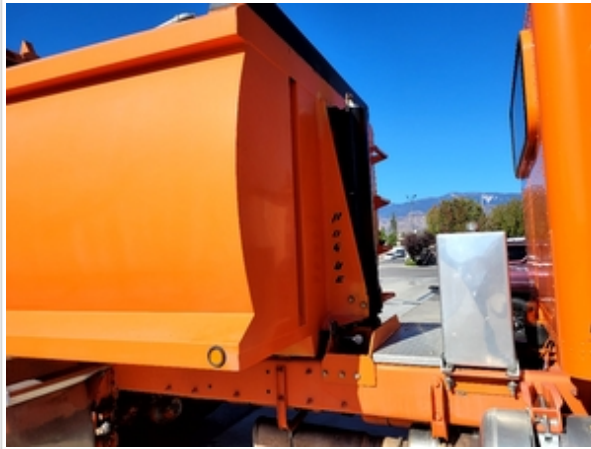
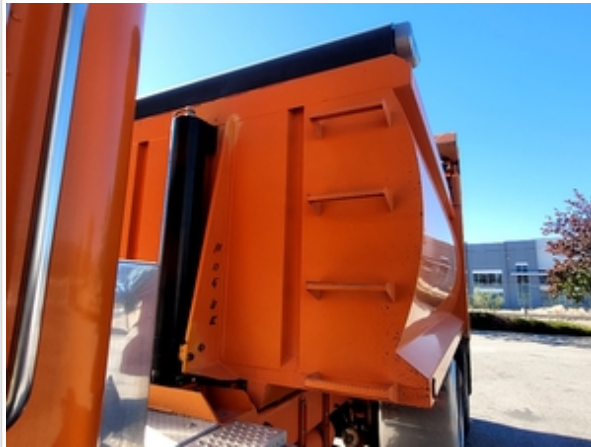
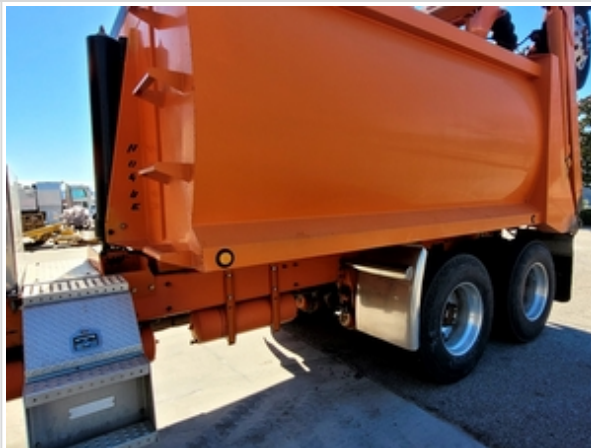
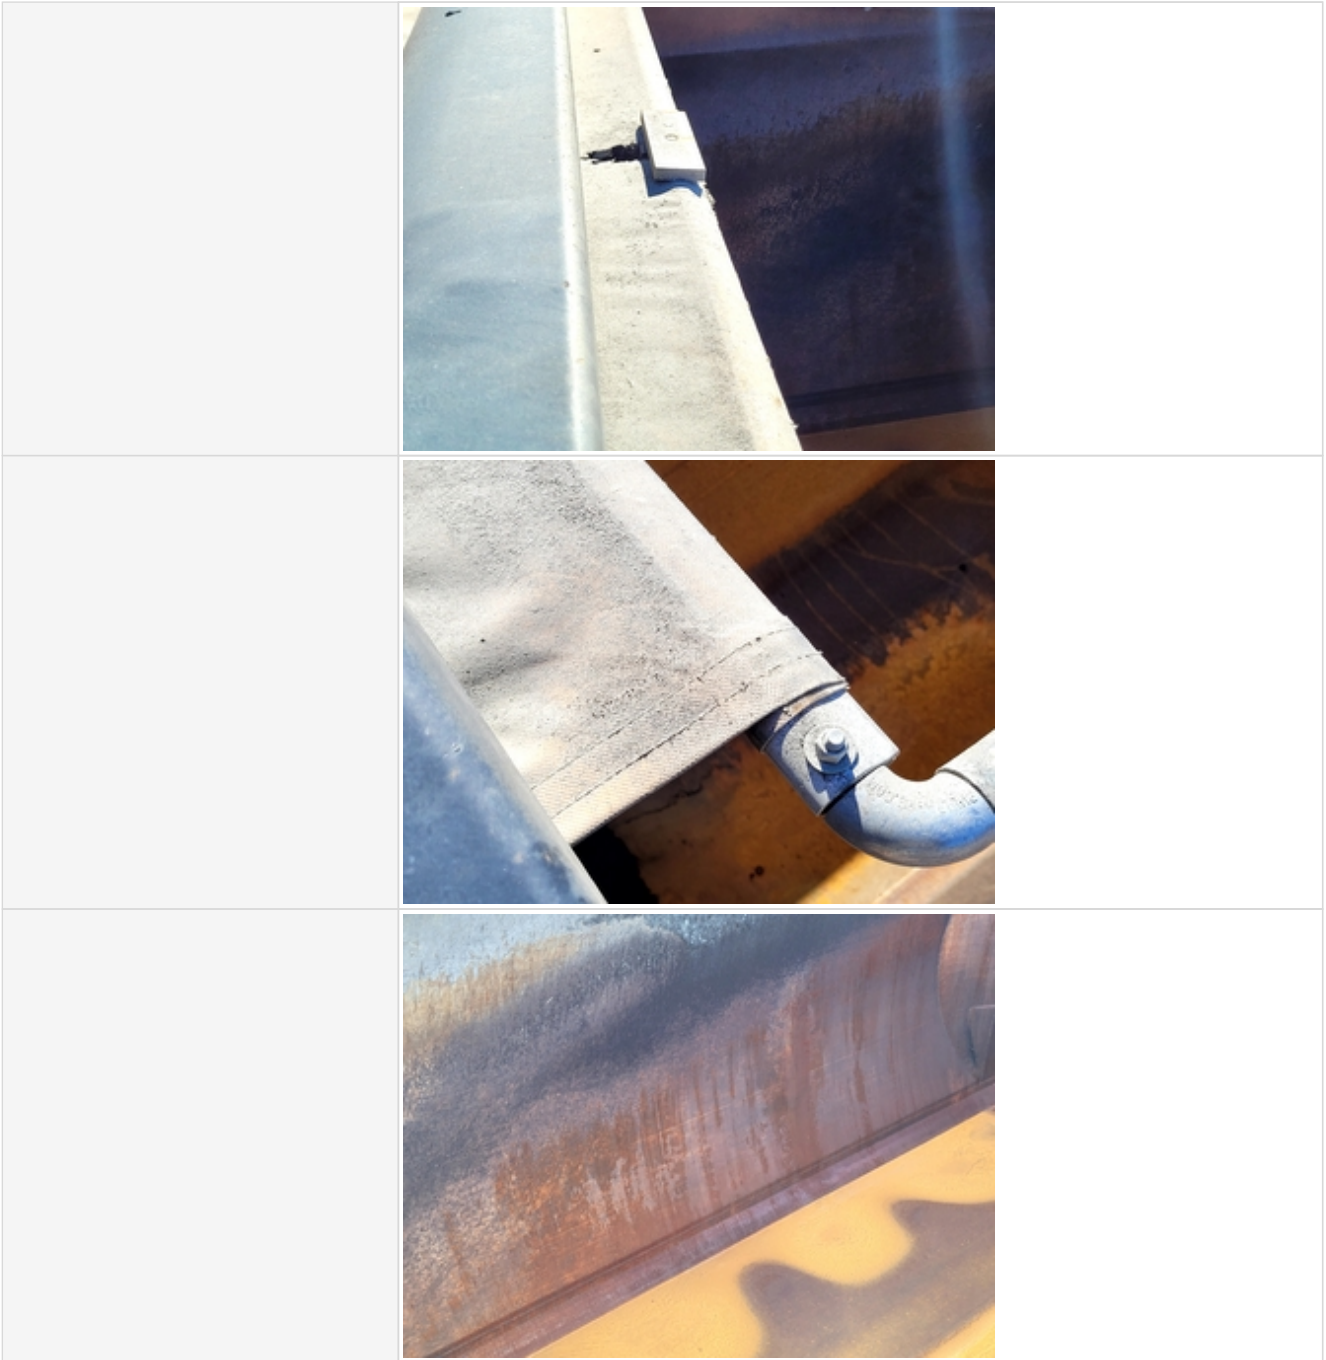
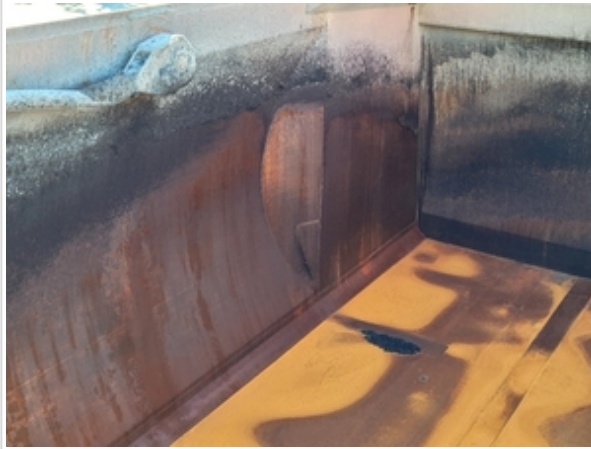
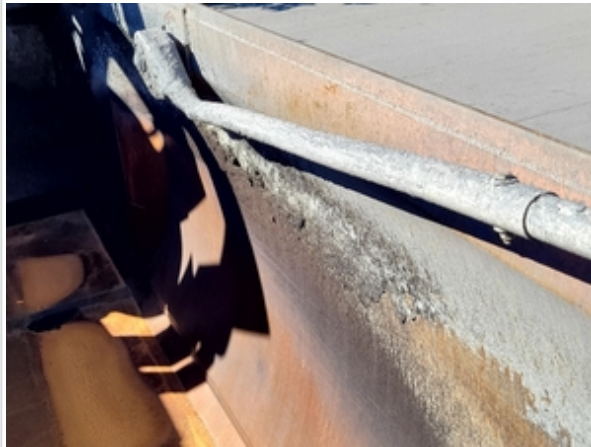
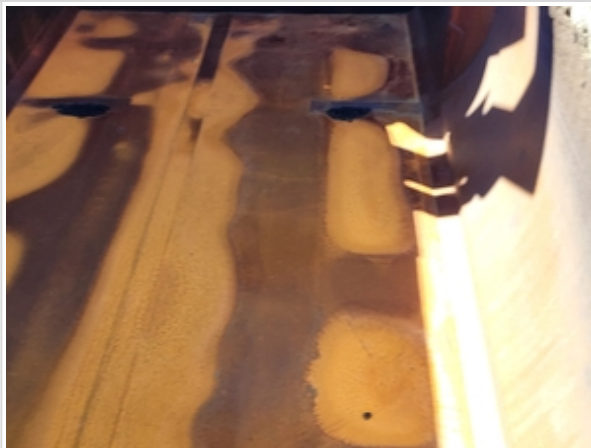
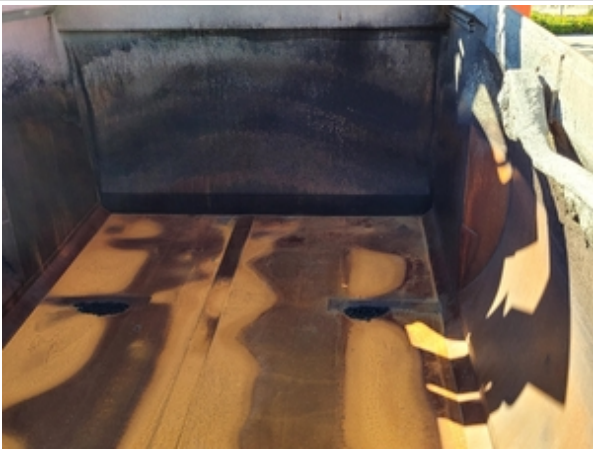
Bed Body Photos

Dump Body Make & Material	Rogue	
Dump Body Length (ft and inches)	15'	
Dump Body Height (ft and inches)	5'3"	
Bed Body	3 - Normal Wear & Tear

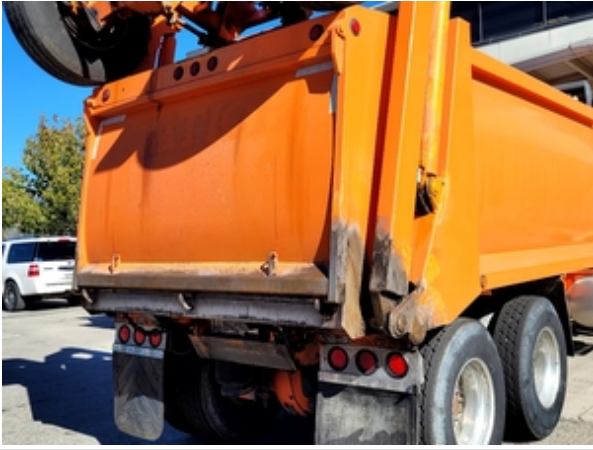
<p>Tailgate</p>	<p>3 - Normal Wear & Tear</p>	
<p>Tailgate Photos</p>

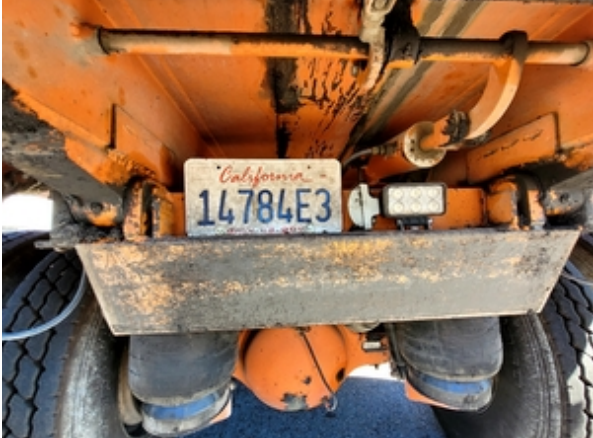
<p>Tailgate Latch</p>	<p>3 - Normal Wear & Tear</p>	
<p>Tailgate Latch Photos</p>

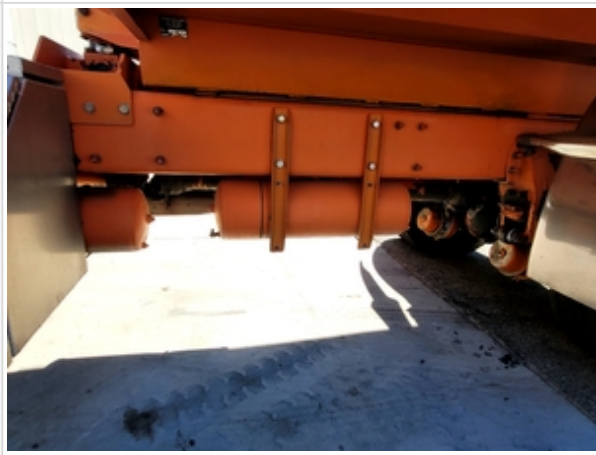
Support Frame	3 - Normal Wear & Tear	
Support Frame Photos

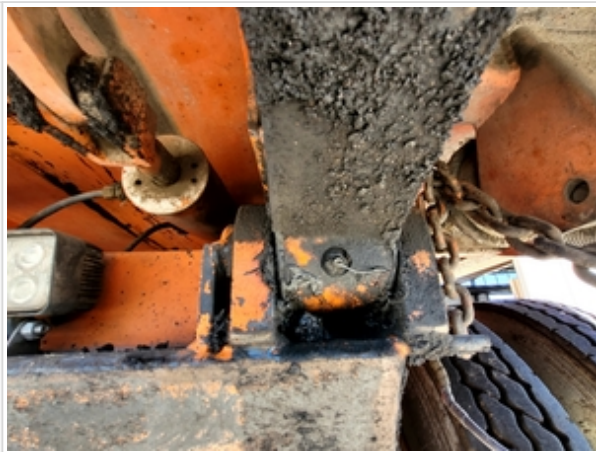
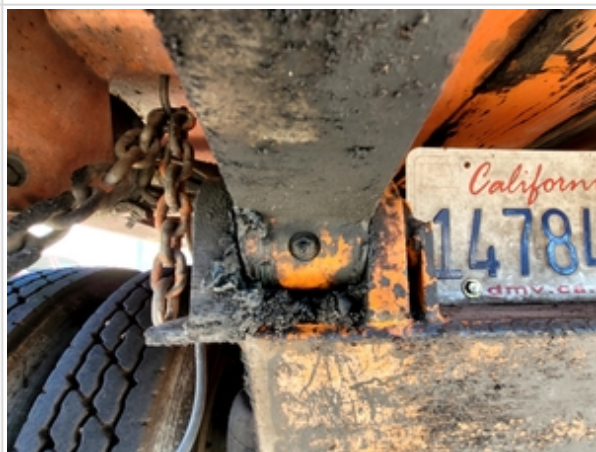
Hinge Point Photos

Hinge Points	3 - Normal Wear & Tear

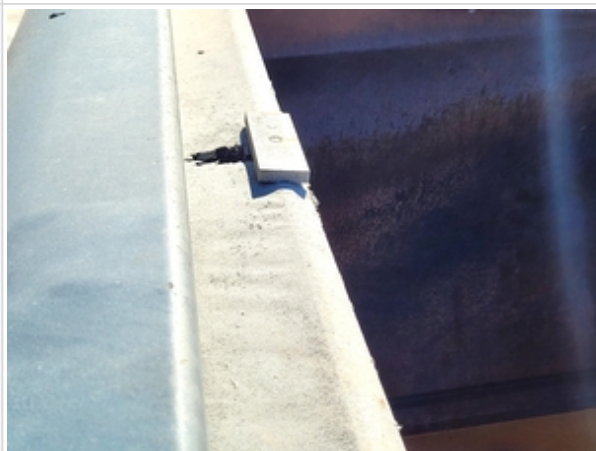
Tarp	3 - Normal Wear & Tear
Tarp Photos

Forward & Reverse	3 - Normal Wear & Tear
Steering	3 - Normal Wear & Tear
Engine	3 - Normal Wear & Tear
Controls	3 - Normal Wear & Tear
Overall Functional Test Comments	Overall all functions operate well. The dump body raises and lowers normally. The strong arm axle operates great. The tarp assembly works well.

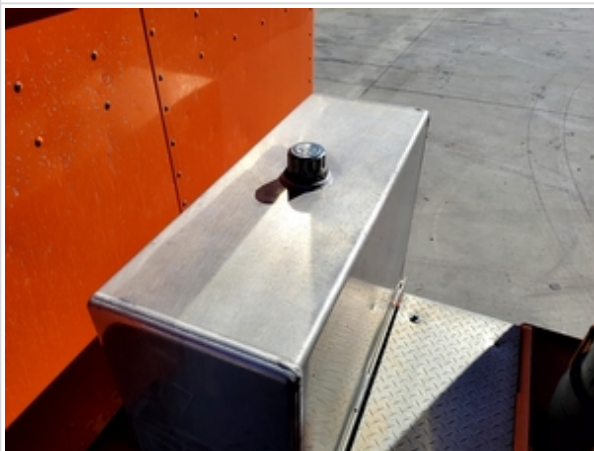
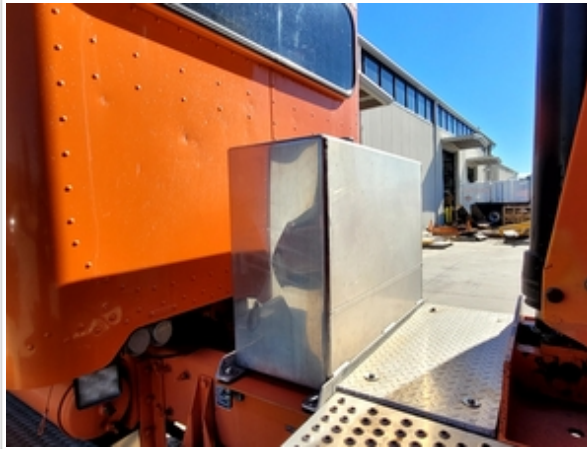
Hydraulics	Check the condition of the hydraulics. Check lines, hoses, fittings, leaks, function, etc. Note any damage or wear. Take photos.
Hydraulic Tank	3 - Normal Wear & Tear
Hydraulic Tank Photos
