## Inspection Report (Mini Excavator)

| Make | Bobcat |
| Model | 324M |
| Serial Number | AKY522295 |

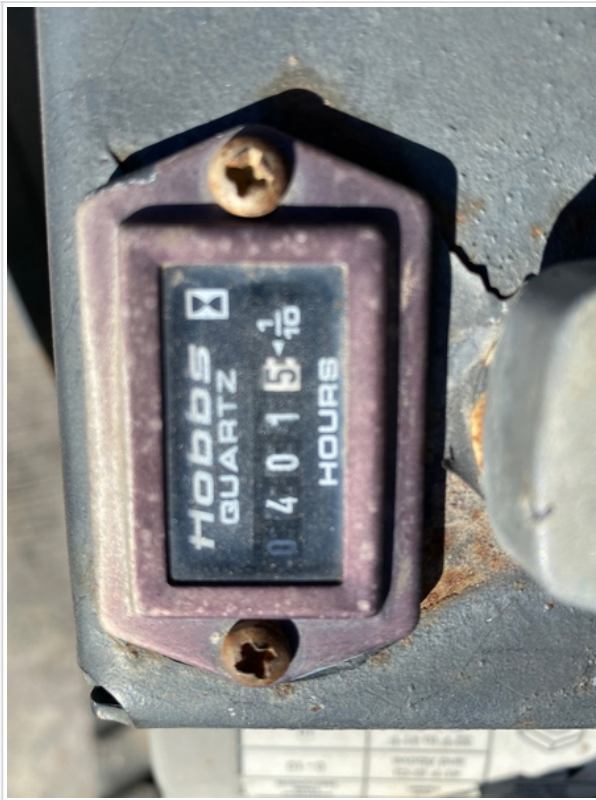
| <p>Hour Meter Activity Photos</p> | |

| <b>Hour Meter Condition</b> | Hour meter is functional and in good condition |

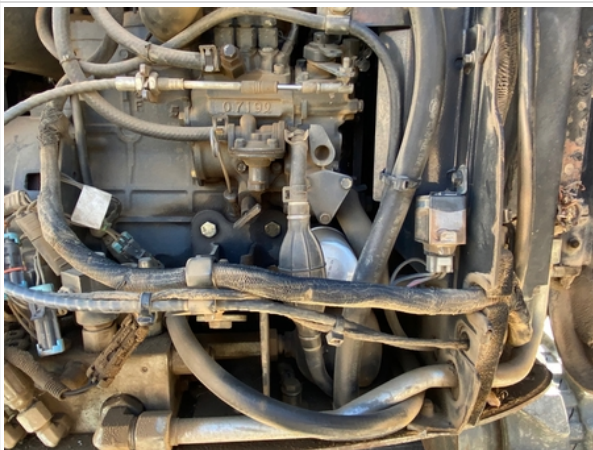
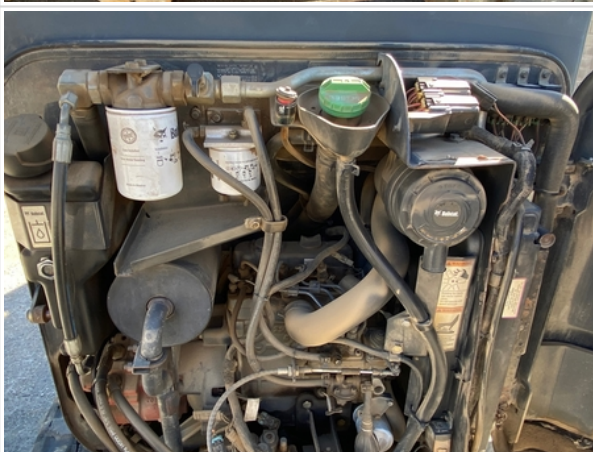
| Engine Photos | |

| <b>Overall Engine Comments</b> | Overall engine in good condition. No obvious major problems observed with engine components. |

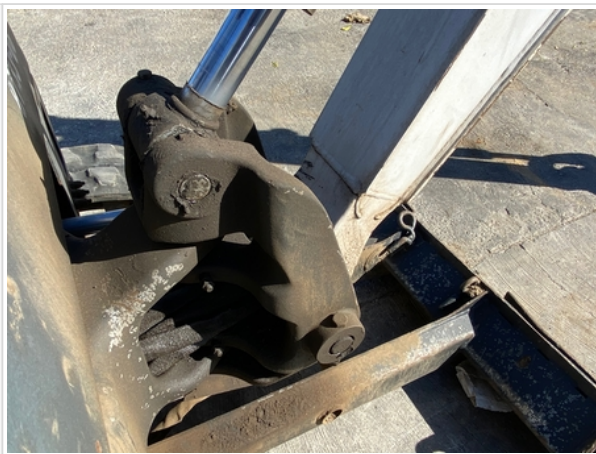
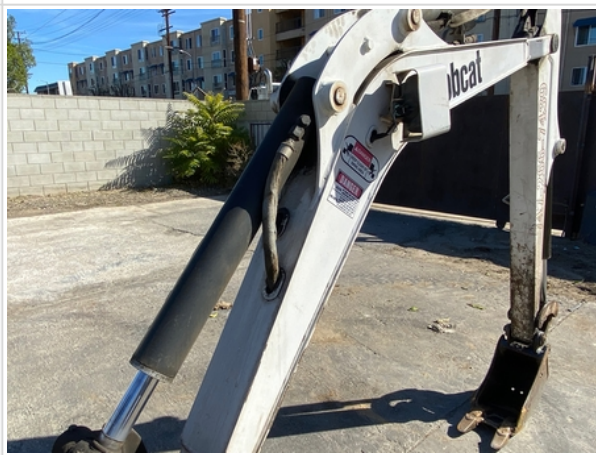
| Boom Photos | |

| Boom Condition | 3 - Normal Wear & Tear |

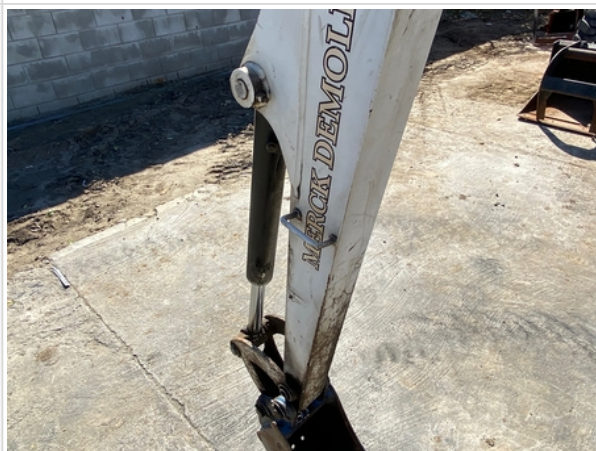
| <p><b>Stick Photos</b></p> | |

| <p><b>Stick Condition</b></p> | <p>3 - Normal Wear &amp; Tear</p> |

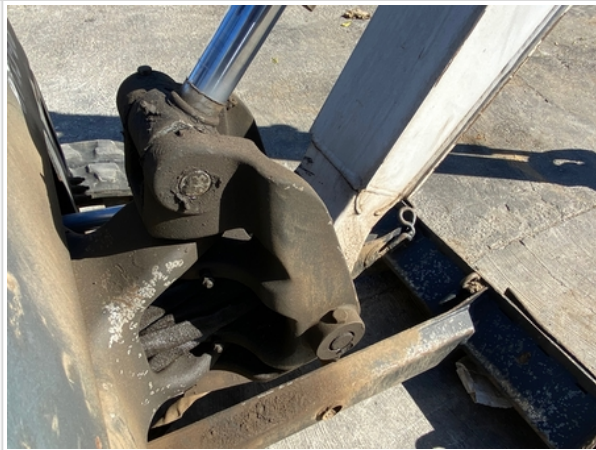
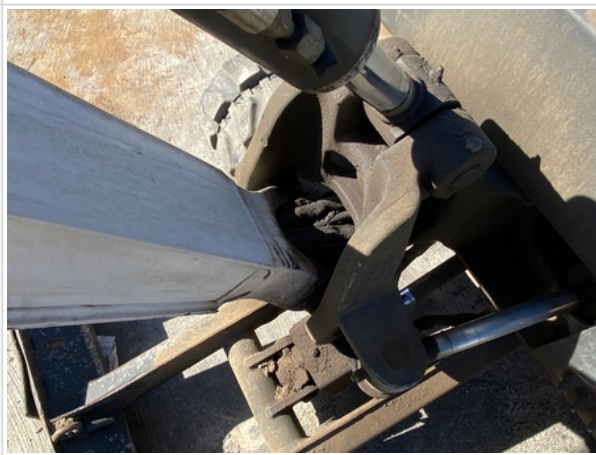
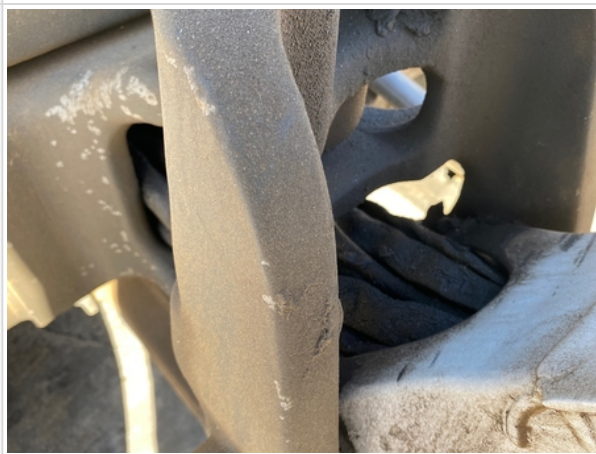
| <p>Boom Base Pin &amp; Bushings<br/>Photos</p> | | |

3 - Normal Wear & Tear

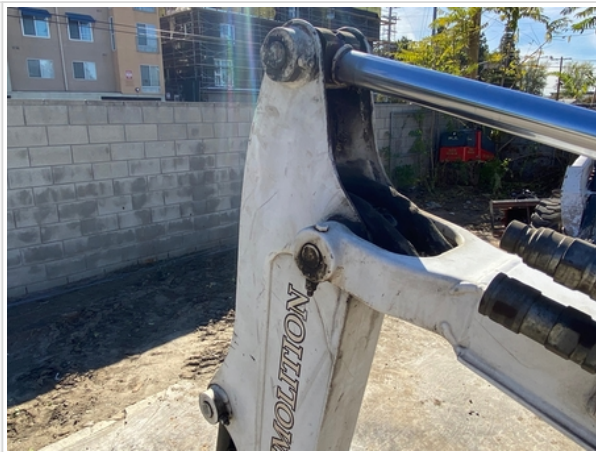
| <p><b>Boom to Stick Pin &amp; Bushings Photos</b></p> | |

| <p>Boom to Stick Pin &amp; Bushings</p> | <p>3 - Normal Wear &amp; Tear</p> | |

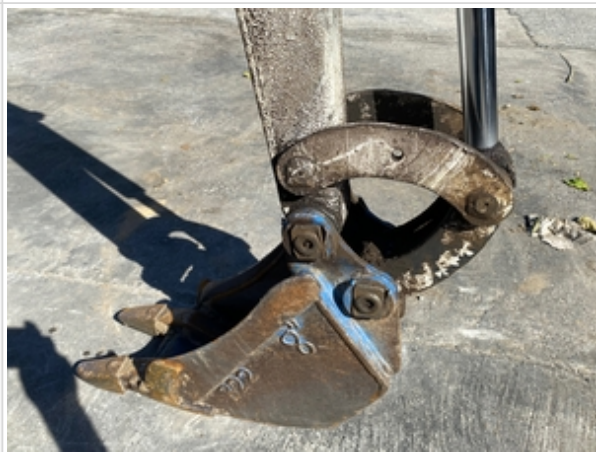
| <p><b>Stick to Bucket Pin &amp; Bushings Photos</b></p> | |

| <p><b>Stick to Bucket Pin &amp; Bushings</b></p> | <p>3 - Normal Wear &amp; Tear</p> |

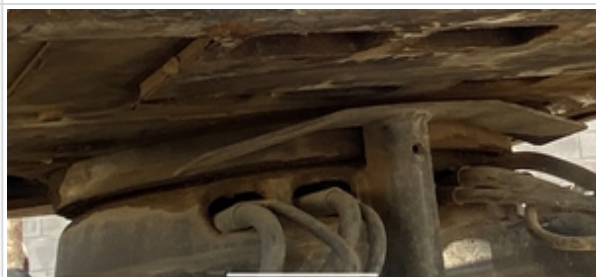
| <p><b>Turntable Bearing Photos</b></p> | |

| <p><b>Turntable Bearing Photos</b></p> | <p>3 - Normal Wear &amp; Tear</p> |

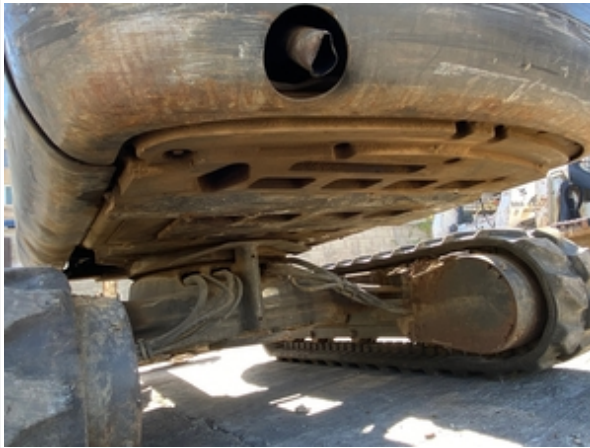
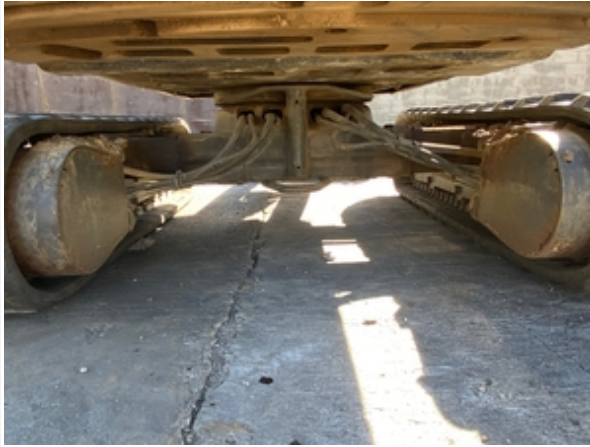
| <b>Bottom Covers Photos</b> | | |

| <b>Bottom Covers</b> | 3 - Normal Wear & Tear | |

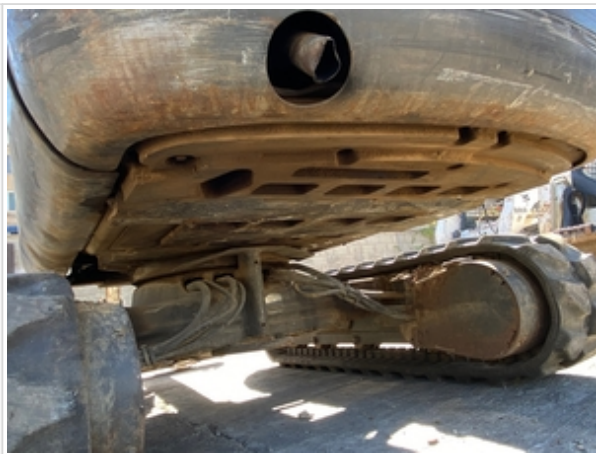
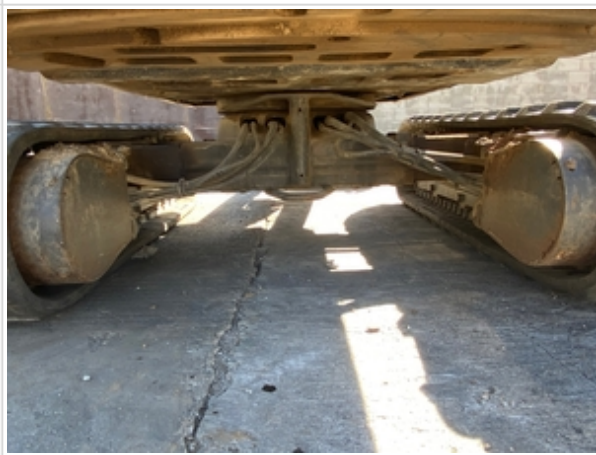
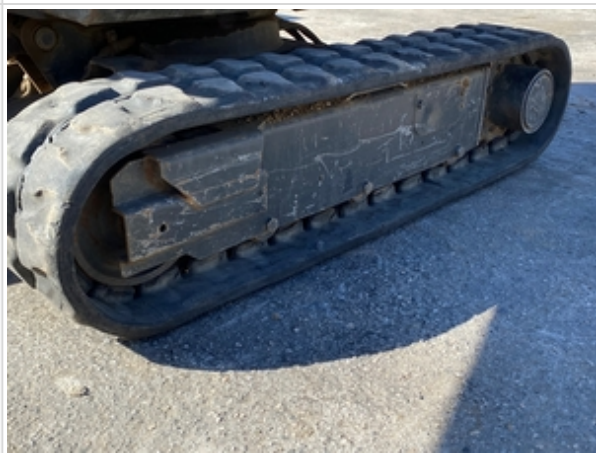
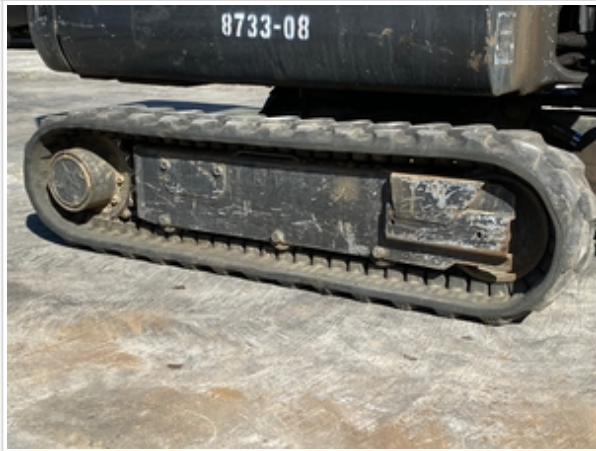
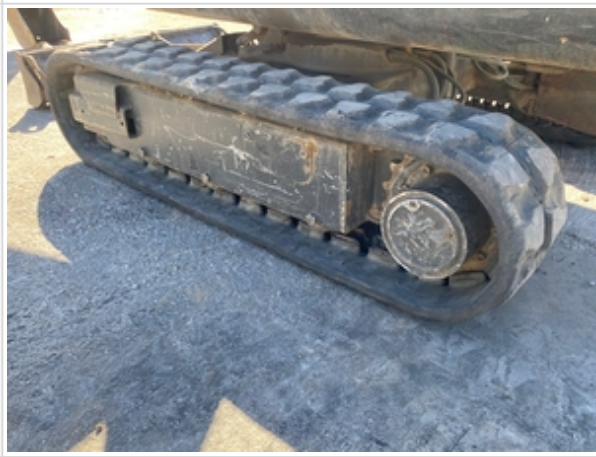
| <p>Roller Frames Photos</p> | | |

| <b>Roller Frames</b> | 3 - Normal Wear & Tear |

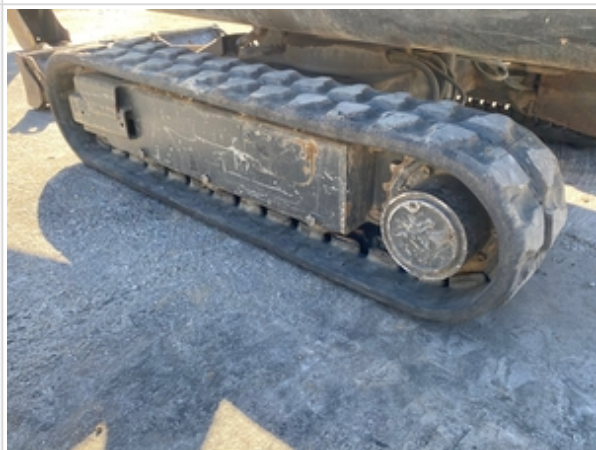
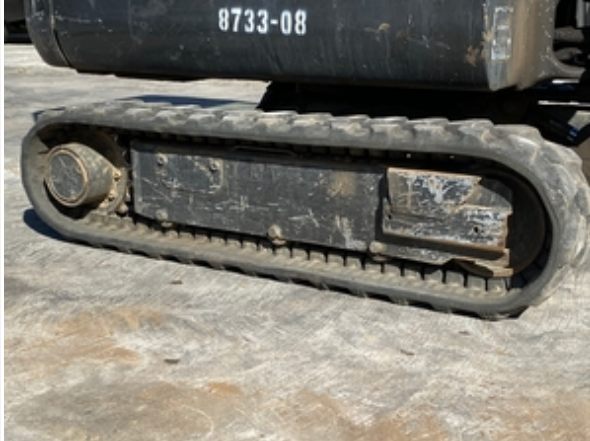
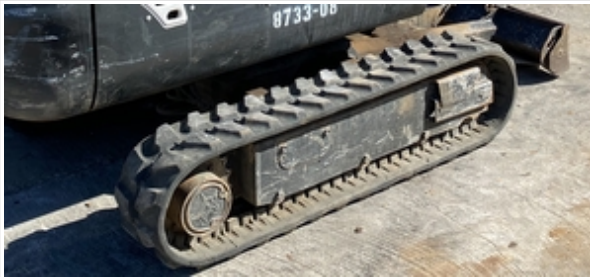
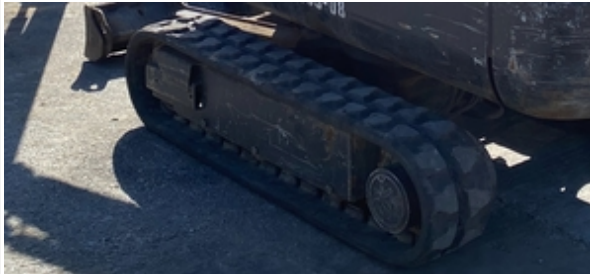
| <b>Track Belt Photos</b> | |

| <b>Track Belt</b> | 3 - Normal Wear & Tear |
| <b>Comments</b> | Track belts above 60% of tread life left |

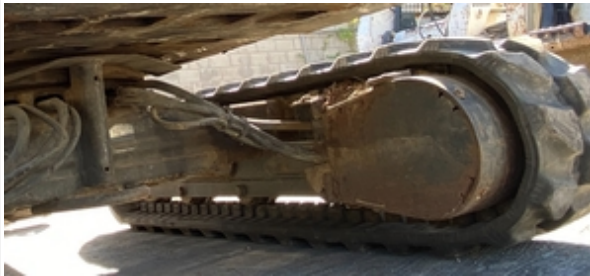
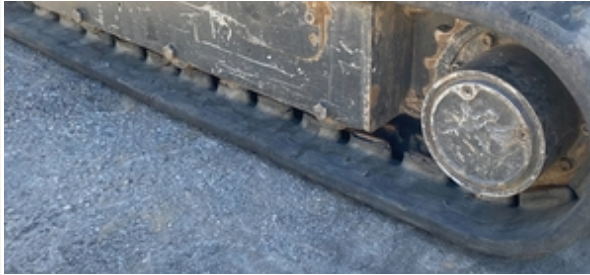
| <b>Rubber Belt Drive Lugs Photos</b> | | |

| <b>Rubber Belt Drive Lugs</b> | 3 - Normal Wear & Tear | |

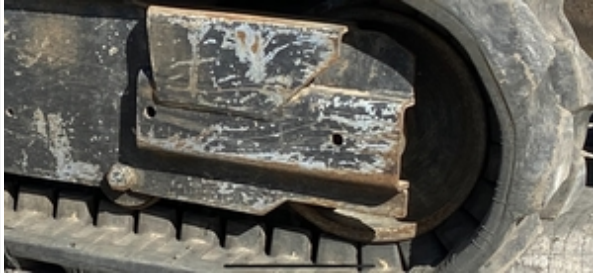
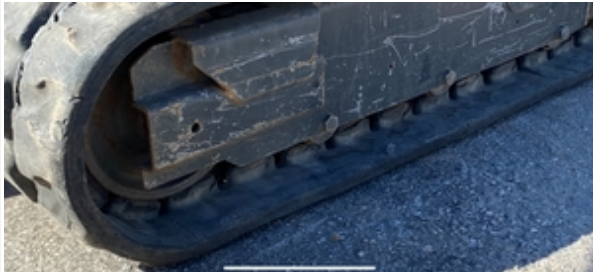
| Front Idlers Photos | |

| <b>Front Idlers</b> | 3 - Normal Wear & Tear | |

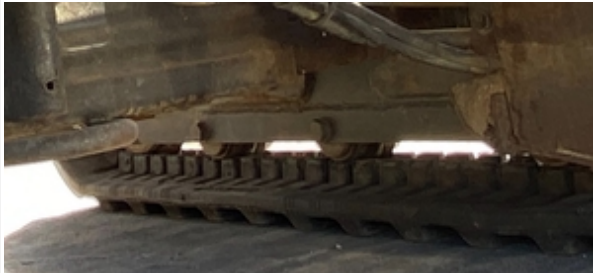
| Track Rollers Photos | |

| Track Rollers | 3 - Normal Wear & Tear |

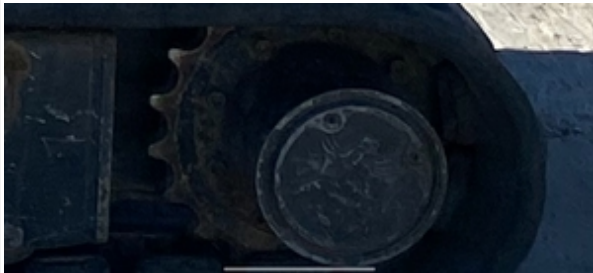
| Sprockets Photos | |

| Sprockets | 3 - Normal Wear & Tear |

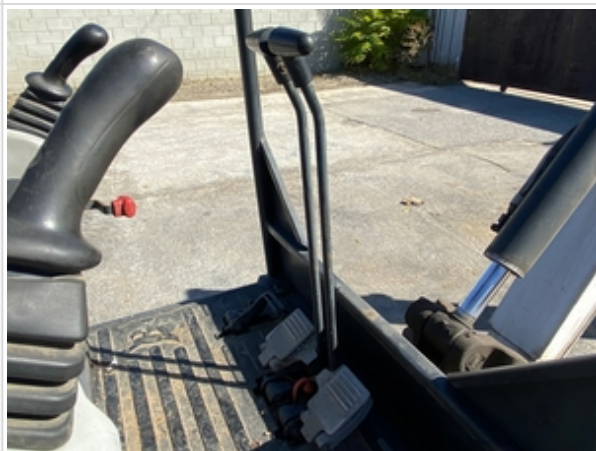
| <b>External Controls / Levers Photos</b> | | |

| <b>External Controls / Levers</b> | 3 | |
| <b>External Controls / Levers Condition</b> | Good function & condition of hydraulic controls | |

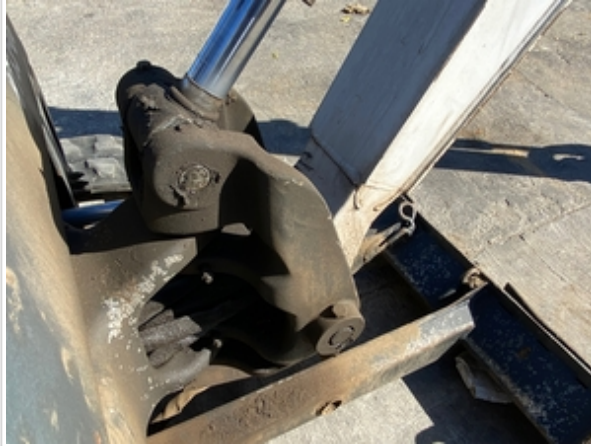
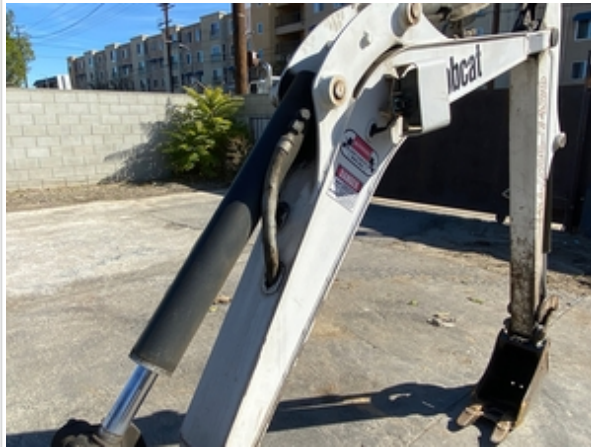
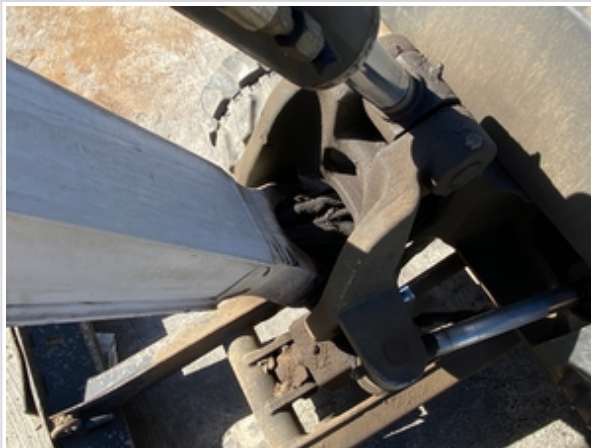
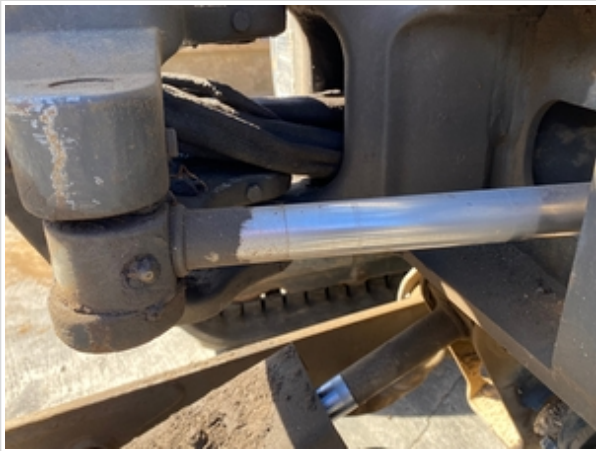
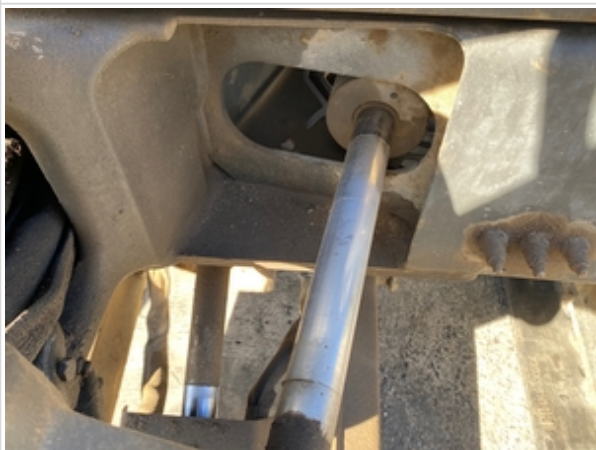
Boom Cylinder Photos

| Boom Cylinder: Oil Leaks | No |

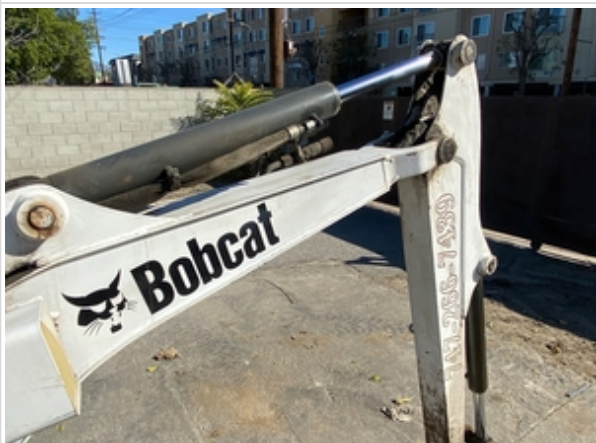
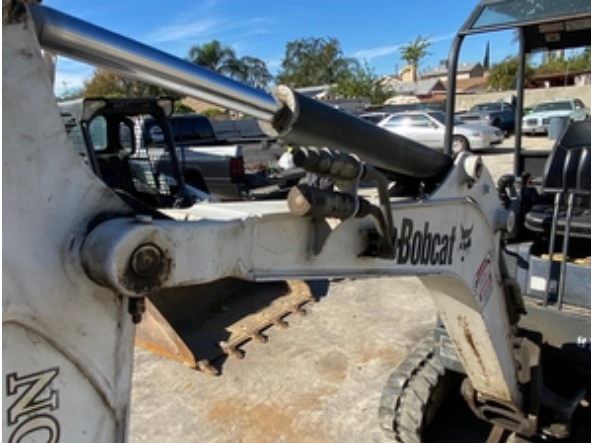
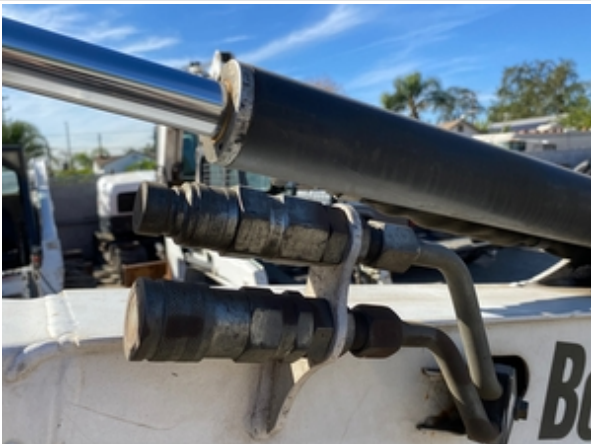
| <b>Stick Cylinder Photos</b> | | |

| <b>Stick Cylinder: Mounting Pin</b> | 3 | |
| <b>Stick Cylinder: Oil Leaks</b> | No | |
