Inspection Report (On-Highway Dump Truck)

Year	2011
Make	Peterbilt
Model	367
Serial Number	1NP - TLUOX - 2 - BD127975
Truck Odometer Reading	423,441
Previous Application (e.g., earth moving, mining, demolition, etc)	Asphalt Construction

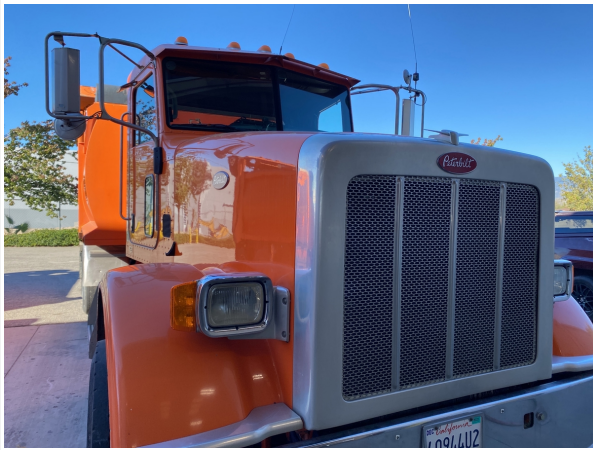
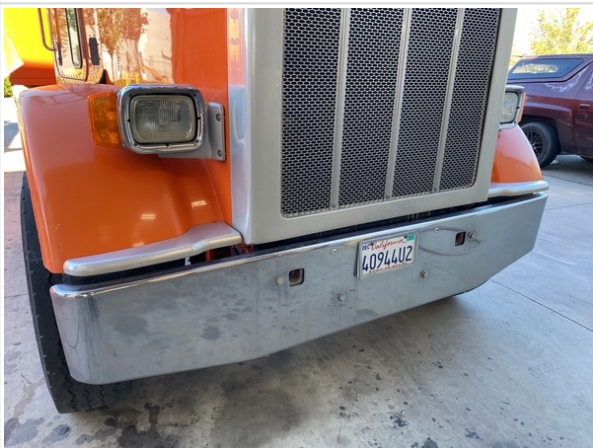
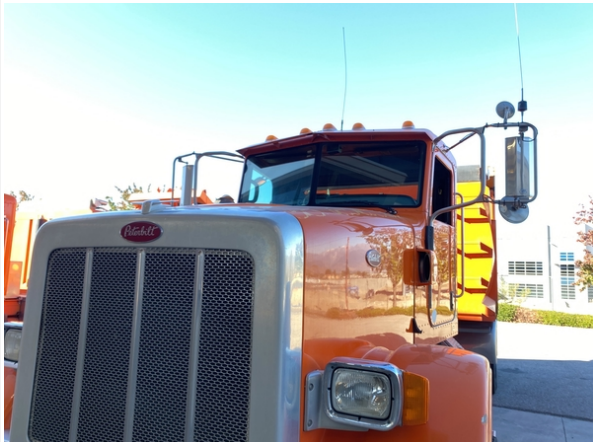
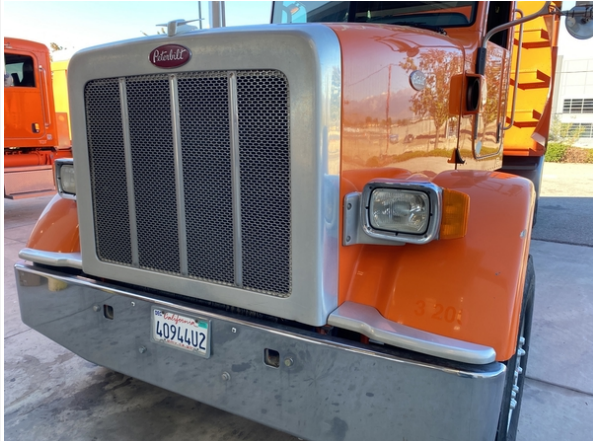
Front	3 - Normal Wear & Tear
Front Condition	No visible damage
Front Photos

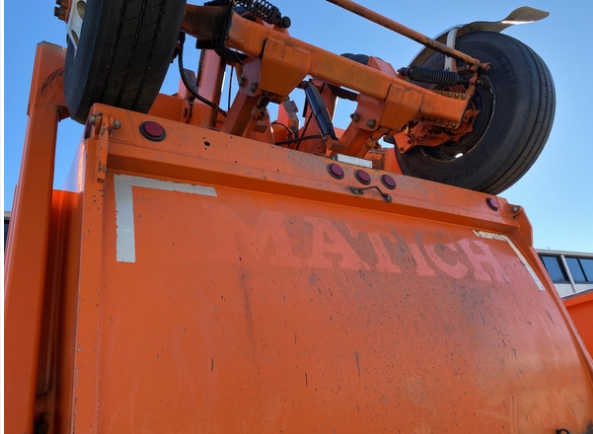
Rear	3 - Normal Wear & Tear
Rear Condition	No visible damage, Visible chipped paint or dents, Other (see comments)
Comments	Rear body straight and solid, normal wear
Rear Photos

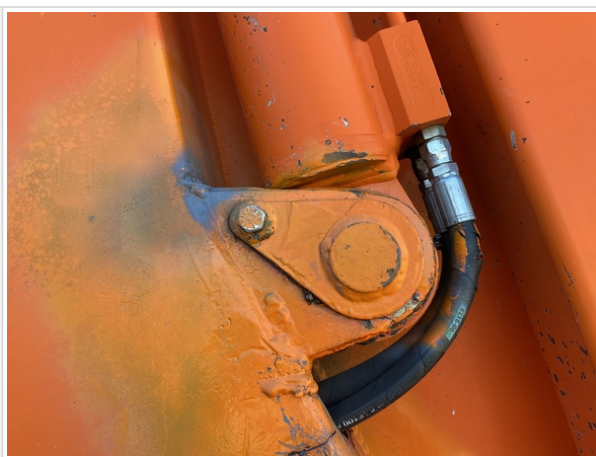
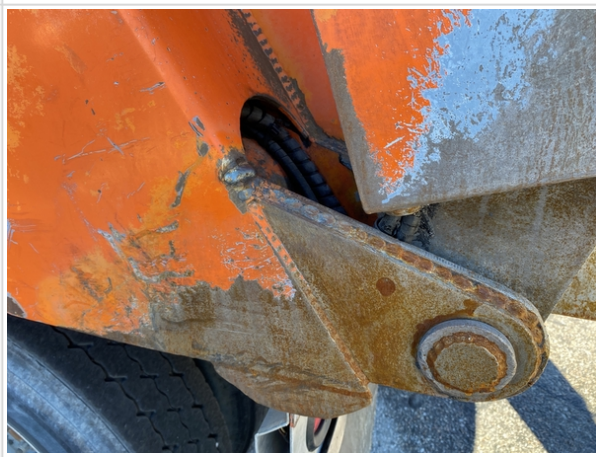
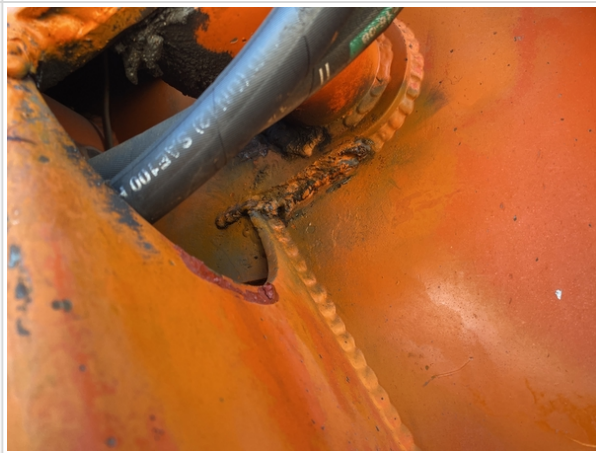
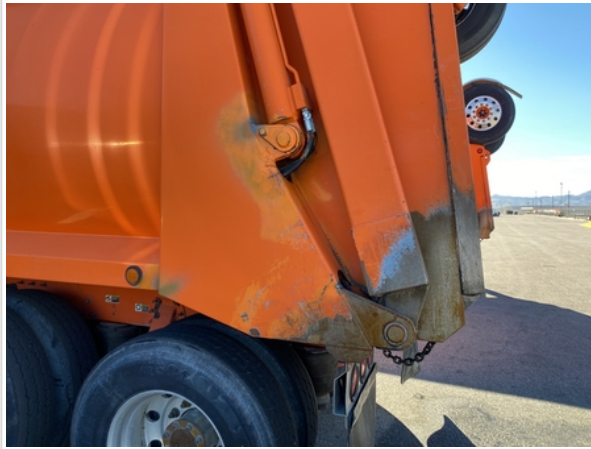
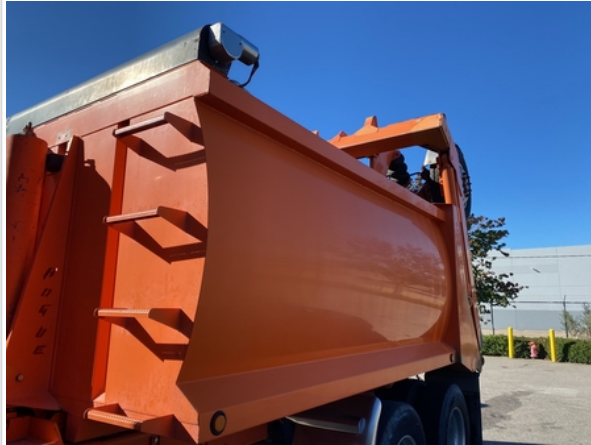
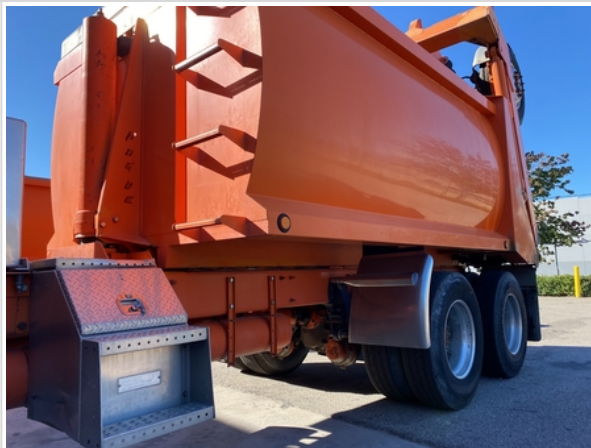
<p>Left Photos</p>

Left	3 - Normal Wear & Tear
Left Condition	No visible damage, Other (see comments)
Comments	Left side storage box dented

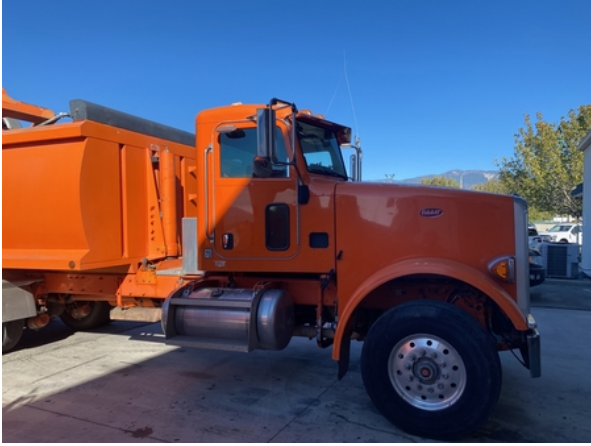
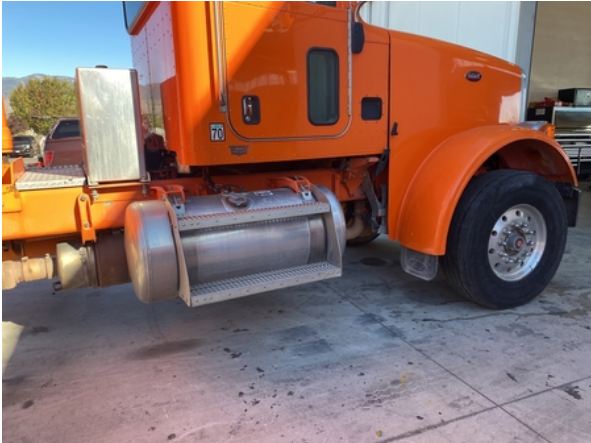
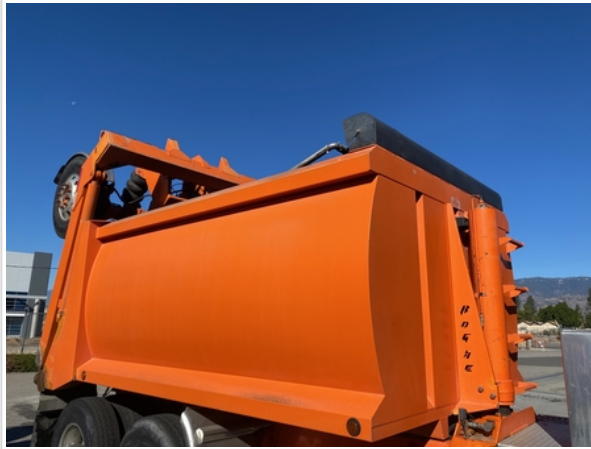
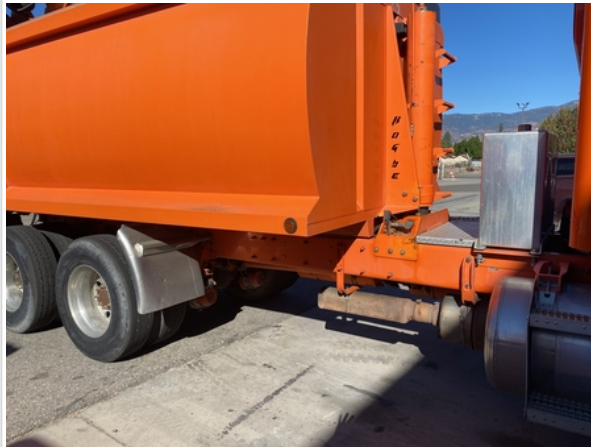
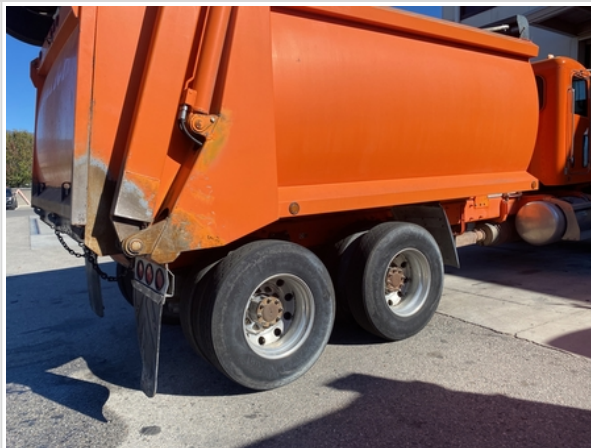
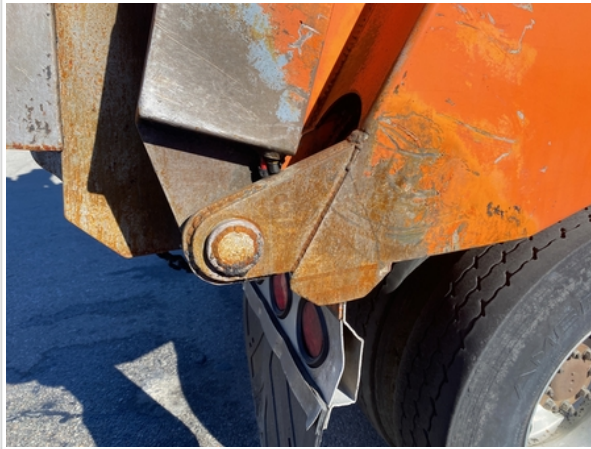
Right	3 - Normal Wear & Tear	
Right Condition	Visible chipped paint or dents, No visible damage, Other (see comments)	
Comments	No major damage just minor paint chipped areas on front fender	
Right Photos

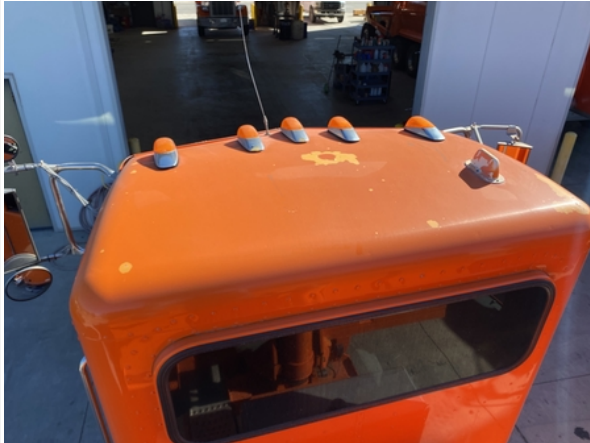
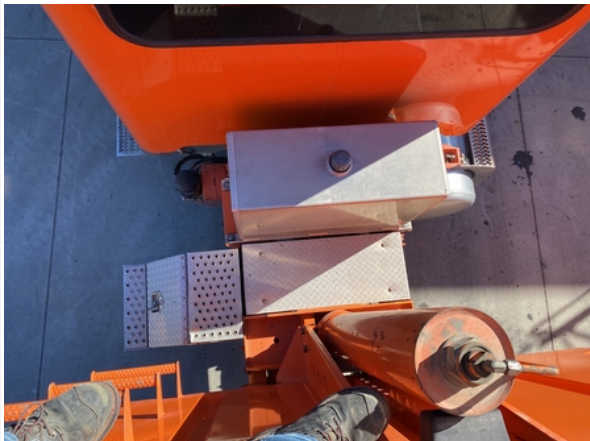
Upper	3 - Normal Wear & Tear	
Upper Condition	No visible damage, Other (see comments)	
Comments	Clear coat peeling	
Upper Photos

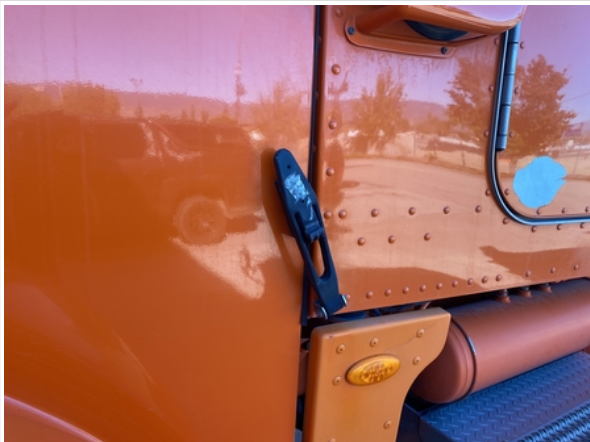
Body Panels (Any Rust Damage?)	3 - Normal Wear & Tear	
Body Panel Condition	No visible damage, good paint condition and panel fitment, Other (see comments)	
Doors / Canopy Latches	3 - Normal Wear & Tear	
Doors / Canopy Latches Condition	No visible damage	
Doors / Canopy Latches Photos

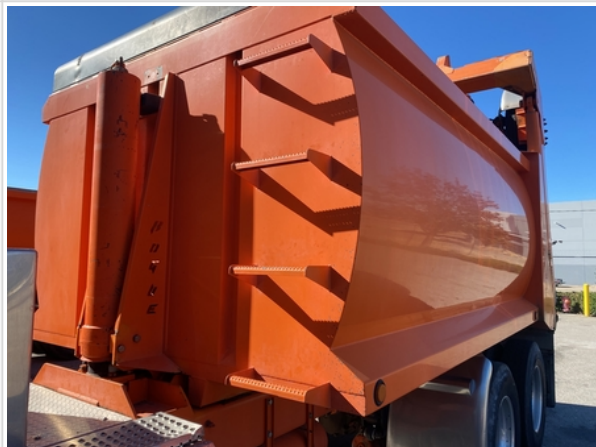
Steps / Ladders	3 - Normal Wear & Tear	
Steps / Ladders Condition	Steps/ladders are fully intact and appear structurally sound	
Steps / Ladders Photos

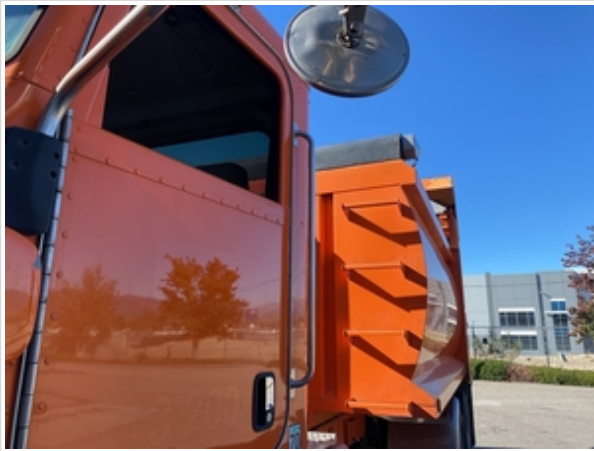
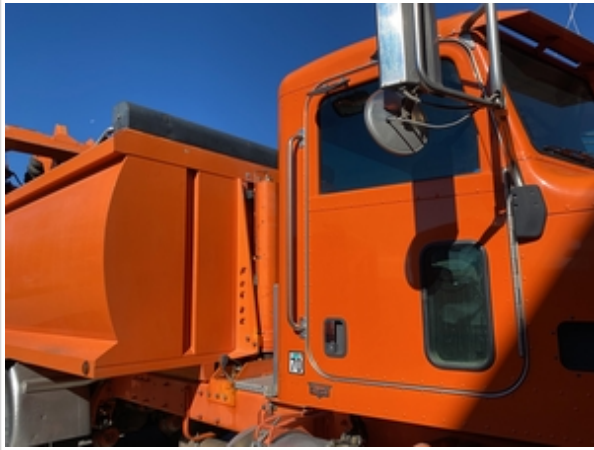
Handrails	3 - Normal Wear & Tear
Handrails Condition	Handrails are fully intact and appear structurally sound

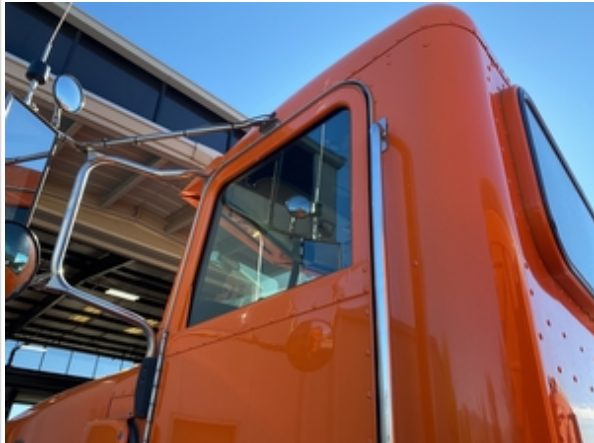
Glass Condition	3 - Normal Wear & Tear
Glass Condition Notes	Glass intact, no visible damage
Glass Condition Photos

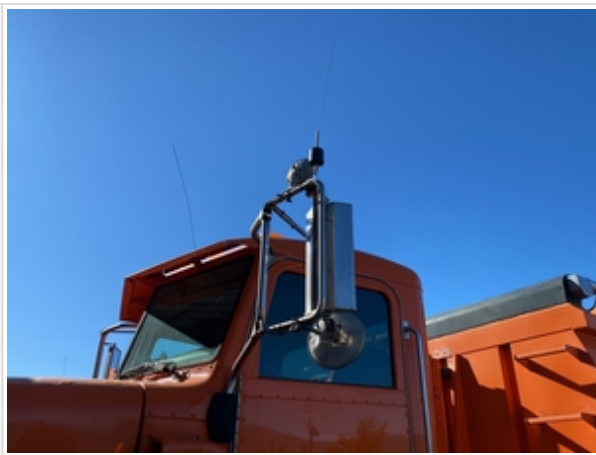
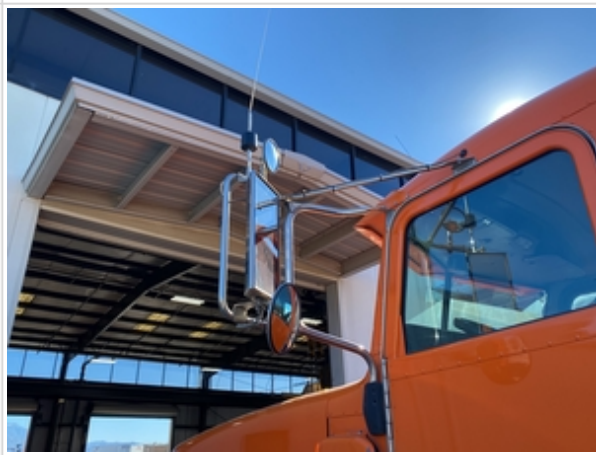
Mirrors	3 - Normal Wear & Tear	
Mirror Condition Notes	Mirrors present and intact, no visible damage	
Mirrors Photos

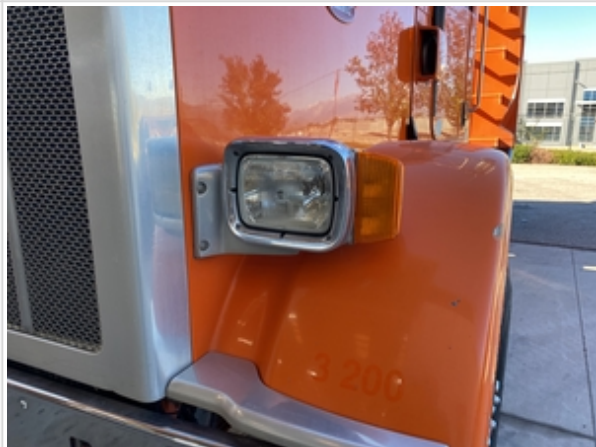
Lighting System	3 - Normal Wear & Tear	
Lighting System Condition	No visible damage, lighting system is operational	
Lighting System Photos

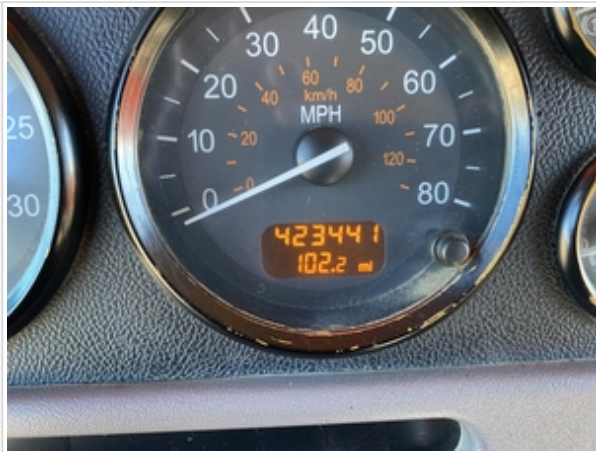
Odometer Activity Photos

<p>Odometer Activity</p>	<p>3 - Normal Wear & Tear</p>

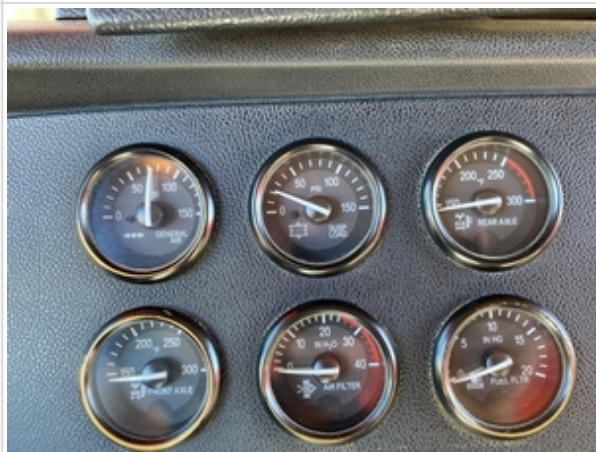
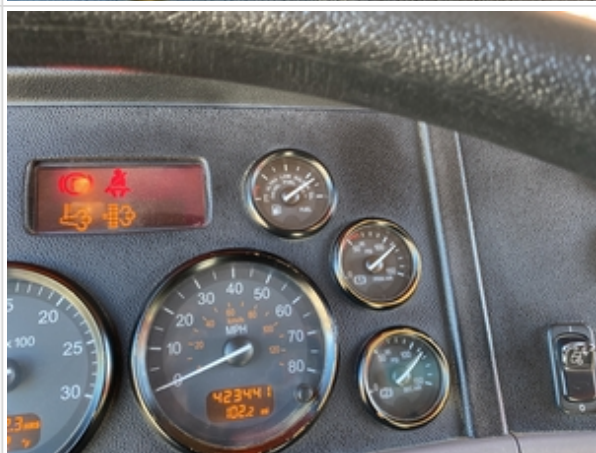
Other Gauge Activity	3 - Normal Wear & Tear
Other Gauge Activity Photos

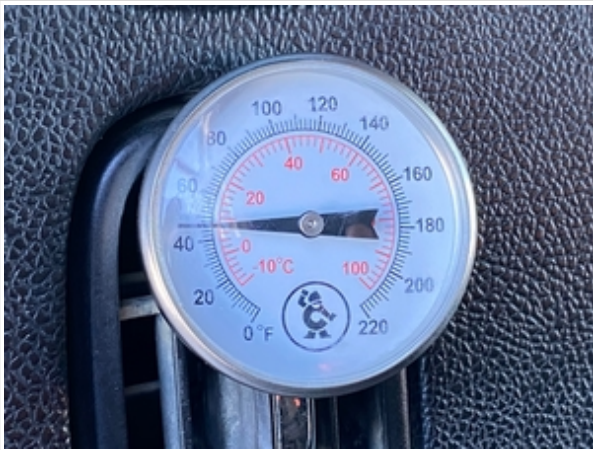
Heater & A/C	3 - Normal Wear & Tear
Heater & A/C Photos

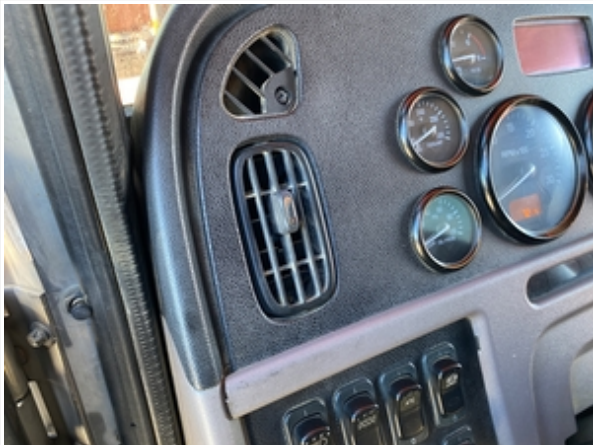
Fans / Vents	3 - Normal Wear & Tear
Fans / Vents Photos

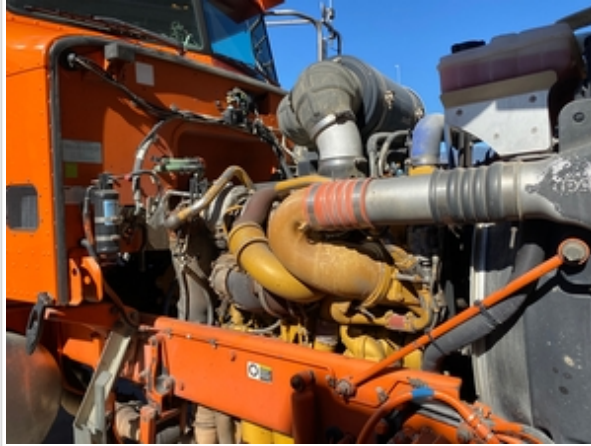
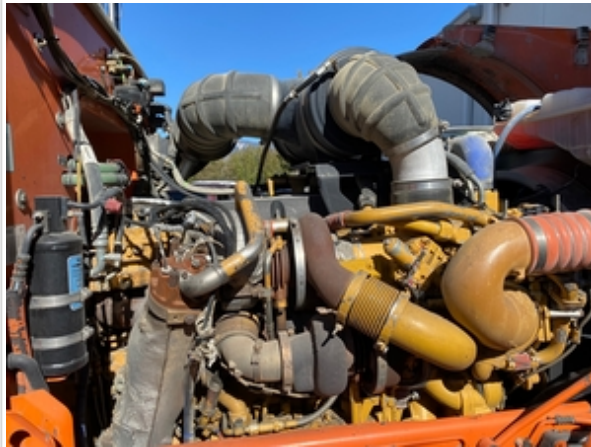
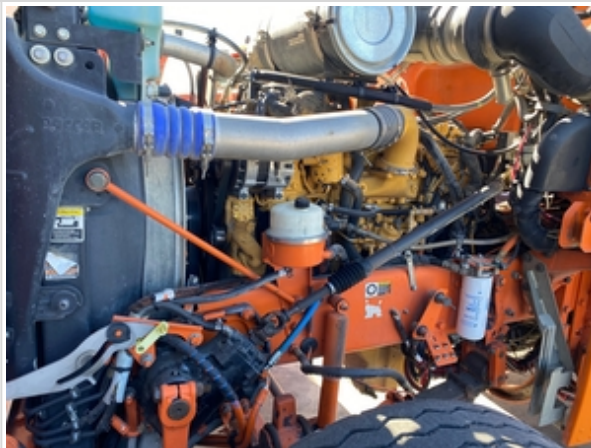
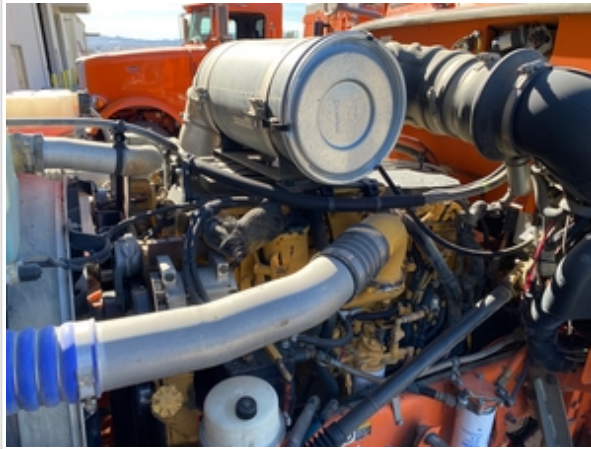
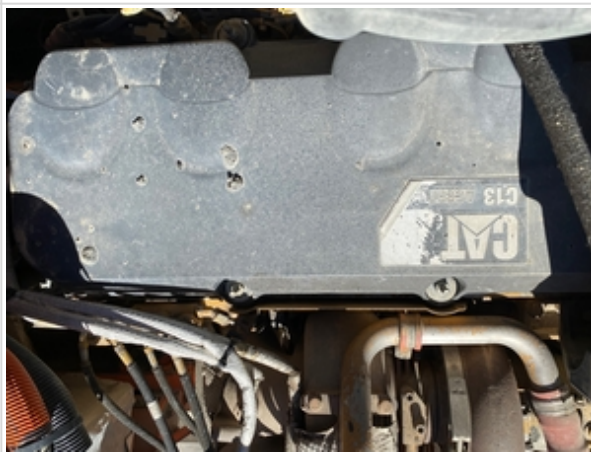
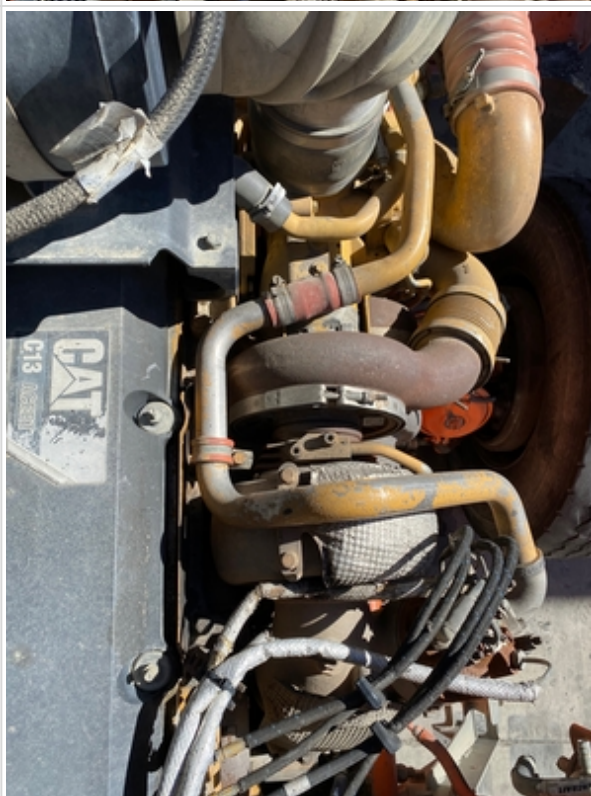
Engine Photos

Requires DEF (Diesel Exhaust Fluid)	No
Overall Engine Appearance	Clean & dry, Areas of dried seepage seen on engine hoses & components
Overall Engine Comments	Minor oil leak may be coming from engine oil pan and around bell housing.

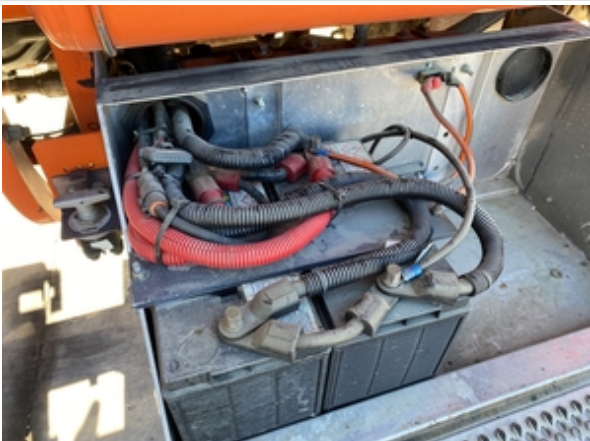
Blow-by (Visual Observation Check)	No	
Unusual Noises (Upon Start-up, Idle, Shutdown)	No	
Unusual Noise Notes	No unusual noises heard	
Engine Smoke (Upon Start-up, Idle, Shutdown)	No	
Engine Smoke Notes	No engine smoke issues observed	
Engine Exhaust Color	Clear	
Battery	2 - Above Average Wear	
Battery Condition	Needs charge or replacement	
Comments	Engine starter hesitation observed	
Battery Condition Photos

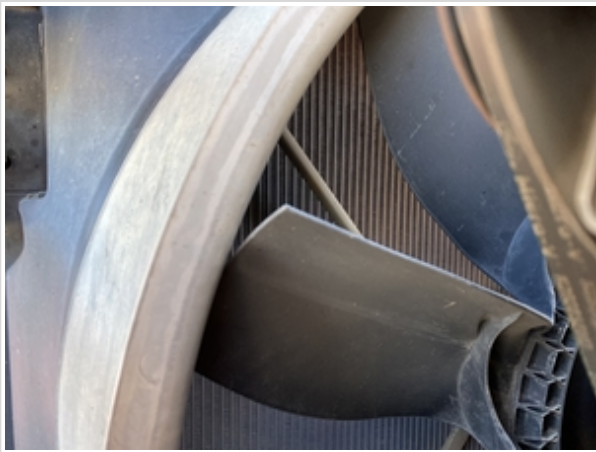
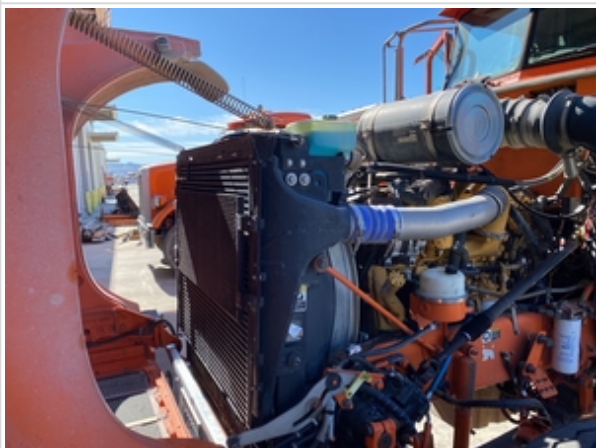
Radiator	3 - Normal Wear & Tear	
Radiator Condition	Radiator fins & components appear to be in good working order, no signs of damage or leaks	
Radiator Photos

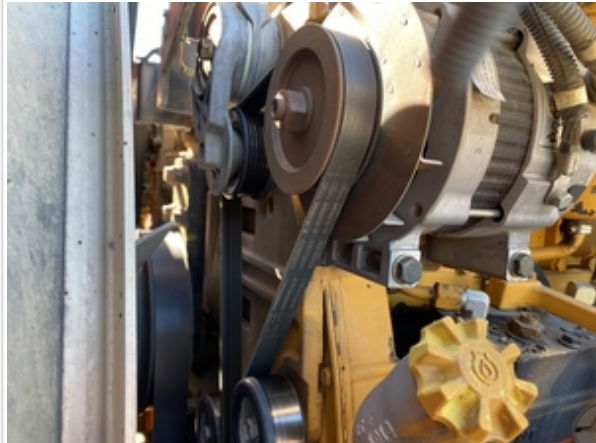
Belts	3 - Normal Wear & Tear
Belt Condition	Belts appear in good condition & alignment with proper tension
Belt Photos

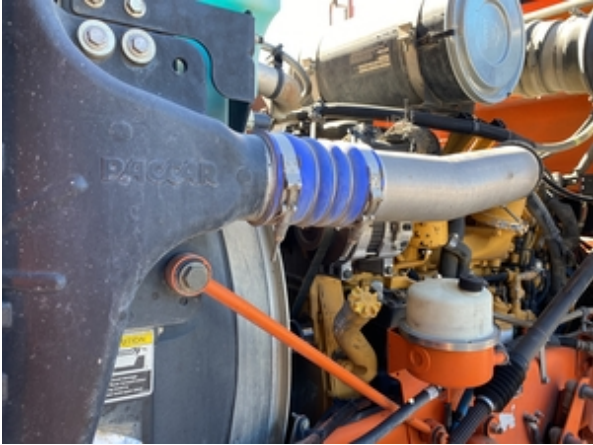
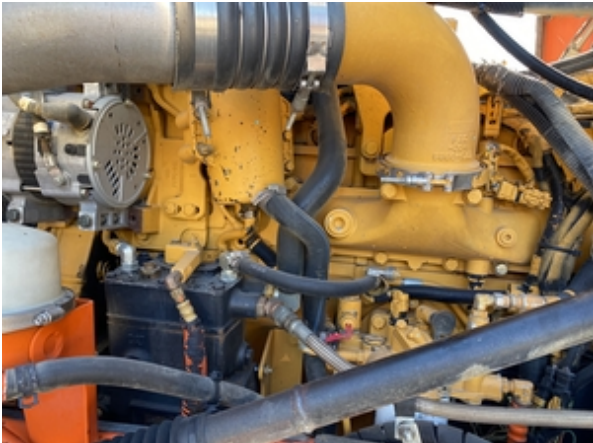
Hoses	3 - Normal Wear & Tear	
Hose Condition	Firm, pliant hoses with no signs of wear or leaks	
Hose Photos

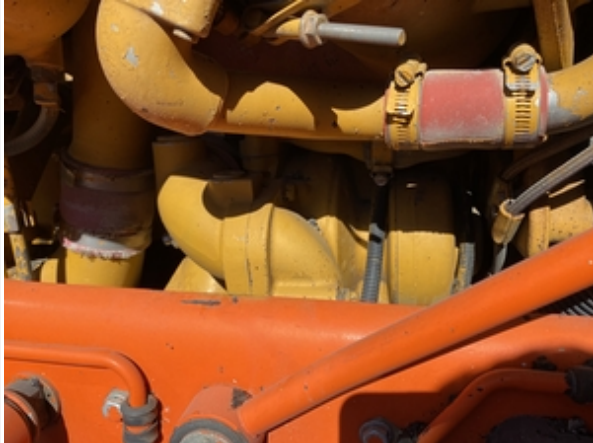
Water Pump Photos

Water Pump	3 - Normal Wear & Tear
Water Pump Condition	No unusual pump noises heard

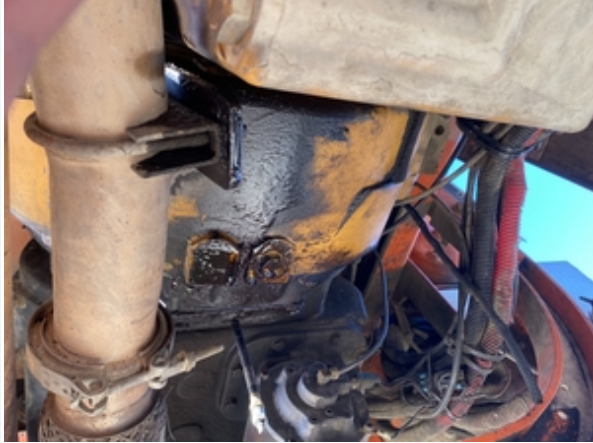
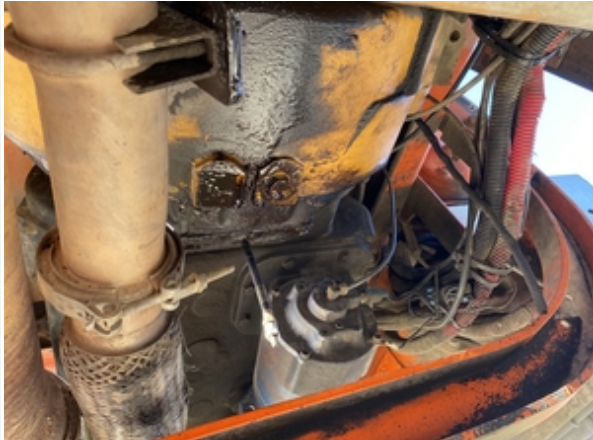
Cooling System Leaks	No
Coolant Color / Appearance	3 - Normal Wear & Tear
Coolant Color/Appearance Notes	Normal Translucent appearance, no visual signs of contamination
Oil Leaks	Yes
Oil Leak Notes	Wet areas with drops forming due to oil leakage, Other (see comments)
Comments	Oil leak at rear top side of oil pan and around bell housing
Oil Leak Photos

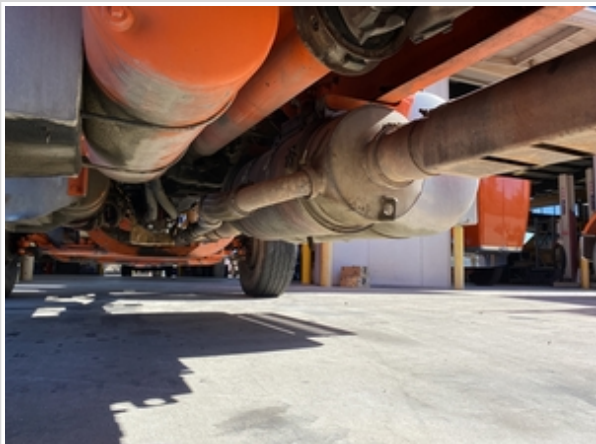
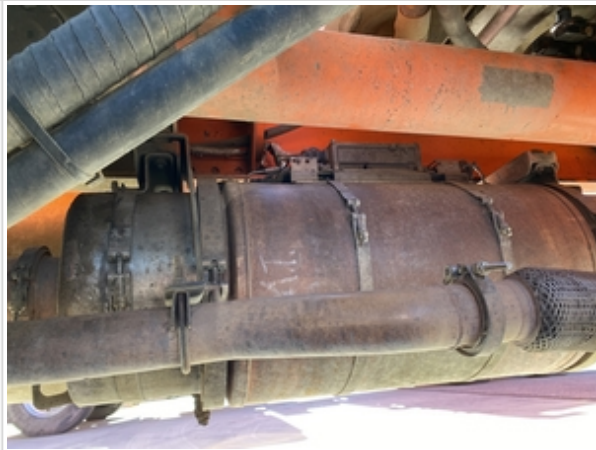
Oil Color / Appearance	3 - Normal Wear & Tear	
Oil Color / Appearance Notes	Clean oil appearance, no signs of cross contamination, Appropriate oil level	
Fuel Leaks	No	
Equipped with DPF (Diesel Particulate Filter)	Yes	
DPF Condition	3 - Normal Wear & Tear	
DPF Condition Notes	Filter housing is intact with no signs of damage or malfunction, DPF indicator is not illuminated	
DPF Photos

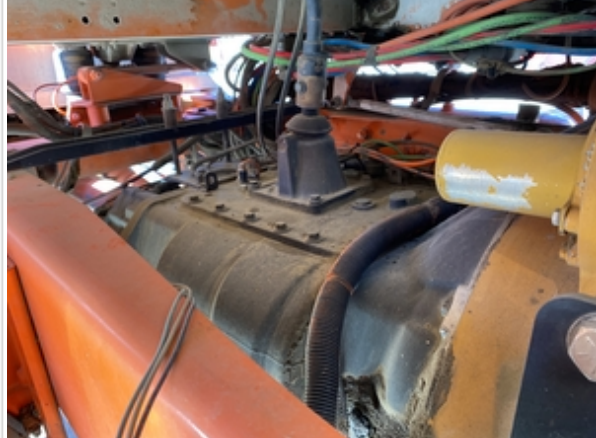
Transmission Info (Make/Model)	Eaton 10 Speed Manual
Drive Type	6X4
Overdrive	No
Transmission	3 - Normal Wear & Tear
Transmission Condition	No unusual noises or vibrations
Transmission Condition Photos

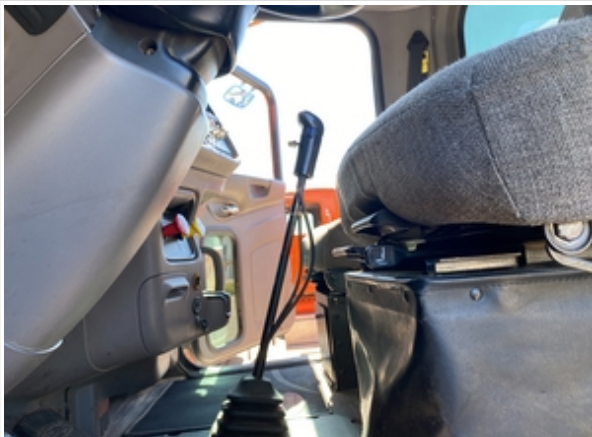
Clutch	3 - Normal Wear & Tear	
Clutch Condition	Clutch is functioning as expected	
Shift Lever	3 - Normal Wear & Tear	
Shift Lever Condition	Good forward and reverse function	
Shift Lever Photos

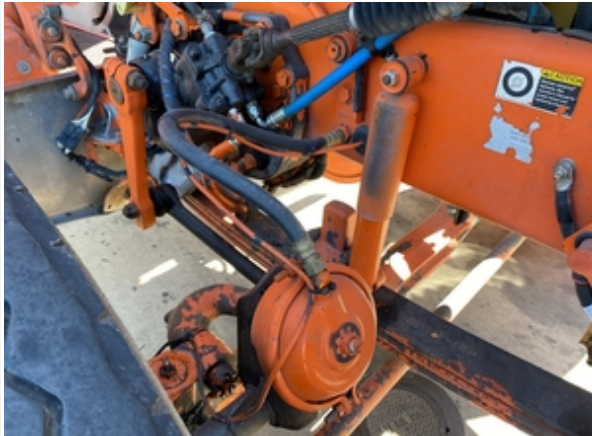
Brake System Type	Air Brakes	
Air Brakes Build Correct Pressure	Yes	
Air Brake System Leaks	Yes	
Comments	Minor air leak observed beneath cab	
Air Brake Hose Condition	3 - Normal Wear & Tear	
Air Brake System Photos

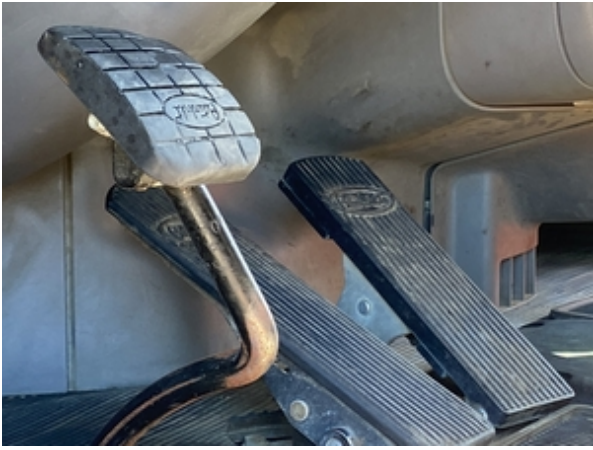
Foot Brake	3 - Normal Wear & Tear	
Foot Brake Condition	Good brake function	
Foot Brake Photos

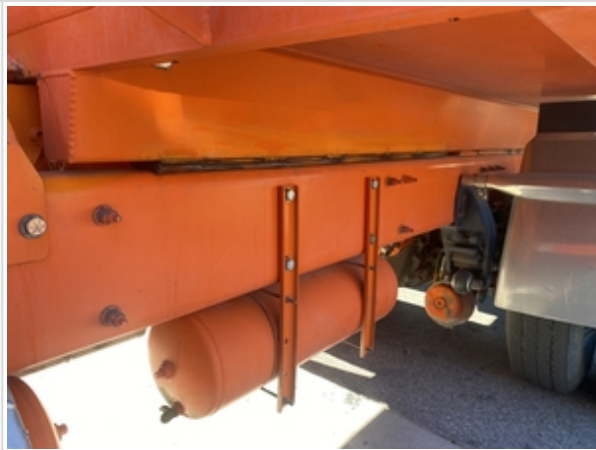
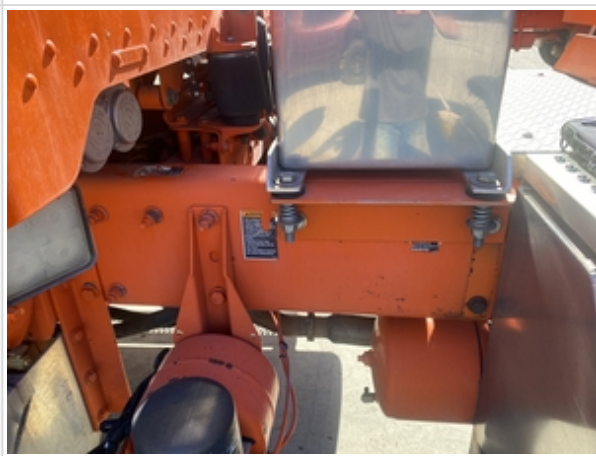
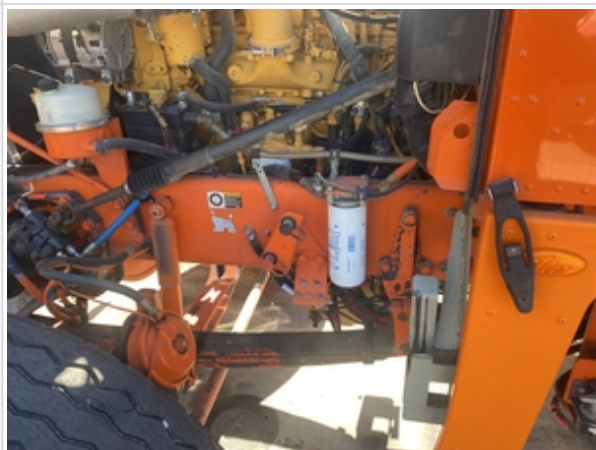
Frame Condition	3
Frame Photos

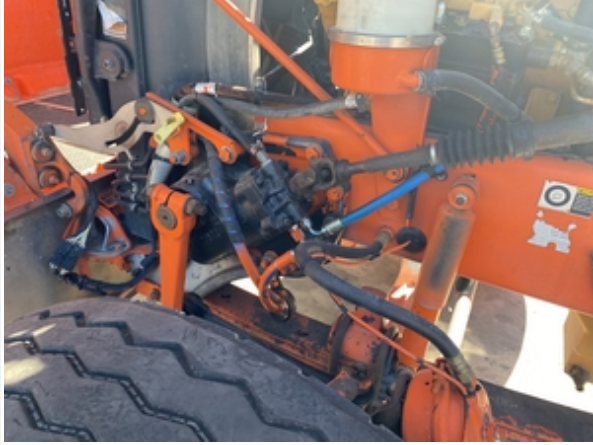
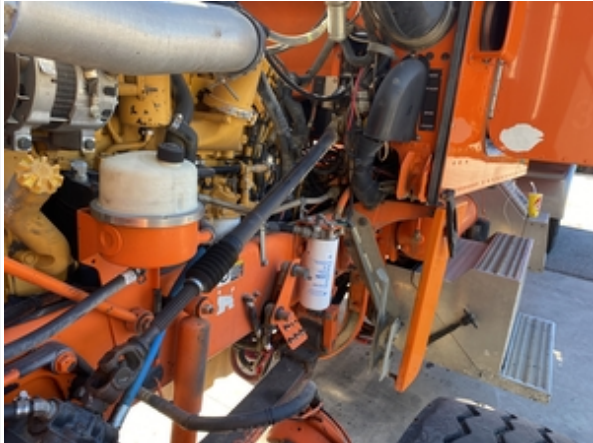
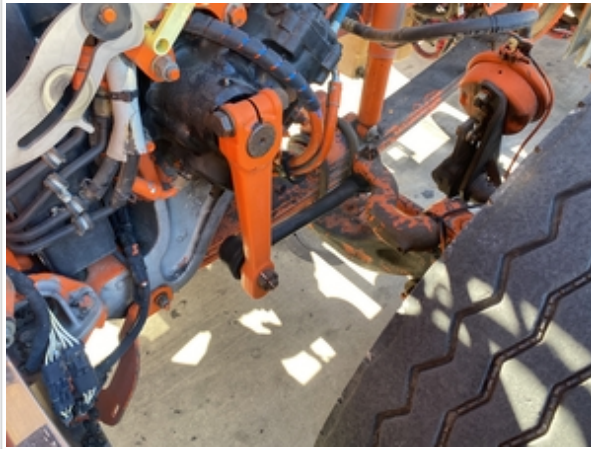
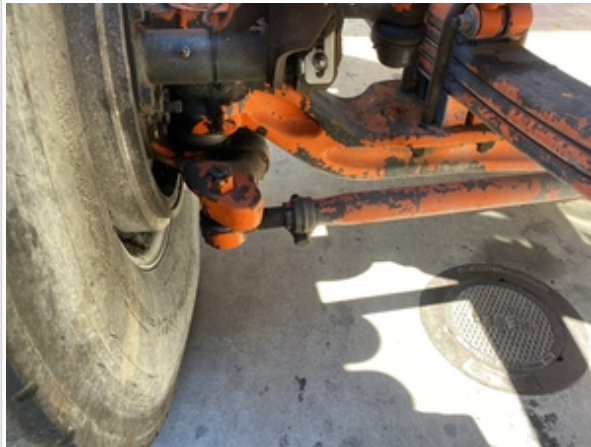
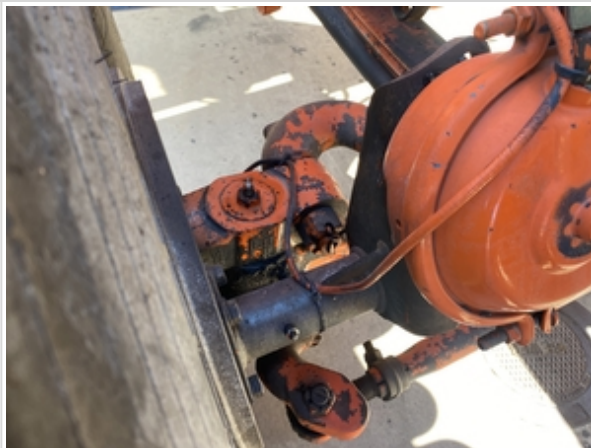
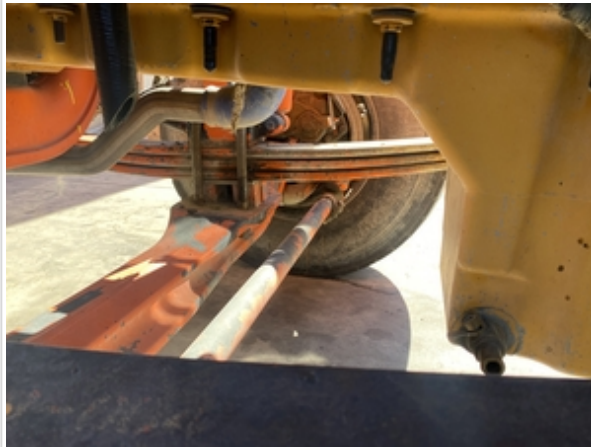
Steering Components	3
Steering Components Photos

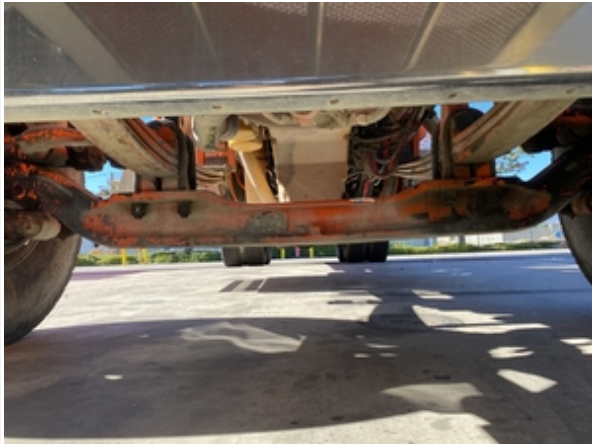
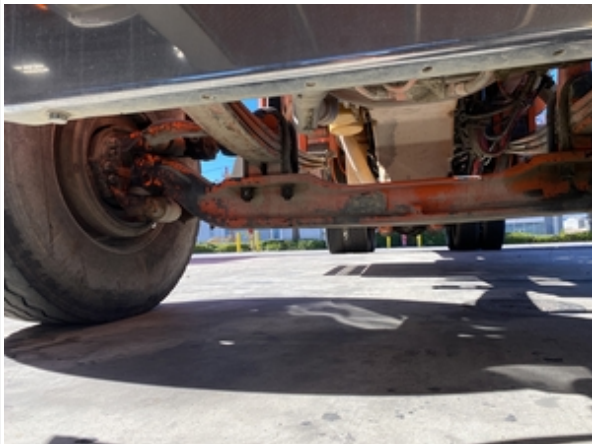
Steer Axle Condition	3	
Steer Axle Photos

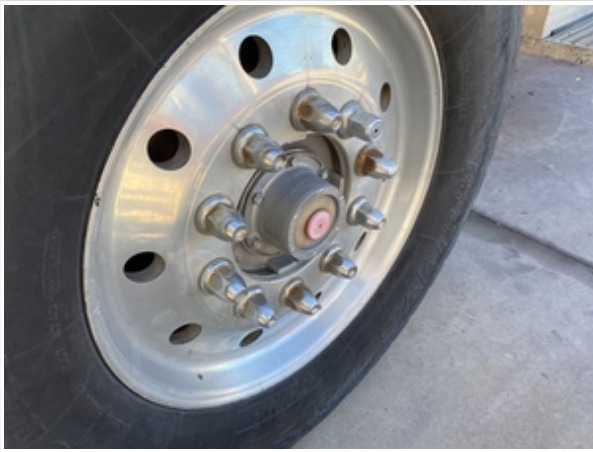
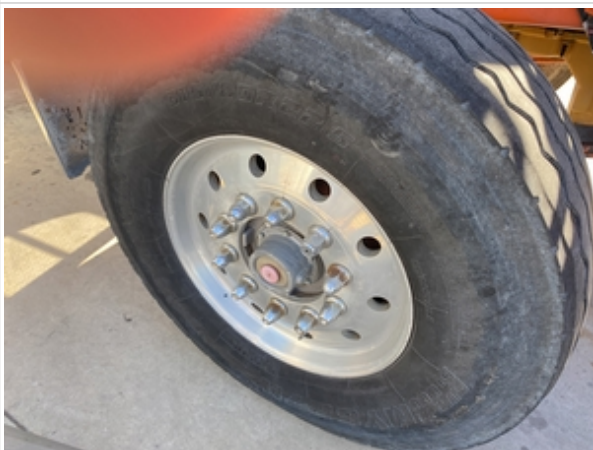
Wheels & Hub Condition	3
Wheels & Hub Photos

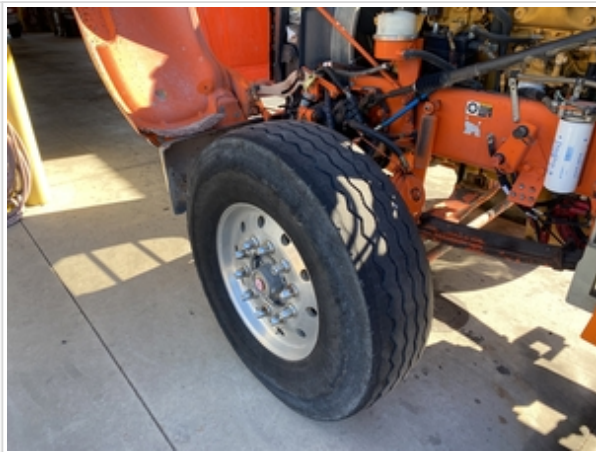
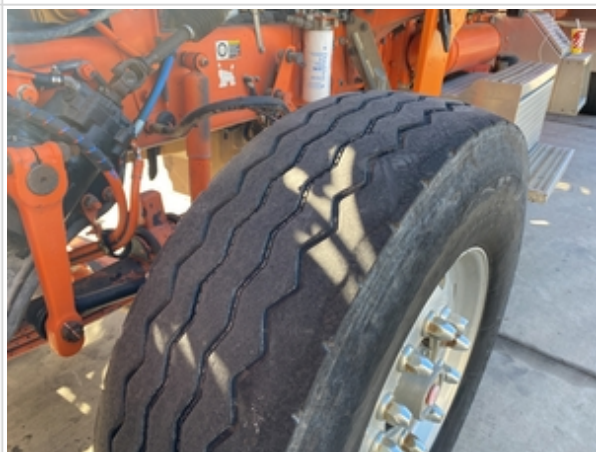
Front Left Tire Photos

Wheel Seal Leaks	No
Tire Brand	(Front) Yokohama (Rear) generic recaps
Tire Size	315/80R/22.5 (Rear) 11R22.5
Front Left Tire - Ratio Remaining	10%

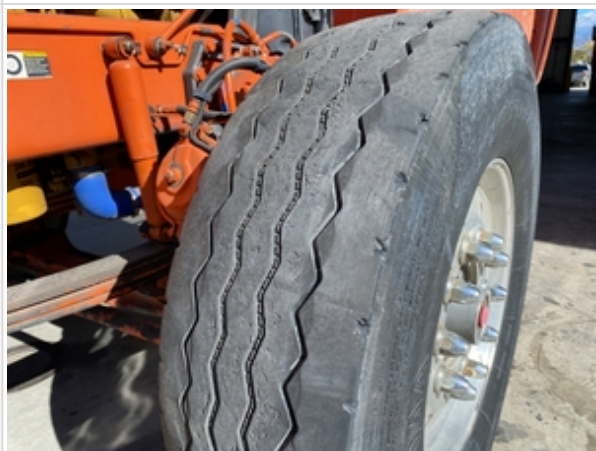
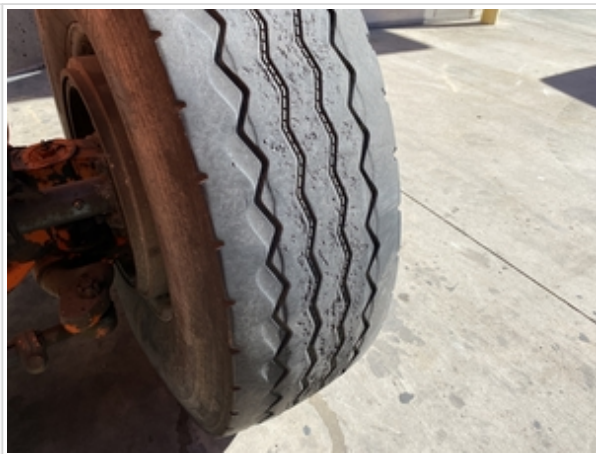
Front Right Tire - Ratio Remaining	10%
Front Right Tire Photos

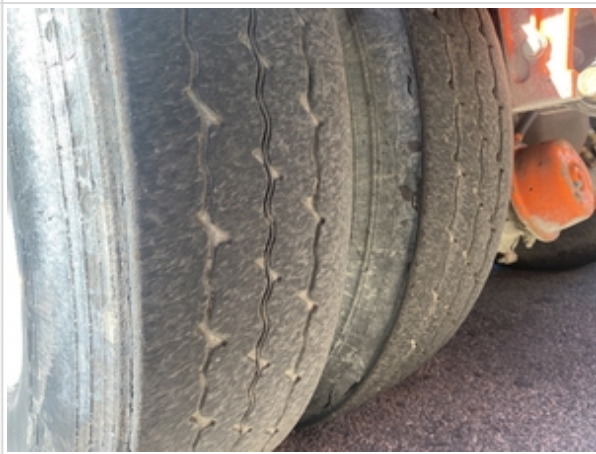
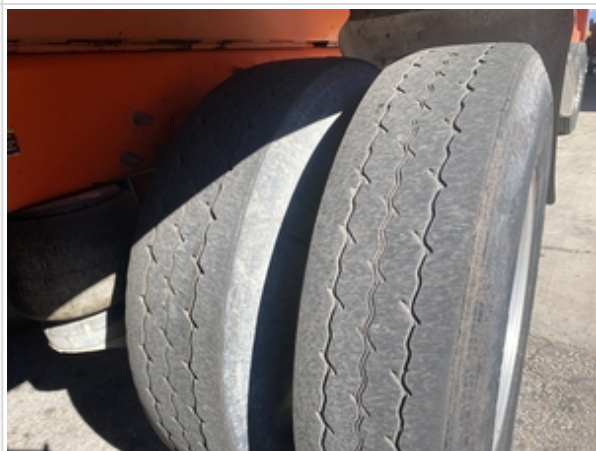
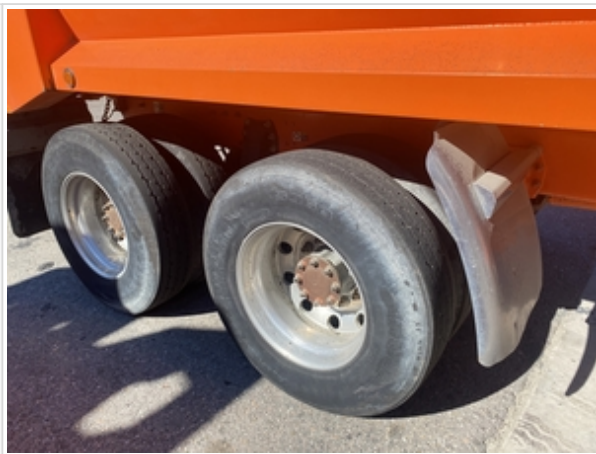
Rear Right Tire - Ratio Remaining	10%	
Rear Right Tire Photos

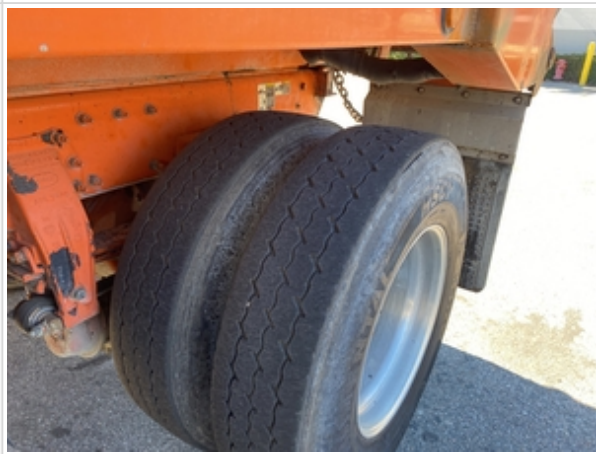
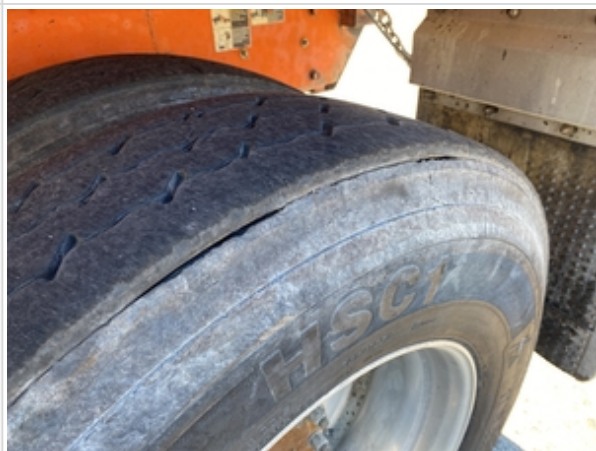
Rear Left Tire - Ratio Remaining	10%	
Rear Left Tire Photos

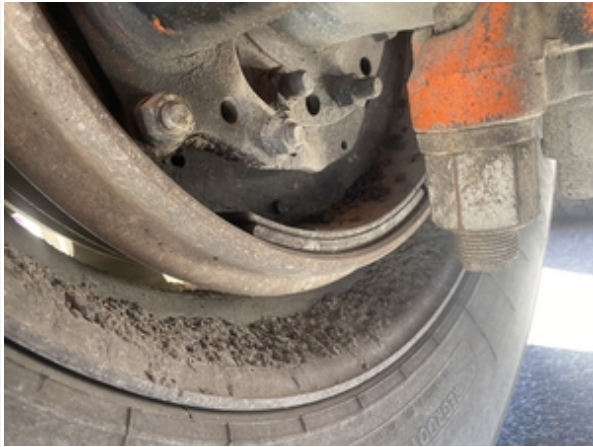
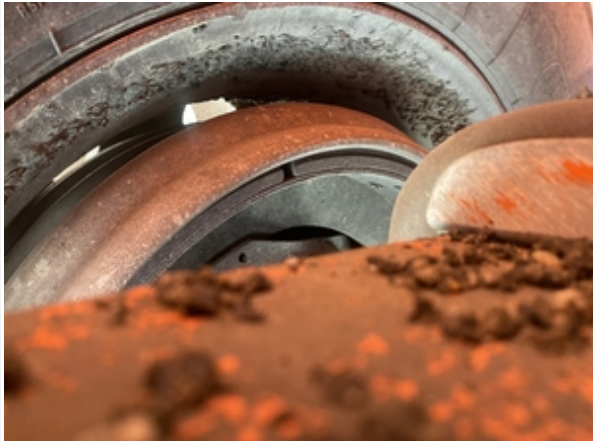
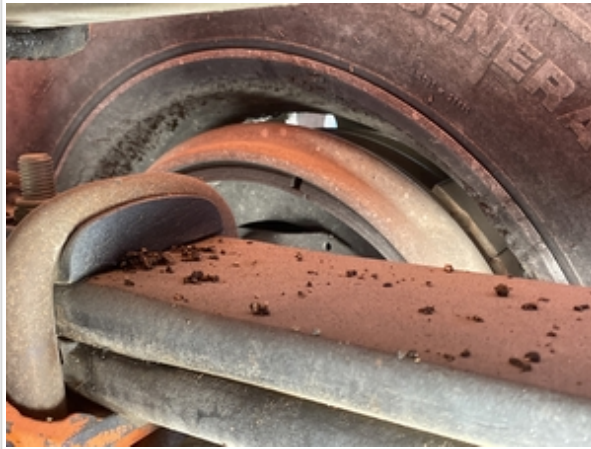
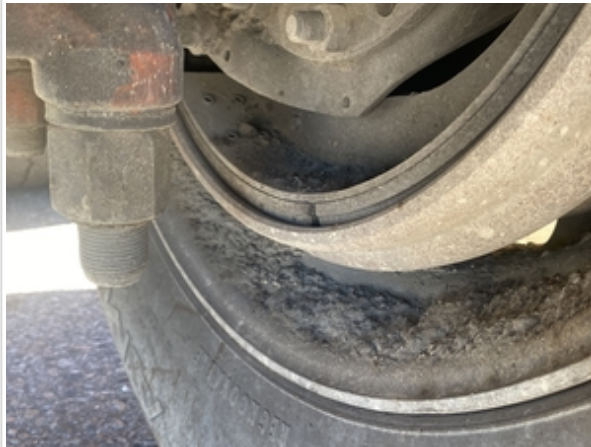
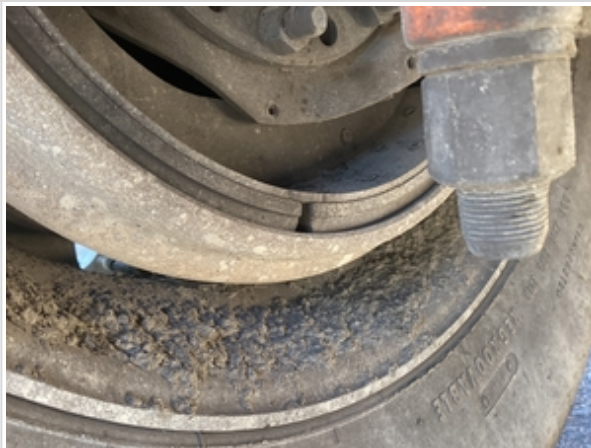
Brake Shoe Thickness	30%
Comments	3rd axle (rear) brakes shoes above 50% all others at 30% life left
Brake Shoe Photos
